# WEST MARTELLO TOWERS HISTORIC AMMUNITION BUNKERS

## DAMAGE ASSESSMENT REPORT

January 2019

# Structural Condition Assessment West Martello Batteries and Ammunition Bunkers Key West, Florida

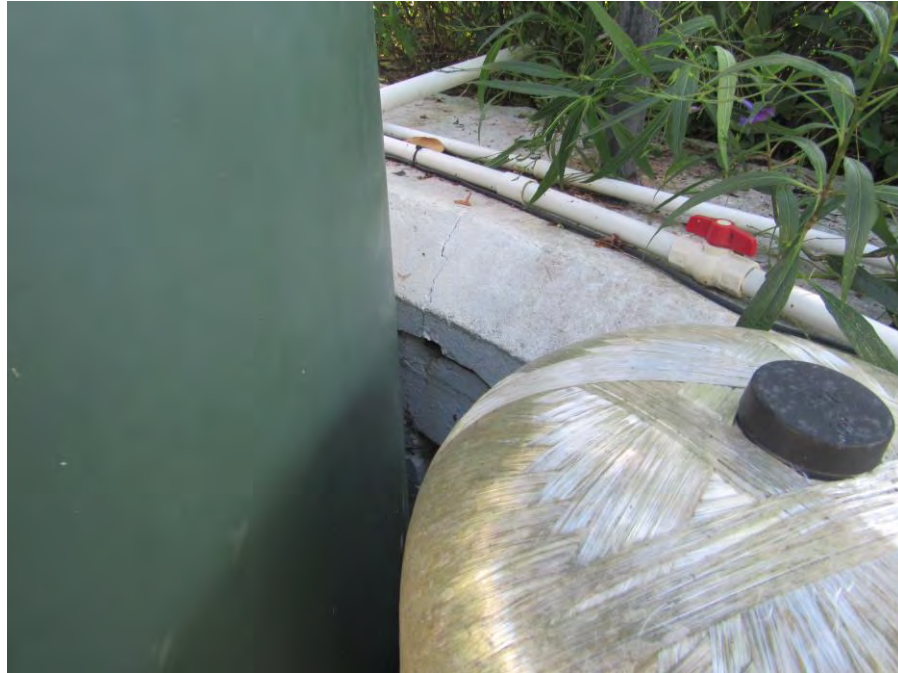
**Photograph 3**

The gun emplacement walls are in good condition with random vertical and horizontal hairline cracks and one (1) location of rust stains indicating exposed corroding reinforcing (See Photographs 3, 4 and 5). Each artillery gun emplacement wall has two (2) expansion joints through the wall that are open, and the sealant has deteriorated away (see Photograph 6).

The West Martello artillery gun emplacements are in good condition, but they do require repair. The expansion joints need to be cleaned of debris and filled with sealant and the exposed corroding reinforcing drilled out and patched with a corrosion inhibiting repair mortar. The hairline cracks should be injected with epoxy to weatherproof them.

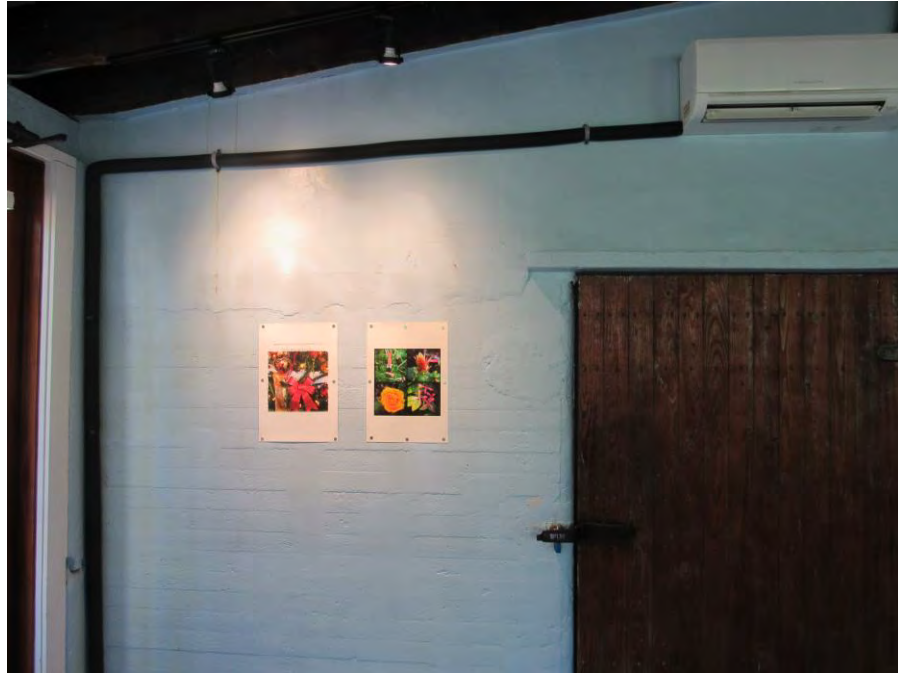
Photograph 7

The ammunition bunker walls are also in good condition with random vertical hairline cracks and isolated larger cracks. Over the doors, there are large areas of wall that are spalling (see Photograph 7). The bottoms of the ammunition bunker slabs are in poor condition with the east and west slab bottoms delaminated, and exposed corroding reinforcing (see Photograph 8). At the middle ammunition bunker, the slab bottom is partially delaminated with exposed corroding reinforcing. The remainder is separated from the main slab above and could fall at any time.

The ammunition bunker walls are also in good condition, but they do require repair. The hairline cracks should be injected with epoxy and the larger cracks filled with a flowable corrosion inhibiting repair mortar. The wall areas that are spalling should have the loose concrete removed and replaced with a corrosion inhibiting repair concrete. The bottoms of the ammunition bunker slabs are in poor condition, but due to their significant thickness, are stable. To repair them, all loose concrete needs to be removed and the existing reinforcing cleaned of corrosion and supplemental reinforcing added with the new steel mat connected to the upper main slab, and new concrete placed at the bottom of the slabs. The bottom of the slabs should be board-formed to match the walls and existing slab bottoms, and the concrete should contain a corrosion inhibitor and should be self-consolidating to aid in placement. The middle ammunition bunker should have the delaminated slab bottom concrete that is still in place removed, or the bunker should not be used for storage until the slab is repaired.

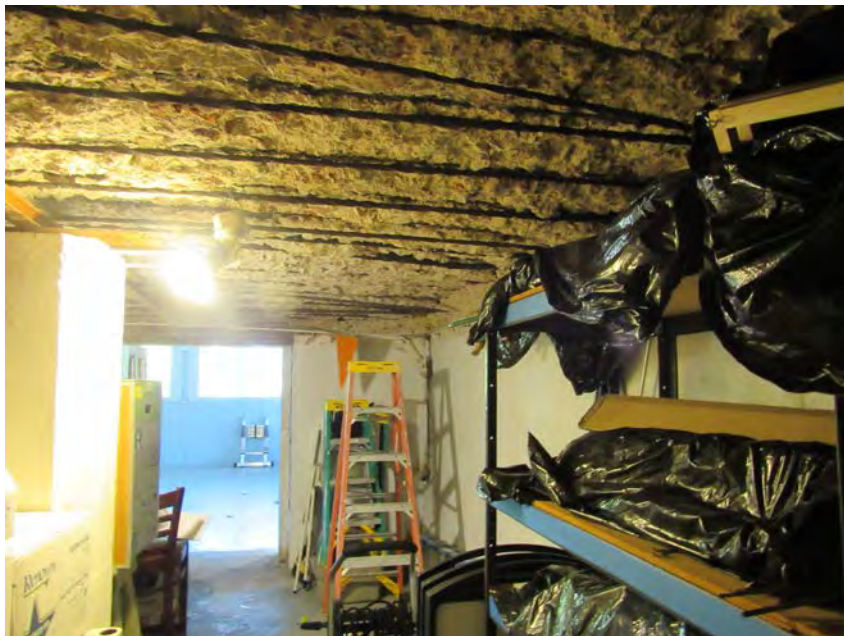
A view of the bunker interior. The finishes of the three ammunition bunkers consist of painted concrete walls, floors and ceilings. The ceilings of the bunkers have delaminated, and around 6" of the 4 foot thick ceiling has fallen. The cause of this delamination is the original reinforcement

bars, which have rusted and expanded, popping off the lower layer of concrete. The original ceilings of the bunkers were board formed concrete. There are also many smaller cracks in the concrete, caused by spalling concrete. The concrete ceilings and walls should be repaired, which is the goal of this project. The Secretary of Interior's Standards dictate that the repair should match the original finishes, board formed concrete.

The structural assessment of this report explains the proposed concrete repair method in detail.

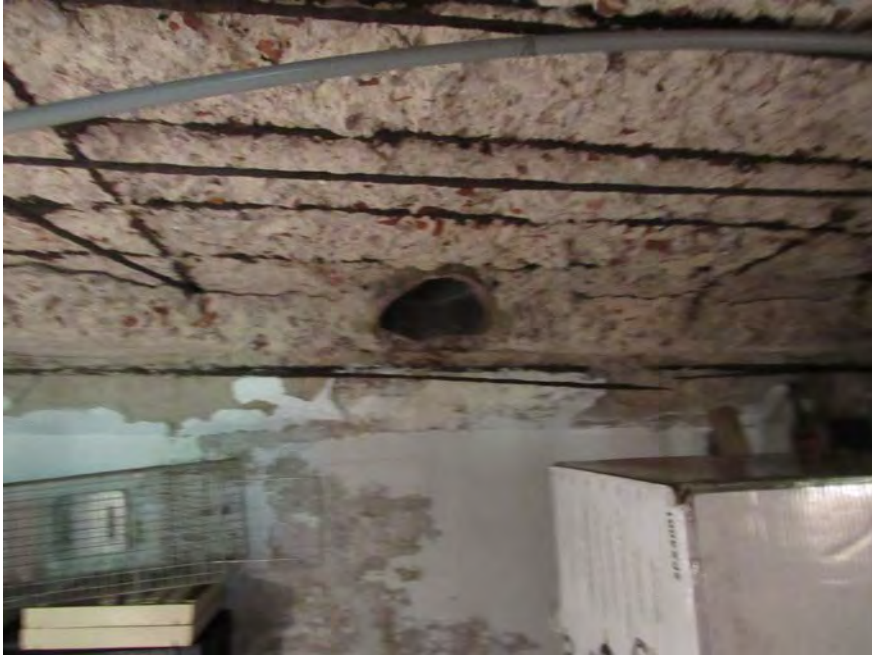
Each of the bunkers contains a ventilation shaft at the rear. This 12" wide shaft is composed of hollow clay pipe, and originally provided fresh air from the top. The pipes are blocked by small concrete plugs now, and terminate around 8" below the existing earth surface of the top of the bunker. The pipes are historic, and should be retained. It is possible that the pipes can be used to assist in the pouring of new concrete ceilings, to admit concrete and to expel air during the pour.

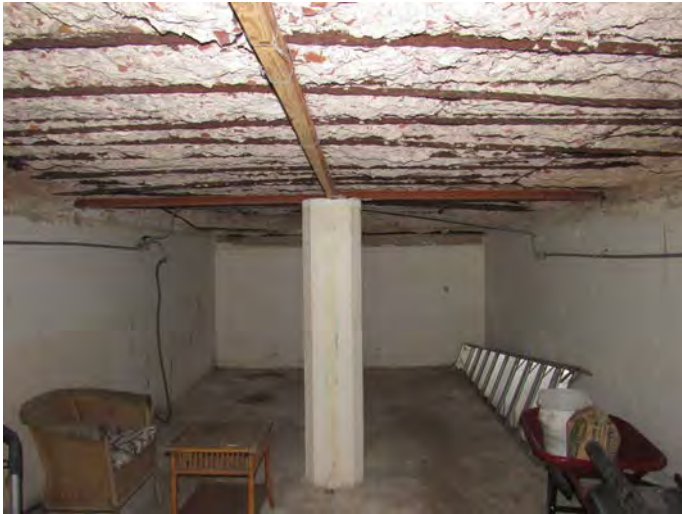
General view of empty ammunition bunker. Each bunker has a single concrete column at center. The original 1904 rebar can be seen running through the ceiling. This bar has rusted and expanded, causing the delamination of the lower 6" of the concrete ceiling, which is several feet thick. The bar and the small metal beams should be removed before new concrete is poured. New reinforcement will then be installed, followed by a new pour of board-formed concrete. The concrete can be poured from the top, utilizing the original ventilation pipes and new holes. All of the miscellaneous electric conduit should also be removed.

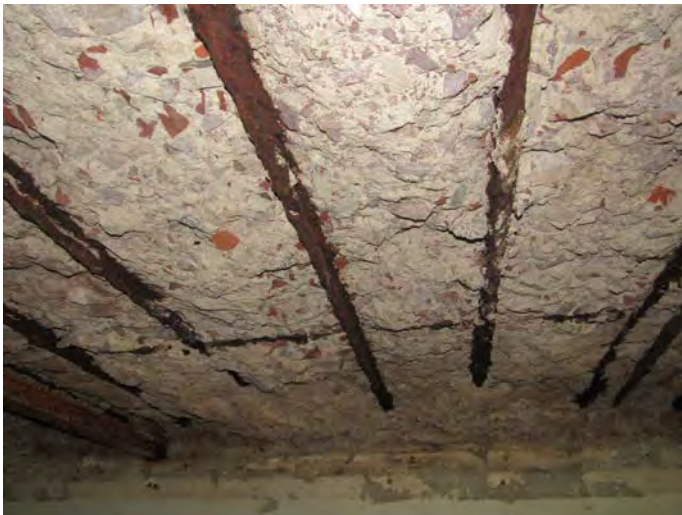
This detail photo of the ceiling shows the original rebar partially embedded in the concrete. The original bar was square and was twisted. Note the chips of brick in the concrete. All of this rebar should be removed and new bar should be installed, which should be doweled and epoxied to the original concrete.

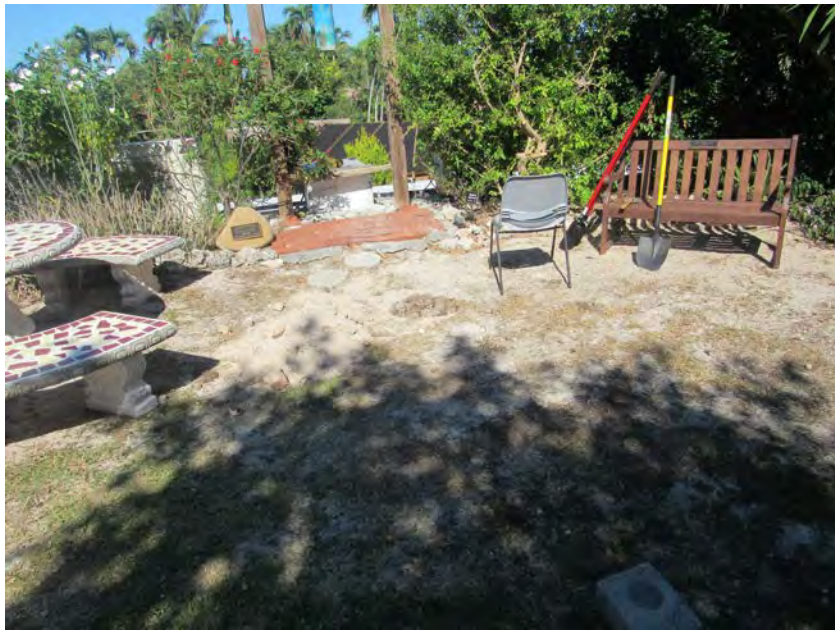
General view of the top of the bunkers. During this assessment, holes were dug to locate the original vent pipes, which are around 8" below the surface and capped with a thin layer of concrete. These pipes can be excavated and used in the new concrete pour.

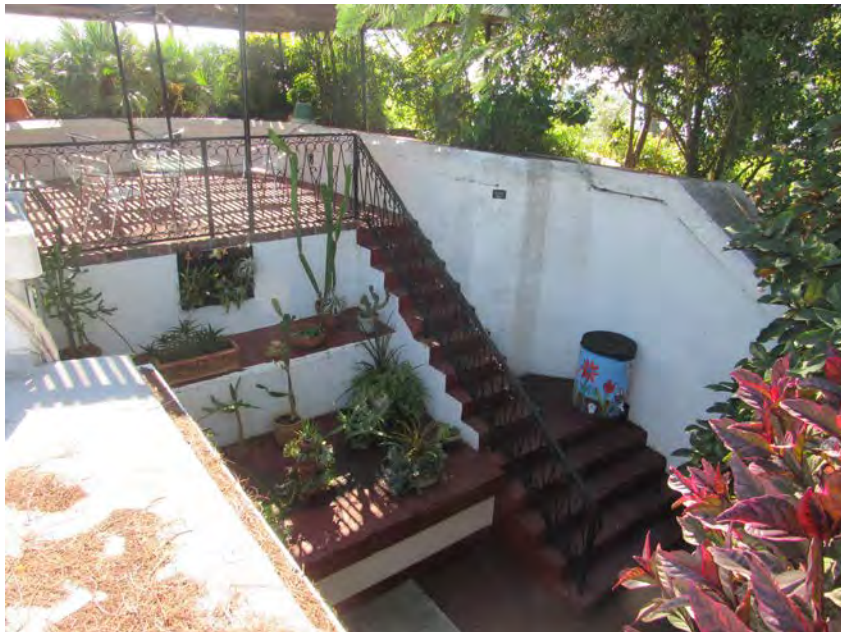
This photo shows the original gun mount at the west side. The gun mount walls and stairs are in fairly good condition, and are used as a garden area housing native and exotic plants. Contemporary stair railings and guardrails have been installed, as well as a trellis. Many of the walls have minor cracks which should be repaired in this scope of work.

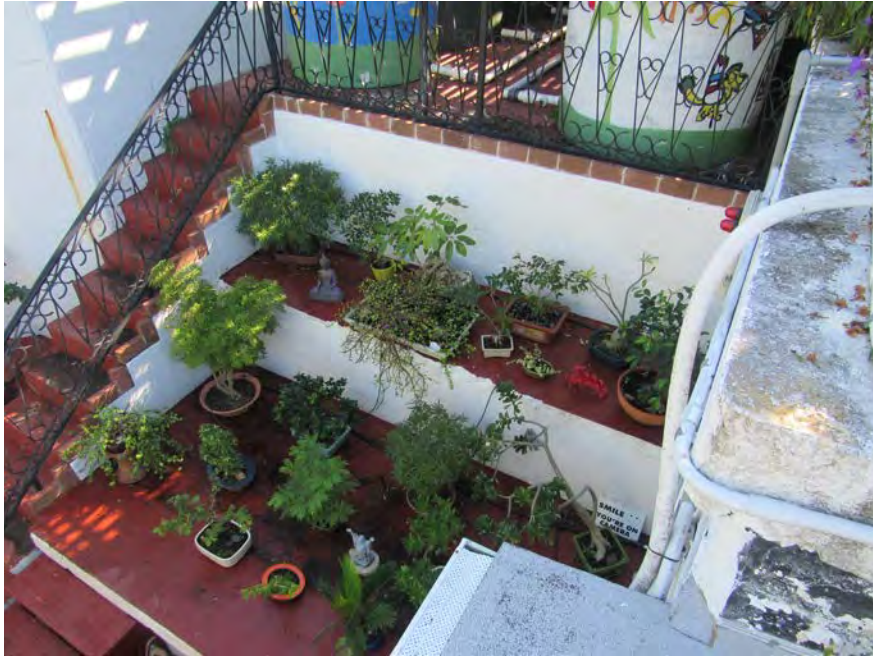
This photo shows the original gun mount at the east side, which is identical to the west, and used for the same purpose. These walls also have minor cracks which should be repaired in this scope.

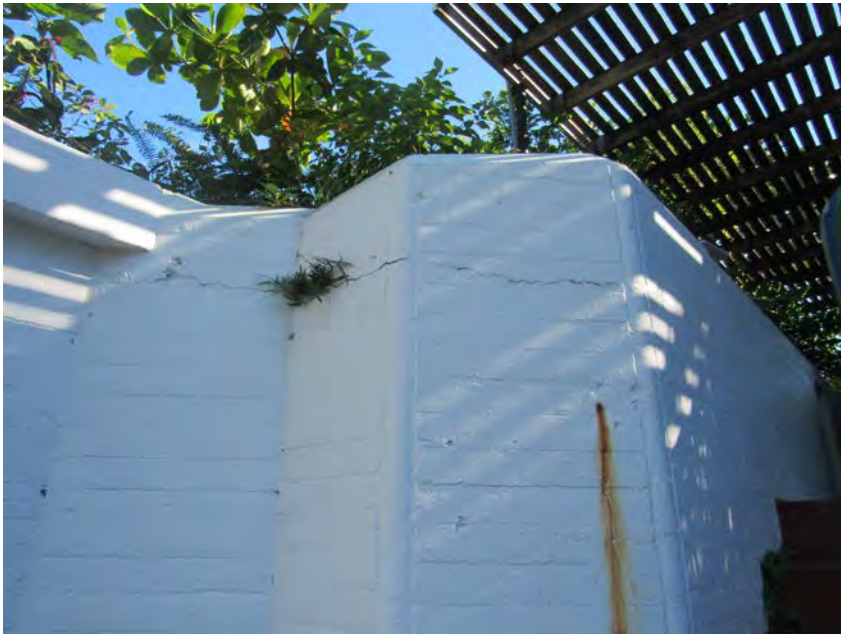
This photo shows the minor cracks in the wall of the gun battery, which should be repaired in this scope of work. Note the 1904-era board formed concrete.
