Americans with Disabilities Act Transition Plan Upper Keys

Volume 1 of 4

Monroe County

October 29, 2010

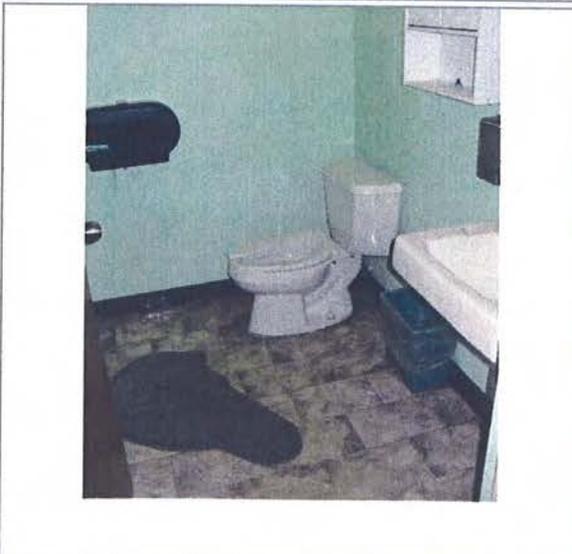
Employee's Restroom

| Observation | Recommendations |
|--|--|
| <p>There is one restroom for employee use only.</p> <ul style="list-style-type: none"> ⊗ The room measures 65" x 67" and is too small to be accessible. ⊗ Door handles are twist knob style. ⊗ There is no signage. ⊗ Grab bars are incorrect. | <p>F\$\$ - Replace this restroom with a new accessible restroom in accordance with the Florida Building Code.</p> |
