Americans with Disabilities Act Transition Plan Middle Keys

Volume 2 of 4

Monroe County

October 29, 2010

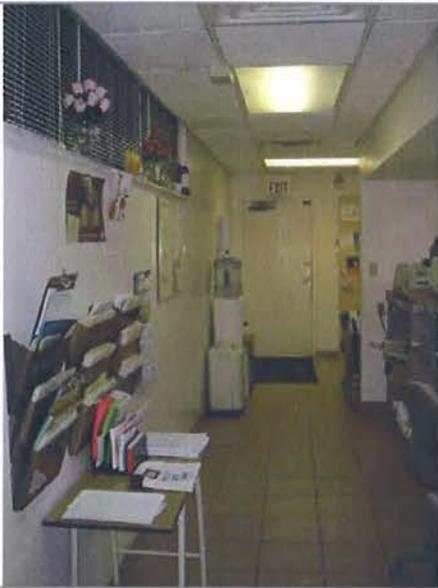
Emergency Exit Door	Main Entrance Door

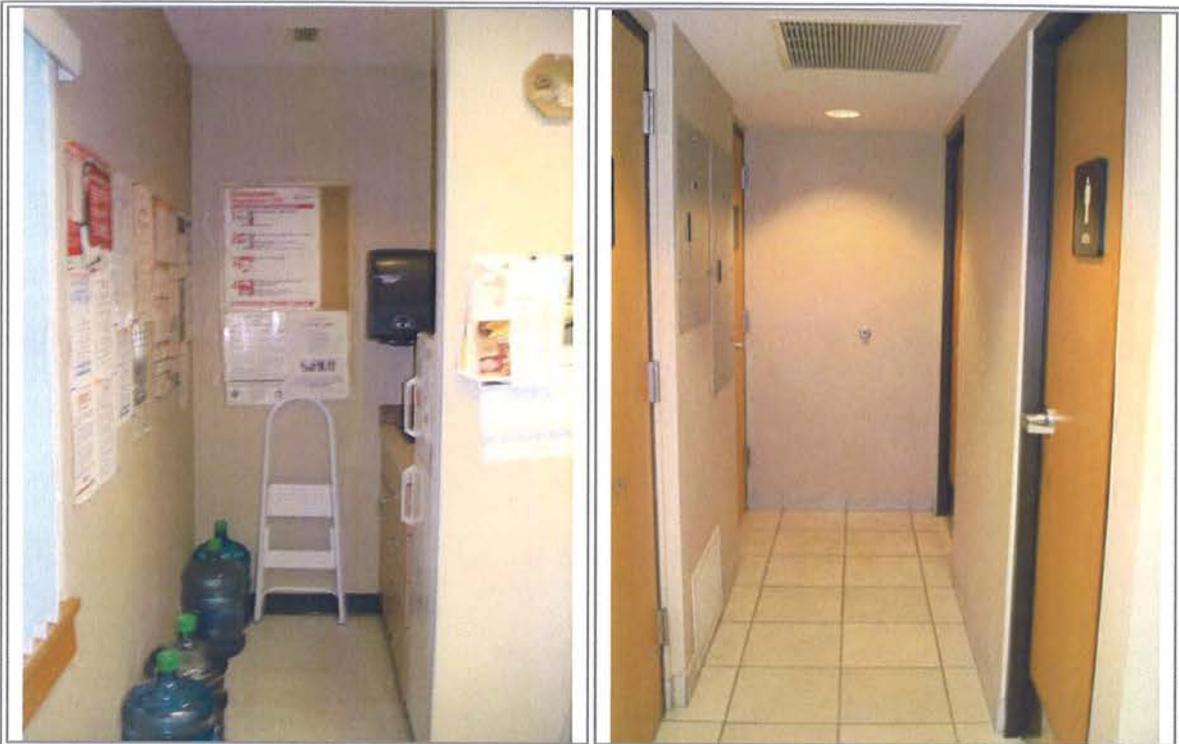
Kitchenette

Corridor to Maintenance and Restroom Areas

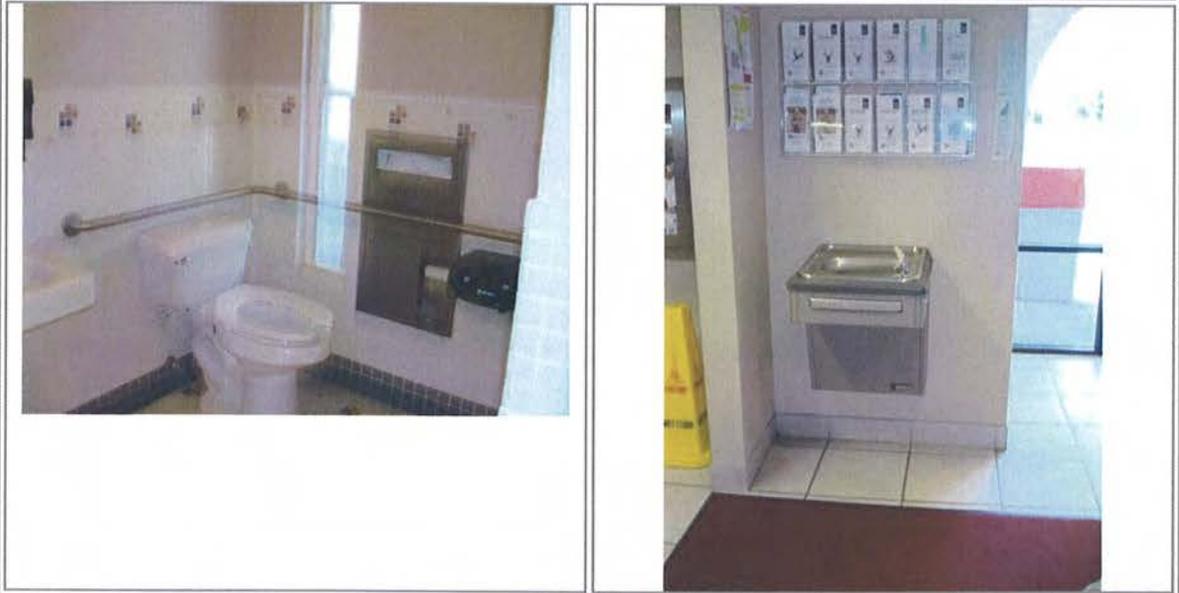
Accessible Restroom

Drinking Fountain

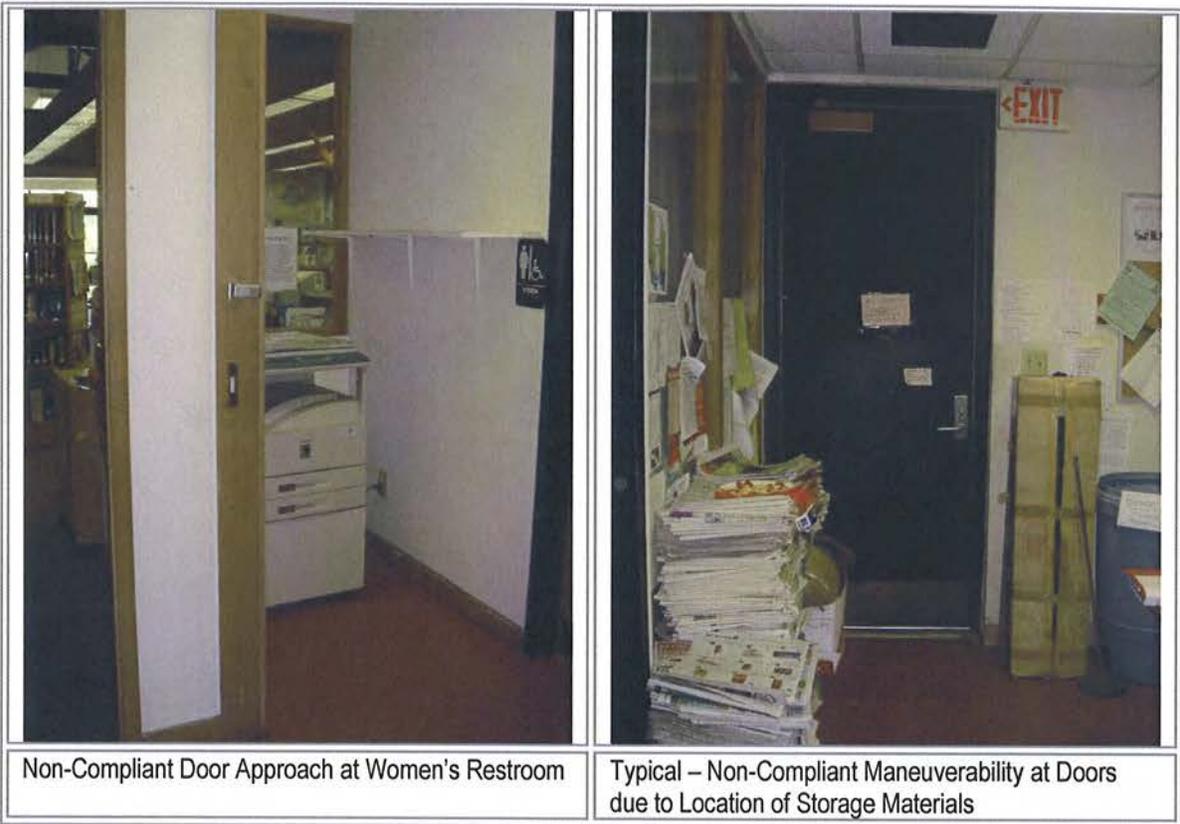
Non-Compliant Door Approach at Women's Restroom

Typical – Non-Compliant Maneuverability at Doors
due to Location of Storage Materials

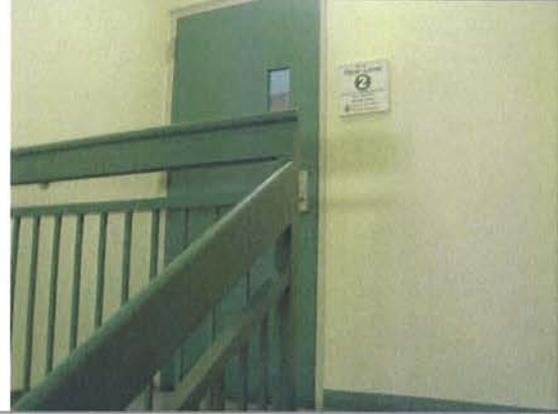
Non-compliant Stair Handrail

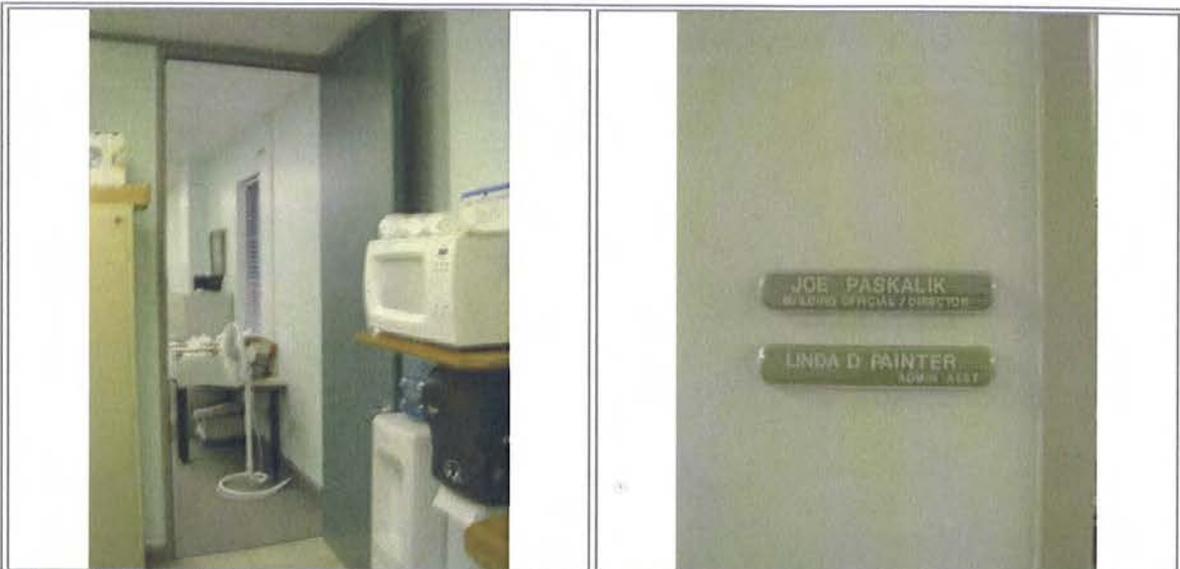
Door at Lounge 01

Non-compliant Signage

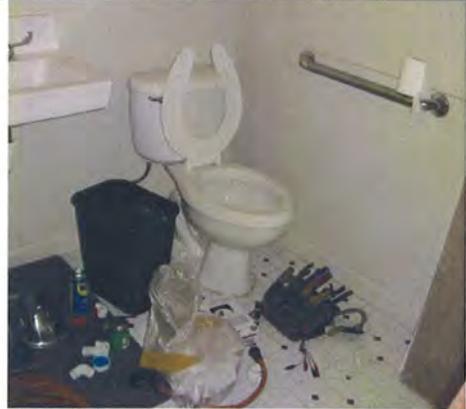
<p>State Attorneys Public Restroom</p> <p>The room is 92" x 60" and has the required clear floor space.</p> <ul style="list-style-type: none"> ✓ There is room on the latch side to open the door. ✓ Door is 34" clear. ⊗ Grab bar is 27" long and mounted on the side. There is none behind the toilet. 	<p>This restroom is accessible but not compliant.</p> <p>AS - Add new grab bars to meet requirements of ADAAG 4.16.4.</p>

State Attorney's Public Restroom	State Attorney's Employee Restroom

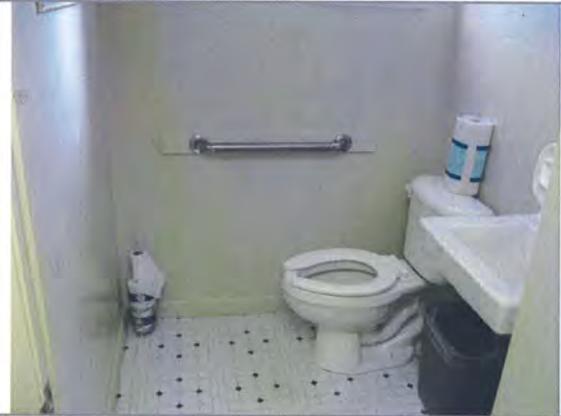
<p>State Attorney Employee's Restroom</p> <ul style="list-style-type: none"> ✓ The door opens out and has 34" clear. There are no closures. ⊗ The room is 58" x 57" and does not have the required floor space. ⊗ The door opens out and has only 30" clear ⊗ Grab bar is 27" long and mounted on the side. There is none behind the toilet. ⊗ Toilet flush handle is on the far side. 	<p>TI - This restroom is not accessible and cannot be made accessible within the confines of the building.</p> <p>AS - Add new grab bars to meet requirements of ADAAG 4.16.4.</p> <p>AS - Install a toilet tank with the flush handle on the wide side in accordance with FACBC 11-4.16.5.</p>
--	--

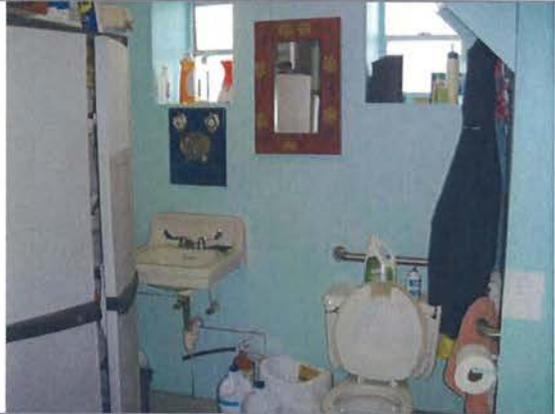
Restroom

Inspection Area: 6.3 RESTROOMS	
Observation	Recommendations
There is one restroom for general use. ☒ It is not accessible in any way.	F\$ - Rebuild restroom in accordance with the Florida Building Code 2007.

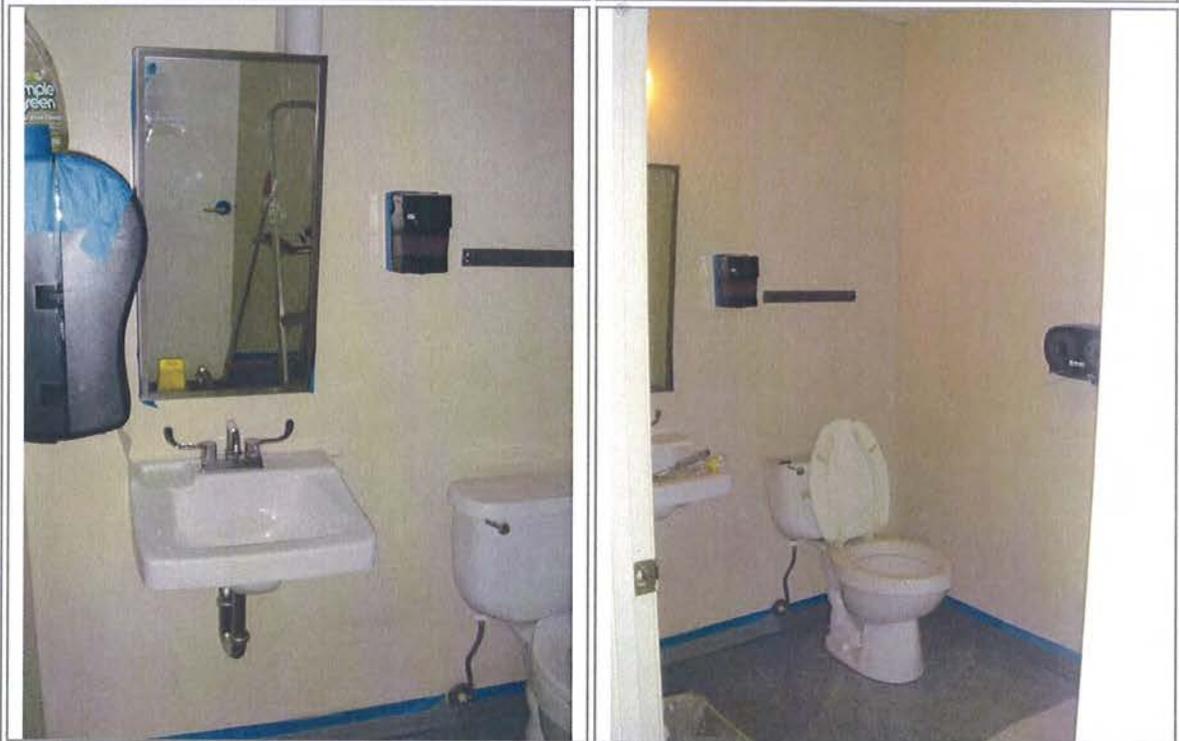
Accessible Unisex Restroom (grab bars removed for painting)

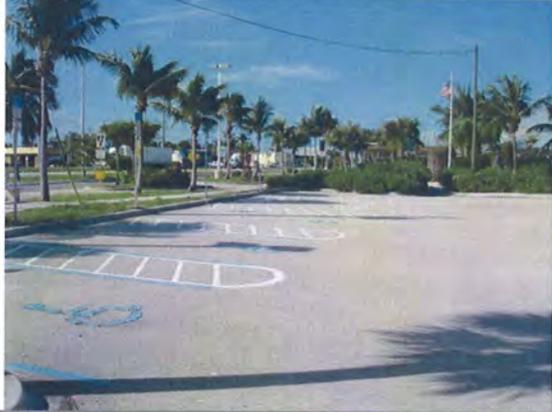
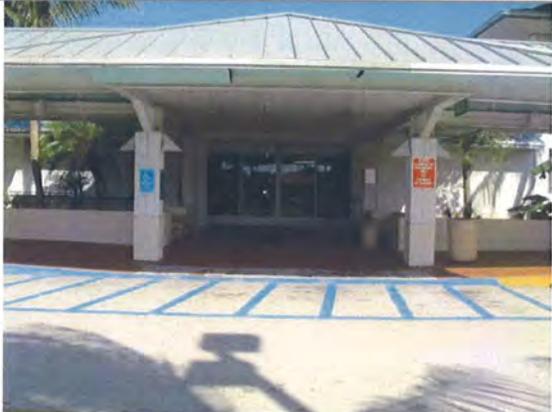
Accessible Parking	Accessible Loading Zone

Inspection Area:	
4.2 MAIN TERMINAL: EXTERIOR ROUTES	
Observation	Recommendations
<p>Main Entrances An Accessible Route is not provided connecting the parking area with the primary building entrances.</p> <ul style="list-style-type: none"> ⊗ Pavement markings are not provided indicating the accessible route. ⊗ The only accessible route is through the parking lot. It is not marked and is not in compliance. <p>Sidewalk The sidewalk connects the parking area with the main building entrance.</p> <ul style="list-style-type: none"> ⊗ The cross slope of the sidewalk exceeds 2% intermittently. 	<p>ASS - Provide an accessible route via the adjacent sidewalk that does not require users to travel behind parked cars in accordance with FACBC 11-4.6.2. Install curb ramps in accordance with FACBC 11-4.7.</p> <p>AS - Rebuild the sidewalk to provide maximum 2% cross slope throughout in accordance with FACBC 11-4.3.</p>

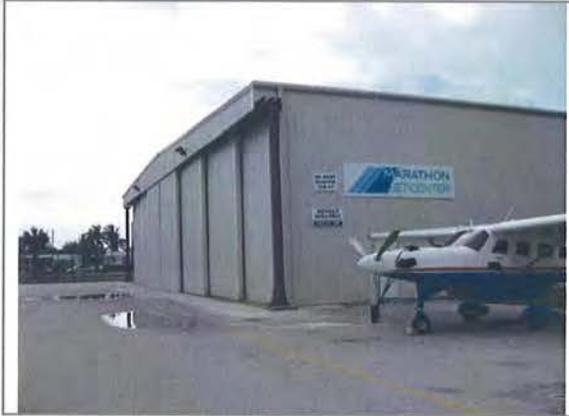
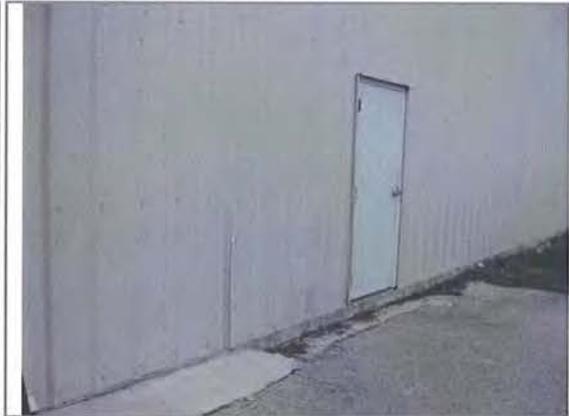
Marathon Jet Center Hanger	Entrance Door

<p>The tarmac in front of the hanger bay is flat and firm asphalt. However, the track for the hanger doors creates a gap greater than ½".</p>
