Americans with Disabilities Act Transition Plan Lower Keys - Part 1

Volume 3 of 4

Monroe County

October 29, 2010

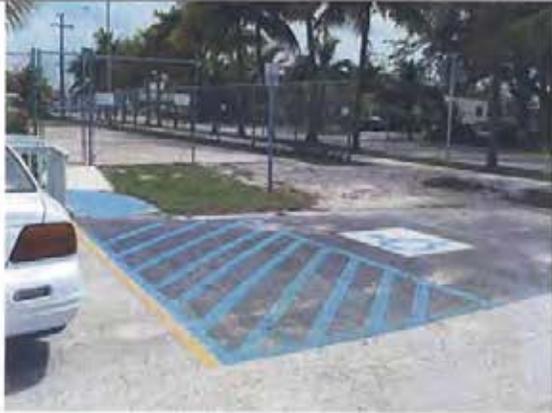
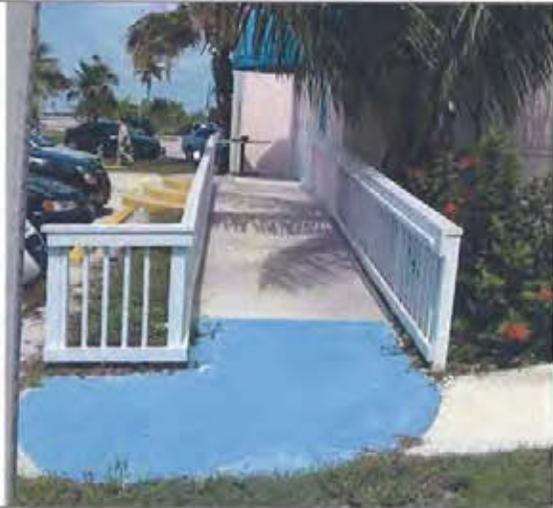
3.3 PHOTOS: PARKING AND EXTERIOR ROUTES

Inspection Area:	
3.2 RAMP	
Observation	Recommendations
<ul style="list-style-type: none"> ⊗ The Ramp has no landing at the bottom. ✓ The handrail is at the proper height, however ⊗ The railing is only on one side and does not extend at the bottom. ⊗ The slope is 8.5 – 9.5%, greater than the 8.33% allowed. 	<p>AS - Rebuild the ramp to have the proper slope, toe guard, handrails on both sides, and a 72" landing at the bottom in accordance with FACBC 11-4.8.</p>

Accessible Parking	Route to Main Entrance

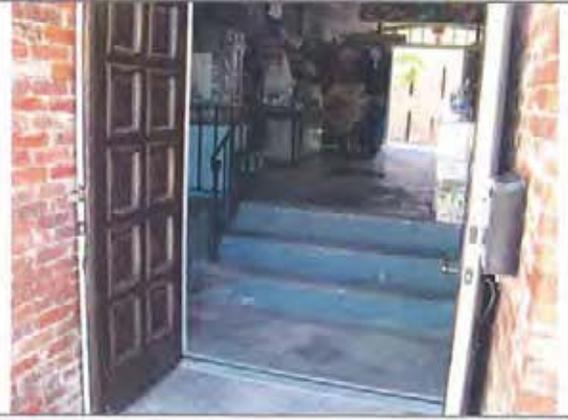
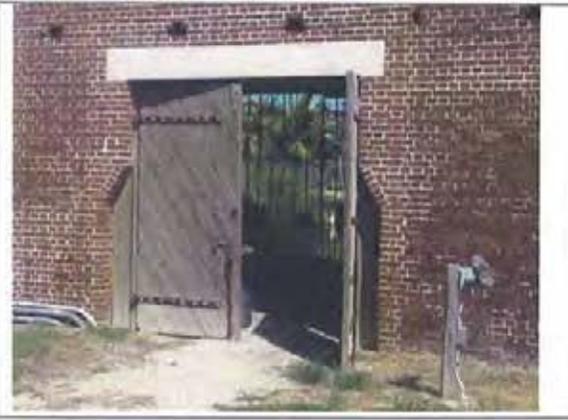
<p>4.2 PHOTOS: ENTRANCES</p>

<p>Inspection Area: 4.1 ENTRANCES</p>	
Observation	Recommendations
<p>Main Entrance Door</p> <p>✓ The front doors are double doors. Each has the proper clearance of 32". They are blocked open during business hours. There is no self-closer.</p> <p>The door opens directly to three steps leading to the ticket sales area.</p> <p>⊗ The steps do not have the correct handrail.</p> <p>⊗ There is no Braille signage indicating the entrance, or interior features of the fort.</p>	<p>RAS - Provide proper signage in accordance with FACBC 11-4.6.4.</p> <p>AS - Install a handrail on each side of the steps in accordance with FACBC 11-4.9.4.</p>
<p>Rear Entrance</p> <p>The rear entrance has an iron gate locked with chain and padlock. It is not available to the public without first going to the front desk.</p> <p>⊗ There are no signs indicating the direction to the accessible entrance from the front of the building.</p> <p>⊗ This door and gate can only be opened by museum staff in case of emergency or to allow a handicapped visitor to enter.</p>	<p>Front desk policy in case of a handicapped visitor is to explain the difficulties of the fort and then call the maintenance person to unlock and open the rear gate.</p> <p>AS - Build a pathway from the required accessible parking area.</p>

<p>Front Entrance</p>	<p>Accessible Rear Entrance</p>

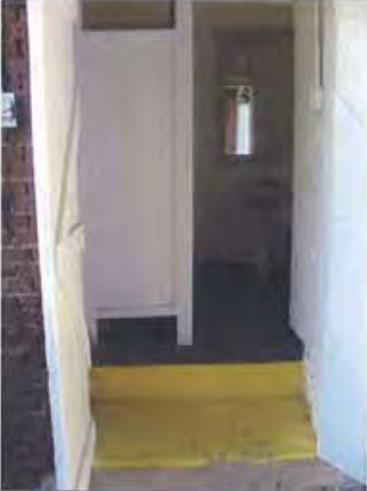
Men's Restroom

Inspection Area: 4.5 RESTROOMS	
Observation	Recommendations
<p>There are two restrooms for public and employee use. Neither of the restroom is accessible.</p> <p>⊗ The Men's restroom is up three steps and is too small to be compliant. There is no room for a ramp.</p> <p>The Women's restroom could be reconfigured to become a unisex lockout accessible restroom; however, the door is only 22" wide and may not be possible to change.</p>	<p>FSS - Reconfigure women's restroom area to be a unisex restroom. Adjust the run of the ramp leading to the restroom for proper slope by adding approximately 48" to its length. Or,</p> <p>FSS - Build an accessible restroom building near the recommended accessible parking area.</p>
4.6 PHOTOS: RESTROOMS

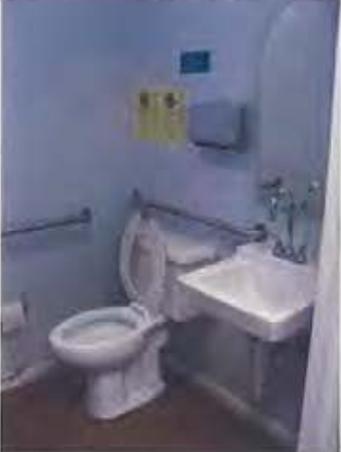
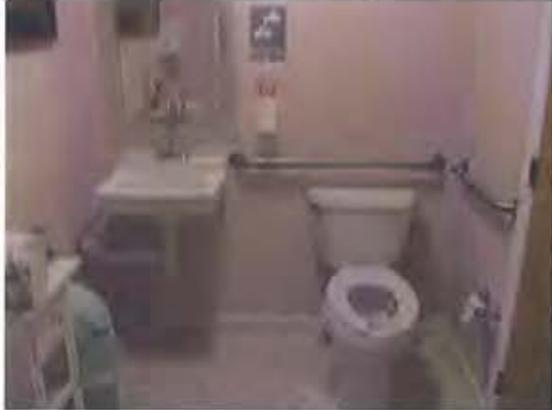
6.4 PHOTOS: RESTROOMS

Inspection Area:	
6.3 RESTROOMS	
Observation	Recommendations
<p>The accessible restroom on the second floor is compliant, except</p> <p>⊗ There is no sign indicating that it is accessible, and it is employee only. This is the only accessible floor.</p> <p>⊗ A garbage can and small stand block access to the sink.</p>	<p>RAS - Provide proper signage in accordance with FACBC 11-4.6.4.</p> <p>RAS - Remove garbage can and stand.</p>

First Floor Restroom	Second Floor Restroom

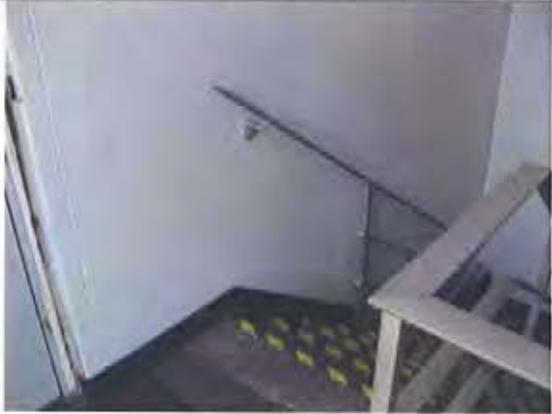
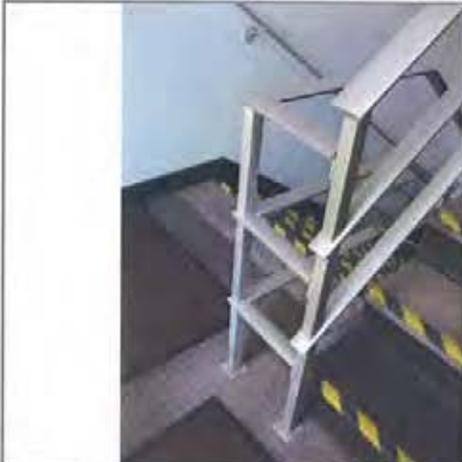
<p>4.7 PHOTOS: STAIRS</p>

<p>Inspection Area: 4.6 SIDE STAIRS</p>	
Observation	Recommendations
<p>There is a set of stairs from the second floor on the Fleming Street side down to the first floor level. The door was stuck shut and the sign says it is not an exit. These stairs were not investigated.</p>	<p>AS - Replace railings with ones that meet ADAAG 4.9.4</p> <p>RAS - Correct and replace the signs indicating the stairs and their limited access to floors.</p>

<p>Front Stairs</p>	<p>Front Stairs</p>

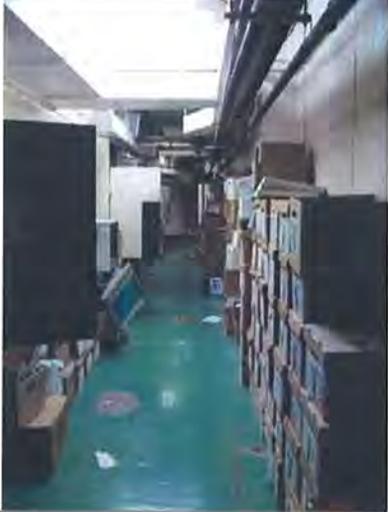
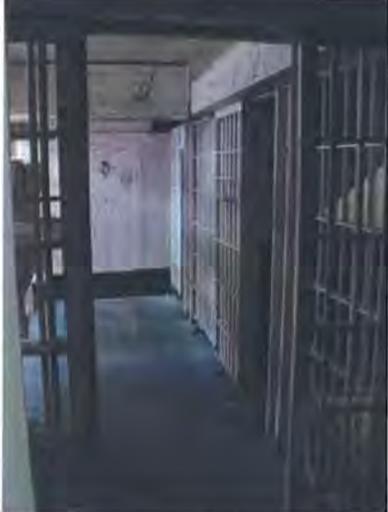
<p>6.3 PHOTOS: SECOND FLOOR</p>

<ul style="list-style-type: none"> ⊗ The flooring is uneven and has many cracks in the linoleum tile. There are thresholds at many locations that are higher than ¾". ⊗ There are too many obstructions to note. ⊗ Doors to the cell areas are 26" wide. Most are steel and difficult to open. They require more than 5 lbs to open and close. Cell doors were not tested. ⊗ Doors to the main hallways are 33" clear. Thresholds are low. ⊗ The door to the stairs on the Fleming Street side did not open. It is marked as Not an Exit and not tested. ⊗ One restroom was located. It is small and the door is 24" clear. 	<p>corrected within the confines of the existing structure.</p>
<ul style="list-style-type: none"> ⊗ There are a few exit signs and there are arrows on the floor leading to the rear stairs. ⊗ Three emergency lights were found. ✓ Fire pulls are near each exit. 	<p>RAS - Replace or add signage in compliance with ADAAG 4.30.4 LS-AS - Ensure that the emergency exit doors all open properly.</p>

<p>Main Hall</p>	<p>Jail cells</p>

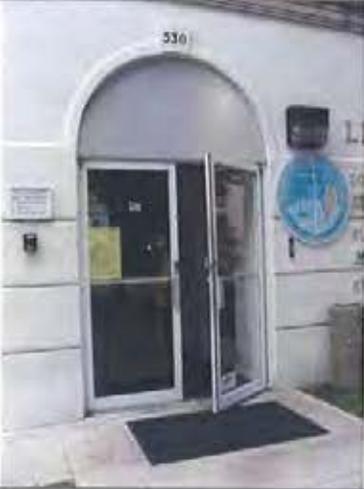
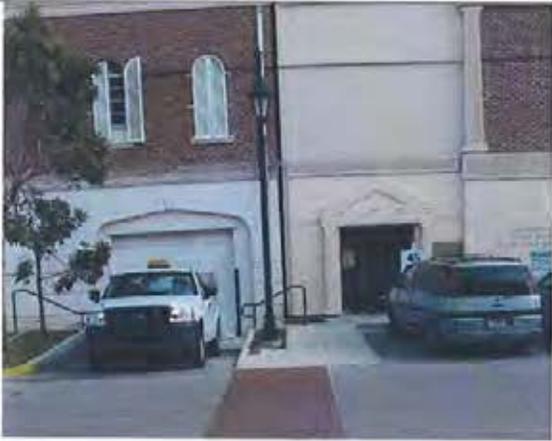
4.2 PHOTOS: ENTRANCES

Main Entrance	Side Entrance

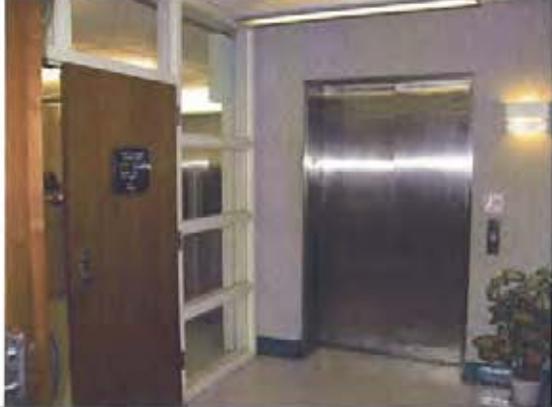
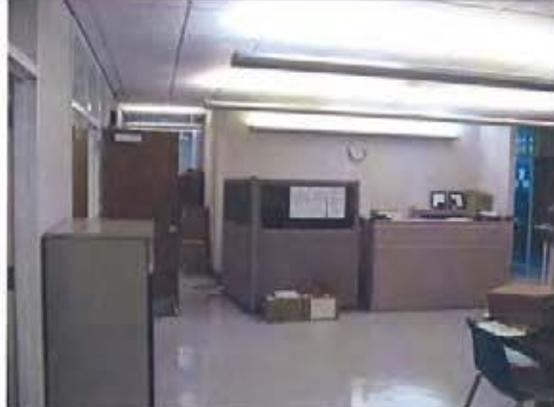
<p>9.2 PHOTOS: FIRST FLOOR REAR</p>

discussed above.	
<p>Restrooms</p> <p>⊗ There are two restrooms in this area, one for men, and one for women. They are marked as accessible (with incorrect signage). However, neither restroom is accessible. There is inadequate floor space to make these rooms accessible.</p>	<p>TI – These restrooms cannot be made accessible within the confines of the building.</p> <p>RAS – Change the existing signage to indicate non-accessible restroom.</p>

<p>Entrance to Records Room</p>	<p>Records Room</p>

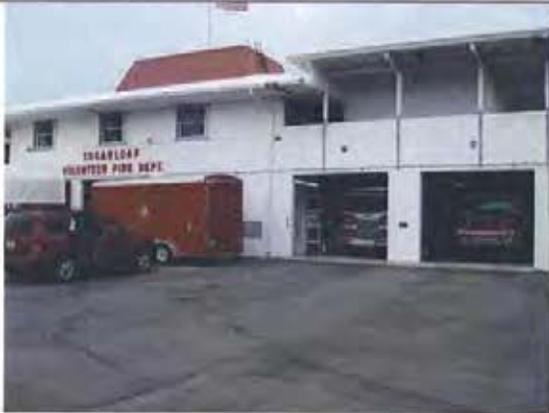
Observation	Recommendations
<p>The parking lot is a large asphalt paved area accessed directly from the Overseas Highway.</p> <ul style="list-style-type: none"> ⊗ There are no accessible parking spaces. <p>The pavement near the bay doors is fairly smooth and flat. It then slopes up at approximately 5% to the concrete bib.</p> <ul style="list-style-type: none"> ⊗ The bib is 36" wide with a slope of more than 10% and a rise greater than 3". 	<p>AS - Reconfigure the accessible parking area to have the proper size space and access aisle, with the proper markings, an accessible route to the door, and proper signage in accordance with FACBC 11-4.6.</p> <p>AS - Provide a ramp to allow access over the steeply sloped bib area.</p>

Voting in open bays
