Americans with Disabilities Act Transition Plan Lower Keys - Part 2

Volume 4 of 4

Monroe County

October 29, 2010

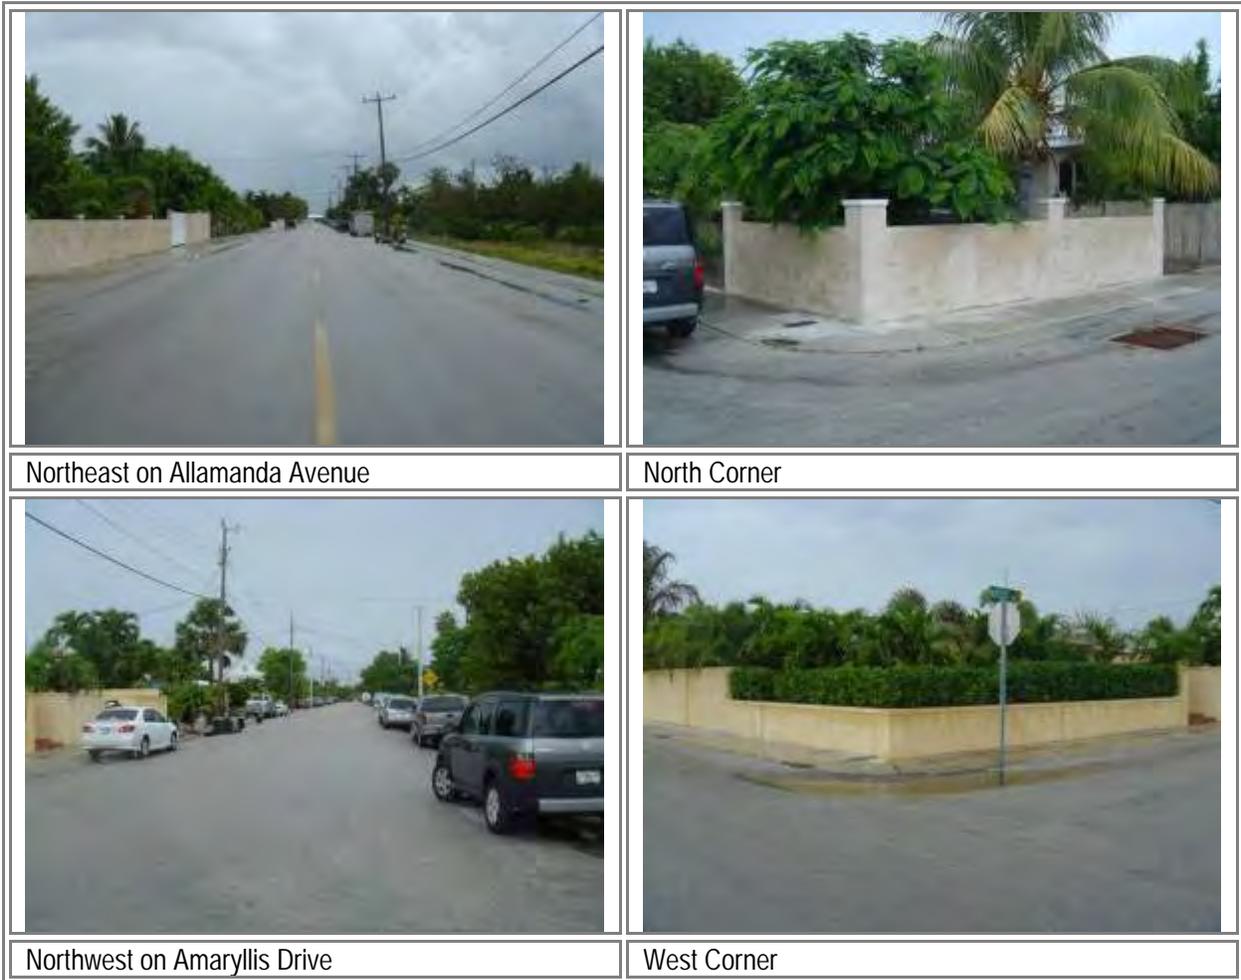
Observation	Recommendations
<p>WEST CORNER</p> <ul style="list-style-type: none"> ⊗ Detectable warnings are not provided. ⊗ Cross Slope exceeds 2%. ⊗ Existing sidewalk does not provide accessible connection to street. (Typical Photo 06) <p>WEST SIDEWALK SOUTHWEST ON ALLAMANDA AVENUE</p> <ul style="list-style-type: none"> • Survey Point 0'-100' <ul style="list-style-type: none"> ⊗ Cross Slope exceeds 2%. ⊗ Running Slope exceeds 5%. <p>WEST SIDEWALK NORTHWEST ON AMARYLLIS DRIVE</p> <ul style="list-style-type: none"> • Survey Point 0'-100' <ul style="list-style-type: none"> ⊗ Cross Slope exceeds 2%. ⊗ Intermittent breaks / cracks in surface / uneven. • Survey Points 100'-300' <ul style="list-style-type: none"> ⊗ Cross Slope exceeds 2%. ⊗ Running Slope exceeds 5%. 	<p>A\$ - F\$\$ - Depending on the specific situation at each location, install accessible sidewalks and intersections in compliance with ADAAG and PROWAAC guidance and FDOT Design Standards. This should include, but not be limited to, detectable warnings, driveway crossings, street crossing markings, signs, and pedestrian crossing signals as required.</p>

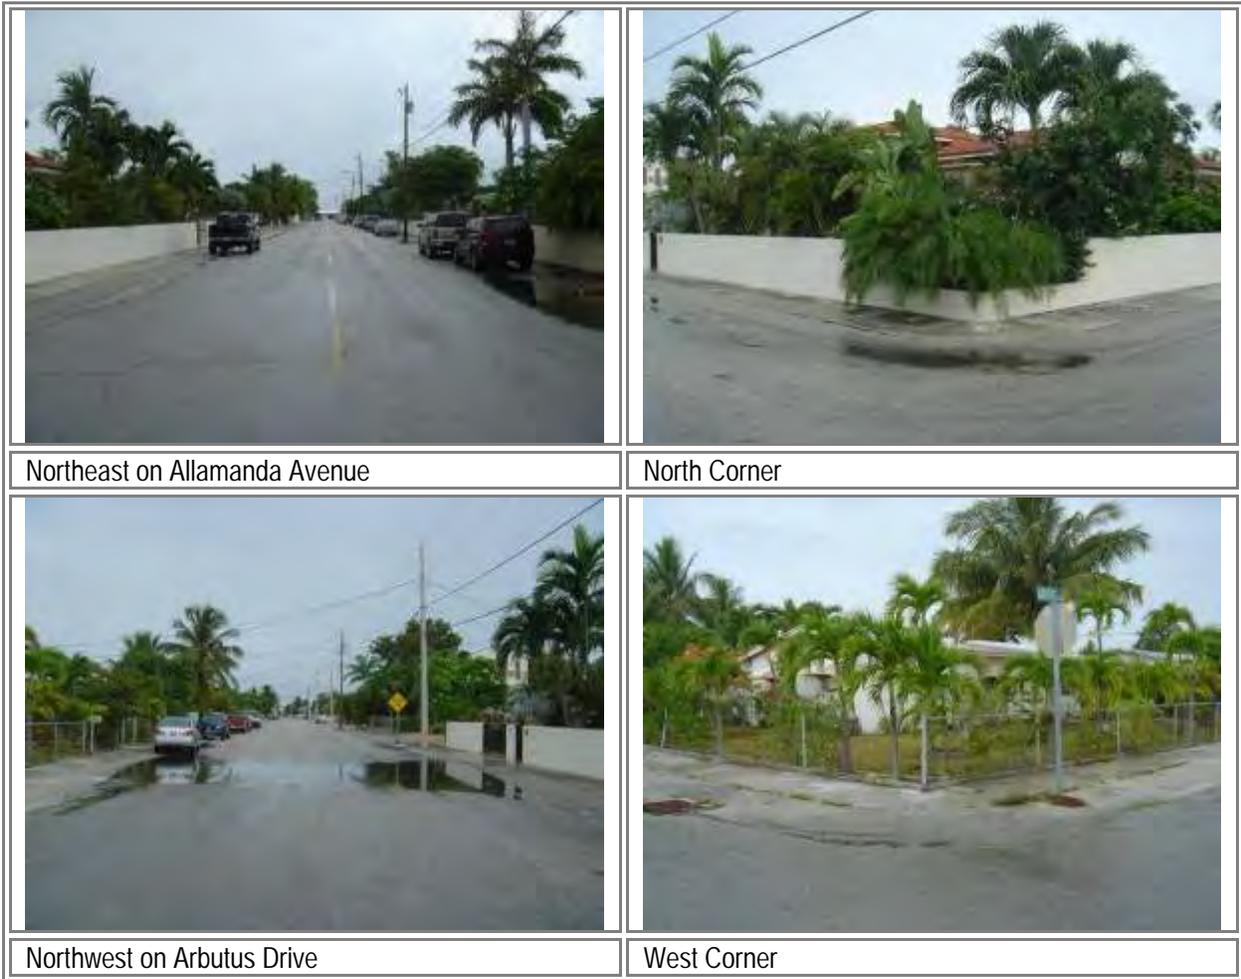
Observation	Recommendations
<p>WEST CORNER</p> <ul style="list-style-type: none"> ⊗ Detectable warnings are not provided. ⊗ Cross Slope exceeds 2%. ⊗ Existing sidewalk does not provide accessible connection to street. (Typical Photo 06) <p>WEST SIDEWALK SOUTHWEST ON ALLAMANDA AVENUE</p> <ul style="list-style-type: none"> • Survey Point 0'-100' ⊗ Cross Slope exceeds 2%. <p>WEST SIDEWALK NORTHWEST ON ARBUTUS DRIVE</p> <ul style="list-style-type: none"> • Survey Point 0'-800' ⊗ Cross Slope exceeds 2%. ⊗ Intermittent breaks / cracks in surface. <p>NORTH CORNER</p> <ul style="list-style-type: none"> ⊗ Detectable warnings are not provided. ⊗ Cross Slope exceeds 2%. <p>NORTH SIDEWALK NORTHEAST ON ALLAMANDA AVENUE</p> <ul style="list-style-type: none"> • Survey Point 0'-200' 	<p>A\$ - F\$\$ - Depending on the specific situation at each location, install accessible sidewalks and intersections in compliance with ADAAG and PROWAAC guidance and FDOT Design Standards. This should include, but not be limited to, detectable warnings, driveway crossings, street crossing markings, signs, and pedestrian crossing signals as required.</p>

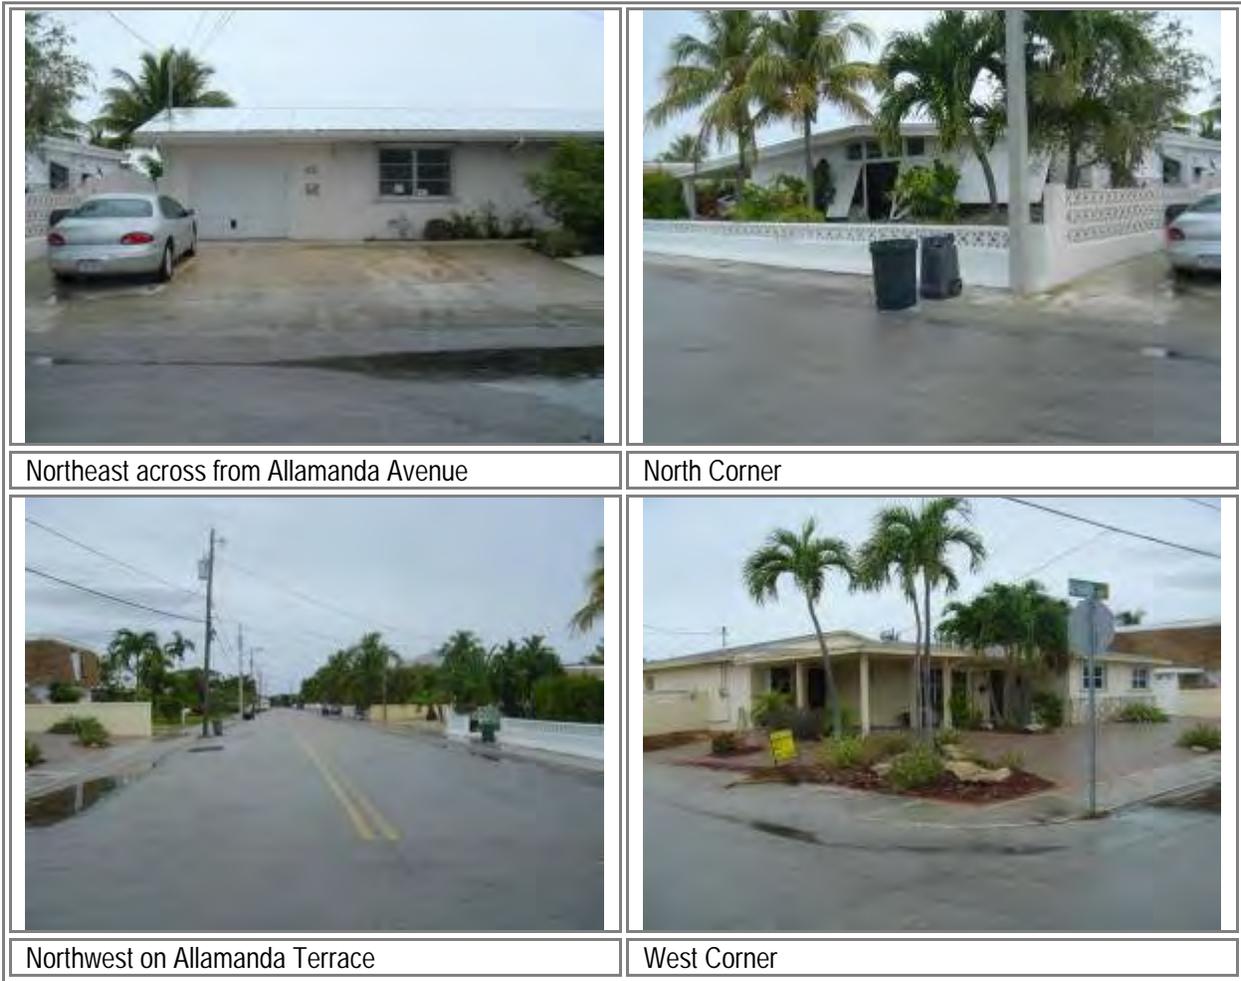
Observation	Recommendations
<p>WEST CORNER</p> <ul style="list-style-type: none"> ⊗ Detectable warnings are not provided. ⊗ Cross Slope exceeds 2%. <p>WEST SIDEWALK SOUTHWEST ON ALLAMANDA AVENUE</p> <ul style="list-style-type: none"> • Survey Point 0'-100' ⊗ Cross Slope exceeds 2%. ⊗ Intermittent breaks / cracks in surface. <p>WEST SIDEWALK NORTHWEST ON ALLAMANDA TERRACE</p> <ul style="list-style-type: none"> • Survey Point 0'-800' ⊗ Cross Slope exceeds 2%. <p>EAST CORNER</p> <ul style="list-style-type: none"> ⊗ Intermittent breaks / cracks in surface. ⊗ Utility pole cut flush to surface <p>EAST SIDEWALK NORTHWEST ON ALLAMANDA TERRACE</p> <ul style="list-style-type: none"> • Survey Point 0'-100' ✓ ADA Compliant • Survey Point 100'-300' 	<p>A\$ - F\$\$ - Depending on the specific situation at each location, install accessible sidewalks and intersections in compliance with ADAAG and PROWAAC guidance and FDOT Design Standards. This should include, but not be limited to, detectable warnings, driveway crossings, street crossing markings, signs, and pedestrian crossing signals as required.</p>

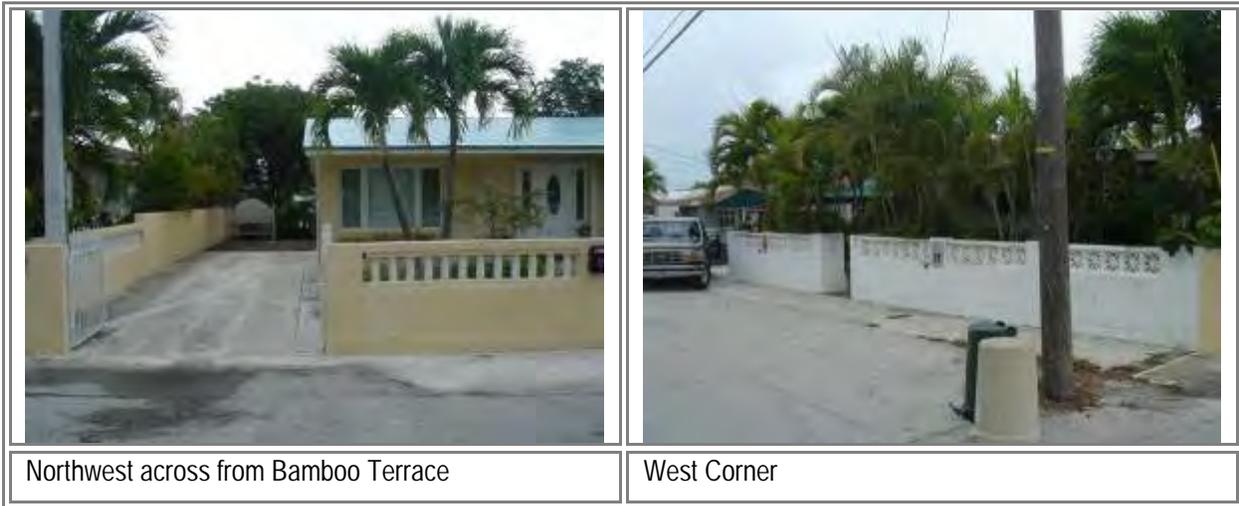
Observation	Recommendations
<p>SOUTH CORNER</p> <ul style="list-style-type: none"> ⊗ Detectable warnings are not provided. ⊗ Cross Slope exceeds 2%. ⊗ Existing sidewalk does not provide accessible connection to street. (Typical Photo 06) <p>SOUTH SIDEWALK SOUTHWEST ON BOUGAINVILLEA AVENUE</p> <ul style="list-style-type: none"> • Survey Point 0'-100' <ul style="list-style-type: none"> ⊗ Cross Slope exceeds 2%. ⊗ Cracks greater than ½" in surface. (Typical Photo 03) • Survey Point 100'-200' <ul style="list-style-type: none"> ⊗ Cross Slope exceeds 2%. ⊗ Cracks greater than ½" in surface. (Typical Photo 03) ⊗ Sidewalk exists partially in this area. (Typical Photo 05) <p>SOUTH SIDEWALK SOUTHEAST ON BAMBOO TERRACE</p> <ul style="list-style-type: none"> • Survey Point 0'-200' <ul style="list-style-type: none"> ⊗ Cross Slope exceeds 2%. ⊗ Cracks greater than ½" in surface. (Typical Photo 03) <p>EAST CORNER</p> <ul style="list-style-type: none"> ⊗ Detectable warnings are not provided. ⊗ Cross Slope exceeds 2%. ⊗ Existing sidewalk does not provide accessible connection to street. (Typical Photo 06) <p>EAST SIDEWALK SOUTHEAST ON BAMBOO TERRACE</p> <ul style="list-style-type: none"> • Survey Point 0'-100' <ul style="list-style-type: none"> ⊗ Cross Slope exceeds 2%. ⊗ Cracks greater than ½" in surface. (Typical Photo 03) ⊗ Required clear width reduced at utility poles. (Typical Photo 01) • Survey Point 100'-200' <ul style="list-style-type: none"> ⊗ Cross Slope exceeds 2%. 	<p>A\$ - F\$\$ - Depending on the specific situation at each location, install accessible sidewalks and intersections in compliance with ADAAG and PROWAAC guidance and FDOT Design Standards. This should include, but not be limited to, detectable warnings, driveway crossings, street crossing markings, signs, and pedestrian crossing signals as required.</p>

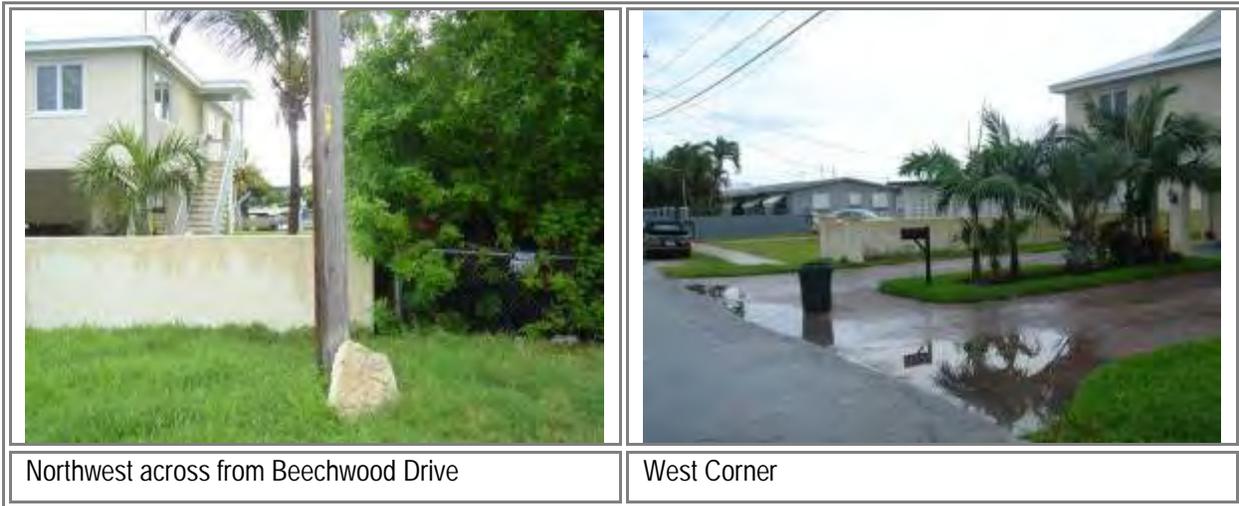
Observation	Recommendations
<p>SOUTH CORNER</p> <ul style="list-style-type: none"> ⊗ Sidewalks do not exist in this area. <p>SOUTH SIDEWALK SOUTHWEST ON BOUGAINVILLEA AVENUE</p> <ul style="list-style-type: none"> • Survey Point 0'-200' <ul style="list-style-type: none"> ⊗ Cross Slope exceeds 2%. ⊗ Cracks greater than ½" in surface. (Typical Photo 03) ⊗ Sidewalk exists partially in this area. (Typical Photo 05) <p>SOUTH SIDEWALK SOUTHEAST ON BEECHWOOD DRIVE</p> <ul style="list-style-type: none"> • Survey Point 0'-100' <ul style="list-style-type: none"> ⊗ Sidewalks exist partially in this area. (Typical Photo 05) • Survey Point 100'-200' <ul style="list-style-type: none"> ⊗ Cross Slope exceeds 2%. • Survey Point 200'-300' <ul style="list-style-type: none"> ⊗ Cross Slope exceeds 2%. ⊗ Sidewalk exists partially in this area. (Typical Photo 05) <p>EAST CORNER</p> <ul style="list-style-type: none"> ⊗ Sidewalks do not exist in this area. <p>EAST SIDEWALK SOUTHEAST ON BEECHWOOD DRIVE</p> <ul style="list-style-type: none"> • Survey Point 0'-100' <ul style="list-style-type: none"> ⊗ Cross Slope exceeds 2%. ⊗ Intermittent breaks / cracks in surface. • Survey Point 100'-200' <ul style="list-style-type: none"> ⊗ Cross Slope exceeds 2%. ⊗ Sidewalk exists partially in this area. (Typical Photo 05) ⊗ Intermittent breaks / cracks in surface. • Survey Point 200'-300' <ul style="list-style-type: none"> ⊗ Sidewalks do not exist in this area. <p>EAST SIDEWALK NORTHEAST ON BOUGAINVILLEA AVENUE</p> <ul style="list-style-type: none"> • Survey Point 0'-100' <ul style="list-style-type: none"> ⊗ Sidewalks do not exist in this area. 	<p>A\$ - F\$\$ - Depending on the specific situation at each location, install accessible sidewalks and intersections in compliance with ADAAG and PROWAAC guidance and FDOT Design Standards. This should include, but not be limited to, detectable warnings, driveway crossings, street crossing markings, signs, and pedestrian crossing signals as required.</p>

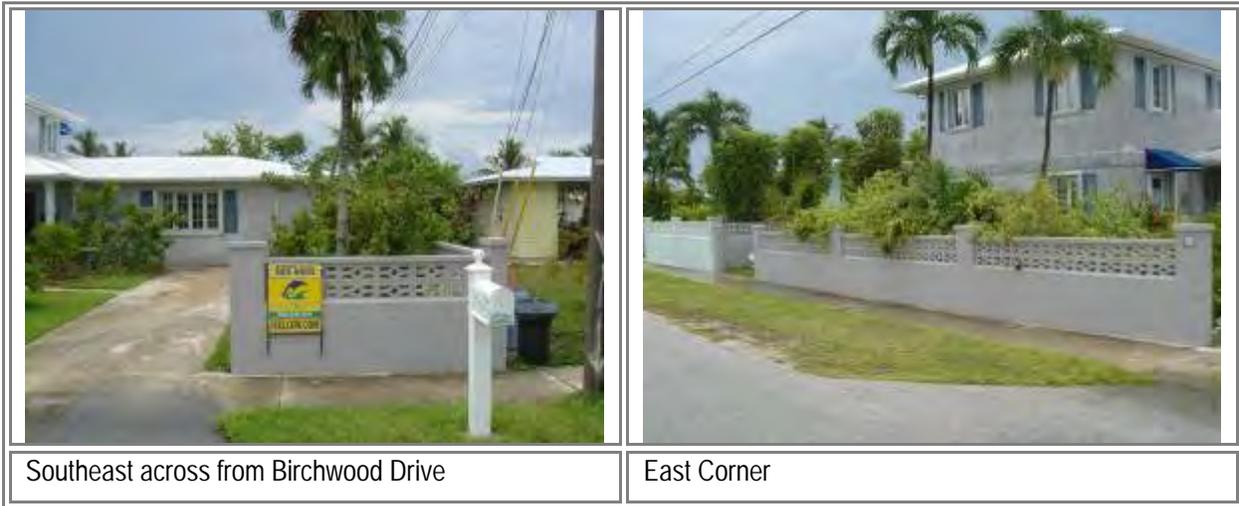
Observation	Recommendations
<p>NORTH CORNER</p> <ul style="list-style-type: none"> ⊗ Detectable warnings are not provided. ⊗ Cross Slope exceeds 2%. ⊗ Existing sidewalk does not provide accessible connection to street. (Typical Photo 06) ⊗ Running Slope exceeds 5%. <p>NORTH SIDEWALK NORTHEAST ON BAMBOO TERRACE</p> <ul style="list-style-type: none"> • Survey Point 0'-100' ⊗ Cross Slope exceeds 2%. <p>NORTH SIDEWALK NORTHWEST ON BIRCHWOOD DRIVE</p> <ul style="list-style-type: none"> • Survey Point 0'-100' ⊗ Cross Slope exceeds 2%. • Survey Point 100'-200' ⊗ Cross Slope exceeds 2%. ⊗ Sidewalk exists partially in this area. (Typical Photo 05) • Survey Point 200'-400' ⊗ Sidewalks do not exist in this area. <p>WEST CORNER</p> <ul style="list-style-type: none"> ⊗ Detectable warnings are not provided. ⊗ Existing sidewalk does not provide accessible connection to street. (Typical Photo 06) <p>WEST SIDEWALK NORTHWEST ON BIRCHWOOD DRIVE</p> <ul style="list-style-type: none"> • Survey Point 0'-100' ⊗ Cross Slope exceeds 2%. ⊗ Sidewalk exists partially in this area. (Typical Photo 05) • Survey Point 100'-400' ⊗ Sidewalks do not exist in this area. <p>WEST SIDEWALK SOUTHWEST ON BAMBOO TERRACE</p> <ul style="list-style-type: none"> • Survey Point 0'-400' ⊗ Cross Slope exceeds 2%. ⊗ Driveway approaches non-compliant. (Typical Photo 04) 	<p>A\$ - F\$\$ - Depending on the specific situation at each location, install accessible sidewalks and intersections in compliance with ADAAG and PROWAAC guidance and FDOT Design Standards. This should include, but not be limited to, detectable warnings, driveway crossings, street crossing markings, signs, and pedestrian crossing signals as required.</p>

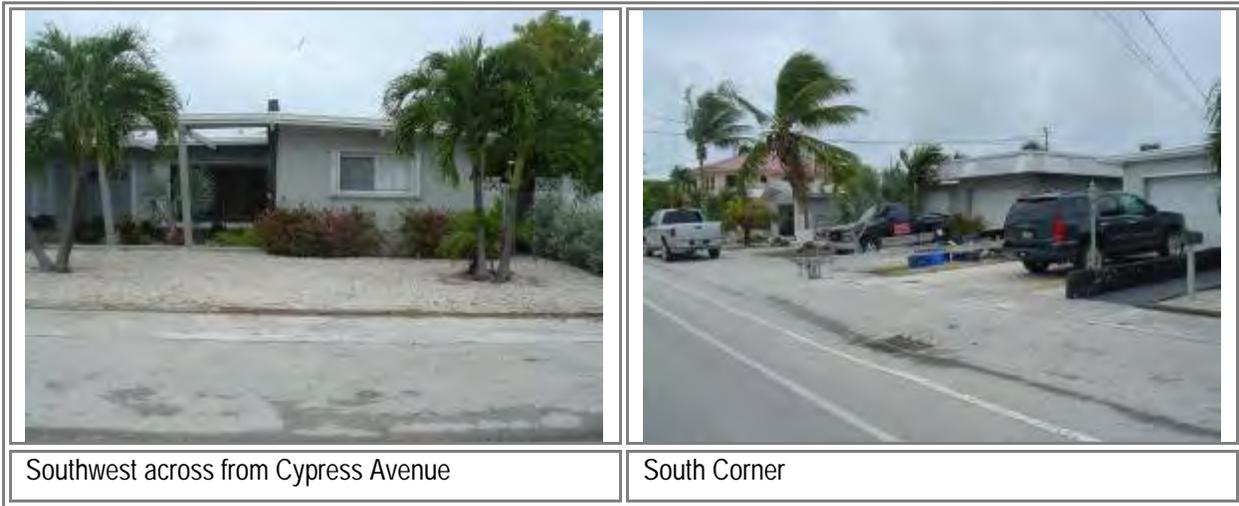
Observation	Recommendations
<p>NORTH CORNER</p> <ul style="list-style-type: none"> ⊗ Sidewalks do not exist in this area. <p>NORTH SIDEWALK NORTHEAST ON CYPRESS AVENUE</p> <ul style="list-style-type: none"> • Survey Point 0'-100' ⊗ Sidewalks do not exist in this area. <p>NORTH SIDEWALK NORTHWEST ON KEY HAVEN ROAD</p> <ul style="list-style-type: none"> • Survey Point 0'-400' ⊗ Sidewalks do not exist in this area. • Survey Point 400'-600' ⊗ Cross Slope exceeds 2%. ⊗ Intermittent breaks / cracks in surface. ⊗ Driveway approaches non-compliant. (Typical Photo 04) ⊗ Running Slope exceeds 5%. • Survey Point 600'-700' ⊗ Sidewalks do not exist in this area. <p>WEST SIDEWALK NORTHWEST ON KEY HAVEN ROAD</p> <ul style="list-style-type: none"> • Survey Point 0'-200' ⊗ Cross Slope exceeds 2%. ⊗ Intermittent breaks / cracks in surface. • Survey Point 200'-300' ⊗ Cross Slope exceeds 2%. ⊗ Intermittent breaks / cracks in surface. ⊗ Sidewalk exists partially in this area. (Typical Photo 05) • Survey Point 300'-400' ⊗ Sidewalks do not exist in this area. • Survey Point 400'-600' ⊗ Cross Slope exceeds 2%. ⊗ Intermittent breaks / cracks in surface. ⊗ Sidewalk exists partially in this area. (Typical Photo 05) • Survey Point 600'-700' ⊗ Sidewalks do not exist in this area. 	<p>A\$ - F\$\$ - Depending on the specific situation at each location, install accessible sidewalks and intersections in compliance with ADAAG and PROWAAC guidance and FDOT Design Standards. This should include, but not be limited to, detectable warnings, driveway crossings, street crossing markings, signs, and pedestrian crossing signals as required.</p>

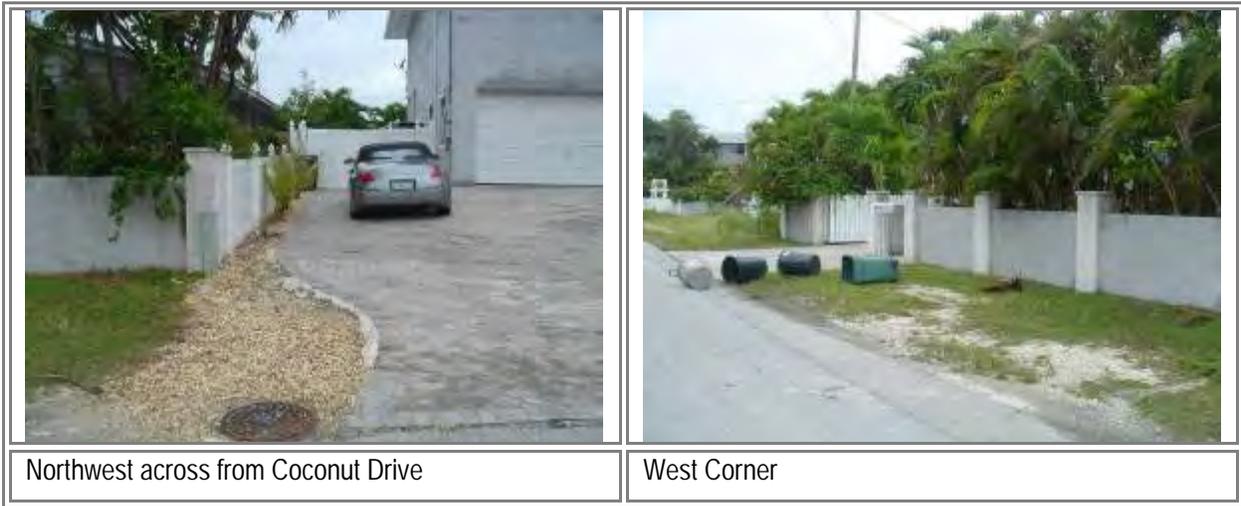
Observation	Recommendations
<p>SOUTH CORNER</p> <ul style="list-style-type: none"> ⊗ Sidewalks do not exist in this area. <p>SOUTH SIDEWALK SOUTHWEST ON CYPRESS AVENUE</p> <ul style="list-style-type: none"> • Survey Point 0'-200' ⊗ Sidewalks do not exist in this area. <p>SOUTH SIDEWALK SOUTHEAST ON COCONUT DRIVE</p> <ul style="list-style-type: none"> • Survey Point 0'-400' ⊗ Sidewalks do not exist in this area. <p>EAST CORNER</p> <ul style="list-style-type: none"> ⊗ Sidewalks do not exist in this area. <p>EAST SIDEWALK SOUTHEAST ON COCONUT DRIVE</p> <ul style="list-style-type: none"> • Survey Point 0'-100' ⊗ Sidewalks do not exist in this area. • Survey Point 100'-300' ⊗ Sidewalk exists partially in this area. (Typical Photo 05) ⊗ Cross Slope exceeds 2%. ⊗ Running Slope exceeds 5%. • Survey Point 100'-400' ⊗ Sidewalks do not exist in this area. <p>EAST SIDEWALK NORTHEAST ON CYPRESS AVENUE</p> <ul style="list-style-type: none"> • Survey Point 0'-600' ⊗ Sidewalks do not exist in this area. <p>WEST SIDEWALK NORTHEAST ON CYPRESS AVENUE</p> <ul style="list-style-type: none"> • Survey Point 0'-100' ⊗ Sidewalks do not exist in this area. • Survey Point 100'-200' ⊗ Sidewalk exists partially in this area. (Typical Photo 05) ⊗ Driveway approaches non-compliant. (Typical Photo 04) ⊗ Cross Slope exceeds 2%. ⊗ Running Slope exceeds 5%. • Survey Point 200'-300' 	<p>A\$ - F\$\$ - Depending on the specific situation at each location, install accessible sidewalks and intersections in compliance with ADAAG and PROWAAC guidance and FDOT Design Standards. This should include, but not be limited to, detectable warnings, driveway crossings, street crossing markings, signs, and pedestrian crossing signals as required.</p>

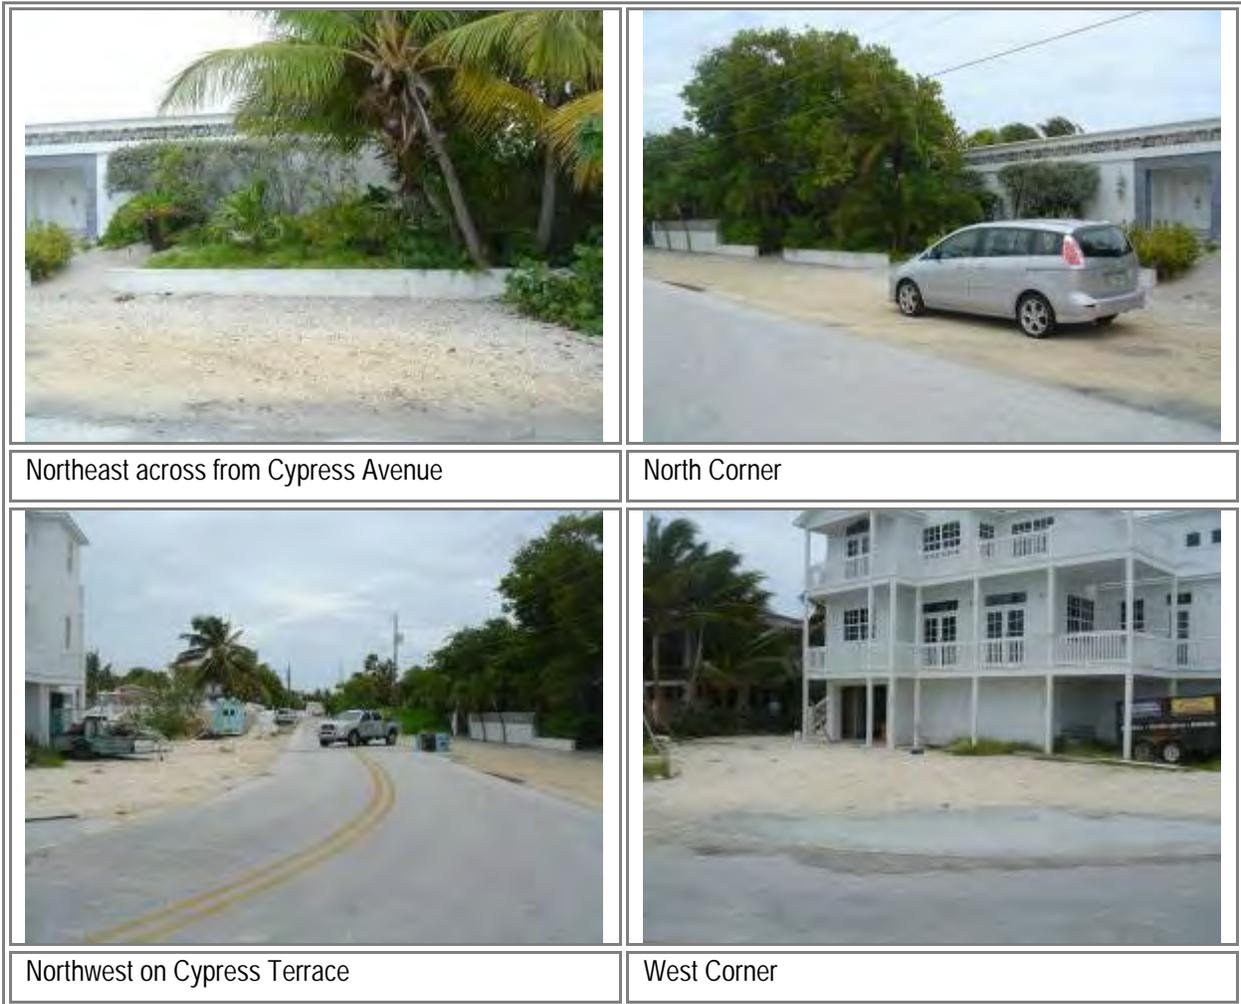
Observation	Recommendations
<p>SOUTH SIDEWALK SOUTHWEST ON CYPRESS AVENUE</p> <ul style="list-style-type: none"> • Survey Point 0'-600' ⊗ Sidewalks do not exist in this area. <p>NORTH CORNER</p> <ul style="list-style-type: none"> ⊗ Sidewalks do not exist in this area. <p>NORTH SIDEWALK NORTHWEST ON CYPRESS TERRACE</p> <ul style="list-style-type: none"> • Survey Point 0'-200' ⊗ Sidewalks do not exist in this area. <p>SOUTHWEST CORNER</p> <ul style="list-style-type: none"> ⊗ Sidewalks do not exist in this area. <p>SOUTH SIDEWALK NORTHWEST ON CYPRESS TERRACE</p> <ul style="list-style-type: none"> • Survey Point 0'-200' ⊗ Sidewalks do not exist in this area. <p>SOUTH SIDEWALK SOUTHWEST ON CYPRESS AVENUE</p> <ul style="list-style-type: none"> • Survey Point 0'-200' ⊗ Sidewalks do not exist in this area. 	<p>A\$ - F\$\$ - Depending on the specific situation at each location, install accessible sidewalks and intersections in compliance with ADAAG and PROWAAC guidance and FDOT Design Standards. This should include, but not be limited to, detectable warnings, driveway crossings, street crossing markings, signs, and pedestrian crossing signals as required.</p>

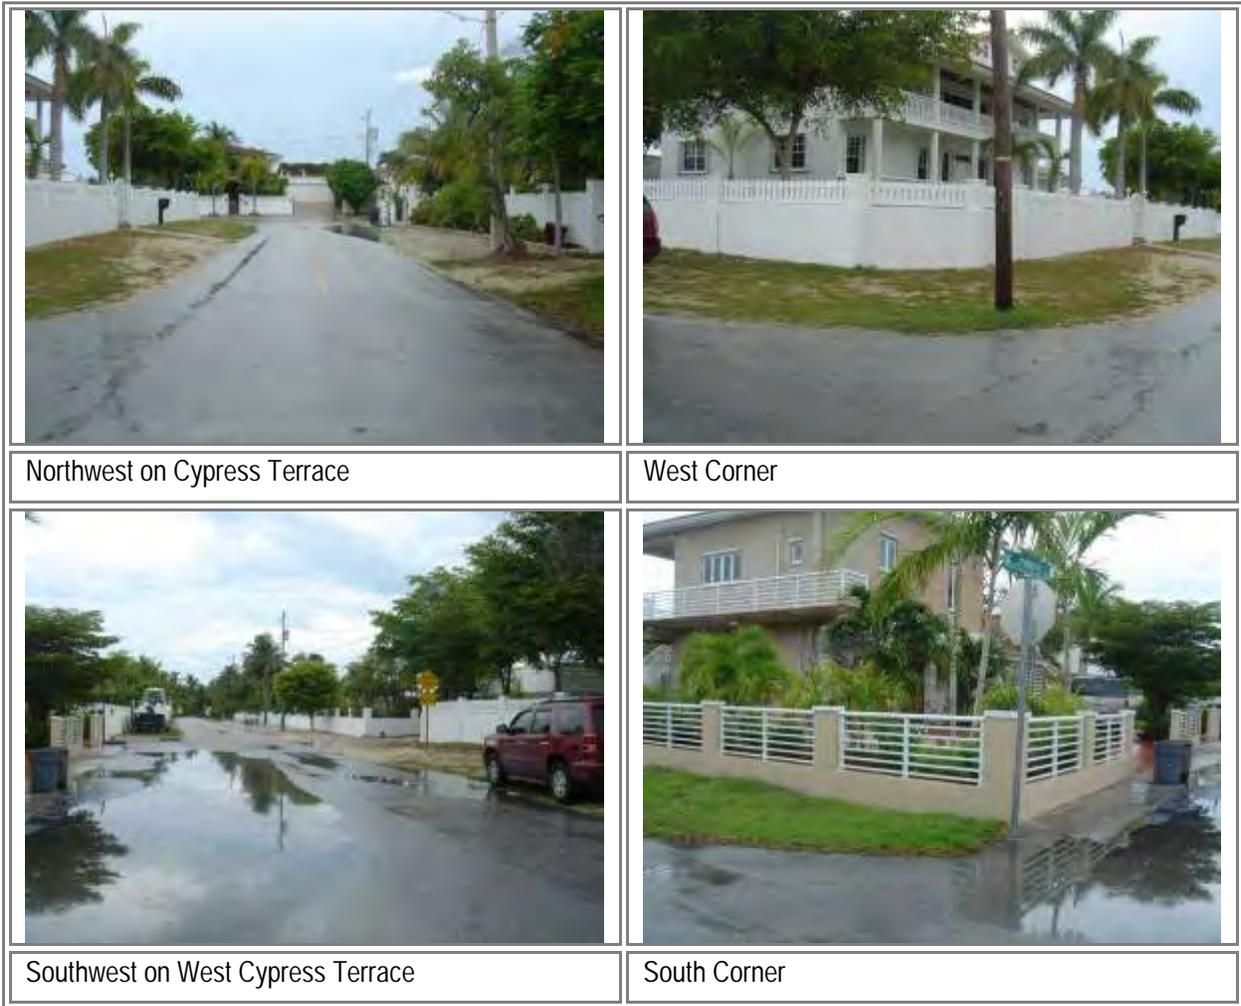
Observation	Recommendations
<p>SOUTH CORNER</p> <ul style="list-style-type: none"> ⊗ Sidewalks do not exist in this area. <p>SOUTH SIDEWALK SOUTHWEST ON WEST CYPRESS TERRACE</p> <ul style="list-style-type: none"> • Survey Point 0'-100' ⊗ Sidewalk exists partially in this area. (Typical Photo 05) • Survey Point 100'-600' ⊗ Sidewalks do not exist in this area. <p>SOUTH SIDEWALK SOUTHEAST ON CYPRESS TERRACE</p> <ul style="list-style-type: none"> • Survey Point 0'-200' ⊗ Sidewalks do not exist in this area. <p>EAST SIDEWALK SOUTHEAST ON CYPRESS TERRACE</p> <ul style="list-style-type: none"> • Survey Point 0'-200' ⊗ Sidewalks do not exist in this area. <p>EAST SIDEWALK NORTHWEST ON CYPRESS TERRACE</p>	<p>A\$ - F\$\$ - Depending on the specific situation at each location, install accessible sidewalks and intersections in compliance with ADAAG and PROWAAC guidance and FDOT Design Standards. This should include, but not be limited to, detectable warnings, driveway crossings, street crossing markings, signs, and pedestrian crossing signals as required.</p>

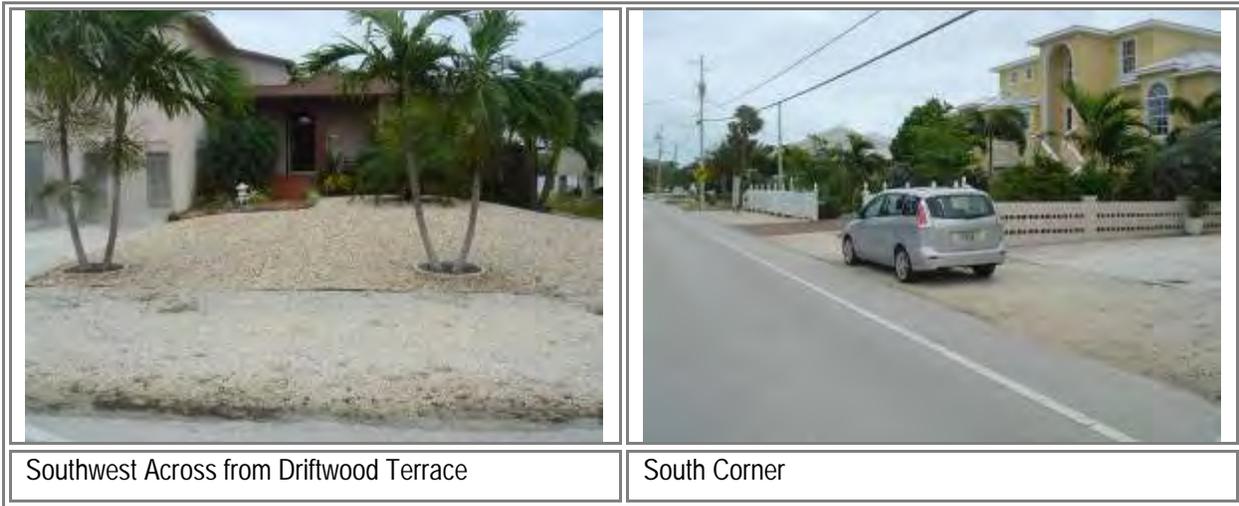
Observation	Recommendations
<p>EAST CORNER</p> <ul style="list-style-type: none"> ⊗ Sidewalks do not exist in this area. <p>EAST SIDEWALK SOUTHEAST ON KEY HAVEN ROAD</p> <ul style="list-style-type: none"> • Survey Point 0'-100' ⊗ Sidewalks do not exist in this area. <p>EAST SIDEWALK NORTHEAST ON DRIFTWOOD TERRACE</p> <ul style="list-style-type: none"> • Survey Point 0'-100' ⊗ Sidewalks do not exist in this area. <p>NORTH CORNER</p> <ul style="list-style-type: none"> ⊗ Sidewalks do not exist in this area. <p>NORTH SIDEWALK NORTHEAST ON DRIFTWOOD TERRACE</p> <ul style="list-style-type: none"> • Survey Point 0'-100' ⊗ Sidewalks do not exist in this area. <p>NORTH SIDEWALK NORTHWEST ON KEY HAVEN ROAD</p> <ul style="list-style-type: none"> • Survey Point 0'-200' ⊗ Sidewalks do not exist in this area. <p>WEST SIDEWALK NORTHWEST ON KEY HAVEN ROAD</p> <ul style="list-style-type: none"> • Survey Point 0'-200' ⊗ Sidewalks do not exist in this area. <p>WEST SIDEWALK SOUTHEAST ON KEY HAVEN ROAD</p> <ul style="list-style-type: none"> • Survey Point 0'-100' ⊗ Sidewalks do not exist in this area. 	<p>A\$ - F\$\$ - Depending on the specific situation at each location, install accessible sidewalks and intersections in compliance with ADAAG and PROWAAC guidance and FDOT Design Standards. This should include, but not be limited to, detectable warnings, driveway crossings, street crossing markings, signs, and pedestrian crossing signals as required.</p>

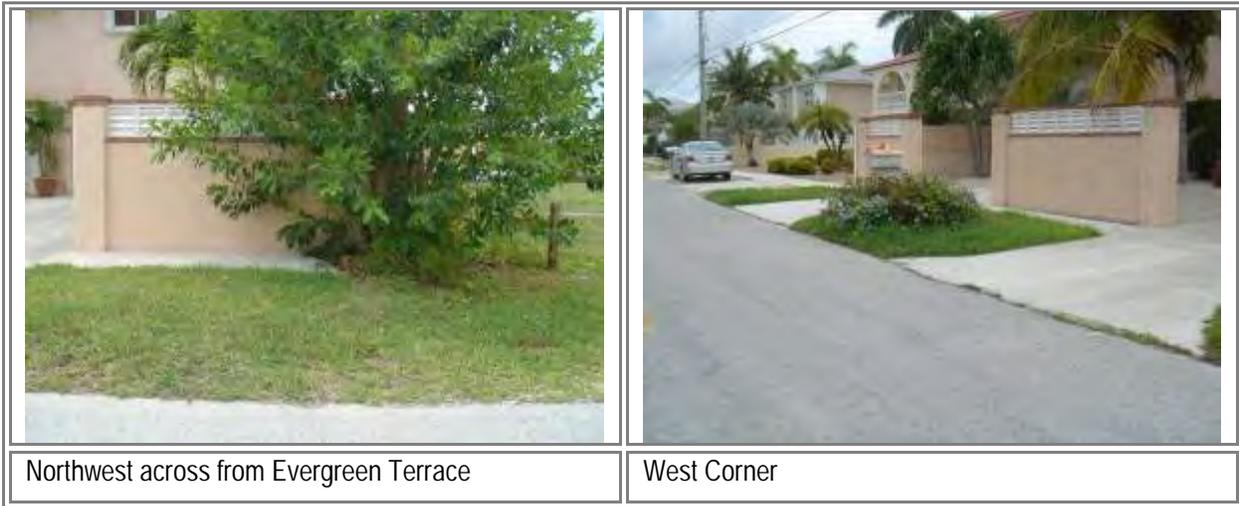
Observation	Recommendations
<p>SOUTH CORNER</p> <ul style="list-style-type: none"> ⊗ Sidewalks do not exist in this area. <p>SOUTH SIDEWALK SOUTHWEST ON EVERGREEN AVENUE</p> <ul style="list-style-type: none"> • Survey Point 0'-200' ⊗ Sidewalks do not exist in this area. <p>SOUTH SIDEWALK SOUTHEAST ON EVERGREEN TERRACE</p> <ul style="list-style-type: none"> • Survey Point 0'-100' ⊗ Sidewalks do not exist in this area. <p>EAST CORNER</p> <ul style="list-style-type: none"> ⊗ Sidewalks do not exist in this area. <p>EAST SIDEWALK SOUTHEAST ON EVERGREEN TERRACE</p> <ul style="list-style-type: none"> • Survey Point 0'-100' ⊗ Sidewalks do not exist in this area. <p>EAST SIDEWALK NORTHEAST ON EVERGREEN AVENUE</p> <ul style="list-style-type: none"> • Survey Point 0'-300' ⊗ Sidewalks do not exist in this area. <p>NORTH SIDEWALK NORTHEAST ON EVERGREEN AVENUE</p> <ul style="list-style-type: none"> • Survey Point 0'-300' ⊗ Sidewalks do not exist in this area. <p>NORTH SIDEWALK SOUTHWEST ON EVERGREEN AVENUE</p> <ul style="list-style-type: none"> • Survey Point 0'-200' ⊗ Driveway approaches non-compliant. (Typical Photo 04) ⊗ Utility pole reduces required clear width. (Typical Photo 01) ⊗ Cross Slope exceeds 2%. 	<p>A\$ - F\$\$ - Depending on the specific situation at each location, install accessible sidewalks and intersections in compliance with ADAAG and PROWAAC guidance and FDOT Design Standards. This should include, but not be limited to, detectable warnings, driveway crossings, street crossing markings, signs, and pedestrian crossing signals as required.</p>

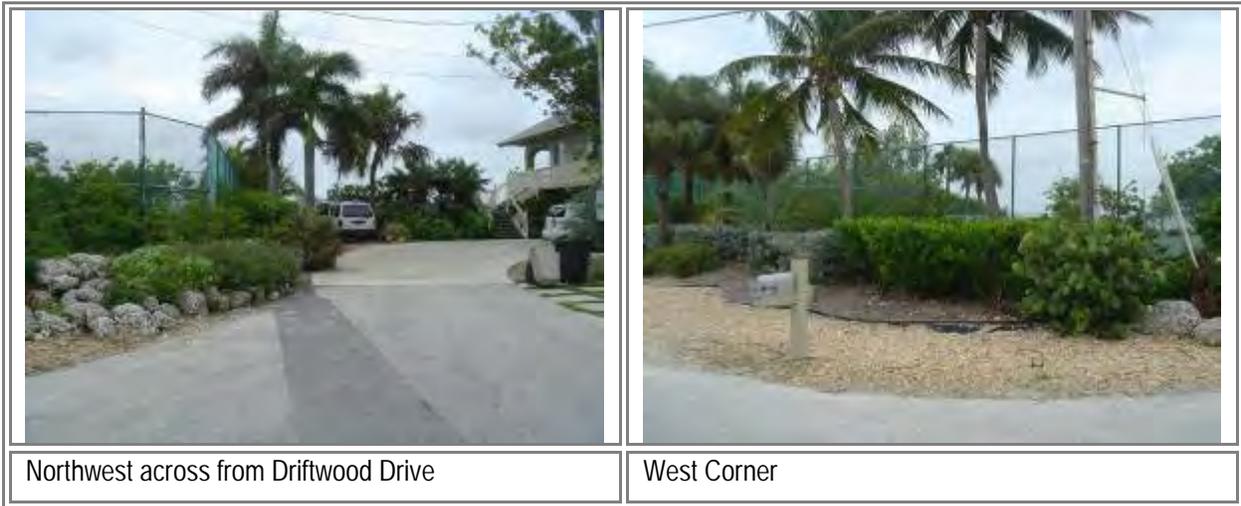
Observation	Recommendations
<p>SOUTH CORNER</p> <ul style="list-style-type: none"> ⊗ Sidewalks do not exist in this area. <p>SOUTH SIDEWALK SOUTHWEST ON FLORAL ROAD</p> <ul style="list-style-type: none"> • Survey Point 0'-800' ⊗ Sidewalks do not exist in this area. <p>SOUTH SIDEWALK SOUTHEAST ON DRIFTWOOD DRIVE</p> <ul style="list-style-type: none"> • Survey Point 0'-300' ⊗ Sidewalks do not exist in this area. <p>EAST SIDEWALK SOUTHEAST ON DRIFTWOOD DRIVE</p> <ul style="list-style-type: none"> • Survey Point 0'-300' ⊗ Sidewalks do not exist in this area. <p>EAST SIDEWALK NORTHWEST ON DRIFTWOOD DRIVE</p> <ul style="list-style-type: none"> • Survey Point 0'-100' ⊗ Sidewalks do not exist in this area. <p>WEST CORNER</p> <ul style="list-style-type: none"> ⊗ Sidewalks do not exist in this area. <p>WEST SIDEWALK NORTHWEST ON DRIFTWOOD DRIVE</p> <ul style="list-style-type: none"> • Survey Point 0'-100' ⊗ Sidewalks do not exist in this area. <p>SOUTH SIDEWALK SOUTHWEST ON FLORAL AVENUE</p> <ul style="list-style-type: none"> • Survey Point 0'-800' ⊗ Sidewalks do not exist in this area. 	<p>A\$ - F\$\$ - Depending on the specific situation at each location, install accessible sidewalks and intersections in compliance with ADAAG and PROWAAC guidance and FDOT Design Standards. This should include, but not be limited to, detectable warnings, driveway crossings, street crossing markings, signs, and pedestrian crossing signals as required.</p>

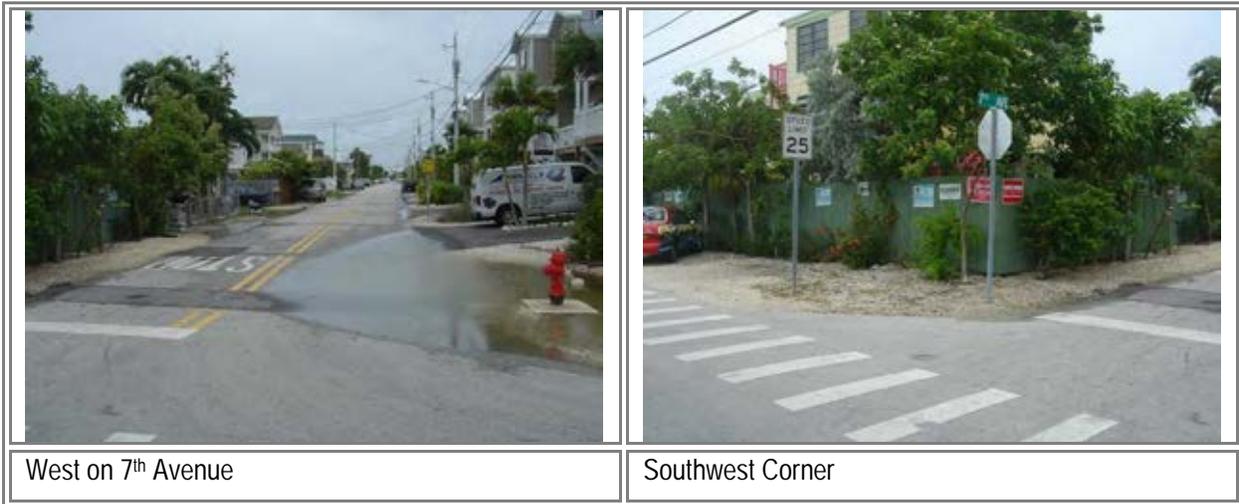
Observation	Recommendations
<p>SOUTHWEST CORNER ☒ Sidewalks do not exist in this area.</p> <p>SOUTHWEST SIDEWALK WEST ON 7th AVENUE • Survey Points 0'-500' ☒ Sidewalks do not exist in this area.</p> <p>SOUTHWEST SIDEWALK SOUTH ON 5th STREET • Survey Points 0'-100' ☒ Sidewalks do not exist in this area.</p> <p>EAST SIDEWALK SOUTH ON 5th STREET • Survey Points 0'-100' ☒ Sidewalks do not exist in this area.</p> <p>EAST SIDEWALK NORTH ON 5th STREET • Survey Points 0'-100' ☒ Sidewalks do not exist in this area.</p> <p>NORTHWEST CORNER ☒ Sidewalks do not exist in this area.</p> <p>NORTHWEST SIDEWALK NORTH ON 5th STREET • Survey Points 0'-100' ☒ Sidewalks do not exist in this area.</p> <p>NORTHWEST SIDEWALK WEST ON 7th AVENUE • Survey Points 0'-500' ☒ Sidewalks do not exist in this area.</p>	<p>AS - F\$\$ - Depending on the specific situation at each location, install accessible sidewalks and intersections in compliance with ADAAG and PROWAAC guidance and FDOT Design Standards. This should include, but not be limited to, detectable warnings, driveway crossings, street crossing markings, signs, and pedestrian crossing signals as required.</p>

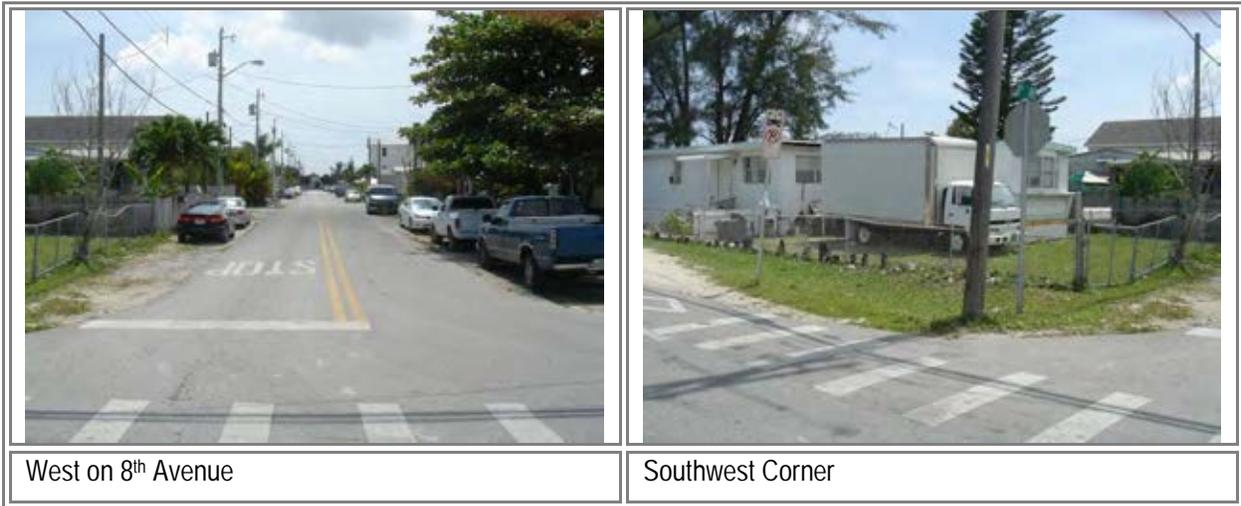
Observation	Recommendations
<p>SOUTHWEST CORNER ☒ Sidewalks do not exist in this area.</p> <p>SOUTHWEST SIDEWALK WEST ON 8th AVENUE • Survey Points 0'-500' ☒ Sidewalks do not exist in this area.</p> <p>SOUTHWEST SIDEWALK SOUTH ON 5th STREET • Survey Points 0'-100' ☒ Sidewalks do not exist in this area.</p> <p>EAST SIDEWALK SOUTH ON 5th STREET • Survey Points 0'-100' ☒ Sidewalks do not exist in this area.</p> <p>EAST SIDEWALK NORTH ON 5th STREET • Survey Points 0'-100' ☒ Sidewalks do not exist in this area.</p> <p>NORTHWEST CORNER ☒ Sidewalks do not exist in this area.</p> <p>NORTHWEST SIDEWALK NORTH ON 5th STREET • Survey Points 0'-100' ☒ Sidewalks do not exist in this area.</p> <p>NORTHWEST SIDEWALK WEST ON 8th AVENUE • Survey Points 0'-500' ☒ Sidewalks do not exist in this area.</p>	<p>A\$ - F\$\$ - Depending on the specific situation at each location, install accessible sidewalks and intersections in compliance with ADAAG and PROWAAC guidance and FDOT Design Standards. This should include, but not be limited to, detectable warnings, driveway crossings, street crossing markings, signs, and pedestrian crossing signals as required.</p>

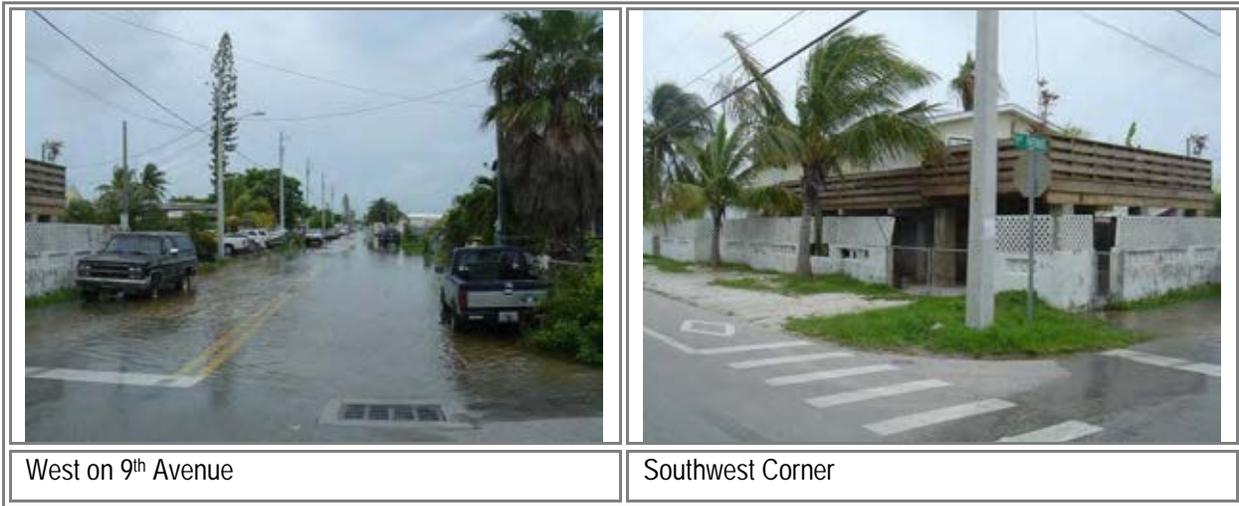
Observation	Recommendations
<p>SOUTHWEST CORNER ☒ Sidewalks do not exist in this area.</p> <p>SOUTHWEST SIDEWALK WEST ON 9th AVENUE • Survey Points 0'-500' ☒ Sidewalks do not exist in this area.</p> <p>SOUTHWEST SIDEWALK SOUTH ON 5th STREET • Survey Points 0'-100' ☒ Sidewalks do not exist in this area.</p> <p>EAST SIDEWALK SOUTH ON 5th STREET • Survey Points 0'-100' ☒ Sidewalks do not exist in this area.</p> <p>EAST SIDEWALK NORTH ON 5th STREET • Survey Points 0'-100' ☒ Sidewalks do not exist in this area.</p> <p>NORTHWEST CORNER ☒ Sidewalks do not exist in this area.</p> <p>NORTHWEST SIDEWALK NORTH ON 5th STREET • Survey Points 0'-100' ☒ Sidewalks do not exist in this area.</p> <p>NORTHWEST SIDEWALK WEST ON 9th AVENUE • Survey Points 0'-500' ☒ Sidewalks do not exist in this area.</p>	<p>AS - F\$\$ - Depending on the specific situation at each location, install accessible sidewalks and intersections in compliance with ADAAG and PROWAAAC guidance and FDOT Design Standards. This should include, but not be limited to, detectable warnings, driveway crossings, street crossing markings, signs, and pedestrian crossing signals as required.</p>

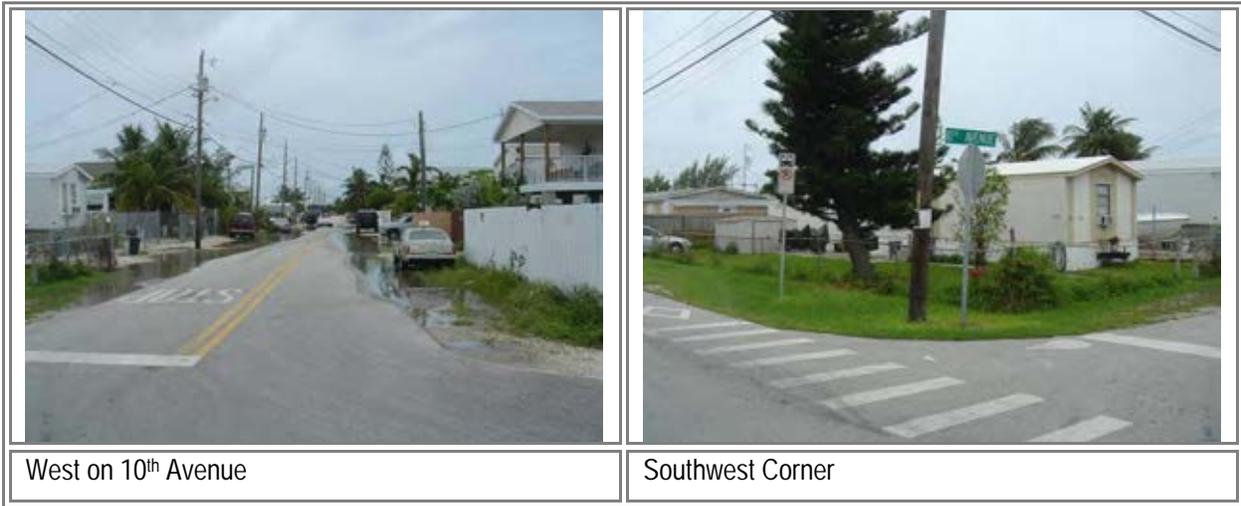
Observation	Recommendations
<p>SOUTHWEST CORNER ☒ Sidewalks do not exist in this area.</p> <p>SOUTHWEST SIDEWALK WEST ON 10th AVENUE • Survey Points 0'-500' ☒ Sidewalks do not exist in this area.</p> <p>SOUTHWEST SIDEWALK SOUTH ON 5th STREET • Survey Points 0'-100' ☒ Sidewalks do not exist in this area.</p> <p>EAST SIDEWALK SOUTH ON 5th STREET • Survey Points 0'-100' ☒ Sidewalks do not exist in this area.</p> <p>EAST SIDEWALK NORTH ON 5th STREET • Survey Points 0'-100' ☒ Sidewalks do not exist in this area.</p> <p>NORTHWEST CORNER ☒ Sidewalks do not exist in this area.</p> <p>NORTHWEST SIDEWALK NORTH ON 5th STREET • Survey Points 0'-100' ☒ Sidewalks do not exist in this area.</p> <p>NORTHWEST SIDEWALK WEST ON 10th AVENUE • Survey Points 0'-500' ☒ Sidewalks do not exist in this area.</p>	<p>A\$ - F\$\$ - Depending on the specific situation at each location, install accessible sidewalks and intersections in compliance with ADAAG and PROWAAC guidance and FDOT Design Standards. This should include, but not be limited to, detectable warnings, driveway crossings, street crossing markings, signs, and pedestrian crossing signals as required.</p>

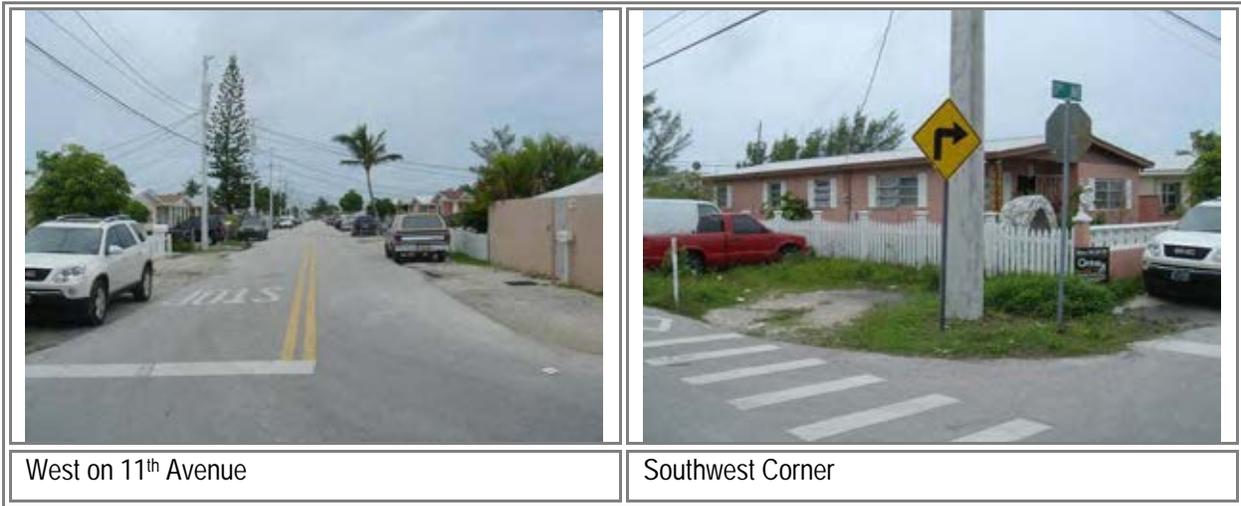
Observation	Recommendations
<p>SOUTHWEST CORNER ☒ Sidewalks do not exist in this area.</p> <p>SOUTHWEST SIDEWALK WEST ON 11th AVENUE • Survey Points 0'-500' ☒ Sidewalks do not exist in this area.</p> <p>SOUTHWEST SIDEWALK SOUTH ON 5th STREET • Survey Points 0'-100' ☒ Sidewalks do not exist in this area.</p> <p>EAST SIDEWALK SOUTH ON 5th STREET • Survey Points 0'-100' ☒ Sidewalks do not exist in this area.</p> <p>EAST SIDEWALK NORTH ON 5th STREET • Survey Points 0'-100' ☒ Sidewalks do not exist in this area.</p> <p>NORTHWEST CORNER ☒ Sidewalks do not exist in this area.</p> <p>NORTHWEST SIDEWALK NORTH ON 5th STREET • Survey Points 0'-100' ☒ Sidewalks do not exist in this area.</p> <p>NORTHWEST SIDEWALK WEST ON 11th AVENUE • Survey Points 0'-500' ☒ Sidewalks do not exist in this area.</p>	<p>AS - F\$\$ - Depending on the specific situation at each location, install accessible sidewalks and intersections in compliance with ADAAG and PROWAAC guidance and FDOT Design Standards. This should include, but not be limited to, detectable warnings, driveway crossings, street crossing markings, signs, and pedestrian crossing signals as required.</p>

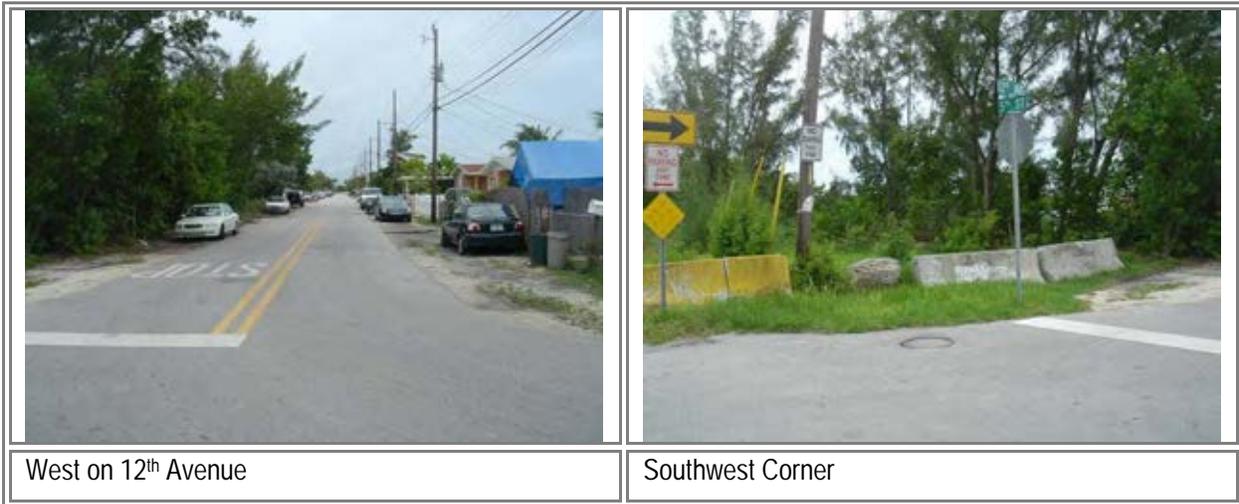
Observation	Recommendations
<p>SOUTHWEST CORNER</p> <ul style="list-style-type: none"> ⊗ Sidewalks do not exist in this area. <p>SOUTHWEST SIDEWALK WEST ON 12th AVENUE</p> <ul style="list-style-type: none"> • Survey Points 0'-500' ⊗ Sidewalks do not exist in this area. <p>SOUTHWEST SIDEWALK SOUTH ON 5th STREET</p> <ul style="list-style-type: none"> ⊗ Road closed. <p>EAST SIDEWALK SOUTH ON 5th STREET</p> <ul style="list-style-type: none"> ⊗ Road closed. <p>EAST SIDEWALK NORTH ON 5th STREET</p> <ul style="list-style-type: none"> • Survey Points 0'-100' ⊗ Sidewalks do not exist in this area. <p>NORTHWEST CORNER</p> <ul style="list-style-type: none"> ⊗ Sidewalks do not exist in this area. <p>NORTHWEST SIDEWALK NORTH ON 5th STREET</p> <ul style="list-style-type: none"> • Survey Points 0'-100' ⊗ Sidewalks do not exist in this area. <p>NORTHWEST SIDEWALK WEST ON 12th AVENUE</p> <ul style="list-style-type: none"> • Survey Points 0'-500' ⊗ Sidewalks do not exist in this area. 	<p>A\$ - F\$\$ - Depending on the specific situation at each location, install accessible sidewalks and intersections in compliance with ADAAG and PROWAAC guidance and FDOT Design Standards. This should include, but not be limited to, detectable warnings, driveway crossings, street crossing markings, signs, and pedestrian crossing signals as required.</p>
