Americans with Disabilities Act Transition Plan Lower Keys - Part 2

Volume 4 of 4

Monroe County

October 29, 2010

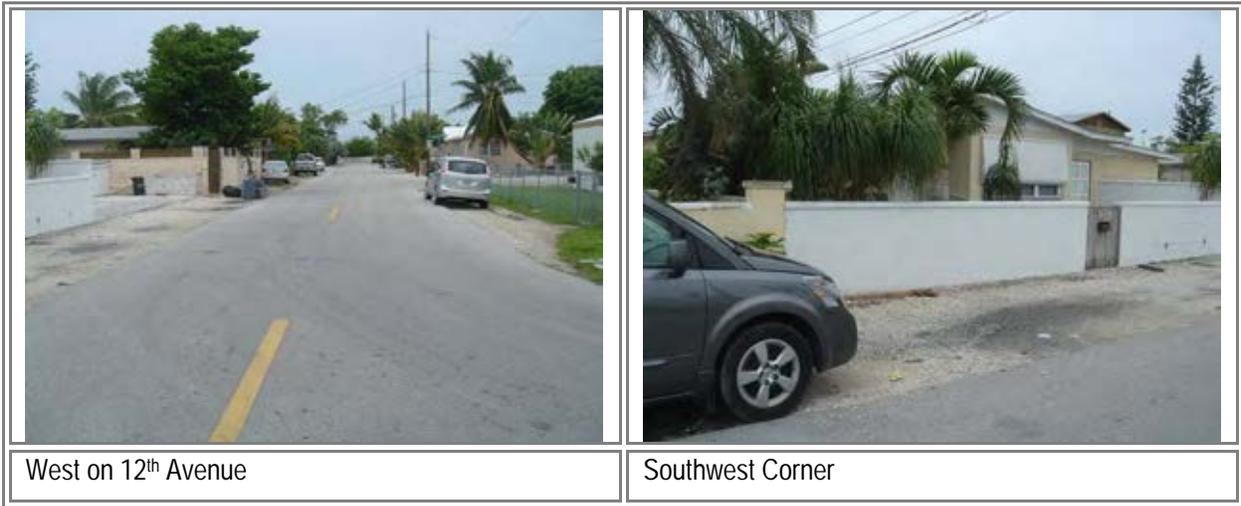
Observation	Recommendations
<p>SOUTH SIDEWALK WEST ON 12th AVENUE</p> <ul style="list-style-type: none"> • Survey Points 0'-100' ⊗ Sidewalks do not exist in this area. <p>SOUTH SIDEWALK EAST ON 12th AVENUE</p> <ul style="list-style-type: none"> • Survey Points 0'-500' ⊗ Sidewalks do not exist in this area. <p>NORTHEAST CORNER</p> <ul style="list-style-type: none"> ⊗ Sidewalks do not exist in this area. <p>NORTHEAST SIDEWALK EAST ON 12th AVENUE</p> <ul style="list-style-type: none"> • Survey Points 0'-500' ⊗ Sidewalks do not exist in this area. <p>NORTHEAST SIDEWALK NORTH ON CROSS STREET</p> <ul style="list-style-type: none"> • Survey Points 0'-100' ⊗ Sidewalks do not exist in this area. <p>NORTHWEST CORNER</p> <ul style="list-style-type: none"> ⊗ Sidewalks do not exist in this area. <p>NORTHWEST SIDEWALK NORTH ON CROSS STREET</p> <ul style="list-style-type: none"> • Survey Points 0'-100' ⊗ Sidewalks do not exist in this area. <p>NORTHWEST SIDEWALK WEST ON 12th AVENUE</p> <ul style="list-style-type: none"> • Survey Points 0'-100' ⊗ Sidewalks do not exist in this area. 	<p>A\$ - F\$\$ - Depending on the specific situation at each location, install accessible sidewalks and intersections in compliance with ADAAG and PROWAAC guidance and FDOT Design Standards. This should include, but not be limited to, detectable warnings, driveway crossings, street crossing markings, signs, and pedestrian crossing signals as required.</p>

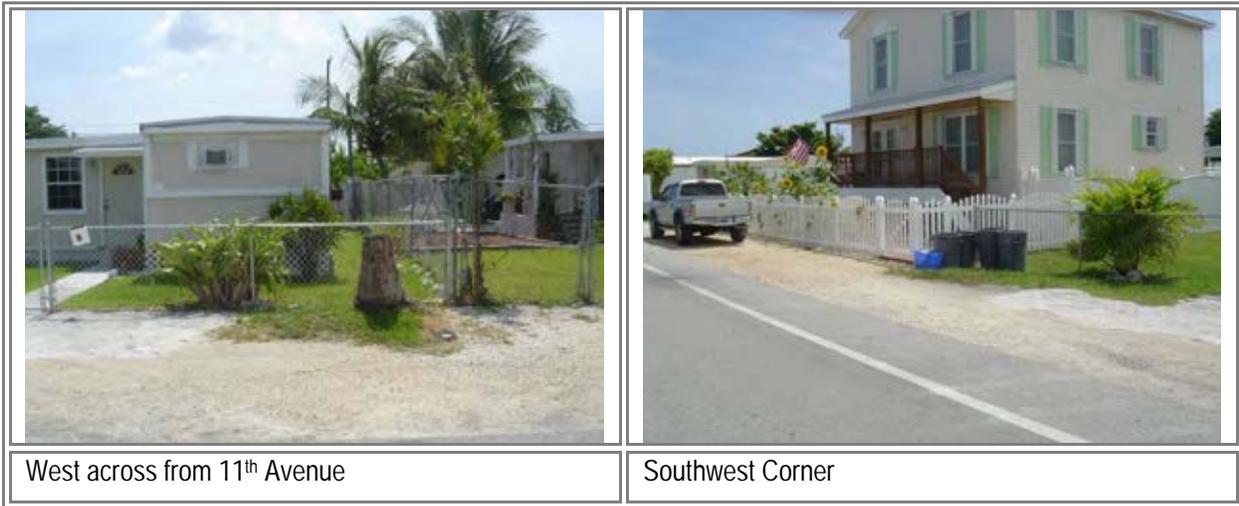
Observation	Recommendations
<p>SOUTHEAST CORNER</p> <ul style="list-style-type: none"> ⊗ Sidewalks do not exist in this area. <p>SOUTHEAST SIDEWALK SOUTH ON CROSS STREET</p> <ul style="list-style-type: none"> • Survey Points 0'-100' ⊗ Sidewalks do not exist in this area. <p>SOUTHEAST SIDEWALK EAST ON 11th Avenue</p> <ul style="list-style-type: none"> • Survey Points 0'-500' ⊗ Sidewalks do not exist in this area. <p>NORTHEAST CORNER</p> <ul style="list-style-type: none"> ⊗ Sidewalks do not exist in this area. <p>NORTHEAST SIDEWALK EAST ON 11th AVENUE</p> <ul style="list-style-type: none"> • Survey Points 0'-500' ⊗ Sidewalks do not exist in this area. <p>NORTHEAST SIDEWALK NORTH ON CROSS STREET</p> <ul style="list-style-type: none"> • Survey Points 0'-100' ⊗ Sidewalks do not exist in this area. <p>WEST SIDEWALK NORTH ON CROSS STREET</p> <ul style="list-style-type: none"> • Survey Points 0'-100' ⊗ Sidewalks do not exist in this area. <p>WEST SIDEWALK SOUTH ON CROSS STREET</p> <ul style="list-style-type: none"> • Survey Points 0'-100' ⊗ Sidewalks do not exist in this area. 	<p>A\$ - F\$\$ - Depending on the specific situation at each location, install accessible sidewalks and intersections in compliance with ADAAG and PROWAAC guidance and FDOT Design Standards. This should include, but not be limited to, detectable warnings, driveway crossings, street crossing markings, signs, and pedestrian crossing signals as required.</p>

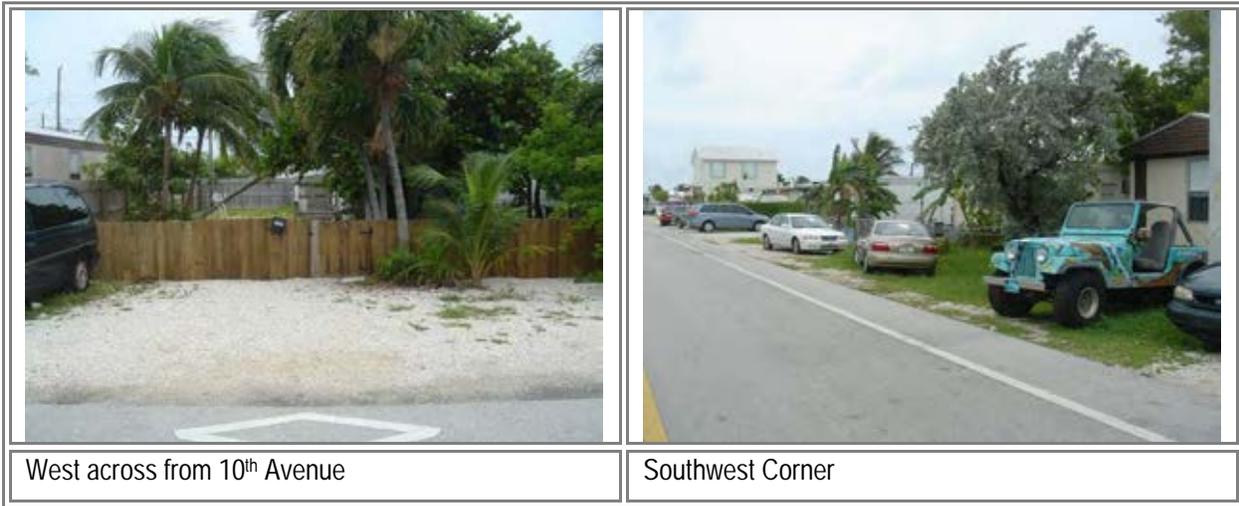
Observation	Recommendations
<p>SOUTHEAST CORNER</p> <ul style="list-style-type: none"> ⊗ Sidewalks do not exist in this area. <p>SOUTHEAST SIDEWALK SOUTH ON CROSS STREET</p> <ul style="list-style-type: none"> • Survey Points 0'-100' ⊗ Sidewalks do not exist in this area. <p>SOUTHEAST SIDEWALK EAST ON 10th Avenue</p> <ul style="list-style-type: none"> • Survey Points 0'-500' ⊗ Sidewalks do not exist in this area. <p>NORTHEAST CORNER</p> <ul style="list-style-type: none"> ⊗ Sidewalks do not exist in this area. <p>NORTHEAST SIDEWALK EAST ON 10th AVENUE</p> <ul style="list-style-type: none"> • Survey Points 0'-500' ⊗ Sidewalks do not exist in this area. <p>NORTHEAST SIDEWALK NORTH ON CROSS STREET</p> <ul style="list-style-type: none"> • Survey Points 0'-100' ⊗ Sidewalks do not exist in this area. <p>WEST SIDEWALK NORTH ON CROSS STREET</p> <ul style="list-style-type: none"> • Survey Points 0'-100' ⊗ Sidewalks do not exist in this area. <p>WEST SIDEWALK SOUTH ON CROSS STREET</p> <ul style="list-style-type: none"> • Survey Points 0'-100' ⊗ Sidewalks do not exist in this area. 	<p>A\$ - F\$\$ - Depending on the specific situation at each location, install accessible sidewalks and intersections in compliance with ADAAG and PROWAC guidance and FDOT Design Standards. This should include, but not be limited to, detectable warnings, driveway crossings, street crossing markings, signs, and pedestrian crossing signals as required.</p>

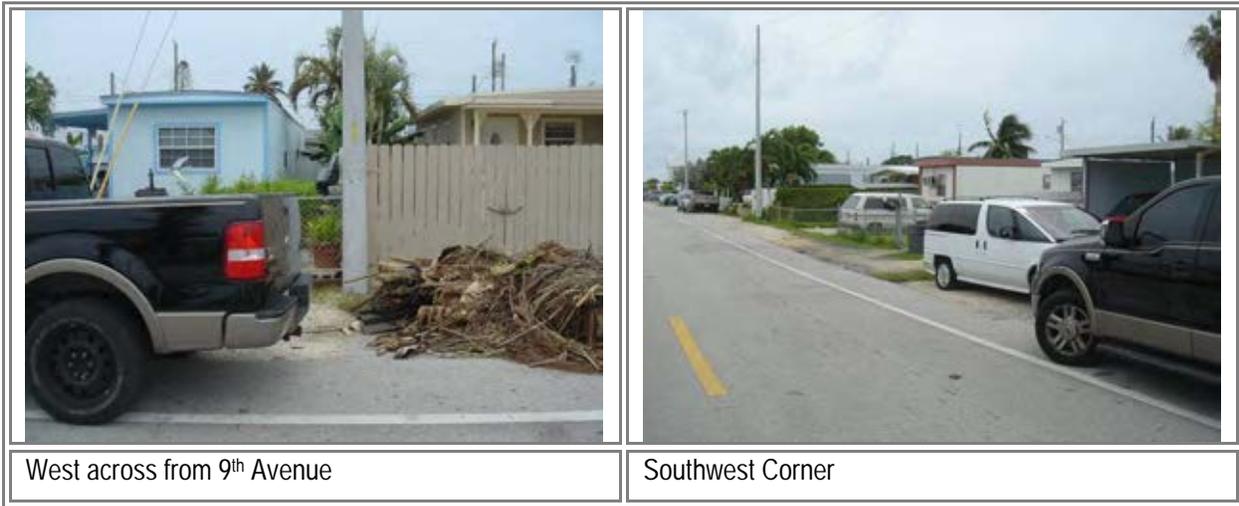
Observation	Recommendations
<p>SOUTHEAST CORNER</p> <ul style="list-style-type: none"> ⊗ Sidewalks do not exist in this area. <p>SOUTHEAST SIDEWALK SOUTH ON CROSS STREET</p> <ul style="list-style-type: none"> • Survey Points 0'-100' ⊗ Sidewalks do not exist in this area. <p>SOUTHEAST SIDEWALK EAST ON 9th Avenue</p> <ul style="list-style-type: none"> • Survey Points 0'-500' ⊗ Sidewalks do not exist in this area. <p>NORTHEAST CORNER</p> <ul style="list-style-type: none"> ⊗ Sidewalks do not exist in this area. <p>NORTHEAST SIDEWALK EAST ON 9th AVENUE</p> <ul style="list-style-type: none"> • Survey Points 0'-500' ⊗ Sidewalks do not exist in this area. <p>NORTHEAST SIDEWALK NORTH ON CROSS STREET</p> <ul style="list-style-type: none"> • Survey Points 0'-100' ⊗ Sidewalks do not exist in this area. <p>WEST SIDEWALK NORTH ON CROSS STREET</p> <ul style="list-style-type: none"> • Survey Points 0'-100' ⊗ Sidewalks do not exist in this area. <p>WEST SIDEWALK SOUTH ON CROSS STREET</p> <ul style="list-style-type: none"> • Survey Points 0'-100' ⊗ Sidewalks do not exist in this area. 	<p>A\$ - F\$\$ - Depending on the specific situation at each location, install accessible sidewalks and intersections in compliance with ADAAG and PROWAAC guidance and FDOT Design Standards. This should include, but not be limited to, detectable warnings, driveway crossings, street crossing markings, signs, and pedestrian crossing signals as required.</p>

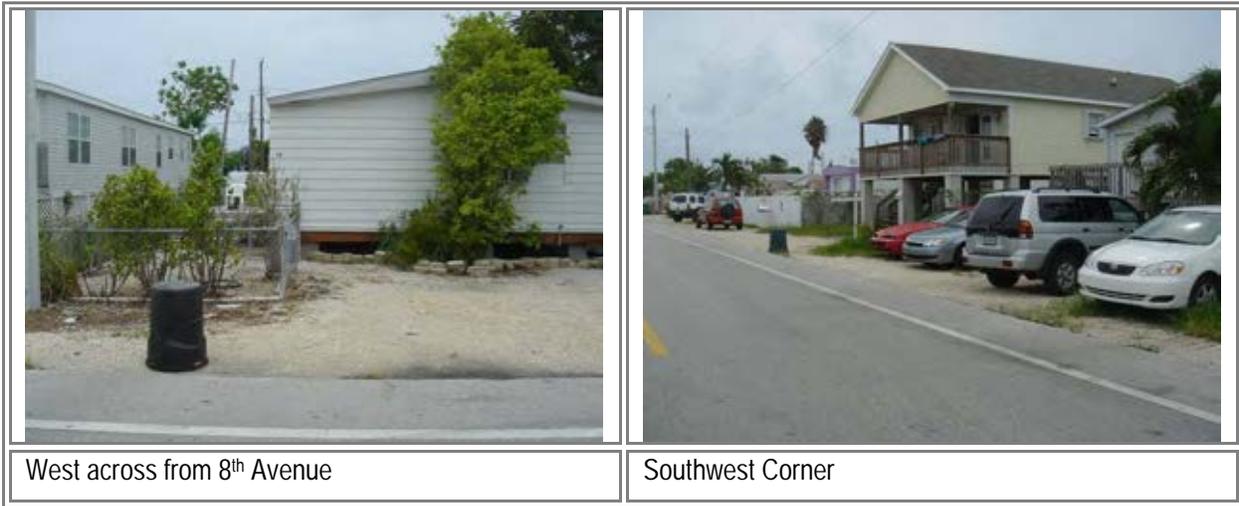
Observation	Recommendations
<p>SOUTHEAST CORNER</p> <ul style="list-style-type: none"> ⊗ Sidewalks do not exist in this area. <p>SOUTHEAST SIDEWALK SOUTH ON CROSS STREET</p> <ul style="list-style-type: none"> • Survey Points 0'-100' ⊗ Sidewalks do not exist in this area. <p>SOUTHEAST SIDEWALK EAST ON 8th Avenue</p> <ul style="list-style-type: none"> • Survey Points 0'-500' ⊗ Sidewalks do not exist in this area. <p>NORTHEAST CORNER</p> <ul style="list-style-type: none"> ⊗ Sidewalks do not exist in this area. <p>NORTHEAST SIDEWALK EAST ON 8th AVENUE</p> <ul style="list-style-type: none"> • Survey Points 0'-500' ⊗ Sidewalks do not exist in this area. <p>NORTHEAST SIDEWALK NORTH ON CROSS STREET</p> <ul style="list-style-type: none"> • Survey Points 0'-100' ⊗ Sidewalks do not exist in this area. <p>WEST SIDEWALK NORTH ON CROSS STREET</p> <ul style="list-style-type: none"> • Survey Points 0'-100' ⊗ Sidewalks do not exist in this area. <p>WEST SIDEWALK SOUTH ON CROSS STREET</p> <ul style="list-style-type: none"> • Survey Points 0'-100' ⊗ Sidewalks do not exist in this area. 	<p>A\$ - F\$\$ - Depending on the specific situation at each location, install accessible sidewalks and intersections in compliance with ADAAG and PROWAAC guidance and FDOT Design Standards. This should include, but not be limited to, detectable warnings, driveway crossings, street crossing markings, signs, and pedestrian crossing signals as required.</p>

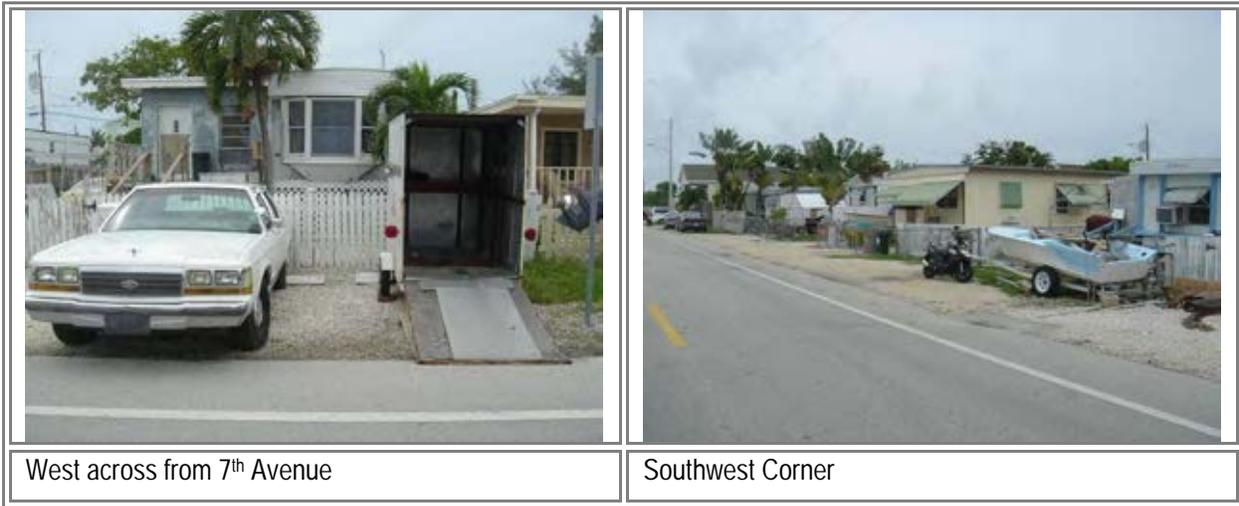
Observation	Recommendations
<p>SOUTHEAST CORNER</p> <ul style="list-style-type: none"> ⊗ Sidewalks do not exist in this area. <p>SOUTHEAST SIDEWALK SOUTH ON CROSS STREET</p> <ul style="list-style-type: none"> • Survey Points 0'-100' ⊗ Sidewalks do not exist in this area. <p>SOUTHEAST SIDEWALK EAST ON 7th Avenue</p> <ul style="list-style-type: none"> • Survey Points 0'-500' ⊗ Sidewalks do not exist in this area. <p>NORTHEAST CORNER</p> <ul style="list-style-type: none"> ⊗ Sidewalks do not exist in this area. <p>NORTHEAST SIDEWALK EAST ON 7th AVENUE</p> <ul style="list-style-type: none"> • Survey Points 0'-500' ⊗ Sidewalks do not exist in this area. <p>NORTHEAST SIDEWALK NORTH ON CROSS STREET</p> <ul style="list-style-type: none"> • Survey Points 0'-100' ⊗ Sidewalks do not exist in this area. <p>WEST SIDEWALK NORTH ON CROSS STREET</p> <ul style="list-style-type: none"> • Survey Points 0'-100' ⊗ Sidewalks do not exist in this area. <p>WEST SIDEWALK SOUTH ON CROSS STREET</p> <ul style="list-style-type: none"> • Survey Points 0'-100' ⊗ Sidewalks do not exist in this area. 	<p>A\$ - F\$\$ - Depending on the specific situation at each location, install accessible sidewalks and intersections in compliance with ADAAG and PROWAAC guidance and FDOT Design Standards. This should include, but not be limited to, detectable warnings, driveway crossings, street crossing markings, signs, and pedestrian crossing signals as required.</p>

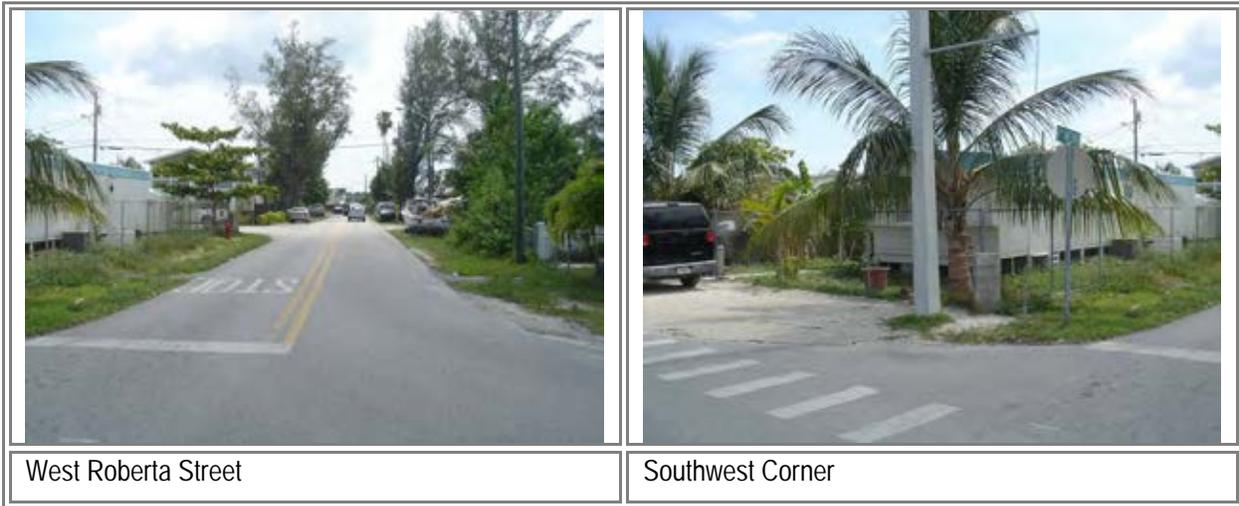
Observation	Recommendations
<p>SOUTHEAST CORNER</p> <ul style="list-style-type: none"> ⊗ Sidewalks do not exist in this area. <p>SOUTHEAST SIDEWALK SOUTH ON CROSS STREET</p> <ul style="list-style-type: none"> • Survey Points 0'-100' ⊗ Sidewalks do not exist in this area. <p>SOUTHEAST SIDEWALK EAST ON 6th Avenue</p> <ul style="list-style-type: none"> • Survey Points 0'-500' ⊗ Sidewalks do not exist in this area. <p>NORTHEAST CORNER</p> <ul style="list-style-type: none"> ⊗ Existing Sidewalks do not provide accessible connection to street. (Typical Photo 10) ⊗ Detectable warnings are not provided. ⊗ Utility pole reduces required clear width. (Typical Photo 01) <p>NORTHEAST SIDEWALK EAST ON 6th AVENUE</p> <ul style="list-style-type: none"> • Survey Points 0'-100' ⊗ Cross slope exceeds 2%. ⊗ Non-compliant driveway approach. (Typical Photo 04) ⊗ Intermittent breaks / cracks in surface. • Survey Points 100'-200' ⊗ Cross slope exceeds 2%. ⊗ Non-compliant driveway approach. (Typical Photo 04) ⊗ Intermittent breaks / cracks in surface. ⊗ Water meter recessed below surface. (Typical Photo 03) • Survey Points 200'-500' ⊗ Cross slope exceeds 2%. ⊗ Non-compliant driveway approach. (Typical Photo 04) ⊗ Intermittent breaks / cracks in surface. • Survey Points 500'-600' ⊗ Cross slope exceeds 2%. ⊗ Non-compliant driveway approach. (Typical Photo 04) 	<p>A\$ - F\$\$ - Depending on the specific situation at each location, install accessible sidewalks and intersections in compliance with ADAAG and PROWAAC guidance and FDOT Design Standards. This should include, but not be limited to, detectable warnings, driveway crossings, street crossing markings, signs, and pedestrian crossing signals as required.</p>

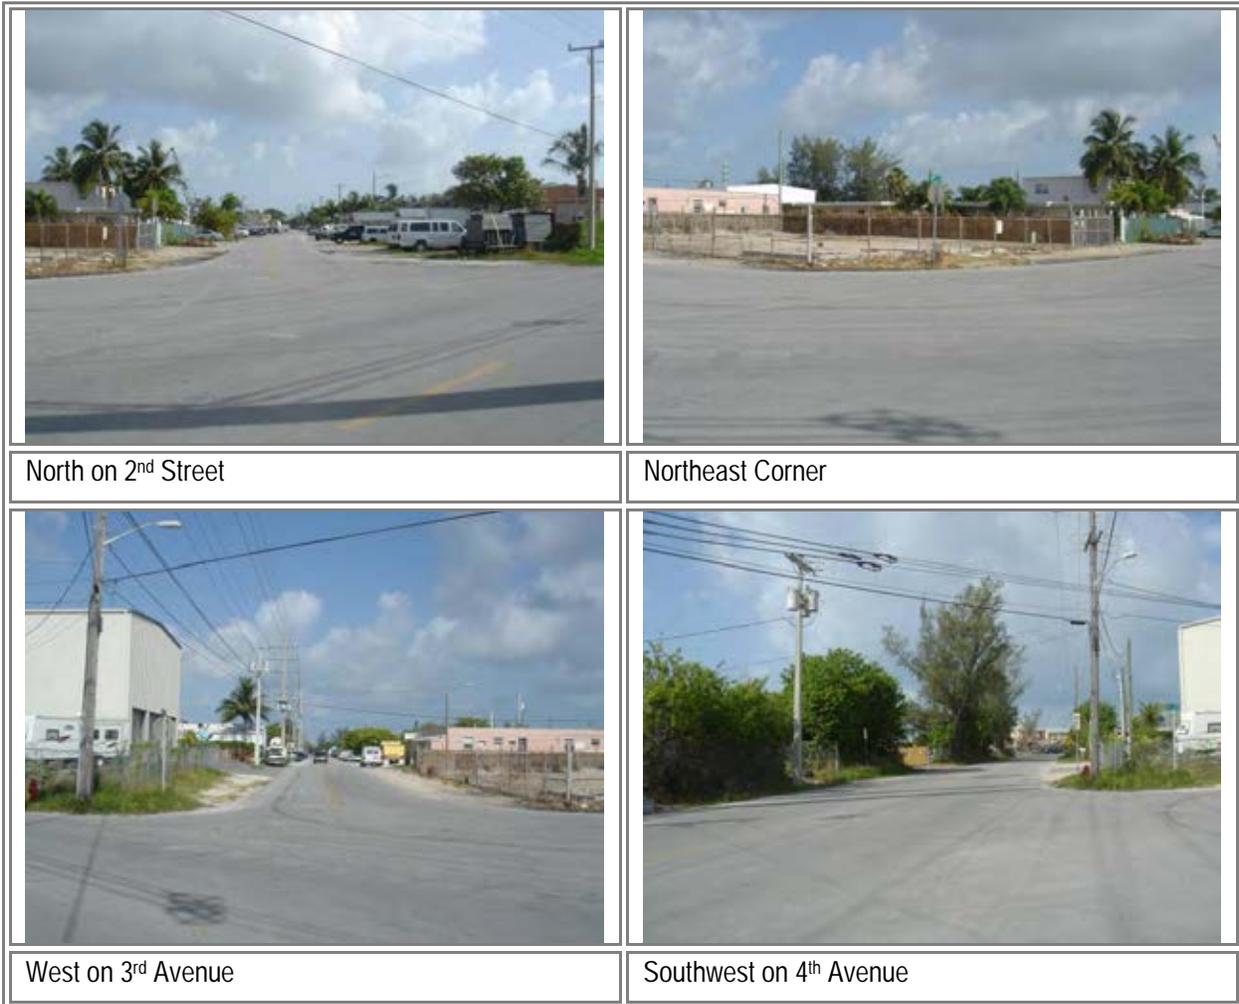
Observation	Recommendations
<p>SOUTHEAST SIDEWALK SOUTHWEST ON 4th AVENUE</p> <ul style="list-style-type: none"> • Survey Points 0'-200' ⊗ Sidewalks do not exist in this area. <p>SOUTHEAST SIDEWALK NORTHEAST ON 4th AVENUE</p> <ul style="list-style-type: none"> • Survey Points 0'-200' ⊗ Sidewalks do not exist in this area. <p>NORTHEAST CORNER</p> <ul style="list-style-type: none"> ⊗ Sidewalks do not exist in this area. <p>NORTHEAST SIDEWALK NORTHEAST ON 4th AVENUE</p> <ul style="list-style-type: none"> • Survey Points 0'-200' ⊗ Sidewalks do not exist in this area. <p>NORTHEAST SIDEWALK NORTH ON 2nd STREET</p> <ul style="list-style-type: none"> • Survey Points 0'-400' ⊗ Sidewalks do not exist in this area. <p>NORTHWEST CORNER</p> <ul style="list-style-type: none"> ⊗ Sidewalks do not exist in this area. 	<p>AS - F\$\$ - Depending on the specific situation at each location, install accessible sidewalks and intersections in compliance with ADAAG and PROWAAC guidance and FDOT Design Standards. This should include, but not be limited to, detectable warnings, driveway crossings, street crossing markings, signs, and pedestrian crossing signals as required.</p>

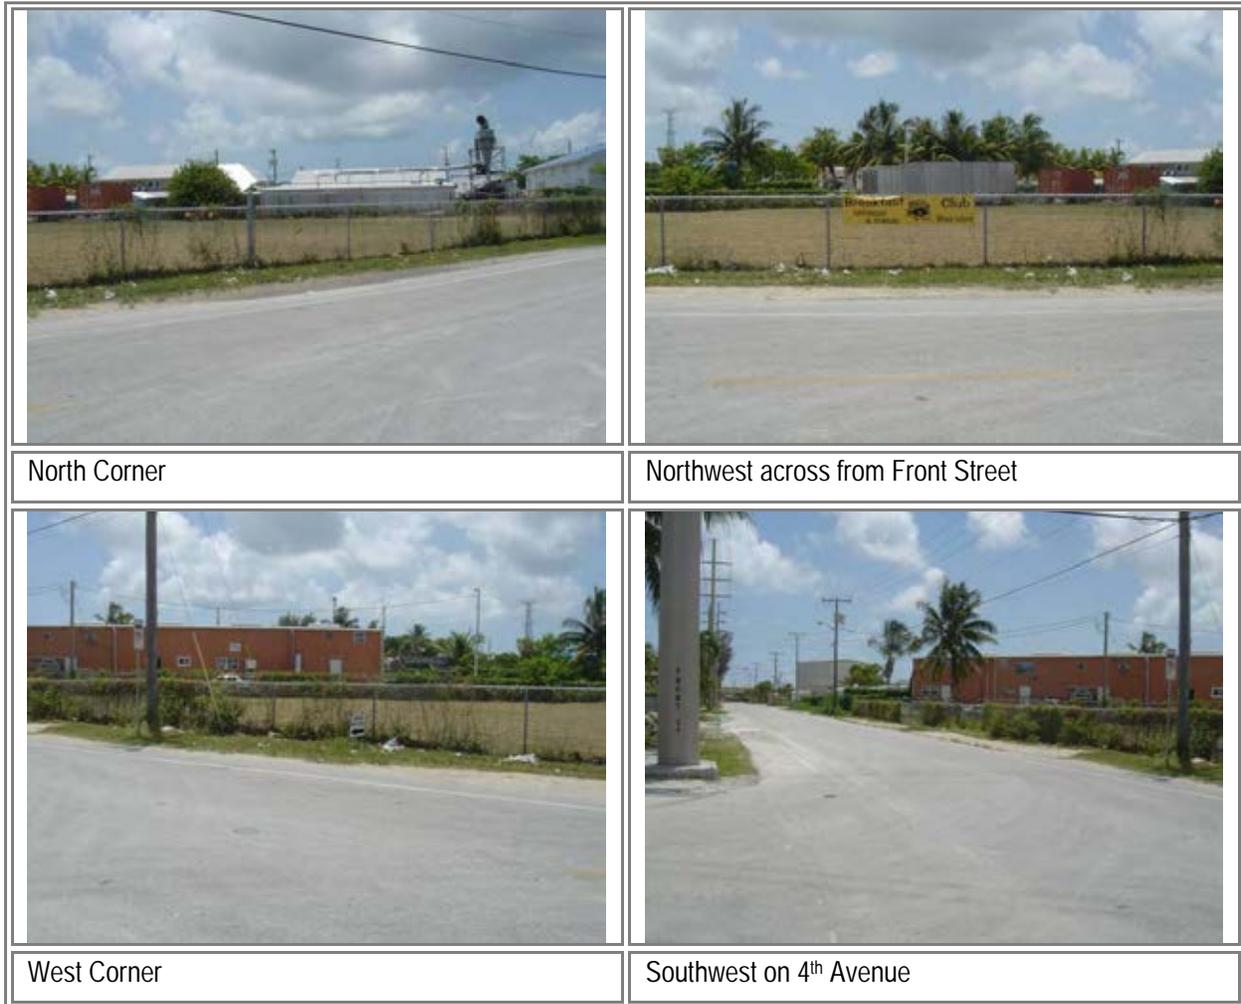
Observation	Recommendations
<p>SOUTH CORNER</p> <ul style="list-style-type: none"> ⊗ Sidewalks do not exist in this area. <p>SOUTH SIDEWALK SOUTHWEST ON 4th AVENUE</p> <ul style="list-style-type: none"> • Survey Points 0'-200' ⊗ Sidewalks do not exist in this area. <p>SOUTH SIDEWALK SOUTHEAST ON FRONT STREET</p> <ul style="list-style-type: none"> • Survey Points 0'-2300' ⊗ Sidewalks do not exist in this area. <p>EAST CORNER</p> <ul style="list-style-type: none"> ⊗ Sidewalk does not exist in this area. <p>EAST SIDEWALK SOUTHEAST ON FRONT STREET</p> <ul style="list-style-type: none"> • Survey Points 0'-2300' ⊗ Sidewalk does not exist in this area. <p>EAST SIDEWALK NORTHEAST ON 4th AVENUE</p> <ul style="list-style-type: none"> • Survey Points 0'-200' ⊗ Sidewalk does not exist in this area. 	<p>AS - FSS - Depending on the specific situation at each location, install accessible sidewalks and intersections in compliance with ADAAG and PROWAAC guidance and FDOT Design Standards. This should include, but not be limited to, detectable warnings, driveway crossings, street crossing markings, signs, and pedestrian crossing signals as required.</p>

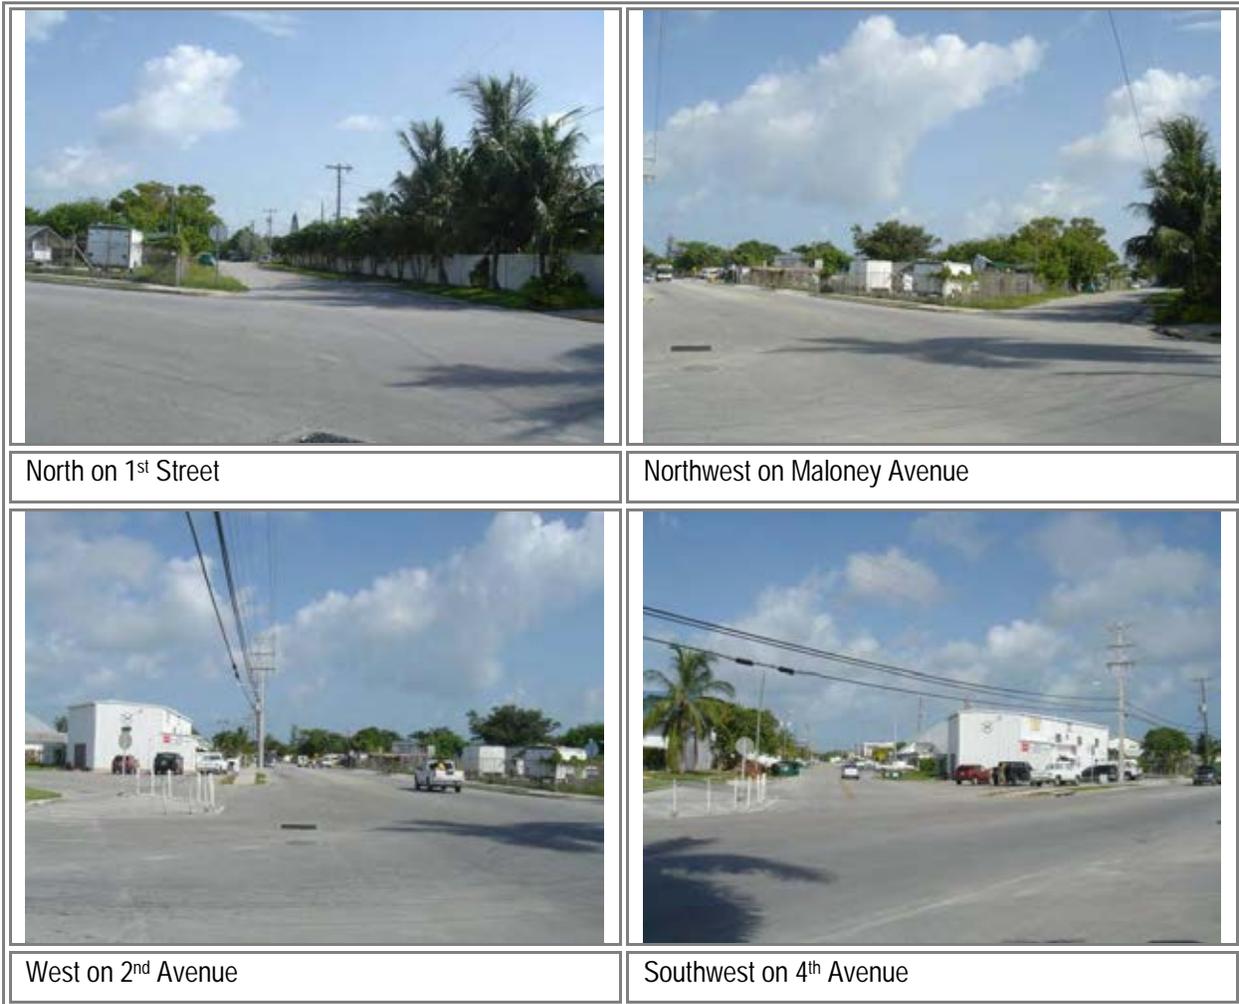
Observation	Recommendations
<p>SOUTH CORNER</p> <ul style="list-style-type: none"> ⊗ Existing sidewalk does not provide accessible connection to street. (Typical Photo 10) <p>SOUTH SIDEWALK SOUTHWEST ON 4th AVENUE</p> <ul style="list-style-type: none"> • Survey Points 0'-200' ⊗ Sidewalks do not exist in this area. <p>SOUTH SIDEWALK SOUTHEAST ON MALONEY AVENUE</p> <ul style="list-style-type: none"> • Survey Points 0'-300' ⊗ Non-compliant driveway approach. (Typical Photo 04) ⊗ Cracks / gaps greater than ½" in surface. (Typical Photo 07) • Survey Points 300'-400' ⊗ Non-compliant driveway approach. (Typical Photo 04) • Survey Points 400'-600' ✓ ADA Compliant • Survey Points 600'-700' 	<p>A\$ - F\$\$ - Depending on the specific situation at each location, install accessible sidewalks and intersections in compliance with ADAAG and PROWAAC guidance and FDOT Design Standards. This should include, but not be limited to, detectable warnings, driveway crossings, street crossing markings, signs, and pedestrian crossing signals as required.</p>

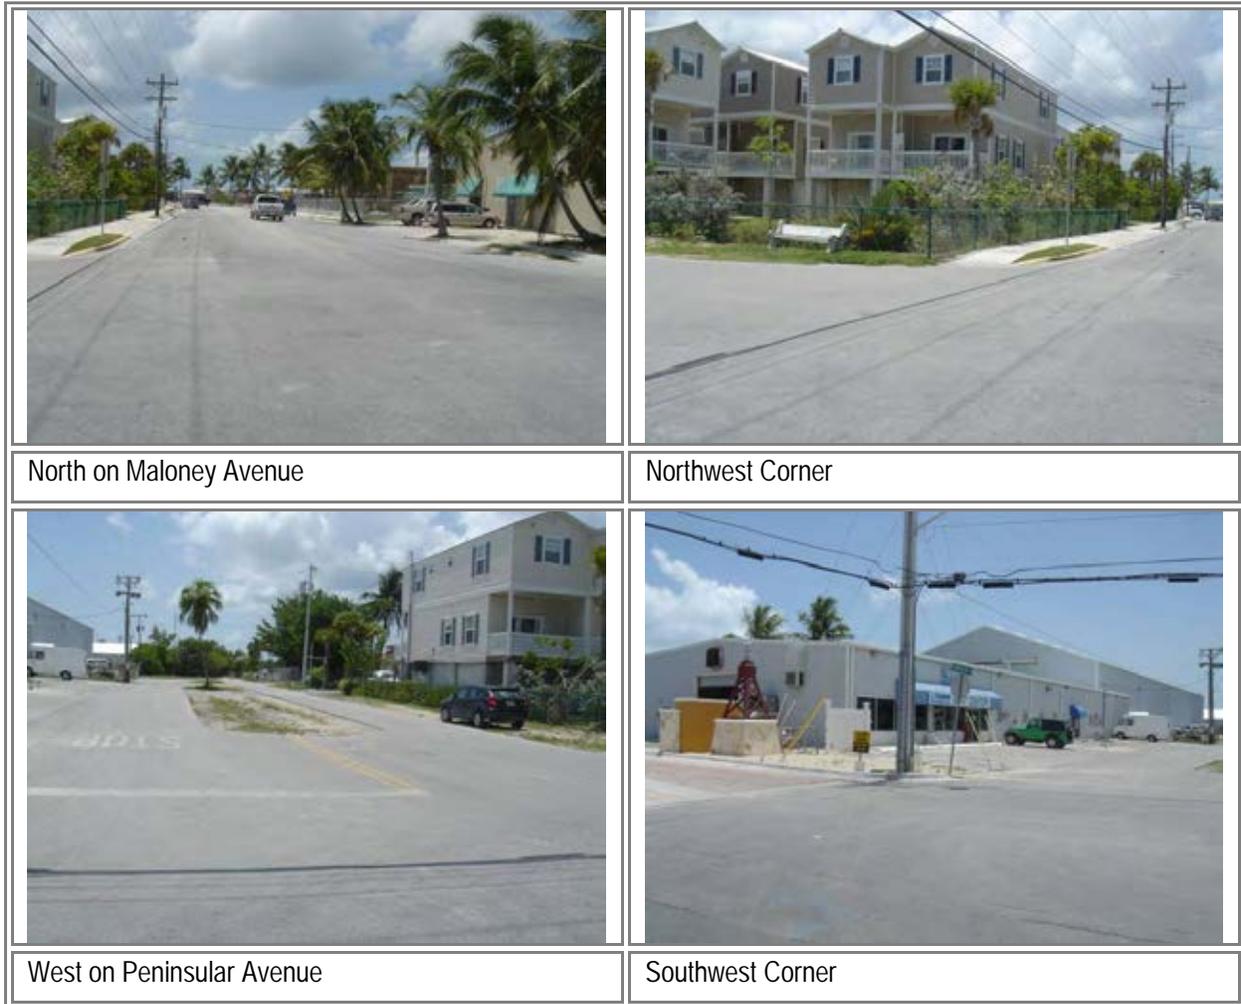
Observation	Recommendations
<p>SOUTH SIDEWALK WEST ON PENINSULAR AVENUE</p> <ul style="list-style-type: none"> Survey Points 0'-200' ⊗ Sidewalks do not exist in this area. <p>SOUTH SIDEWALK EAST ON PENINSULAR AVENUE</p> <ul style="list-style-type: none"> Survey Points 0'-800' ⊗ Sidewalks do not exist in this area. <p>NORTHEAST CORNER</p> <ul style="list-style-type: none"> ⊗ Detectable warnings are non-compliant. ⊗ Running Slope exceeds 5%. <p>NORTHEAST SIDEWALK EAST ON PENINSULAR AVENUE</p> <ul style="list-style-type: none"> Survey Points 0'-800' ⊗ Sidewalks do not exist in this area. <p>NORTHEAST SIDEWALK NORTH ON MALONEY AVENUE</p> <ul style="list-style-type: none"> Survey Points 0'-100' ⊗ Non-compliant driveway approach. (Typical Photo 04) ⊗ Cross slope exceeds 2%. 	<p>A\$ - F\$\$ - Depending on the specific situation at each location, install accessible sidewalks and intersections in compliance with ADAAG and PROWAC guidance and FDOT Design Standards. This should include, but not be limited to, detectable warnings, driveway crossings, street crossing markings, signs, and pedestrian crossing signals as required.</p>

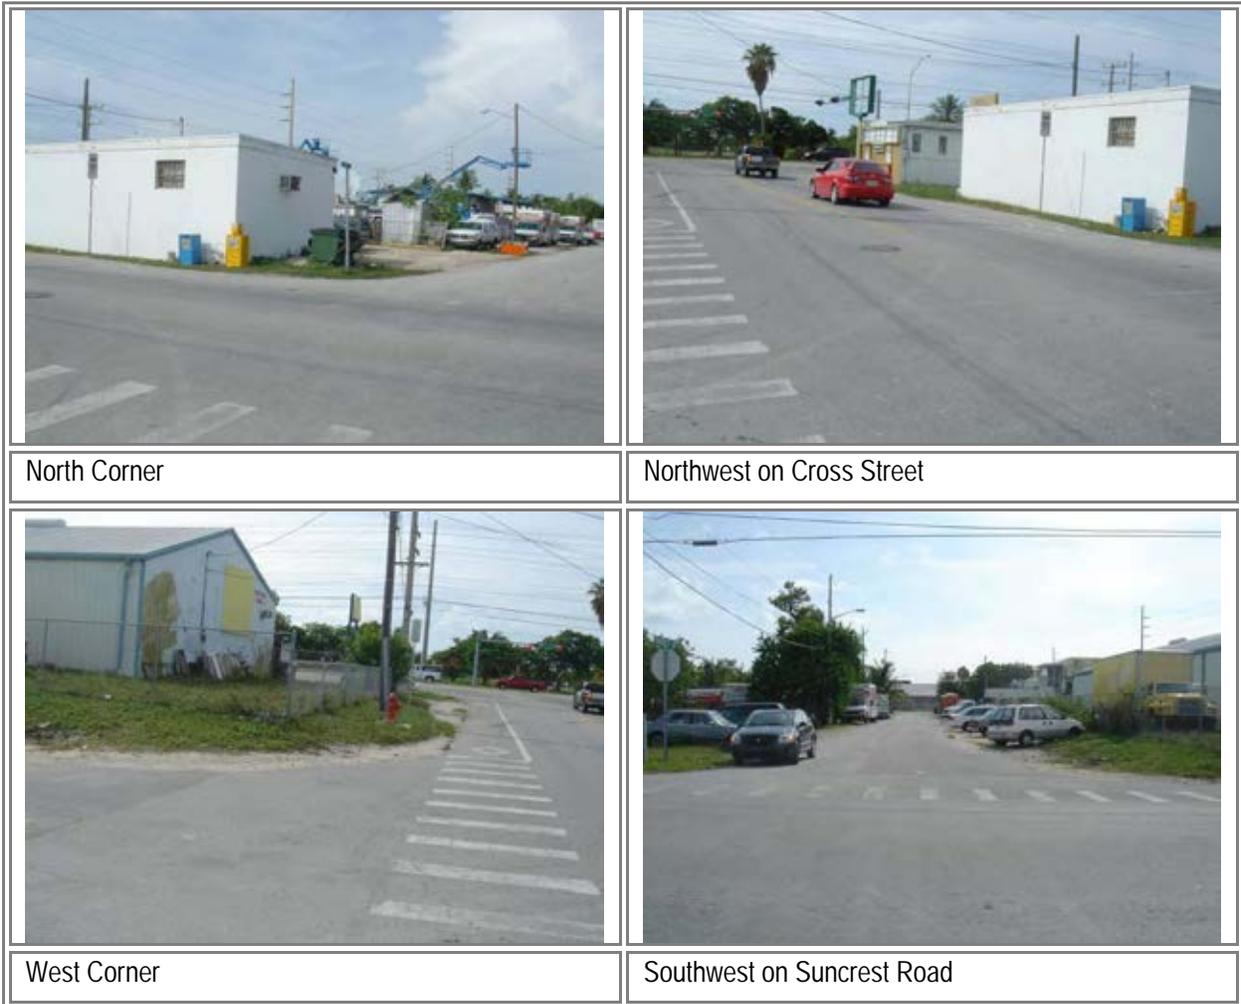
Observation	Recommendations
<p>SOUTH CORNER</p> <ul style="list-style-type: none"> ⊗ Sidewalks do not exist in this area. <p>SOUTH SIDEWALK SOUTHWEST ON SUNCREST ROAD</p> <ul style="list-style-type: none"> • Survey Points 0'-400' ⊗ Sidewalks do not exist in this area. <p>SOUTH SIDEWALK SOUTHEAST ON CROSS STREET</p> <ul style="list-style-type: none"> • Survey Points 0'-300' ⊗ Sidewalks do not exist in this area. <p>EAST CORNER</p> <ul style="list-style-type: none"> ⊗ Sidewalk does not exist in this area. <p>EAST SIDEWALK SOUTHEAST ON CROSS STREET</p> <ul style="list-style-type: none"> • Survey Points 0'-300' ⊗ Sidewalk does not exist in this area. <p>EAST SIDEWALK NORTHEAST ON SUNCREST ROAD</p> <ul style="list-style-type: none"> • Survey Points 0'-500' ⊗ Sidewalk does not exist in this area. 	<p>A\$ - F\$\$ - Depending on the specific situation at each location, install accessible sidewalks and intersections in compliance with ADAAG and PROWAAC guidance and FDOT Design Standards. This should include, but not be limited to, detectable warnings, driveway crossings, street crossing markings, signs, and pedestrian crossing signals as required.</p>

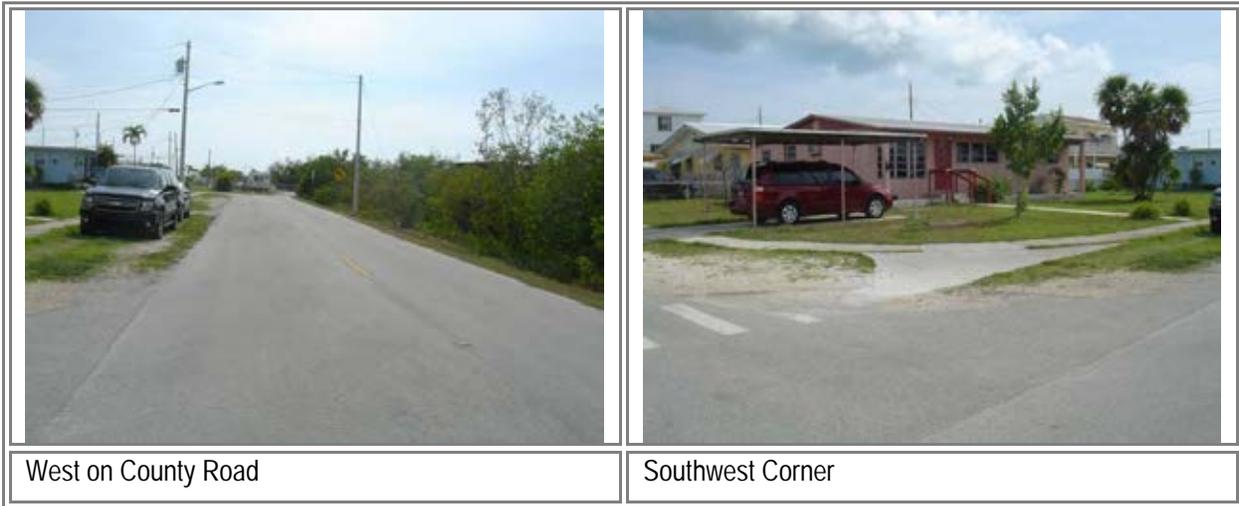
Observation	Recommendations
<p>SOUTHWEST CORNER</p> <ul style="list-style-type: none"> ⊗ Detectable warnings are not provided. ⊗ Cross slope exceeds 2%. ⊗ Running Slope exceeds 5%. ⊗ Existing sidewalk does not provide accessible connection to street. (Typical Photo 10) ✓ Crosswalk markings indicated to Southeast Corner. <p>SOUTHWEST SIDEWALK WEST ON COUNTY ROAD</p> <ul style="list-style-type: none"> • Survey Points 0'-200' ⊗ Cross slope exceeds 2%. ⊗ Non-compliant driveway approach. (Typical Photo 04) ⊗ Cracks / gaps greater than ½" in surface. (Typical Photo 07) <p>SOUTHWEST SIDEWALK SOUTH ON BALIDO STREET</p> <ul style="list-style-type: none"> • Survey Points 0'-200' ⊗ Cross slope exceeds 2%. ⊗ Non-compliant driveway approach. (Typical Photo 04) ⊗ Cracks / gaps greater than ½" in surface. (Typical Photo 07) <p>SOUTHEAST CORNER</p> <ul style="list-style-type: none"> ⊗ Detectable warnings are not provided. ⊗ Cross slope exceeds 2%. ⊗ Running Slope exceeds 5%. ⊗ Existing sidewalk does not provide accessible connection to street. (Typical Photo 10) ✓ Crosswalk markings indicated to Southwest Corner. <p>SOUTHEAST SIDEWALK SOUTH ON BALIDO STREET</p> <ul style="list-style-type: none"> • Survey Points 0'-200' ⊗ Cross slope exceeds 2%. ⊗ Non-compliant driveway approach. (Typical Photo 04) ⊗ Cracks / gaps greater than ½" in surface. (Typical Photo 07) 	<p>A\$ - F\$\$ - Depending on the specific situation at each location, install accessible sidewalks and intersections in compliance with ADAAG and PROWAAC guidance and FDOT Design Standards. This should include, but not be limited to, detectable warnings, driveway crossings, street crossing markings, signs, and pedestrian crossing signals as required.</p>

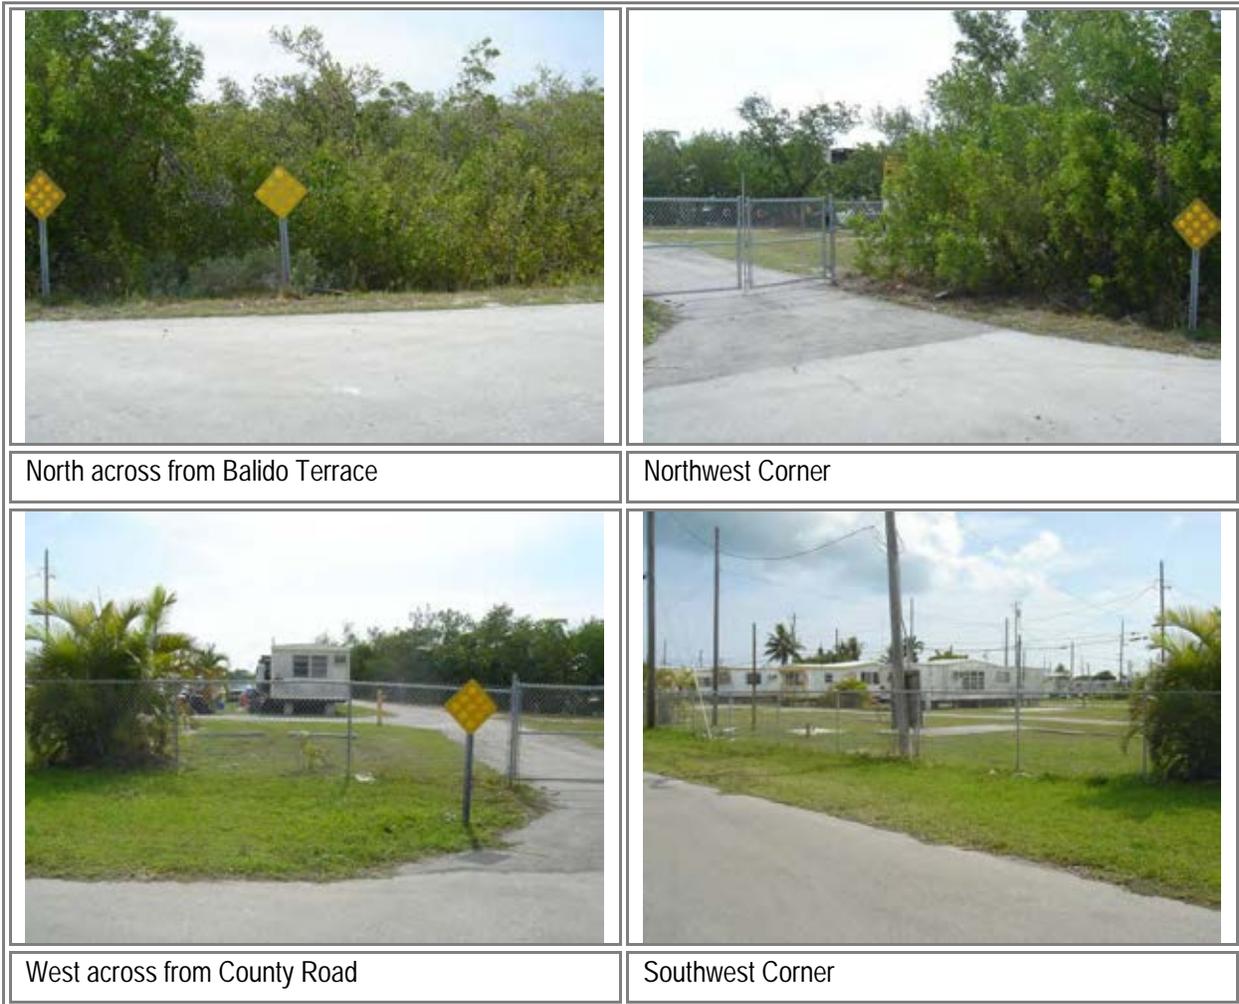
Observation	Recommendations
<p>SOUTHEAST CORNER</p> <ul style="list-style-type: none"> ⊗ Detectable warnings are not provided. ⊗ Cross slope exceeds 2%. ⊗ Running Slope exceeds 5%. ⊗ Existing sidewalk does not provide accessible connection to street. (Typical Photo 10) <p>SOUTHEAST SIDEWALK SOUTH ON BALIDO TERRACE</p> <ul style="list-style-type: none"> • Survey Points 0'-200' ⊗ Cross slope exceeds 2%. ⊗ Running Slope exceeds 5%. ⊗ Rough uneven surface. (Typical Photo 06) ⊗ Cracks / gaps greater than 1/2" in surface. (Typical Photo 07) <p>SOUTHEAST SIDEWALK EAST ON COUNTY ROAD</p> <ul style="list-style-type: none"> • Survey Points 0'-100' ⊗ Cross slope exceeds 2%. 	<p>AS - FSS - Depending on the specific situation at each location, install accessible sidewalks and intersections in compliance with ADAAG and PROWAAC guidance and FDOT Design Standards. This should include, but not be limited to, detectable warnings, driveway crossings, street crossing markings, signs, and pedestrian crossing signals as required.</p>

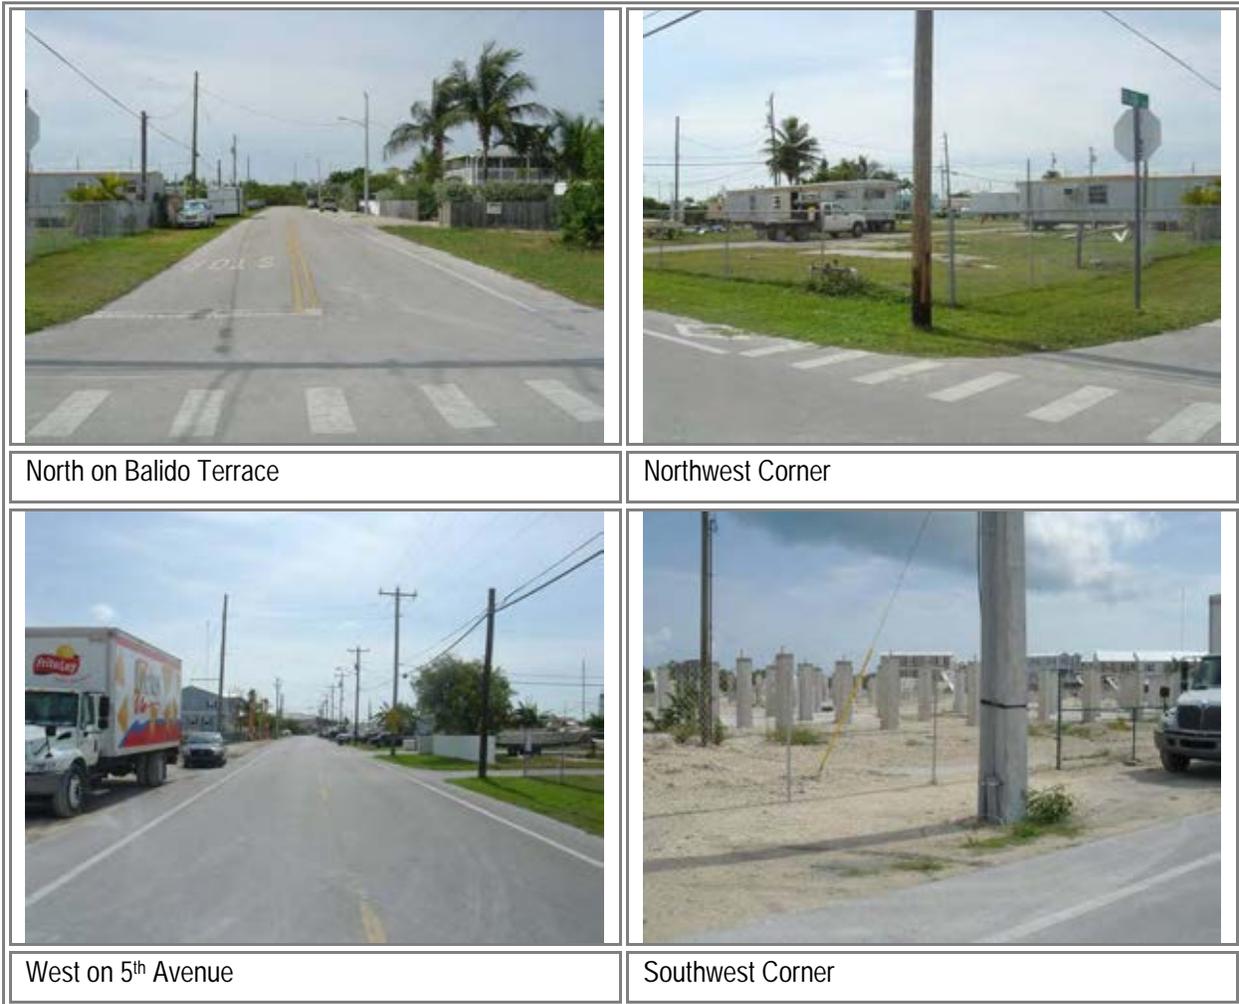
Observation	Recommendations
<p>SOUTH SIDEWALK WEST ON 5TH AVENUE</p> <ul style="list-style-type: none"> Survey Points 0'-800' ⊗ Sidewalks do not exist in this area. <p>SOUTH SIDEWALK EAST ON 5TH AVENUE</p> <ul style="list-style-type: none"> Survey Points 0'-100' ⊗ Sidewalks do not exist in this area. <p>NORTHEAST CORNER</p> <ul style="list-style-type: none"> ⊗ Sidewalks do not exist in this area. <p>NORTHEAST SIDEWALK EAST ON 5TH AVENUE</p> <ul style="list-style-type: none"> Survey Points 0'-100' ⊗ Sidewalks do not exist in this area. <p>NORTHEAST SIDEWALK NORTH ON BALIDO TERRACE</p> <ul style="list-style-type: none"> Survey Points 0'-200' ⊗ Sidewalks do not exist in this area. Survey Points 200'-300' ⊗ Sidewalks exist partially in this area. 	<p>A\$ - F\$\$ - Depending on the specific situation at each location, install accessible sidewalks and intersections in compliance with ADAAG and PROWAAC guidance and FDOT Design Standards. This should include, but not be limited to, detectable warnings, driveway crossings, street crossing markings, signs, and pedestrian crossing signals as required.</p>

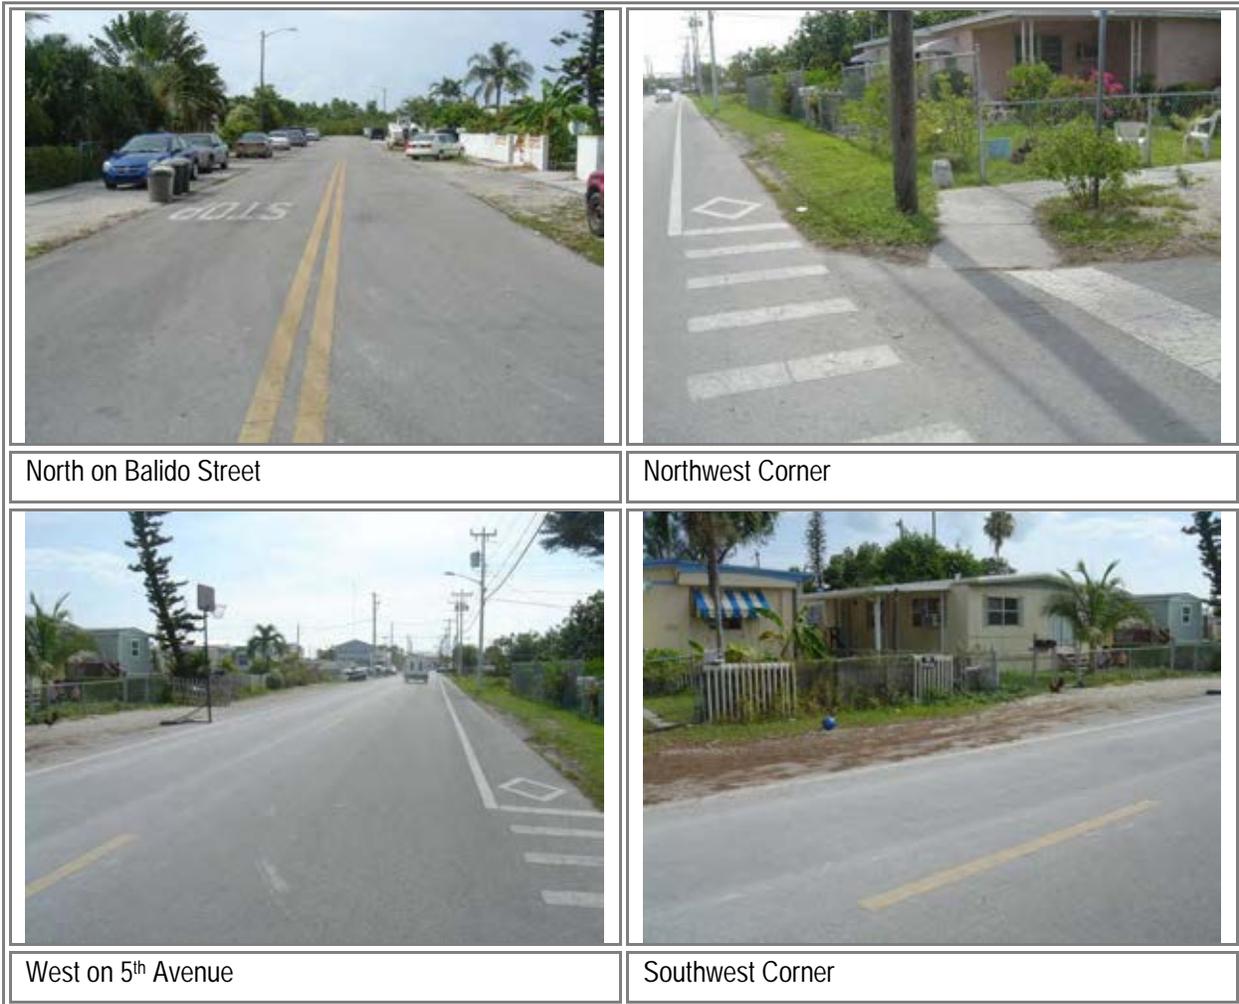
Observation	Recommendations
<p>SOUTH SIDEWALK WEST ON 5th AVENUE</p> <ul style="list-style-type: none"> Survey Points 0'-200' ⊗ Sidewalks do not exist in this area. <p>SOUTH SIDEWALK EAST ON 5th AVENUE</p> <ul style="list-style-type: none"> Survey Points 0'-100' ⊗ Sidewalks do not exist in this area. <p>NORTHEAST CORNER</p> <ul style="list-style-type: none"> ⊗ Detectable warnings are not provided. ⊗ Cross slope exceeds 2%. ⊗ Running Slope exceeds 5%. ⊗ Existing sidewalk does not provide accessible connection to street. (Typical Photo 10) ⊗ Cracks / gaps greater than ½" in surface. (Typical Photo 07) <p>NORTHEAST SIDEWALK EAST ON 5th AVENUE</p> <ul style="list-style-type: none"> Survey Points 0'-100' 	<p>AS - F\$\$ - Depending on the specific situation at each location, install accessible sidewalks and intersections in compliance with ADAAG and PROWAAC guidance and FDOT Design Standards. This should include, but not be limited to, detectable warnings, driveway crossings, street crossing markings, signs, and pedestrian crossing signals as required.</p>

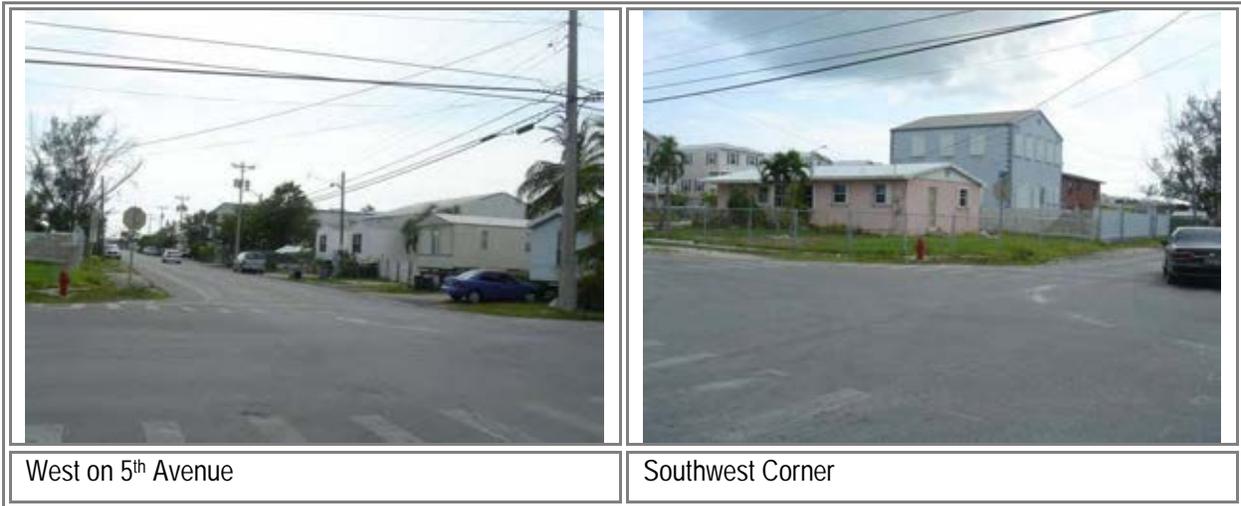
Observation	Recommendations
<p>SOUTHEAST CORNER</p> <ul style="list-style-type: none"> ⊗ Detectable warnings are not provided. ⊗ Cross slope exceeds 2%. ⊗ Running Slope exceeds 5%. ⊗ Surface is asphalt and enters into fenced in park. <p>SOUTHEAST SIDEWALK SOUTH ON 5th STREET</p> <ul style="list-style-type: none"> • Survey Points 0'-100' ⊗ Sidewalks do not exist in this area. <p>SOUTHEAST SIDEWALK EAST ON 5th AVENUE</p> <ul style="list-style-type: none"> • Survey Points 0'-300' ⊗ Asphalt path entering into fence in park; no connection to adjacent properties. <p>NORTHEAST CORNER</p> <ul style="list-style-type: none"> ⊗ Sidewalks do not exist in this area. <p>NORTHEAST SIDEWALK EAST ON 5th AVENUE</p> <ul style="list-style-type: none"> • Survey Points 0'-300' ⊗ Sidewalks do not exist in this area. <p>NORTHEAST SIDEWALK NORTH ON 5th STREET</p> <ul style="list-style-type: none"> • Survey Points 0'-100' ⊗ Sidewalks do not exist in this area. <p>NORTHWEST CORNER</p> <ul style="list-style-type: none"> ⊗ Sidewalks do not exist in this area. <p>NORTHWEST SIDEWALK NORTH ON 5th STREET</p> <ul style="list-style-type: none"> • Survey Points 0'-100' ⊗ Sidewalks do not exist in this area. <p>NORTHWEST SIDEWALK WEST ON 5th AVENUE</p> <ul style="list-style-type: none"> • Survey Points 0'-500' ⊗ Sidewalks do not exist in this area. <p>SOUTHWEST CORNER</p> <ul style="list-style-type: none"> ⊗ Detectable warnings are not provided. ⊗ Cross slope exceeds 2%. 	<p>A\$ - F\$\$ - Depending on the specific situation at each location, install accessible sidewalks and intersections in compliance with ADAAG and PROWAAC guidance and FDOT Design Standards. This should include, but not be limited to, detectable warnings, driveway crossings, street crossing markings, signs, and pedestrian crossing signals as required.</p>
