Americans with Disabilities Act Transition Plan Lower Keys - Part 2

Volume 4 of 4

Monroe County

October 29, 2010

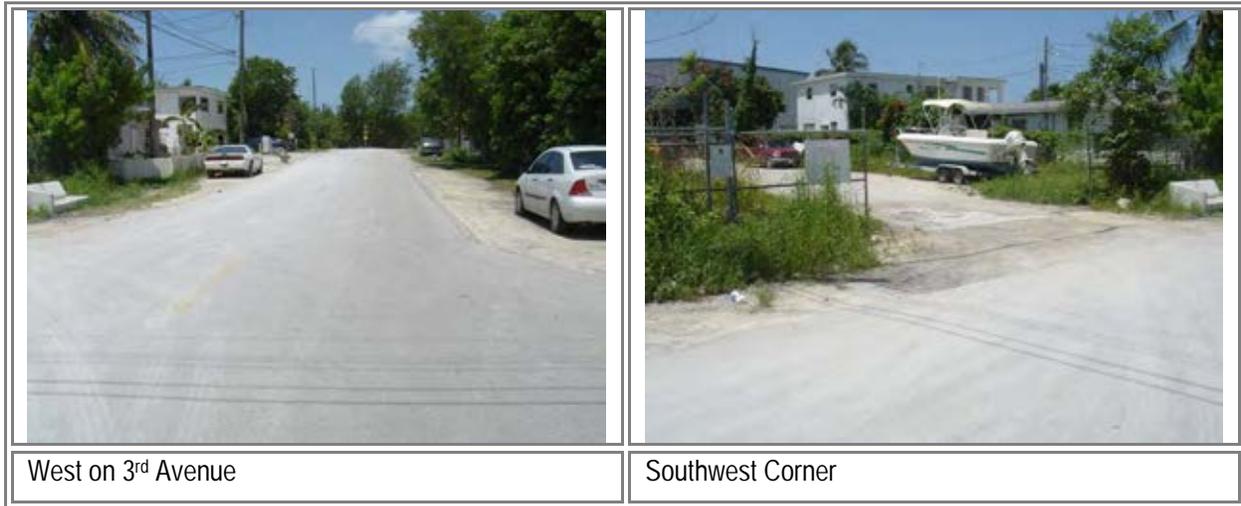
Observation	Recommendations
<p>SOUTH SIDEWALK WEST ON 3rd AVENUE</p> <ul style="list-style-type: none"> • Survey Points 0'-300' ⊗ Sidewalks do not exist in this area. <p>SOUTH SIDEWALK EAST ON 3rd AVENUE</p> <ul style="list-style-type: none"> • Survey Points 0'-100' ⊗ Sidewalks do not exist in this area. <p>NORTHEAST CORNER</p> <ul style="list-style-type: none"> ⊗ Sidewalks do not exist in this area. <p>NORTHEAST SIDEWALK EAST ON 3rd AVENUE</p> <ul style="list-style-type: none"> • Survey Points 0'-100' ⊗ Sidewalks do not exist in this area. <p>NORTHEAST SIDEWALK NORTH ON SUNSHINE STREET</p> <ul style="list-style-type: none"> • Survey Points 0'-300' ⊗ Sidewalks do not exist in this area. <p>NORTHWEST CORNER</p> <ul style="list-style-type: none"> ⊗ Sidewalks do not exist in this area. <p>NORTHWEST SIDEWALK NORTH ON SUNSHINE STREET</p> <ul style="list-style-type: none"> • Survey Points 0'-300' ⊗ Sidewalks do not exist in this area. <p>NORTHWEST SIDEWALK WEST ON 3rd AVENUE</p> <ul style="list-style-type: none"> • Survey Points 0'-300' ⊗ Sidewalks do not exist in this area. 	<p>A\$ - F\$\$ - Depending on the specific situation at each location, install accessible sidewalks and intersections in compliance with ADAAG and PROWAAC guidance and FDOT Design Standards. This should include, but not be limited to, detectable warnings, driveway crossings, street crossing markings, signs, and pedestrian crossing signals as required.</p>

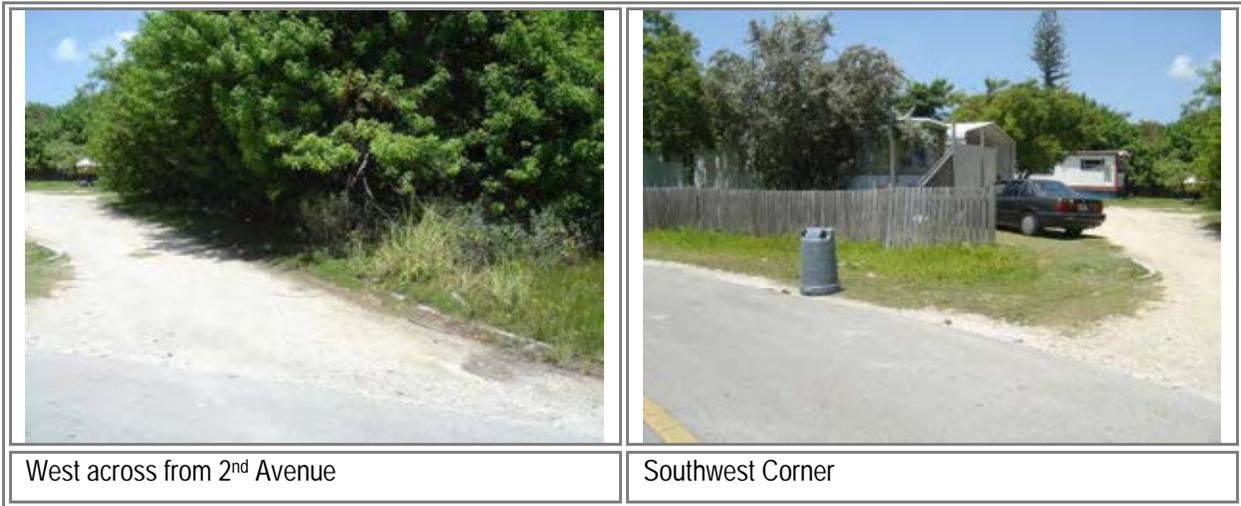
Observation	Recommendations
<p>SOUTHEAST CORNER</p> <ul style="list-style-type: none"> ⊗ Sidewalks do not exist in this area. <p>SOUTHEAST SIDEWALK SOUTH ON SUNSHINE STREET</p> <ul style="list-style-type: none"> • Survey Points 0'-200' ⊗ Sidewalks do not exist in this area. <p>SOUTHEAST SIDEWALK EAST ON 2nd AVENUE</p> <ul style="list-style-type: none"> • Survey Points 0'-100' ⊗ Sidewalks do not exist in this area. <p>NORTHWEST CORNER</p> <ul style="list-style-type: none"> ⊗ Sidewalks do not exist in this area. <p>NORTHWEST SIDEWALK EAST ON 2nd AVENUE</p> <ul style="list-style-type: none"> • Survey Points 0'-100' ⊗ Sidewalks do not exist in this area. <p>NORTHWEST SIDEWALK SOUTH ON SUNSHINE STREET</p> <ul style="list-style-type: none"> • Survey Points 0'-200' ⊗ Sidewalks do not exist in this area. 	<p>A\$ - F\$\$ - Depending on the specific situation at each location, install accessible sidewalks and intersections in compliance with ADAAG and PROWAAC guidance and FDOT Design Standards. This should include, but not be limited to, detectable warnings, driveway crossings, street crossing markings, signs, and pedestrian crossing signals as required.</p>

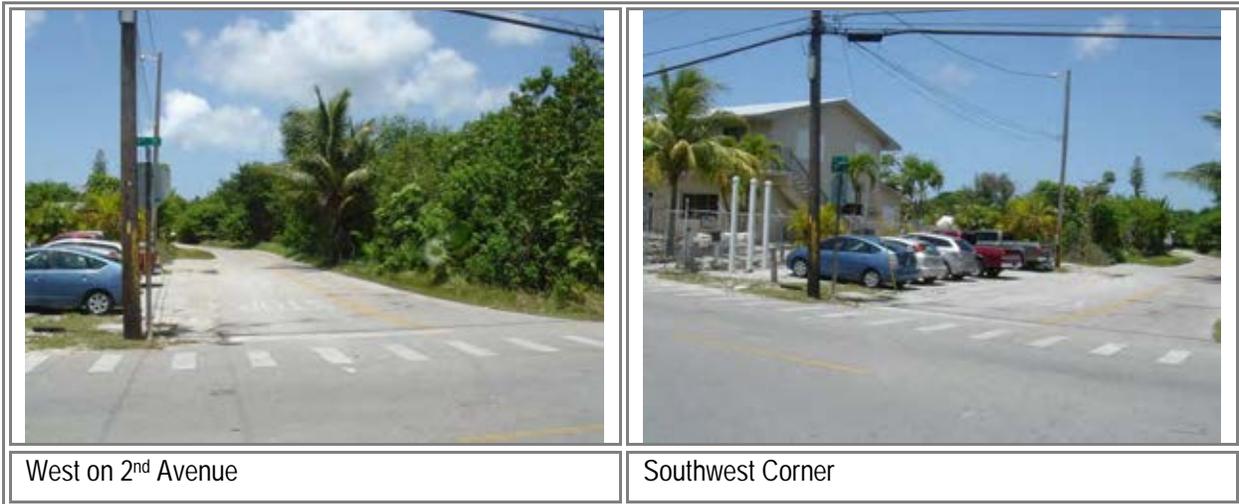
Observation	Recommendations
<p>SOUTHEAST CORNER</p> <ul style="list-style-type: none"> ⊗ Sidewalks do not exist in this area. <p>SOUTHEAST SIDEWALK SOUTH ON 5th STREET</p> <ul style="list-style-type: none"> • Survey Points 0'-200' ⊗ Sidewalks do not exist in this area. <p>SOUTHEAST SIDEWALK EAST ON 2nd AVENUE</p> <ul style="list-style-type: none"> • Survey Points 0'-500' ⊗ Sidewalks do not exist in this area. <p>NORTHEAST CORNER</p> <ul style="list-style-type: none"> ⊗ Sidewalks do not exist in this area. <p>NORTHEAST SIDEWALK EAST ON 2nd AVENUE</p> <ul style="list-style-type: none"> • Survey Points 0'-500' ⊗ Sidewalks do not exist in this area. <p>NORTHEAST SIDEWALK NORTH ON SUNSHINE STREET</p> <ul style="list-style-type: none"> • Survey Points 0'-300' ⊗ Sidewalks do not exist in this area. <p>NORTHWEST CORNER</p> <ul style="list-style-type: none"> ⊗ Sidewalks do not exist in this area. <p>NORTHWEST SIDEWALK NORTH ON 5th STREET</p> <ul style="list-style-type: none"> • Survey Points 0'-300' ⊗ Sidewalks do not exist in this area. <p>NORTHWEST SIDEWALK WEST ON 2nd AVENUE</p> <ul style="list-style-type: none"> • Survey Points 0'-200' ⊗ Sidewalks do not exist in this area. <p>SOUTHWEST CORNER</p> <ul style="list-style-type: none"> ⊗ Sidewalks do not exist in this area. <p>SOUTHWEST SIDEWALK WEST ON 2nd AVENUE</p> <ul style="list-style-type: none"> • Survey Points 0'-200' ⊗ Sidewalks do not exist in this area. <p>SOUTHWEST SIDEWALK SOUTH ON 5th STREET</p> <ul style="list-style-type: none"> • Survey Points 0'-200' 	<p>A\$ - F\$\$ - Depending on the specific situation at each location, install accessible sidewalks and intersections in compliance with ADAAG and PROWAAC guidance and FDOT Design Standards. This should include, but not be limited to, detectable warnings, driveway crossings, street crossing markings, signs, and pedestrian crossing signals as required.</p>

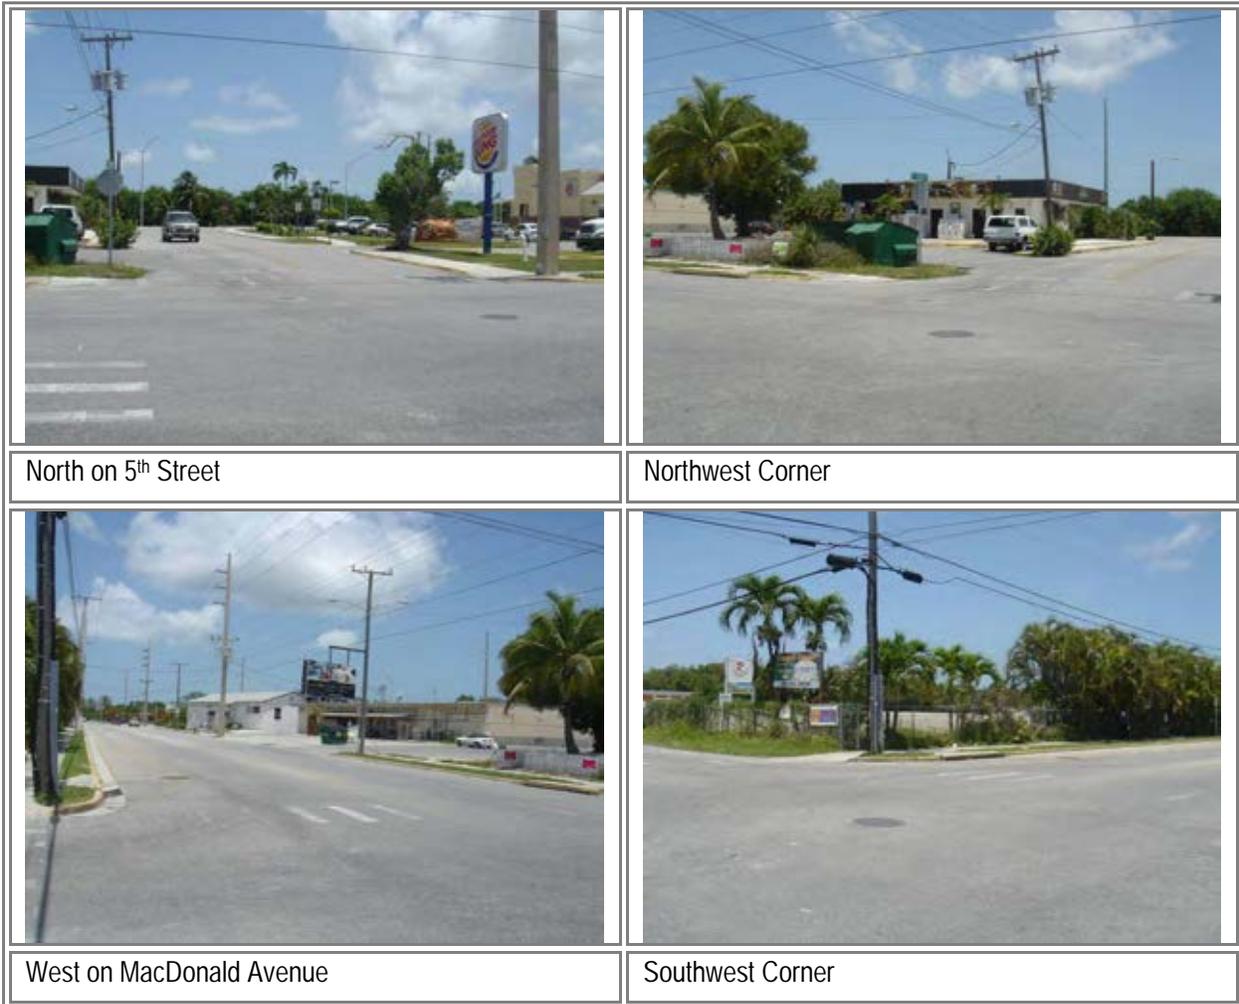
Observation	Recommendations
<p>SOUTHEAST CORNER</p> <ul style="list-style-type: none"> ⊗ Detectable warnings are not provided. ⊗ Running Slope exceeds 5%. ⊗ Existing sidewalk does not provide accessible connection to street. (Typical Photo 10) ✓ Crosswalk markings indicated to Southwest corner. ✓ Crosswalk markings indicated to Northeast corner. <p>SOUTHEAST SIDEWALK SOUTH ON 5th STREET</p> <ul style="list-style-type: none"> • Survey Points 0'-300' ⊗ Sidewalks do not exist in this area. <p>SOUTHEAST SIDEWALK EAST ON MacDONALD AVENUE</p> <ul style="list-style-type: none"> • Survey Points 0'-300' ⊗ Non-compliant driveway approach. (Typical Photo 04) <p>NORTHEAST CORNER</p> <ul style="list-style-type: none"> ⊗ Detectable warnings are not provided. ⊗ Existing sidewalk does not provide accessible 	<p>A\$ - F\$\$ - Depending on the specific situation at each location, install accessible sidewalks and intersections in compliance with ADAAG and PROWAAC guidance and FDOT Design Standards. This should include, but not be limited to, detectable warnings, driveway crossings, street crossing markings, signs, and pedestrian crossing signals as required.</p>

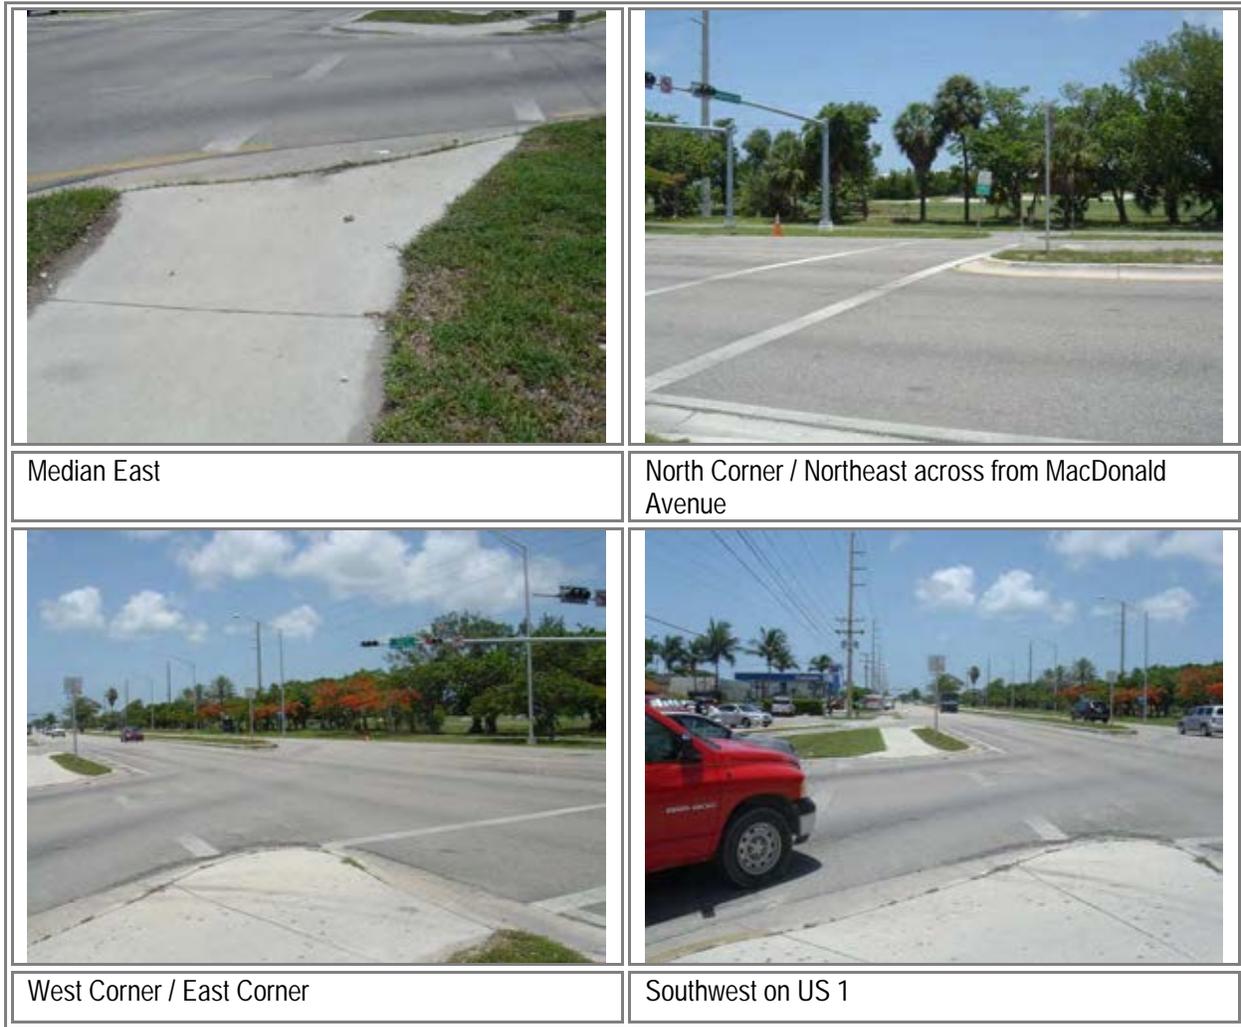
Observation	Recommendations
<p>SOUTH CORNER</p> <ul style="list-style-type: none"> ⊗ Detectable warnings are not provided. ⊗ Existing sidewalk does not provide accessible connection to street. (Typical Photo 10) <p>SOUTH SIDEWALK EAST ON MacDONALD AVENUE</p> <ul style="list-style-type: none"> • Survey Points 0'-300' ⊗ Vegetation reduces required clear width. (Typical Photo 08) <p>MEDIAN WEST</p> <ul style="list-style-type: none"> ⊗ Detectable warnings are not provided. ⊗ Existing sidewalk does not provide accessible connection to street. (Typical Photo 10) <p>MEDIAN EAST</p> <ul style="list-style-type: none"> ⊗ Detectable warnings are not provided. ✓ Crosswalk markings indicated to East corner. <p>EAST CORNER</p>	<p>A\$ - F\$\$ - Depending on the specific situation at each location, install accessible sidewalks and intersections in compliance with ADAAG and PROWAAC guidance and FDOT Design Standards. This should include, but not be limited to, detectable warnings, driveway crossings, street crossing markings, signs, and pedestrian crossing signals as required.</p>

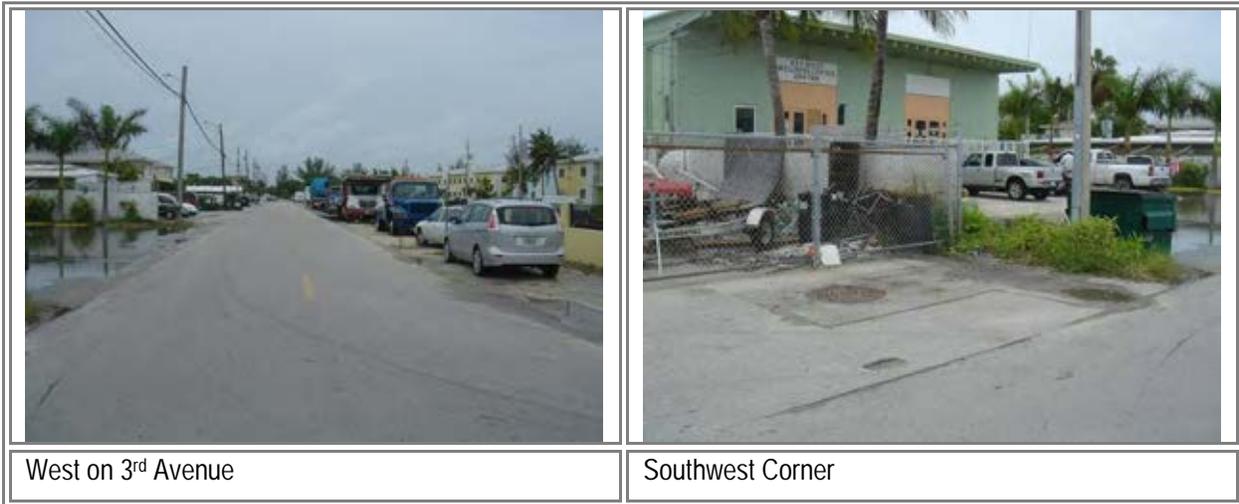
Observation	Recommendations
<p>SOUTH SIDEWALK WEST ON 3rd AVENUE</p> <ul style="list-style-type: none"> Survey Points 0'-600' ⊗ Sidewalks do not exist in this area. <p>SOUTH SIDEWALK EAST ON 3rd AVENUE</p> <ul style="list-style-type: none"> Survey Points 0'-100' ⊗ Sidewalks do not exist in this area. <p>NORTHEAST CORNER</p> <ul style="list-style-type: none"> ⊗ Sidewalk does not exist in this area. <p>NORTHEAST SIDEWALK EAST ON 3rd AVENUE</p> <ul style="list-style-type: none"> Survey Points 0'-100' ⊗ Sidewalk does not exist in this area. <p>NORTHEAST SIDEWALK NORTH ON 3rd STREET</p> <ul style="list-style-type: none"> Survey Points 0'-300' ⊗ Sidewalk does not exist in this area. <p>NORTHWEST CORNER</p> <ul style="list-style-type: none"> ⊗ Sidewalk does not exist in this area. <p>NORTHWEST SIDEWALK NORTH ON 3rd STREET</p> <ul style="list-style-type: none"> Survey Points 0'-300' ⊗ Sidewalk does not exist in this area. <p>NORTHEAST SIDEWALK WEST ON 3rd AVENUE</p> <ul style="list-style-type: none"> Survey Points 0'-600' ⊗ Sidewalk does not exist in this area. 	<p>A\$ - F\$\$ - Depending on the specific situation at each location, install accessible sidewalks and intersections in compliance with ADAAG and PROWAAC guidance and FDOT Design Standards. This should include, but not be limited to, detectable warnings, driveway crossings, street crossing markings, signs, and pedestrian crossing signals as required.</p>

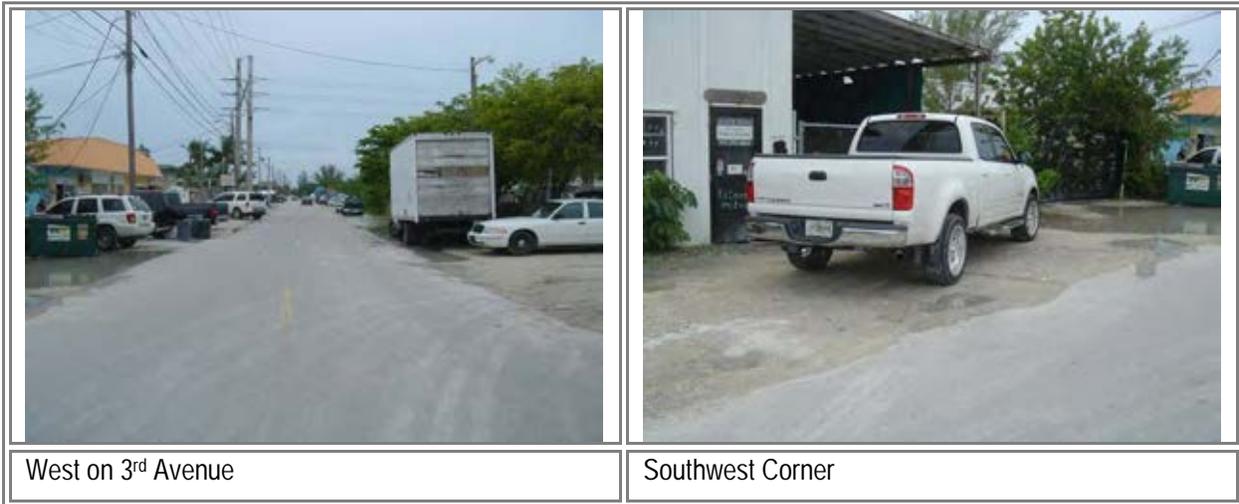
Observation	Recommendations
<p>SOUTH SIDEWALK WEST ON 3rd AVENUE</p> <ul style="list-style-type: none"> • Survey Points 0'-200' ⊗ Sidewalks do not exist in this area. <p>SOUTH SIDEWALK EAST ON 3rd AVENUE</p> <ul style="list-style-type: none"> • Survey Points 0'-100' ⊗ Sidewalks do not exist in this area. <p>NORTHEAST CORNER</p> <ul style="list-style-type: none"> ⊗ Sidewalk does not exist in this area. <p>NORTHEAST SIDEWALK EAST ON 3rd AVENUE</p> <ul style="list-style-type: none"> • Survey Points 0'-100' ⊗ Sidewalk does not exist in this area. <p>NORTHEAST SIDEWALK NORTH ON 2nd TERRACE</p> <ul style="list-style-type: none"> • Survey Points 0'-300' ⊗ Sidewalk does not exist in this area. <p>NORTHWEST CORNER</p> <ul style="list-style-type: none"> ⊗ Sidewalk does not exist in this area. <p>NORTHWEST SIDEWALK NORTH ON 2nd TERRACE</p> <ul style="list-style-type: none"> • Survey Points 0'-300' ⊗ Sidewalk does not exist in this area. <p>NORTHEAST SIDEWALK WEST ON 3rd AVENUE</p> <ul style="list-style-type: none"> • Survey Points 0'-200' ⊗ Sidewalk does not exist in this area. 	<p>A\$ - F\$\$ - Depending on the specific situation at each location, install accessible sidewalks and intersections in compliance with ADAAG and PROWAAC guidance and FDOT Design Standards. This should include, but not be limited to, detectable warnings, driveway crossings, street crossing markings, signs, and pedestrian crossing signals as required.</p>

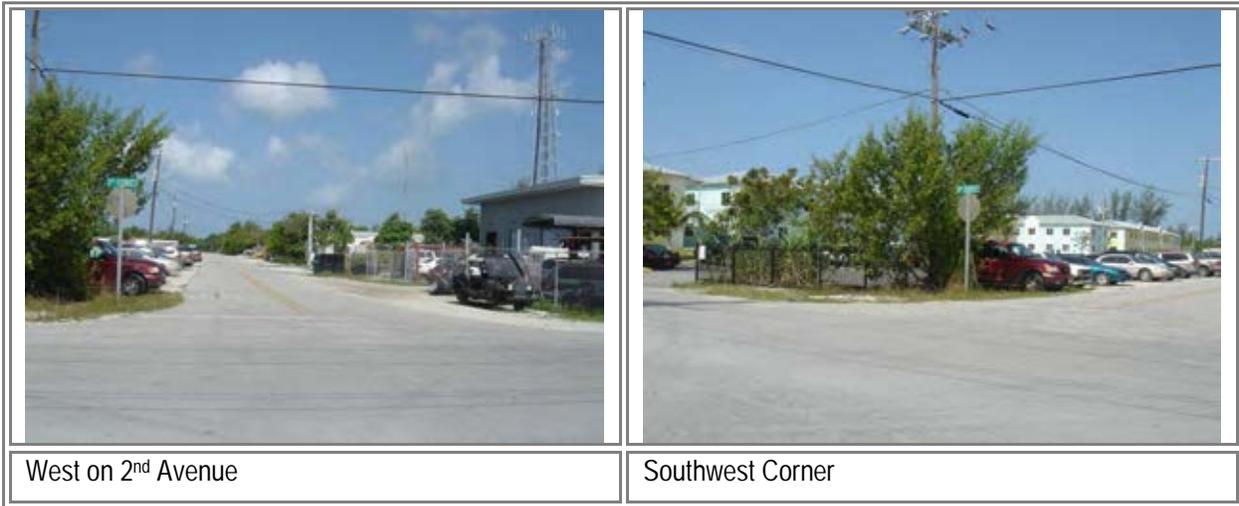
Observation	Recommendations
<p>SOUTHEAST CORNER</p> <ul style="list-style-type: none"> ⊗ Sidewalk does not exist in this area. <p>SOUTHEAST SIDEWALK SOUTH ON 3rd STREET</p> <ul style="list-style-type: none"> • Survey Points 0'-300' ⊗ Sidewalk does not exist in this area. <p>SOUTHEAST SIDEWALK EAST ON 2nd AVENUE</p> <ul style="list-style-type: none"> • Survey Points 0'-100' ⊗ Sidewalk does not exist in this area. <p>NORTHEAST CORNER</p> <ul style="list-style-type: none"> ⊗ Sidewalk does not exist in this area. <p>NORTHEAST SIDEWALK EAST ON 2nd AVENUE</p> <ul style="list-style-type: none"> • Survey Points 0'-100' ⊗ Sidewalk does not exist in this area. <p>NORTHEAST SIDEWALK NORTH ON 3rd STREET</p> <ul style="list-style-type: none"> • Survey Points 0'-200' ⊗ Sidewalk does not exist in this area. <p>NORTHWEST CORNER</p> <ul style="list-style-type: none"> ⊗ Sidewalk does not exist in this area. <p>NORTHWEST SIDEWALK NORTH ON 3rd STREET</p> <ul style="list-style-type: none"> • Survey Points 0'-200' ⊗ Sidewalk does not exist in this area. <p>NORTHEAST SIDEWALK WEST ON 2nd AVENUE</p> <ul style="list-style-type: none"> • Survey Points 0'-600' ⊗ Sidewalk does not exist in this area. <p>SOUTHWEST CORNER</p> <ul style="list-style-type: none"> ⊗ Sidewalk does not exist in this area. <p>SOUTHWEST SIDEWALK WEST ON 2nd AVENUE</p> <ul style="list-style-type: none"> • Survey Points 0'-600' ⊗ Sidewalk does not exist in this area. <p>SOUTHEAST SIDEWALK SOUTH ON 3rd STREET</p> <ul style="list-style-type: none"> • Survey Points 0'-300' 	<p>A\$ - F\$\$ - Depending on the specific situation at each location, install accessible sidewalks and intersections in compliance with ADAAG and PROWAAAC guidance and FDOT Design Standards. This should include, but not be limited to, detectable warnings, driveway crossings, street crossing markings, signs, and pedestrian crossing signals as required.</p>

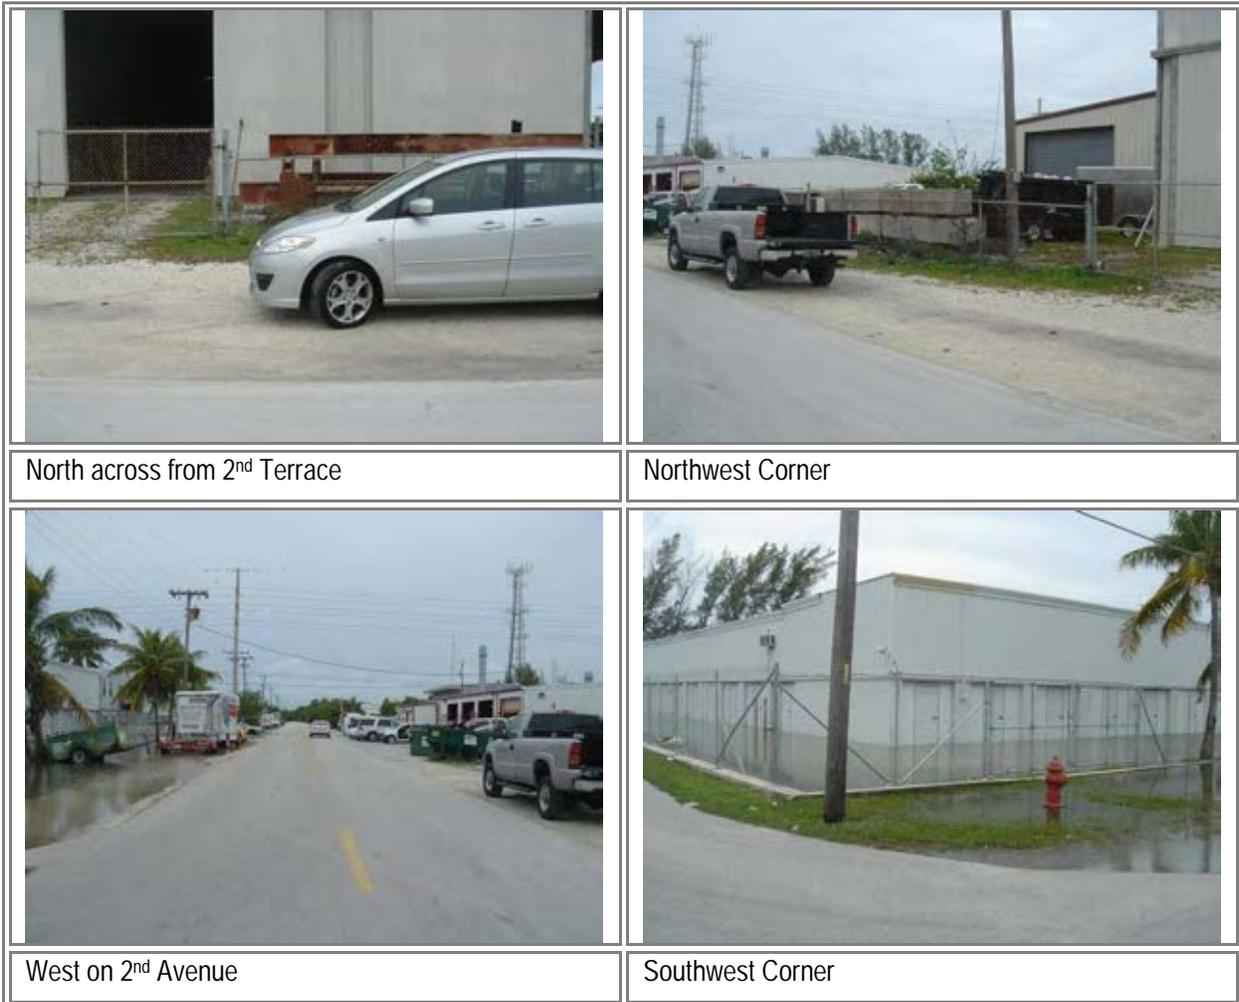
Observation	Recommendations
<p>SOUTHEAST CORNER ☒ Sidewalk does not exist in this area.</p> <p>SOUTHEAST SIDEWALK SOUTH ON 2nd TERRACE</p> <ul style="list-style-type: none"> • Survey Points 0'-200' ☒ Sidewalk does not exist in this area. <p>SOUTHEAST SIDEWALK EAST ON 2nd AVENUE</p> <ul style="list-style-type: none"> • Survey Points 0'-100' ☒ Sidewalk does not exist in this area. <p>NORTH SIDEWALK EAST ON 2nd AVENUE</p> <ul style="list-style-type: none"> • Survey Points 0'-100' ☒ Sidewalks do not exist in this area. <p>NORTH SIDEWALK WEST ON 2nd AVENUE</p> <ul style="list-style-type: none"> • Survey Points 0'-200' ☒ Sidewalks do not exist in this area. <p>SOUTHWEST CORNER ☒ Sidewalk does not exist in this area.</p>	<p>A\$ - F\$\$ - Depending on the specific situation at each location, install accessible sidewalks and intersections in compliance with ADAAG and PROWAAC guidance and FDOT Design Standards. This should include, but not be limited to, detectable warnings, driveway crossings, street crossing markings, signs, and pedestrian crossing signals as required.</p>
