Monroe County Boca Chica Mooring Field Detailed Feasibility Study

Coastal Systems International, Inc.
464 South Dixie Highway
Coral Gables, FL 33146

October 2017

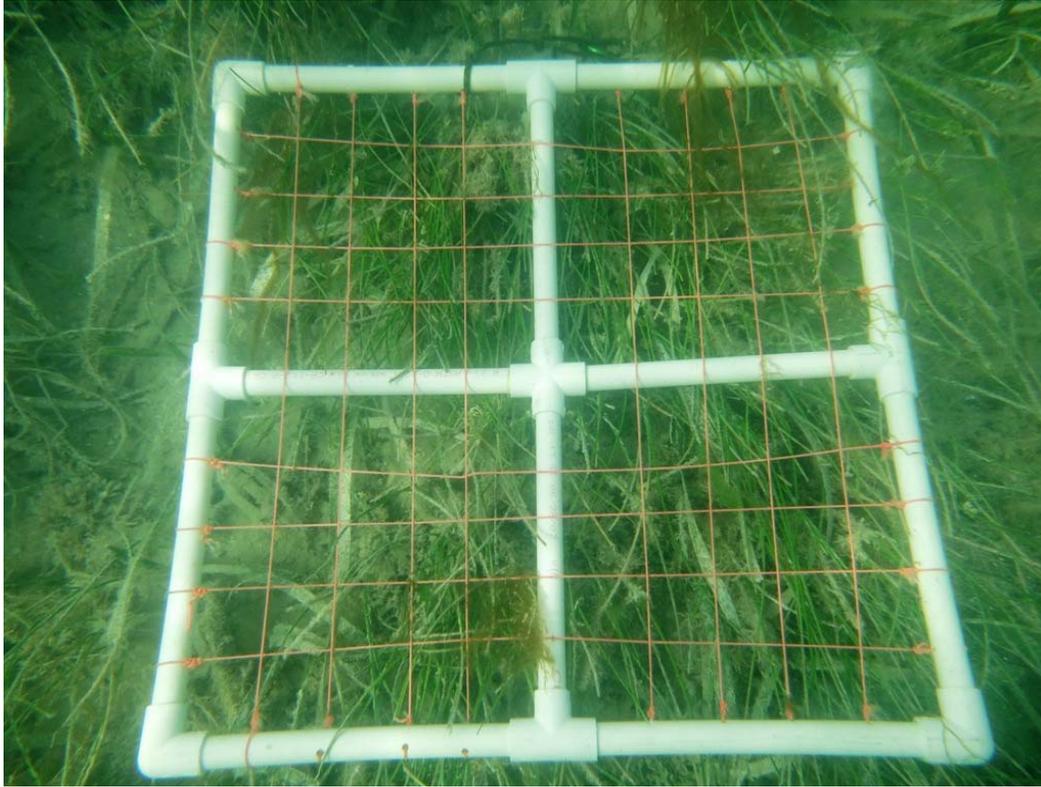
Photo 2. Dense seagrass was commonly observed throughout Boca Chica Basin.

Most of the Boca Chica Basin site consisted of dense coverage (81% to 100%) seagrass beds (Figure 4, and Photograph 2). Two species of seagrass, Turtle grass (*Thalassia testudinum*) and Manatee grass (*Syringodium filiforme*), were observed growing within the Boca Chica Basin (see Figure 5, and Photograph 3 and Appendix D: Field Observation Report). Of these two species *T. testudinum* was the dominant seagrass species observed. Sparse (1% to 20%) seagrass beds are located in deeper water depths at the northernmost corner of the survey area, and within the eastern and western channels leading into the basin; this area surrounds the lobe of shallower water depths in the center of the survey area (Photograph 4).

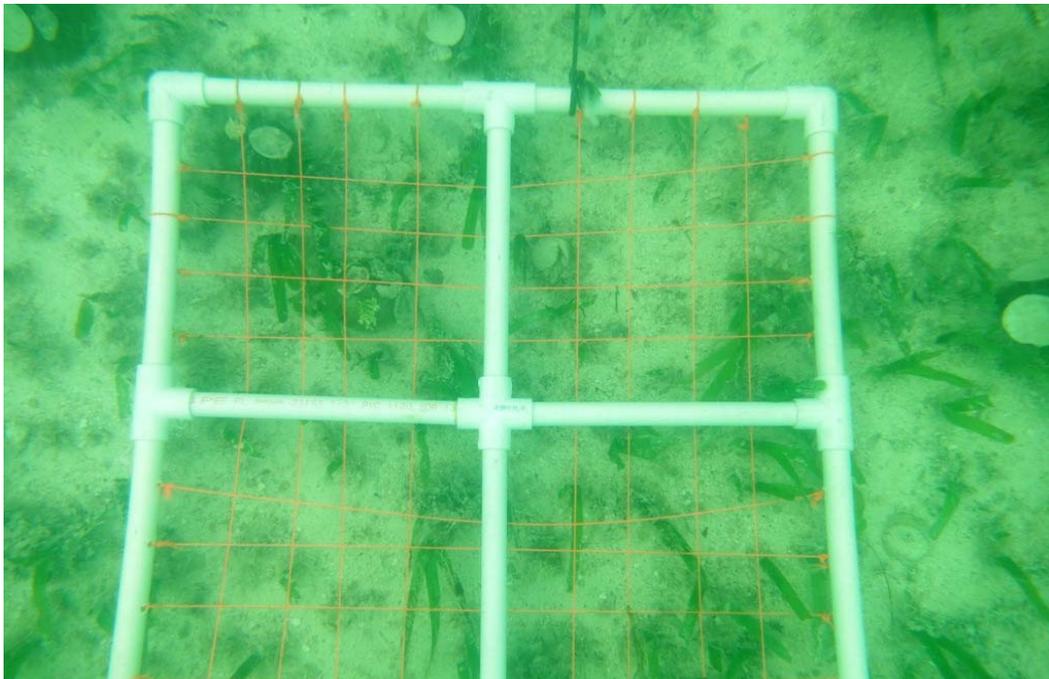
Photo 3. *Thalassia testudinum* and *Syringodium filiforme* were observed within Boca Chica Basin.

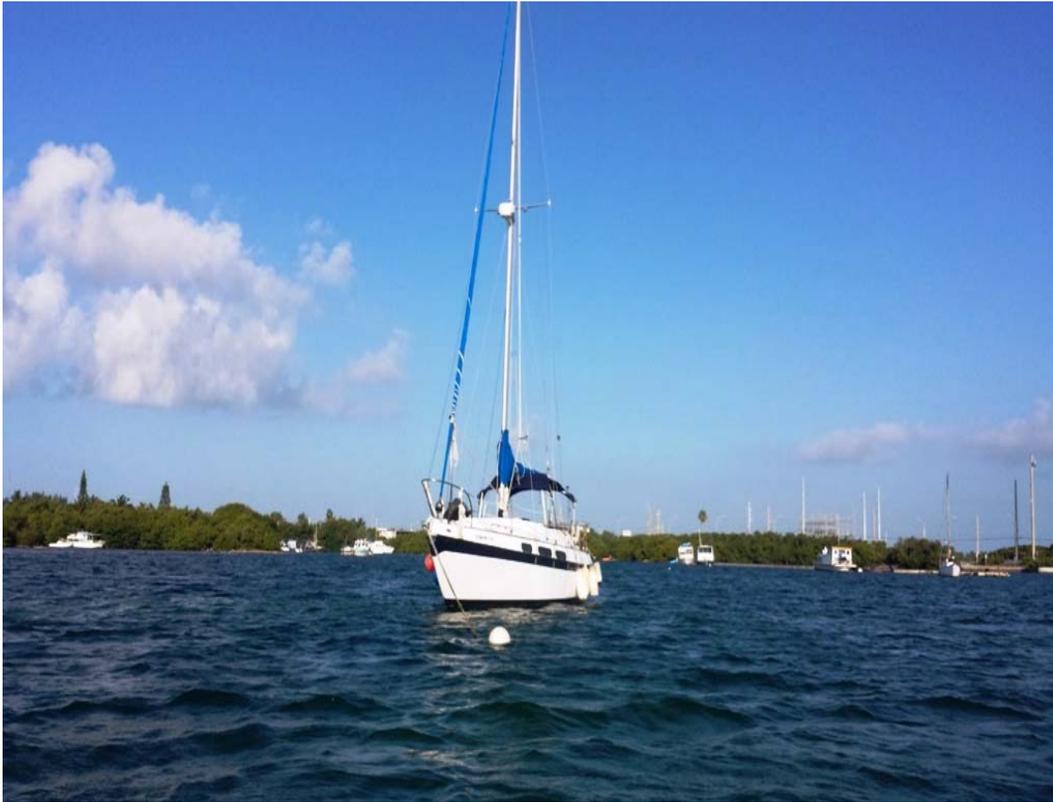
Photo 6. Sailboat anchored in Boca Chica Basin.

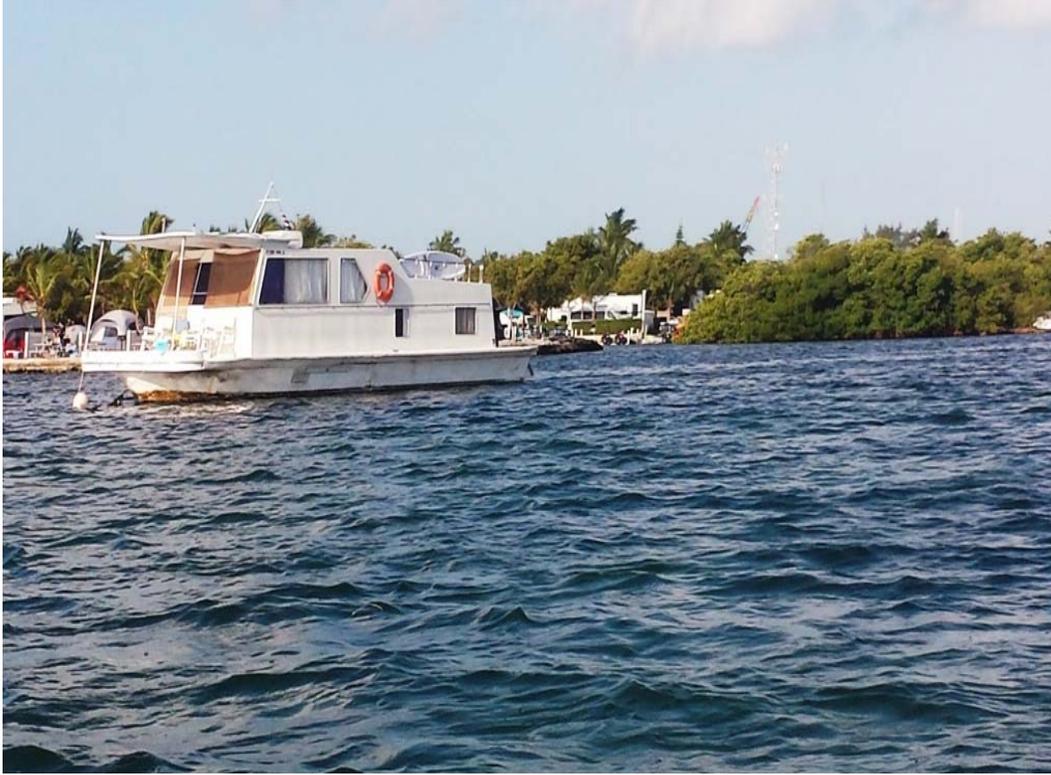
Photo 7. Houseboat anchored in Boca Chica Basin.

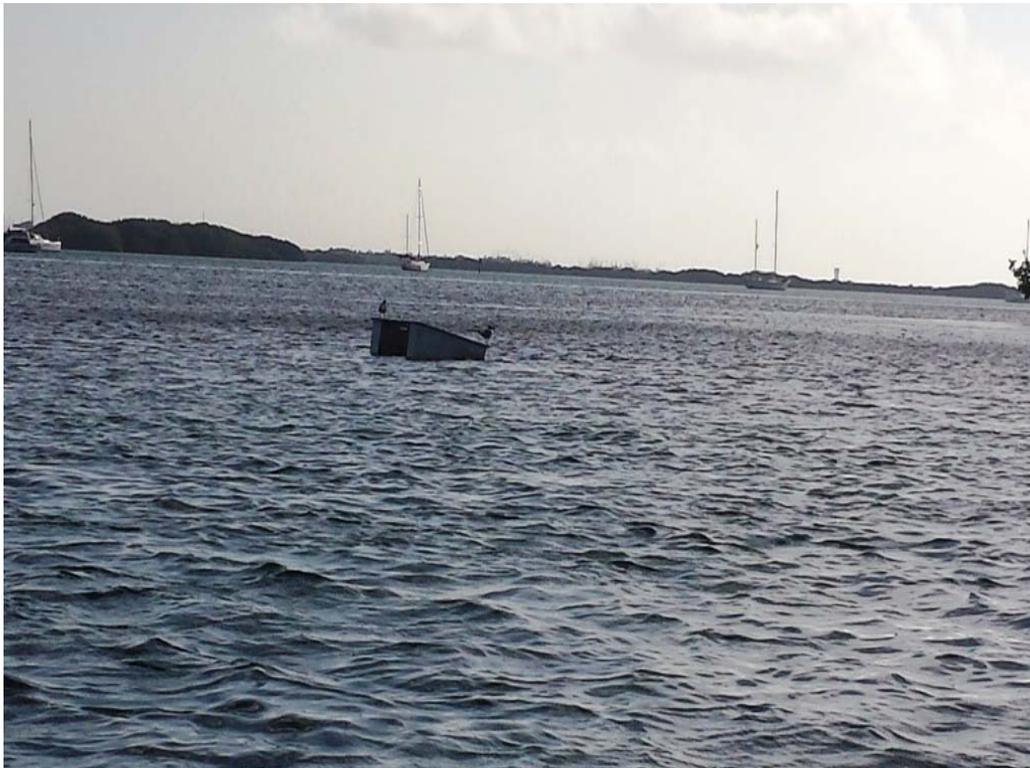
Photo 8. Derelict vessel observed in Boca Chica Basin.

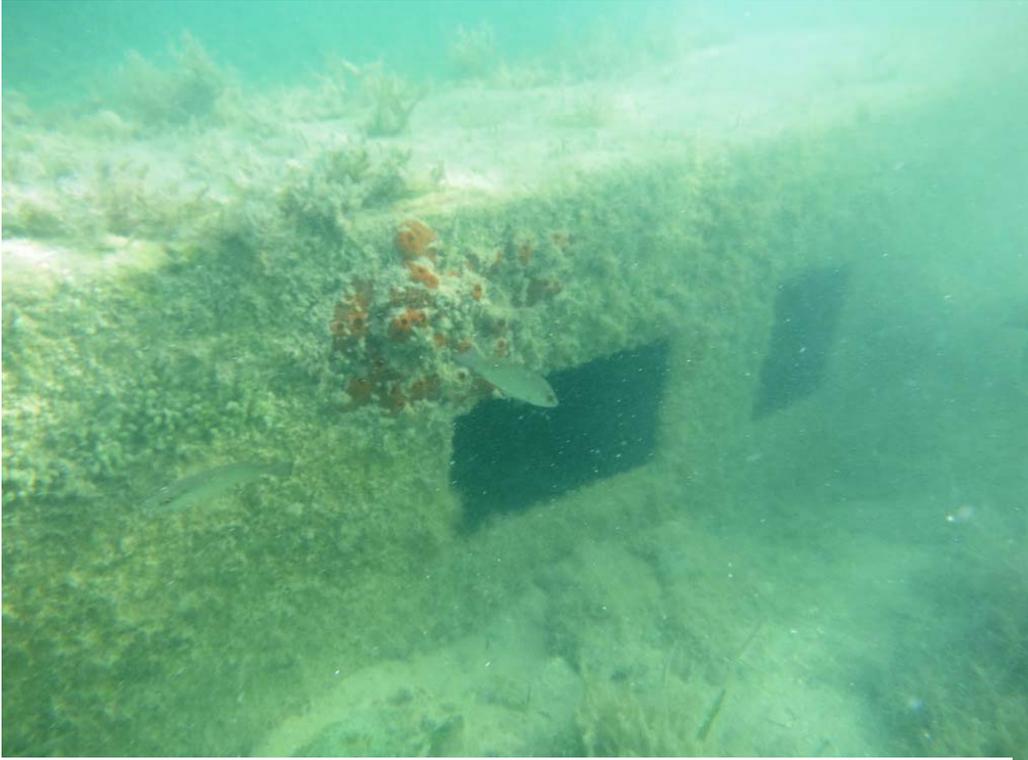
Photo 9. A majority of the mooring devices used by anchored vessels in the basin consisted of marine debris.

Submerged debris observed while conducting the surveys was mapped by collecting the GPS coordinates of the debris, recording a description of what the debris material consisted of, taking representative photographs of the debris, and documenting whether or not corals were growing on the debris piles (Appendix D, Table 1). Fourteen submerged debris piles were observed in Boca Chica Basin and in the channel adjacent to the northern bulkhead along the Gulf Seafood Property. See the Marine Resources Location Map in the Field Observation Report (Appendix D, Attachment 1) for the location of the debris piles observed and mapped. Three of the fourteen debris piles had corals (rose corals – *Manicina areolata* or lesser starlet coral – *Siderastrea radians*) growing on the debris. Almost all of the debris piles served as shelter to juvenile fish and lobsters. Despite their minor role of providing habitat, the presence of debris piles encourages unauthorized mooring and subsequent seagrass impacts.

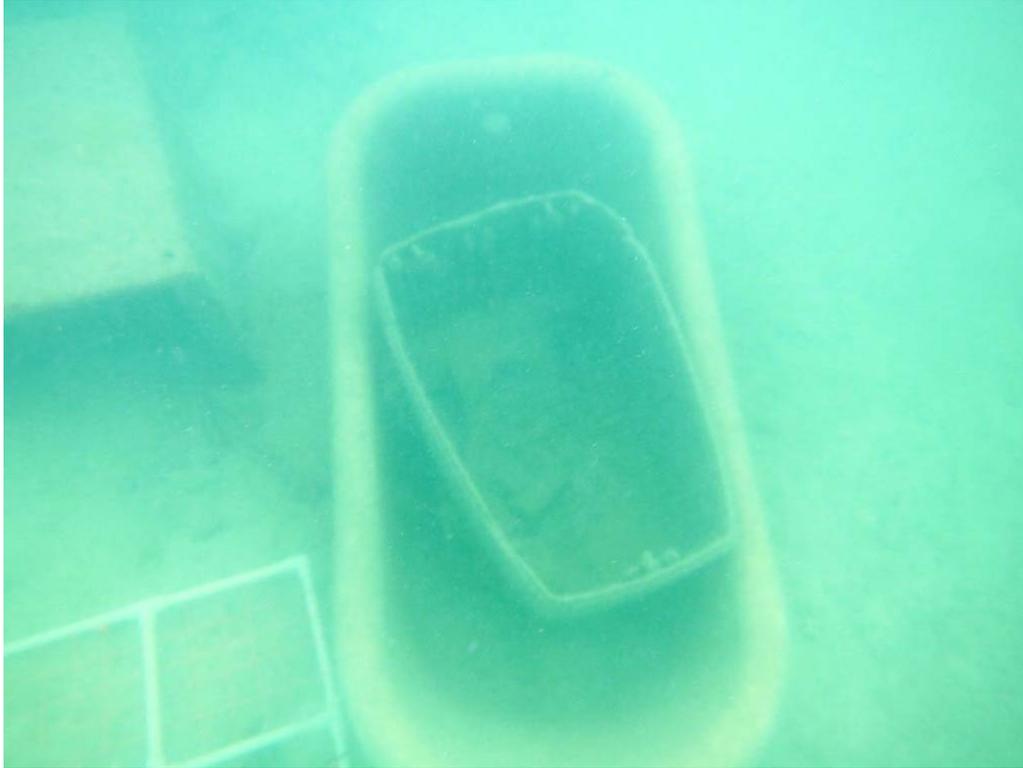
Photo 10. Debris pile # 4 observed within Boca Chica Basin.

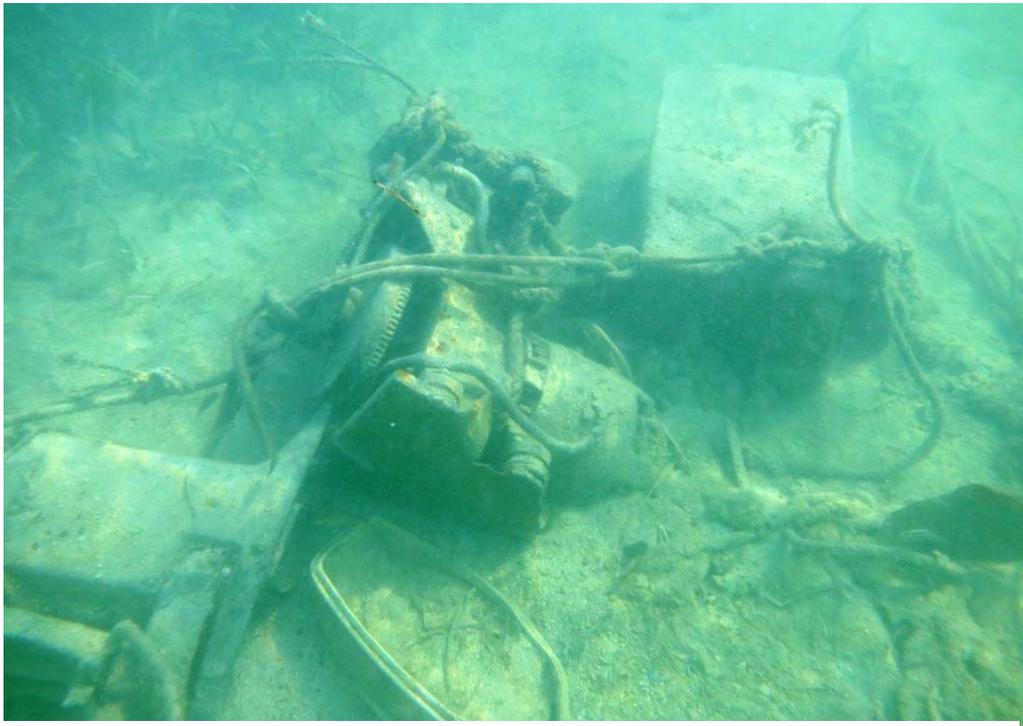
Photo 11. Debris pile # 6 observed within the Boca Chica Basin.

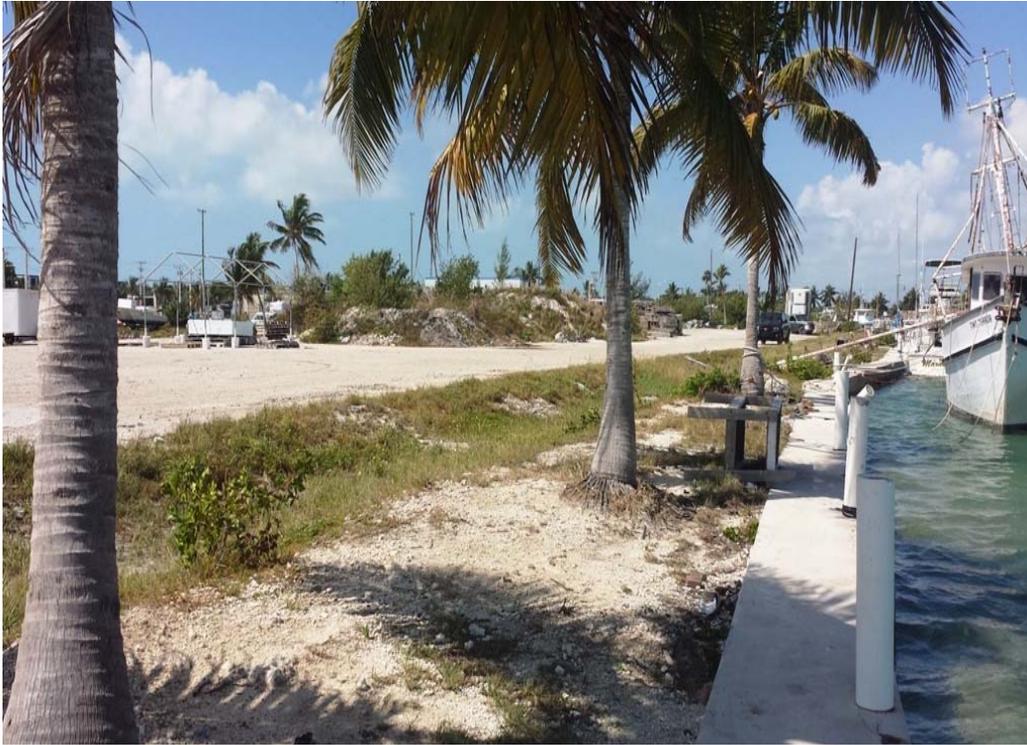
Photo 13. Gulf Seafood Property and northern bulkhead.

Based on the condition of the north bulkhead at the Gulf Seafood property, as observed during the marine resource and bathymetric surveys, development of this facility should consider replacement of the bulkhead prior to the construction of the dinghy and pump-out docks. Refer to the Field Observation Report in Appendix D for further details on the condition of the bulkhead. The structural integrity of the bulkhead at Gulf Seafood should be analyzed to determine its suitability for the proposed uses as rehabilitation or replacement of the bulkhead may be necessary.

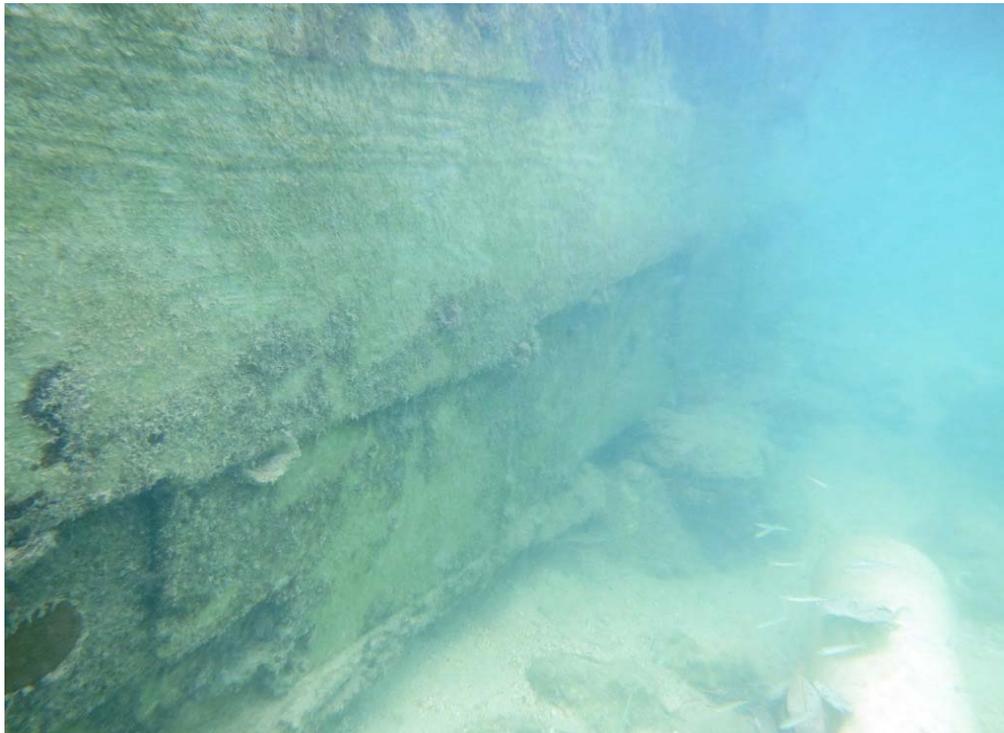
Photo 14. Sparse resource observed along the northern bulkhead.

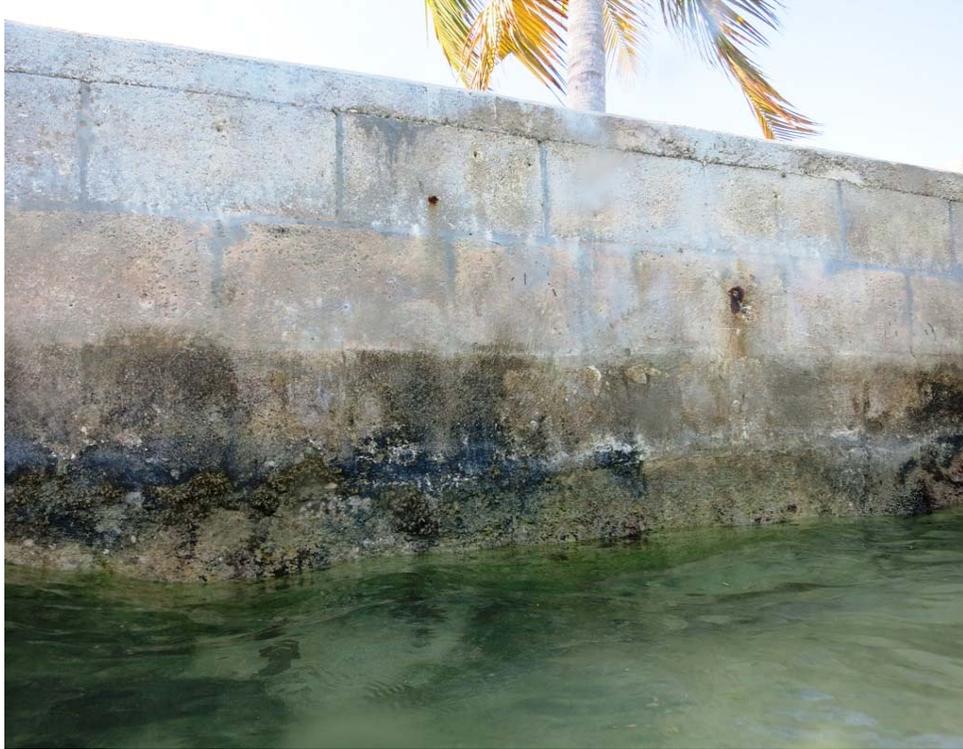
Photo 15. Sparse resource observed along the northern bulkhead.

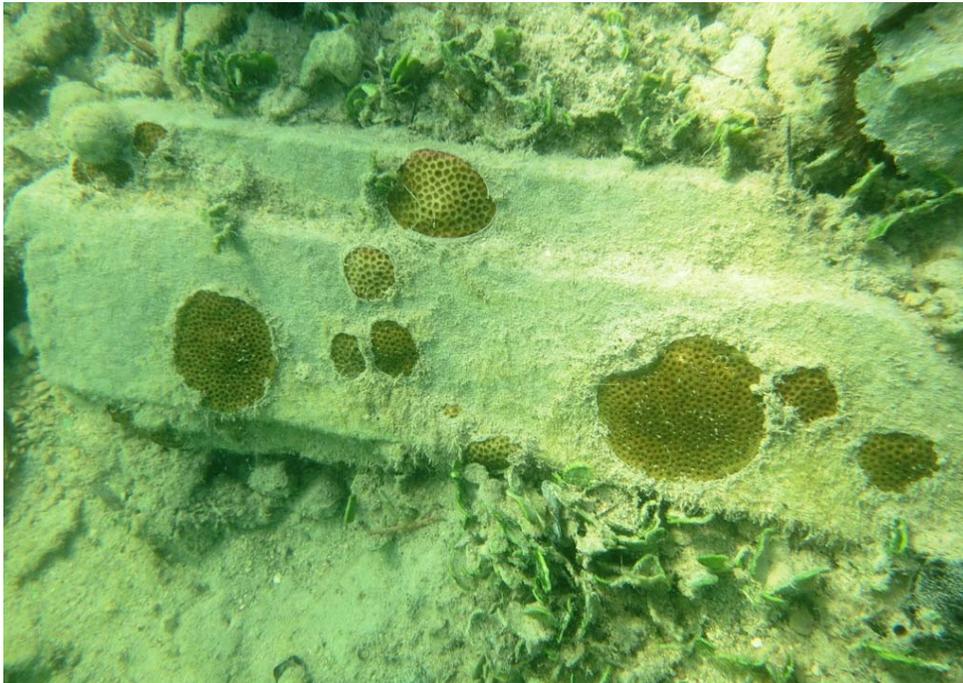
Photo 16. Sparse lesser starlet coral (*Siderastrea radians*) were observed along the footer of the bulkhead.

The marine resource survey was conducted along the northern bulkhead at Gulf Seafood property, along the submerged bottom adjacent to the wall and into the channel running alongside the wall. The majority of the northern bulkhead was bare of marine growth. The dominant resource observed growing along the surface of the wall was cyanobacteria and sparse lesser starlet coral (*Siderastrea radians*) which were observed mostly along the footer of the wall (Photographs 14 - 15). The *S. radians* ranged in size between 1 cm and 24 cm. The *S. radians* corals along the bulkhead towards the western end were often covered in sediment and mucous membranes. The wet face of the northern bulkhead was sparsely populated by rough file clams (*Lima scabra*), flat tree oysters (*Isognomon alatus*), variegated sea urchin (*Lytechinus variegates*), and rock-boring urchins (*Echinometra lucunter*). The northeastern corner of the bulkhead had sparse to moderate density *S. radians* corals (Photograph 16), mostly located on the footer of the wall. These *S. radians* corals ranged in size from 1 cm to 20 cm; however, *S. radians* corals of 1-10 cm were most typically observed.

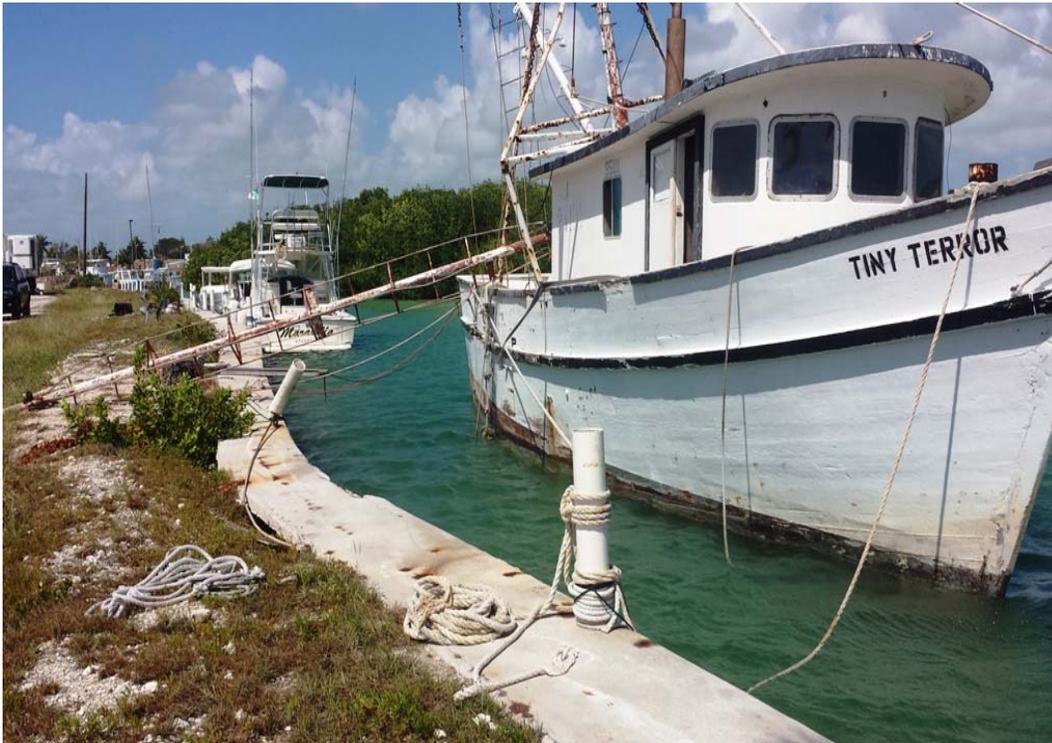
During the time of the survey, 6 vessels were docked along the northern bulkhead (Photograph 17). The northern-most vessel docked alongside the bulkhead was a large wooden fishing vessel named "Tiny Terror", which appeared to be abandoned and derelict. The other 5 vessels appeared to be fishing vessels in working order. The bulkhead adjacent to the vessel docking area was mostly barren of marine resources.

Photo 17. Six vessels were docked along the northern bulkhead at the Gulf Seafood Property.

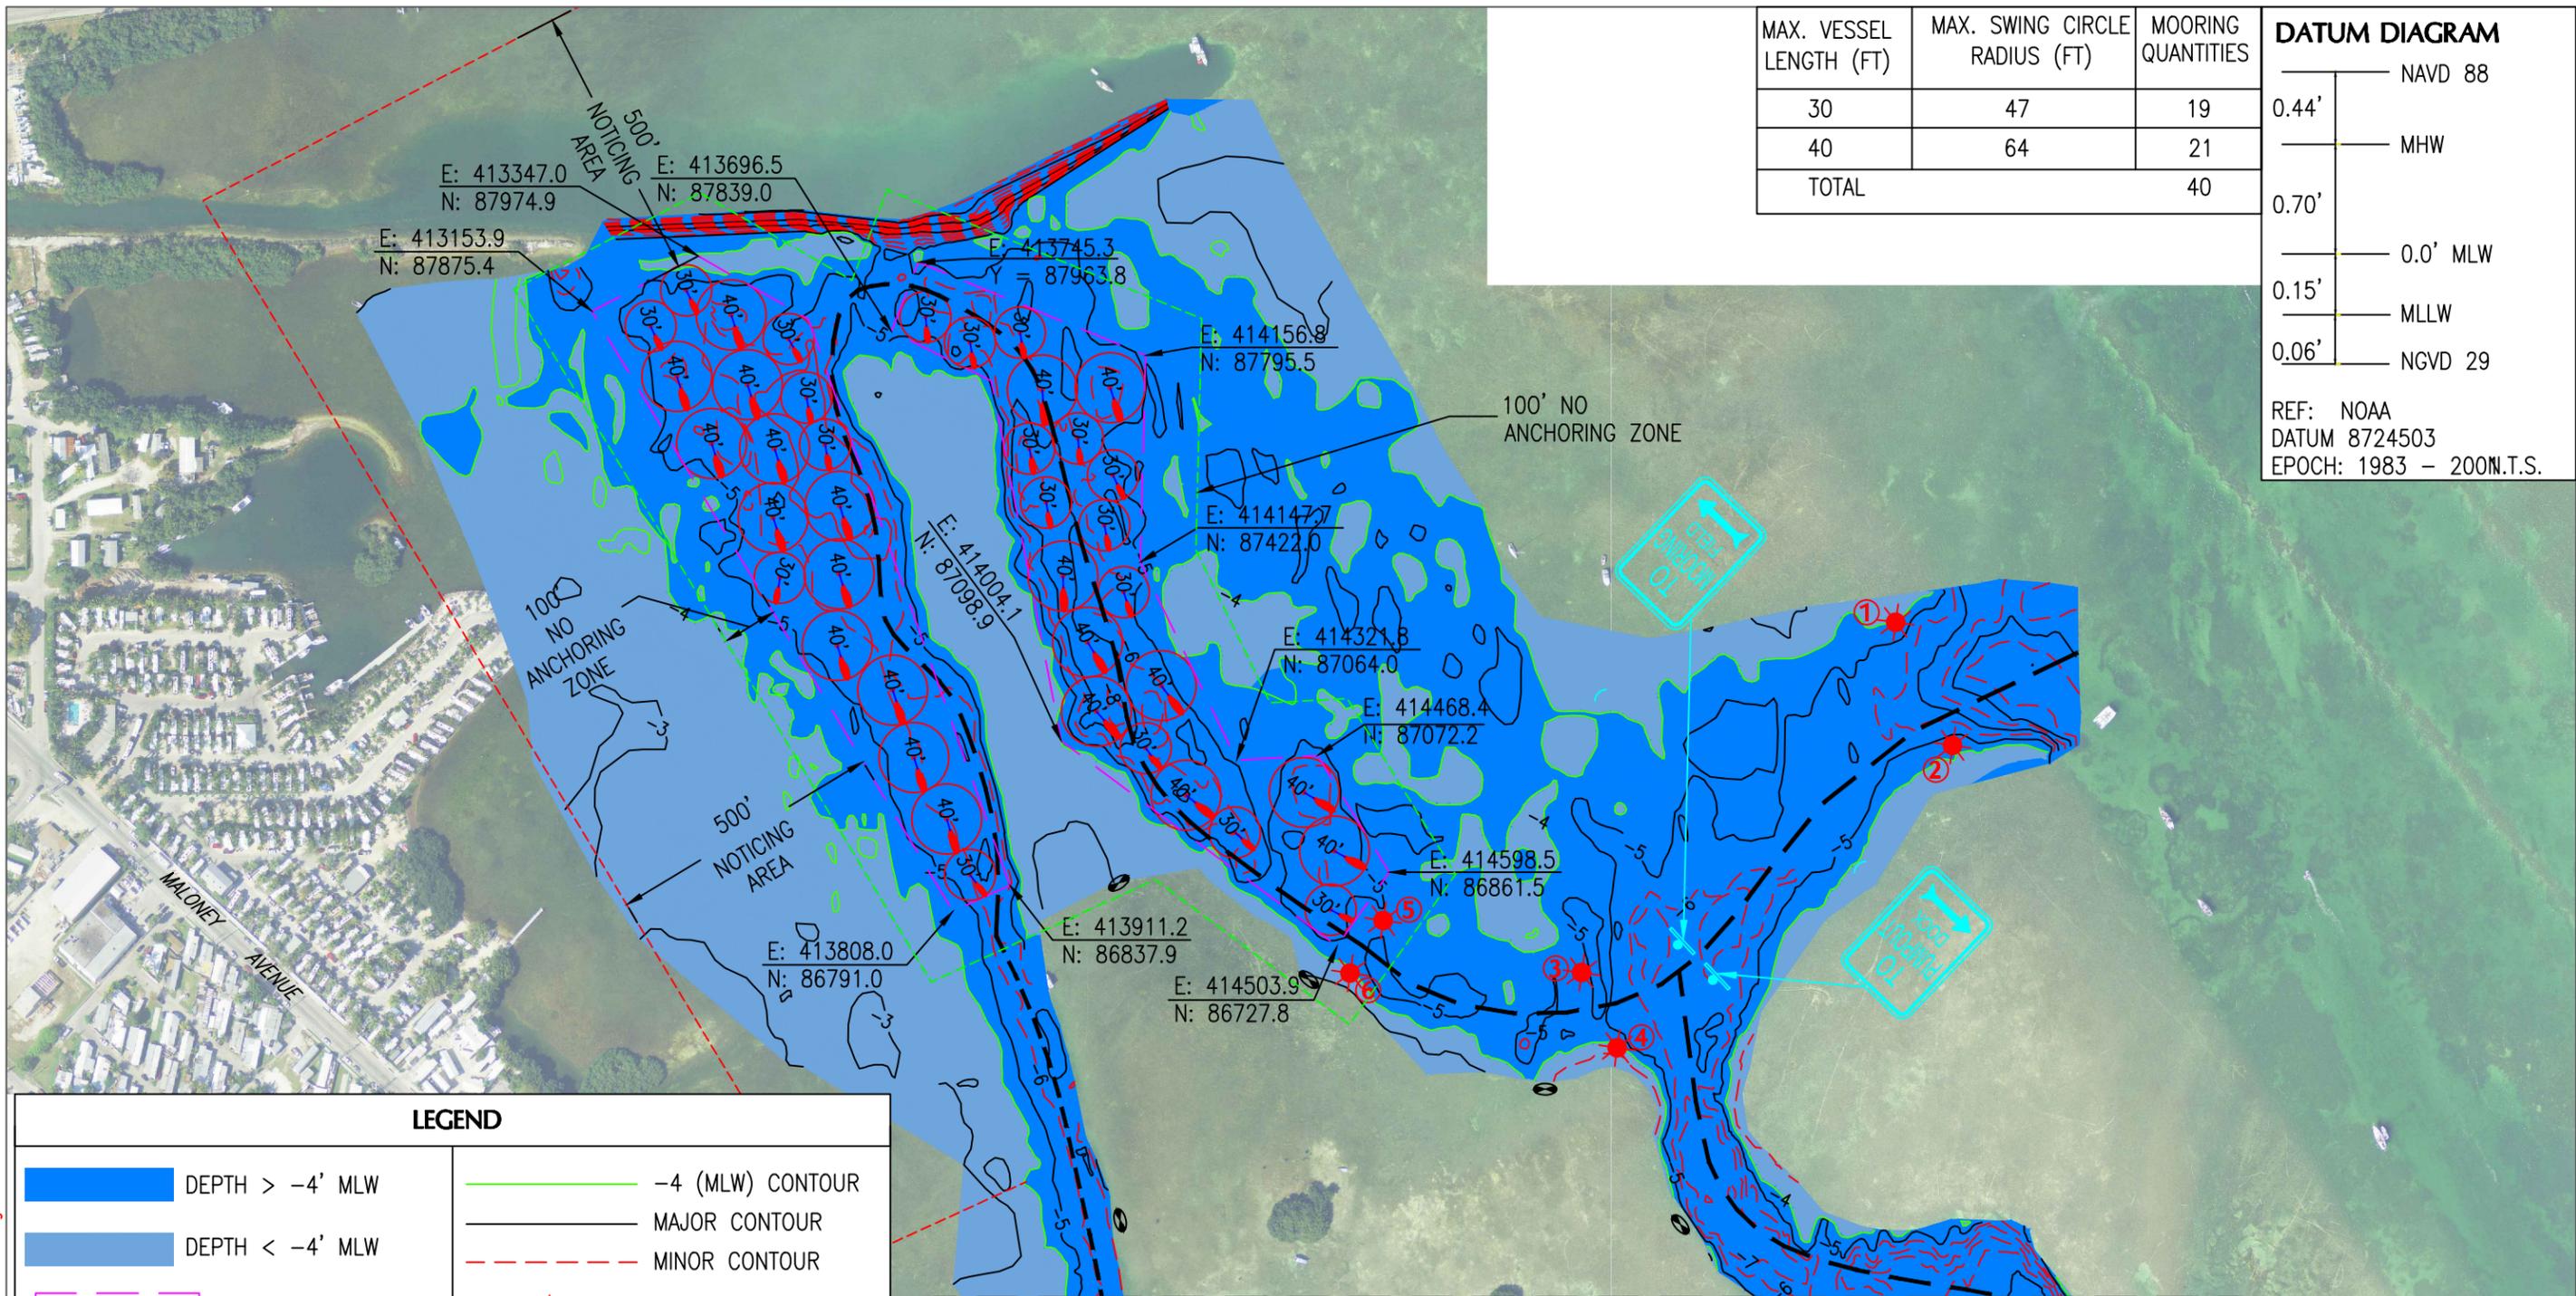
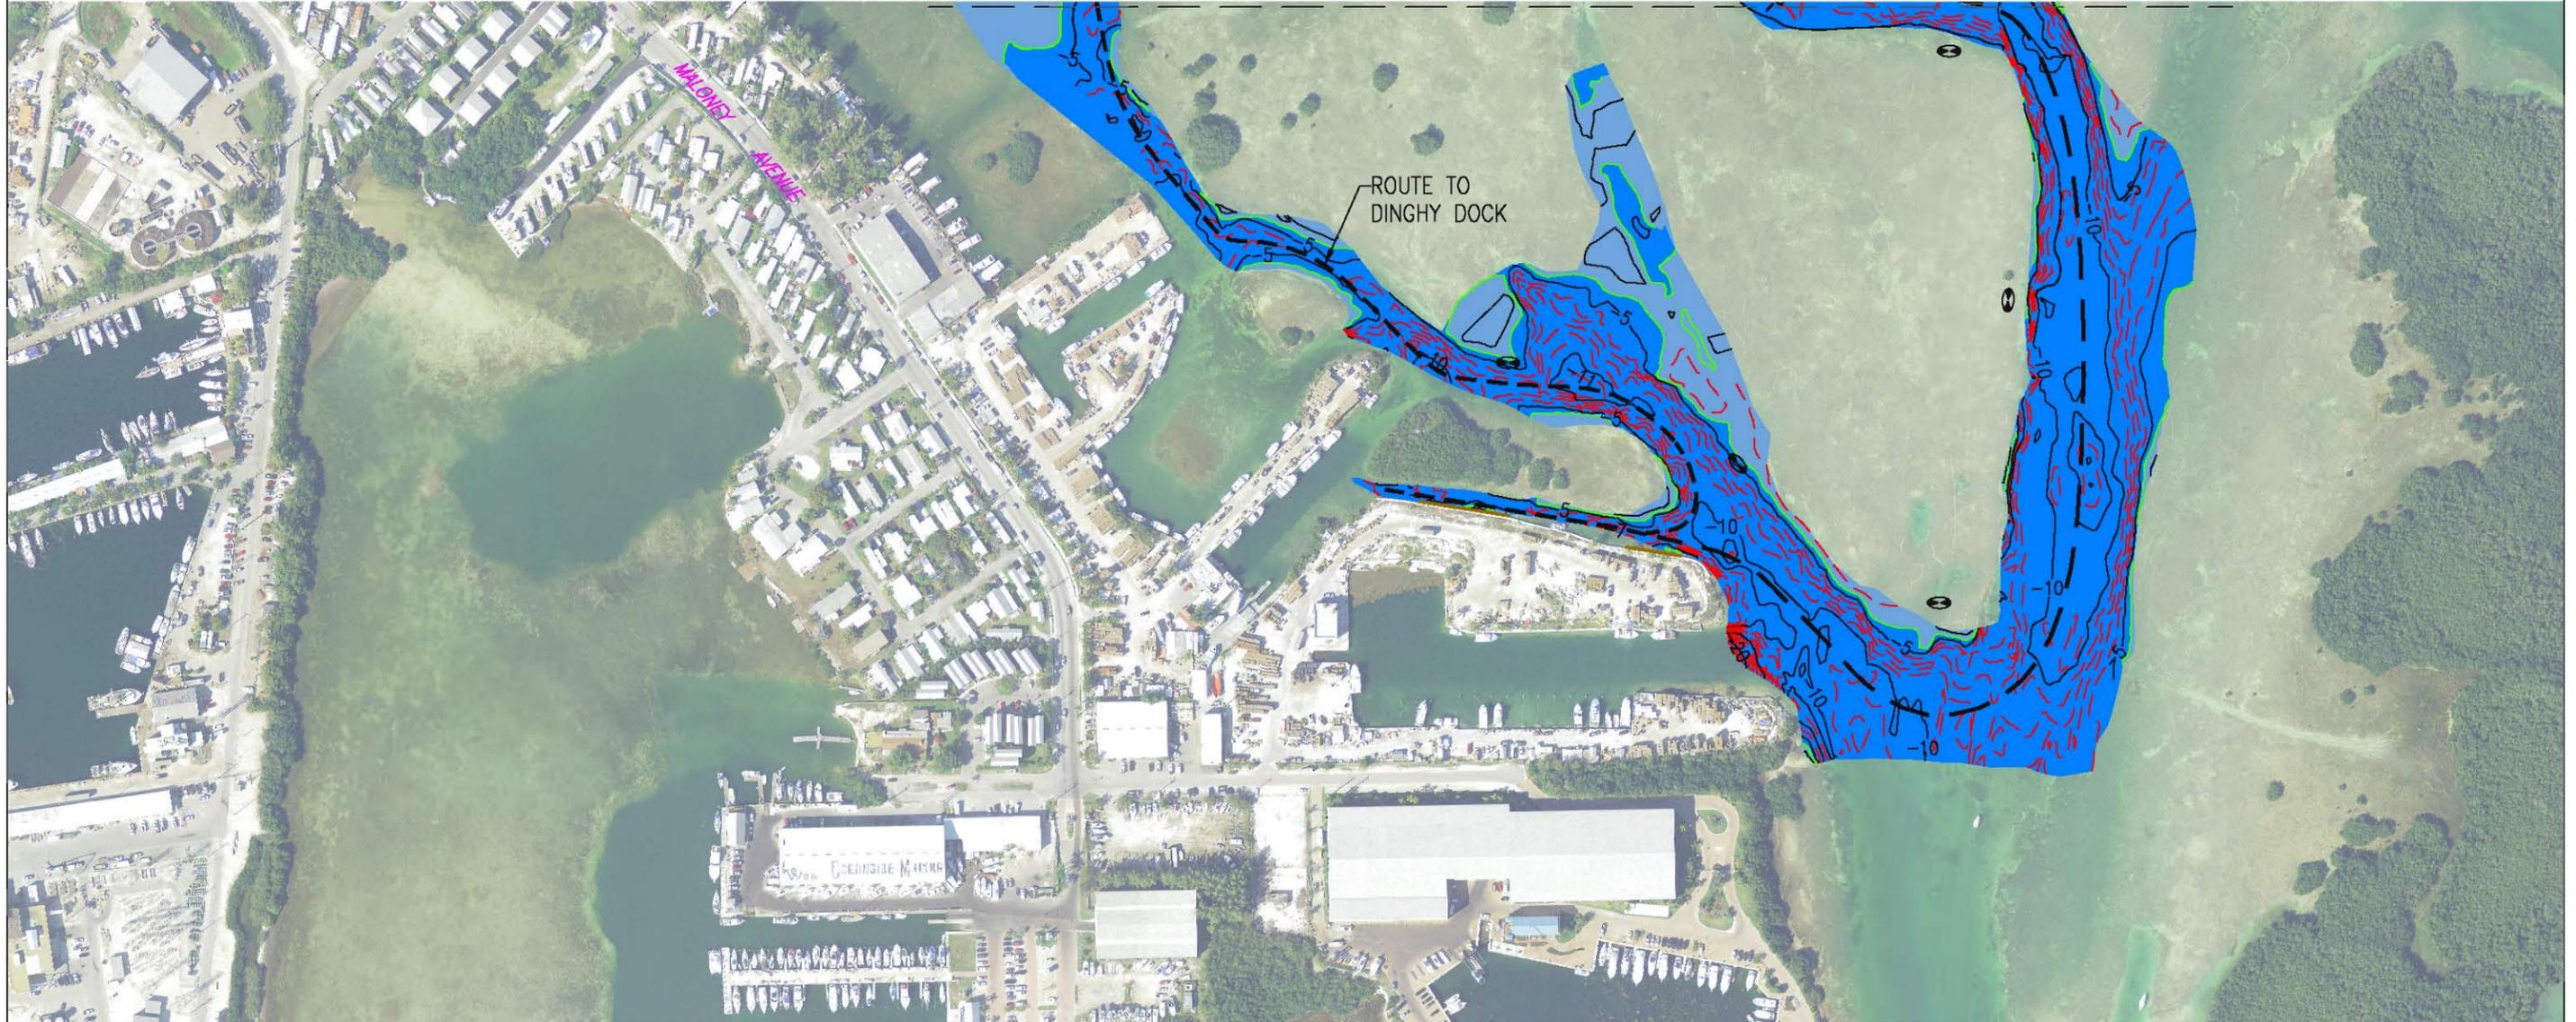
FIGURE 8

CONCEPTUAL MOORING FIELD (SOUTH)
BOCA CHICA, MONROE COUNTY, FLORIDA
05/11/17

There is a large area of shallow water to the south that supports several small mangrove islands; this area is too shallow for vessels to safely cross and shallow water/seagrass signage is recommended to mark this area as “off-limits” to vessel traffic. The north limit of the mooring field abuts the dredged approach channel leading into Murray Marine which provides deeper waters (-20 to -22 feet MLW). Slightly deeper water (-4 to -10 feet MLW) can be found to the east of the mooring area, leading from one of the easterly channels into the mooring area. Navigational buoys are proposed along this channel into the mooring field to safely guide vessels through the shallower waters of the area. Immediately to the south of the proposed mooring field, the “S” shaped channel that extends from the Basin to the Gulf Seafood property would be used as a secondary navigational channel and marked with buoys to outline the eastern edge of the shallow area where the water is too shallow to safely travel. Depths in the eastern channel range between -4 feet MLW at the edges and -12 feet MLW in the center. Along the western edge of the mooring field, abutting the west edge of the shallow area lays a shallower channel that extends down to the Gulf Seafood Property. The western channel ranges in depth from -4 to -9 feet MLW. Signage indicating the direction of the mooring field and directions to the shoreside pump-out dock through the “S” shaped channel is recommended and shown on Figure 7.

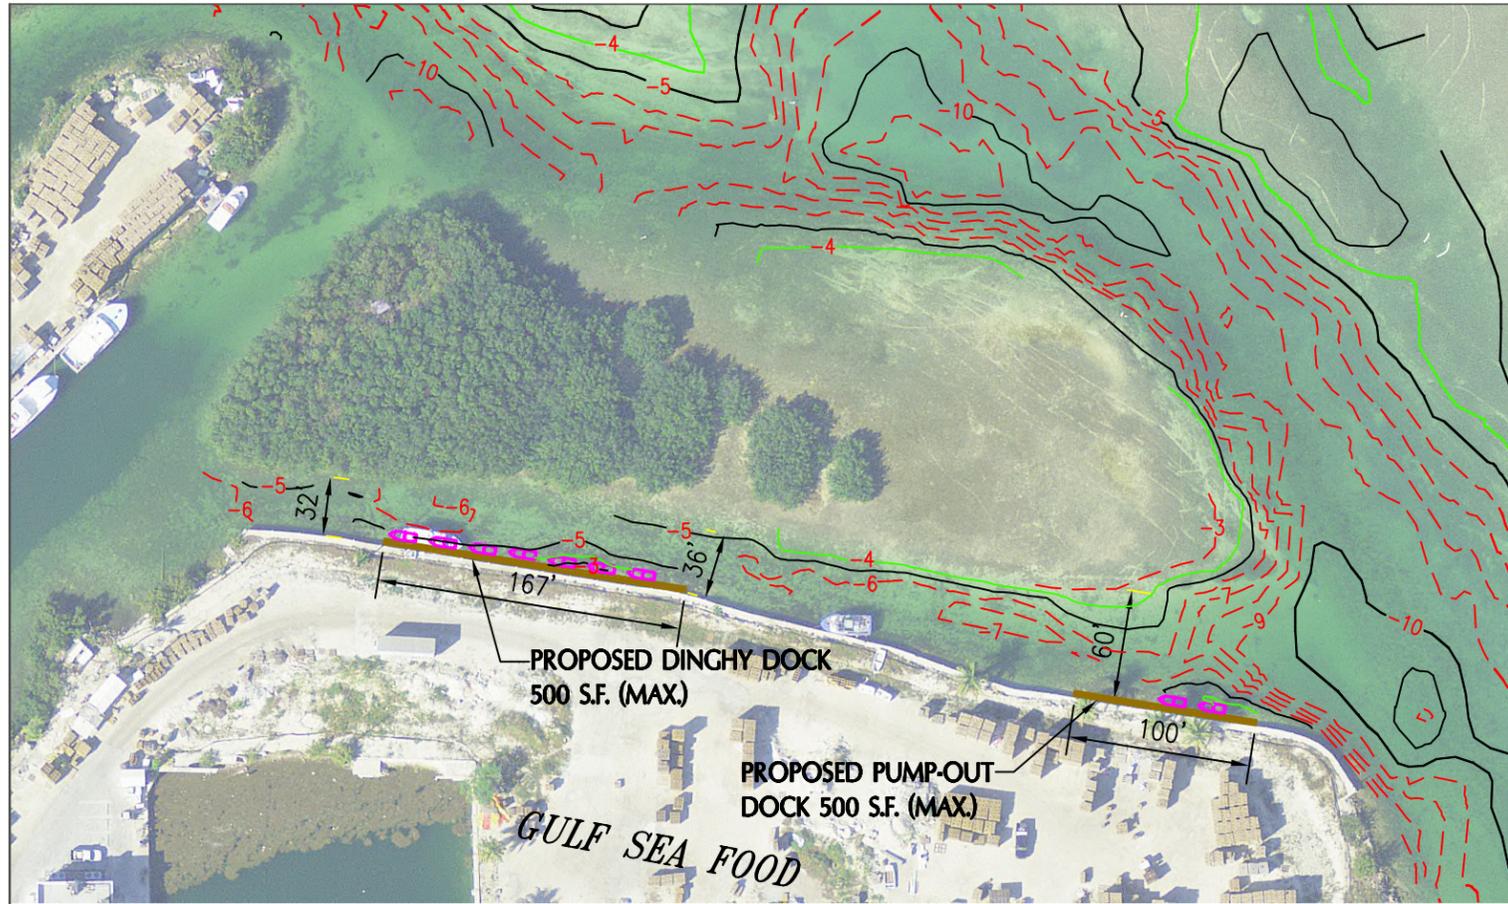
1 PROPOSED DINGHY DOCK & PUMP-OUT DOCK
SCALE: 1"=100'

Impacts associated with the dinghy dock and the pump-out dock mainly consist of shading from the dock and fill from the pilings. The shading impacts can be minimized by using grated decking material, as well as following the other recommendations in the NMFS "Dock Construction Guidelines in Florida for Docks or Other Minor Structures Constructed in or Over Submerged Aquatic Vegetation". While the number, size, and type of pilings at the docks will not be determined until the final design of the shoreside support facility is completed, the impacts from fill will be minor and the impacts from noise generated during the installation of the pilings can be offset by vibratory installation of wooden, concrete or metal pilings (up to 13 inch diameter each). If using an impact hammer for installation of concrete or metal piles, the number of pilings installed per day may have to be limited to 5 concrete piles per day. Noise impact during construction is primarily a concern of the federal permitting agency (the Corps) and their resource agencies (NMFS and FWS). Minor impacts to coral may occur with the development of the shoreside support facility if the bulkhead is replaced.

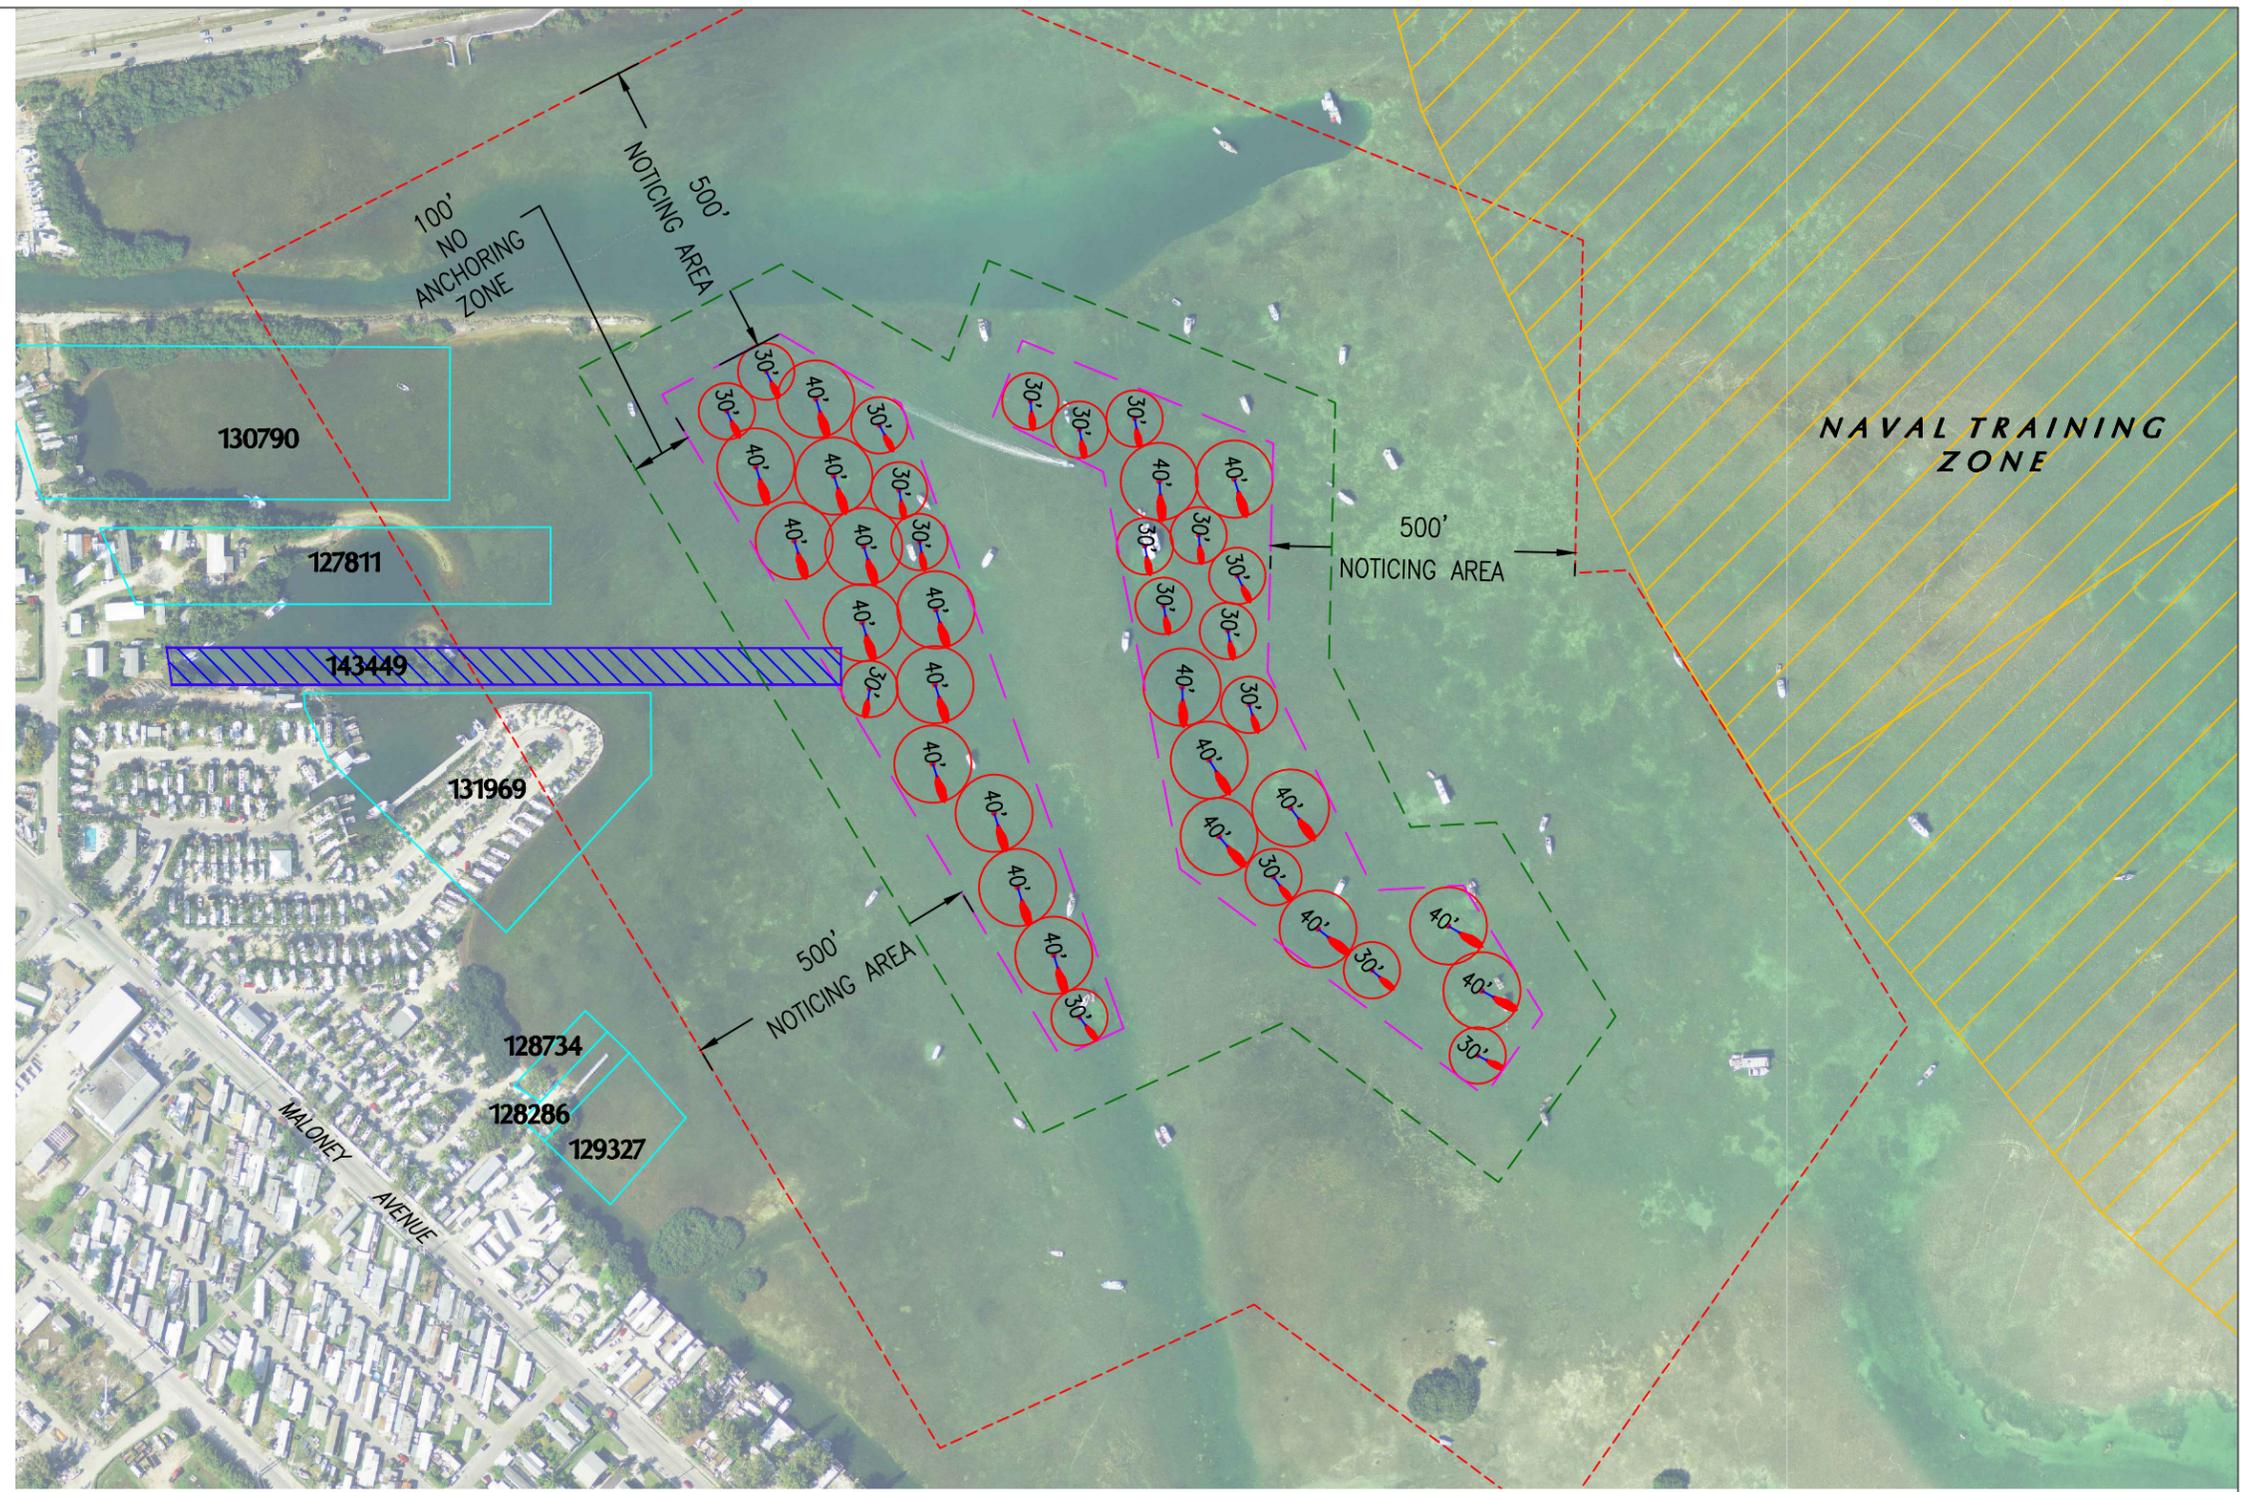
FIGURE 10
 CONCEPTUAL MOORING FIELD AND SOVEREIGNTY SUBMERGED LANDS MAP
 BOCA CHICA, MONROE COUNTY, FLORIDA
 07/05/17

Under FDEP's General Permit and state land rules, a SSL lease is required for the mooring field boundary and the accessory docks at the shoreside support facility. FDEP confirmed that this Project would qualify for a no lease fee.
