Monroe County Boca Chica Mooring Field Detailed Feasibility Study

Coastal Systems International, Inc.
464 South Dixie Highway
Coral Gables, FL 33146

October 2017

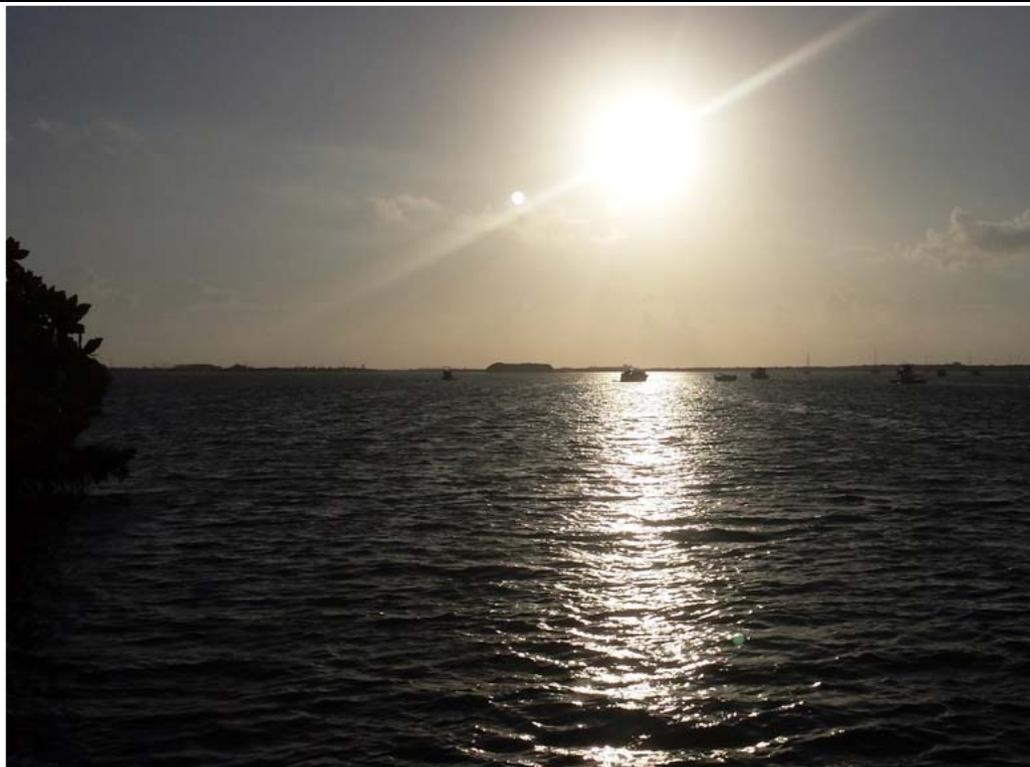
Power Boats anchored in Boca Chica Basin.

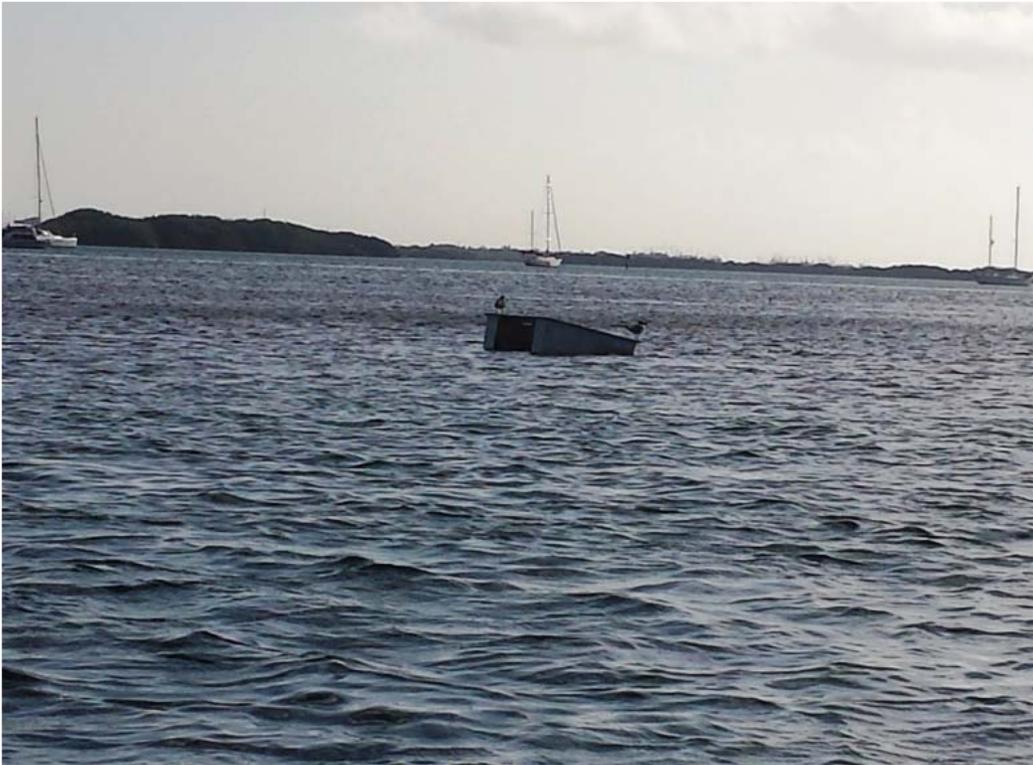
| Description: Derelict Vessel partially submerged in Boca Chica Basin. | | |

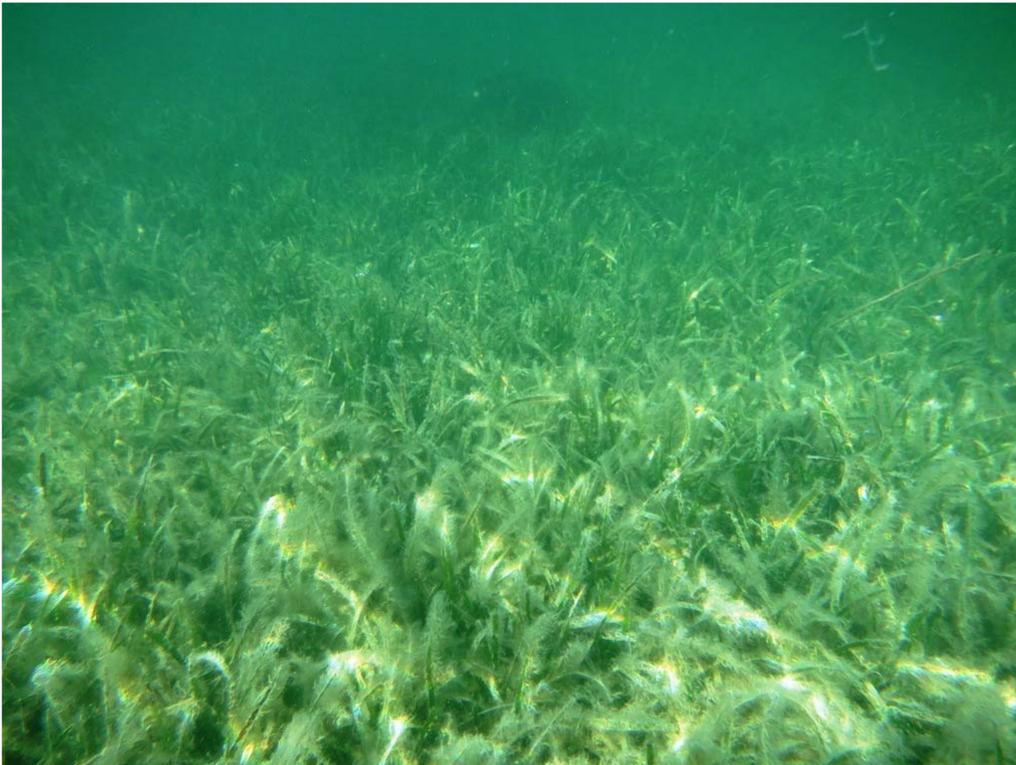
| Photo Location: Boca Chica Basin – Quad 133 | | |

| Description: The dominant benthic functional group in the Boca Chica survey area consisted of dense seagrass. Two species of seagrass (Turtle grass - <i>Thalassia testudinum</i> and Manatee grass – <i>Syringodium filiforme</i> ; were observed growing within the Boca Chica Basin. | | |

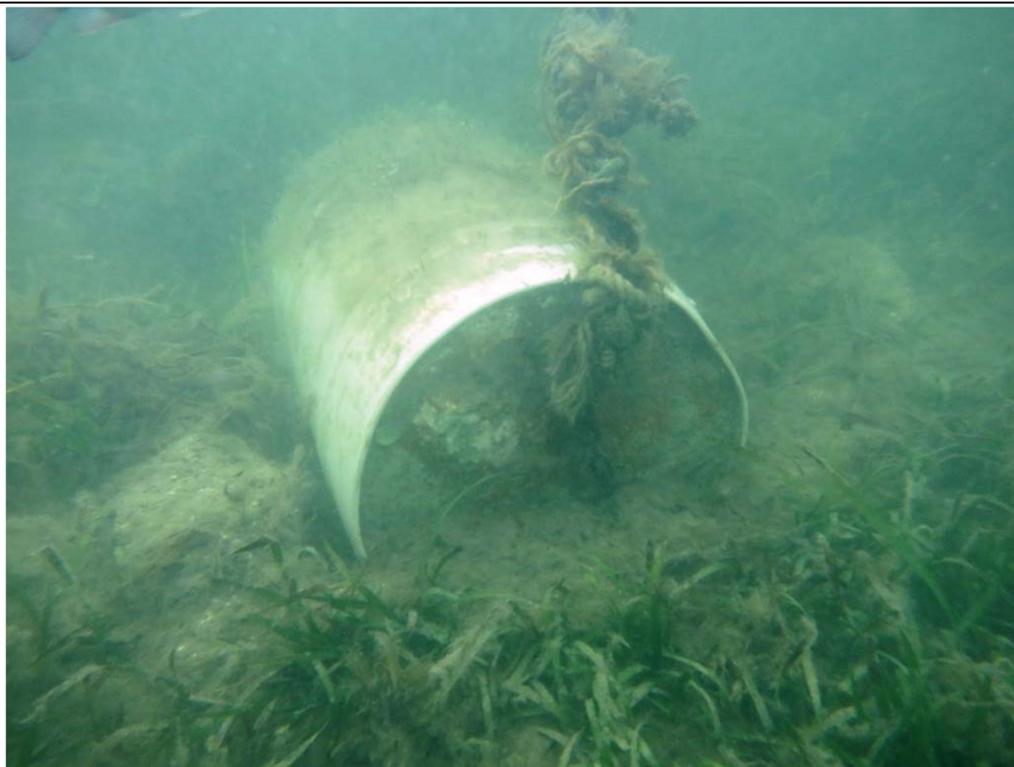
Description:
The majority of the
mooring devices used
in the basin consisted
of marine debris such
as engines,
generators, concrete
filled 55 gallon drums,
etc.

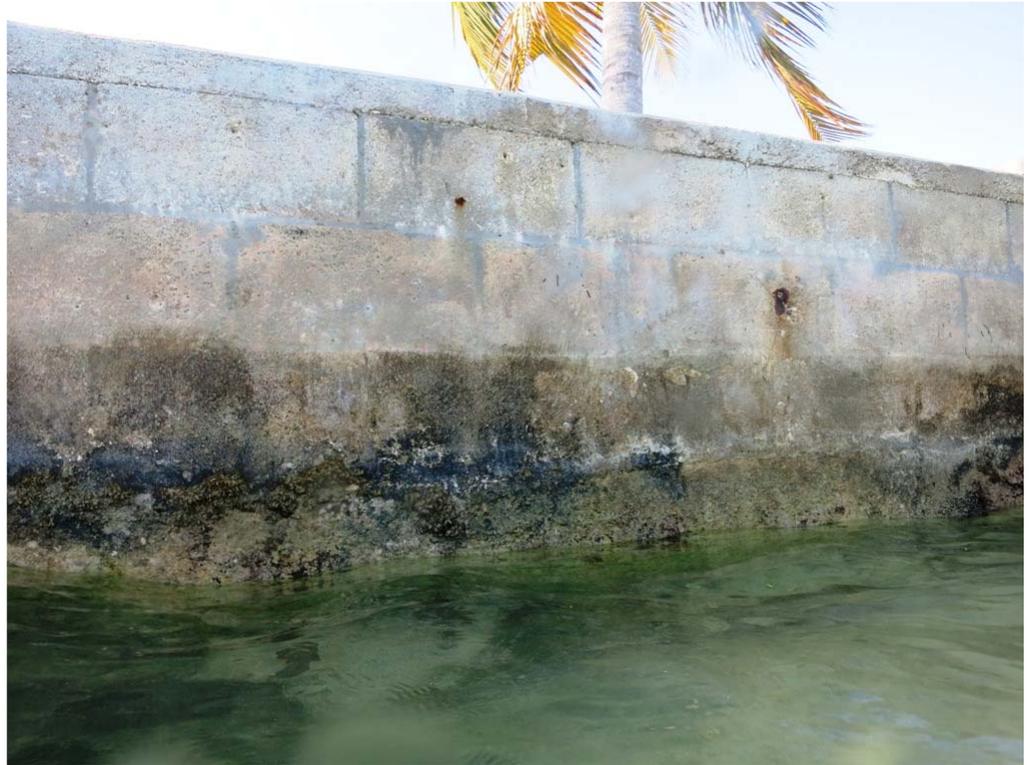
Description:
The northern concrete
bulkhead at Gulf
Seafood.

Based on the condition of the north bulkhead at the Gulf Seafood property, as observed during the marine resource and bathymetric surveys, development of this facility should consider replacement of the bulkhead prior to the construction of the dinghy and pump-out docks. Refer to the Field Observation Report in Appendix D for further details on the condition of the bulkhead. The structural integrity of the bulkhead at Gulf Seafood should be analyzed to determine its suitability for the proposed uses as rehabilitation or replacement of the bulkhead may be necessary.

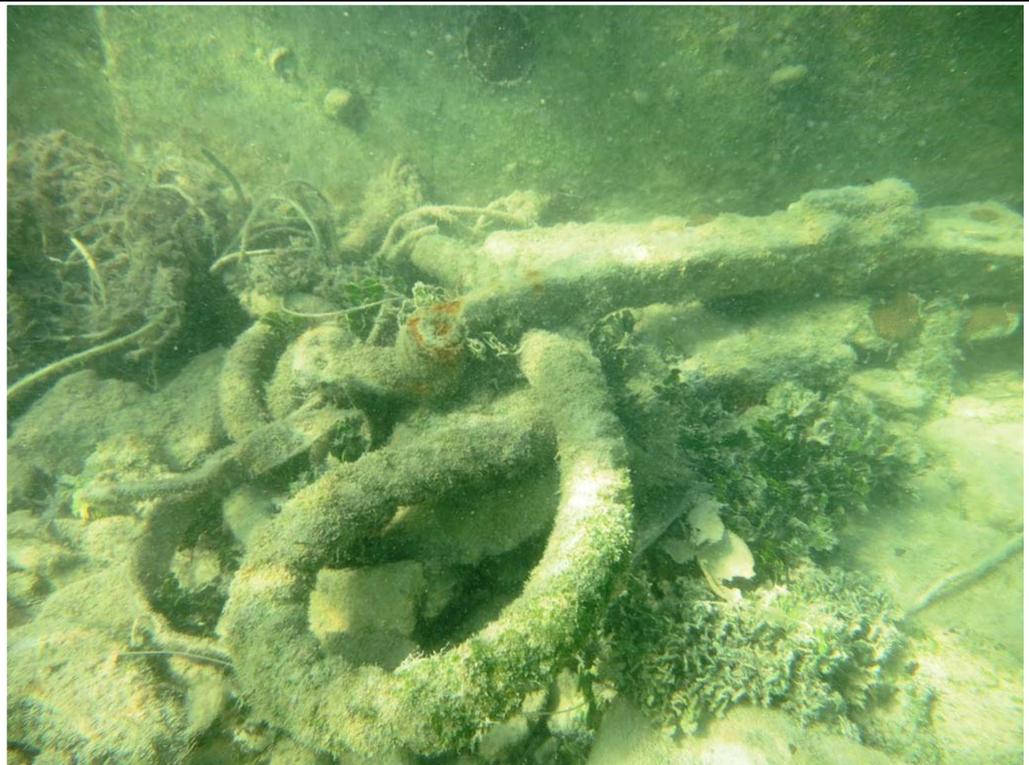
Description:
Ropes, nets and other debris were entangled in the rocks in the eastern corner of the bulkhead.

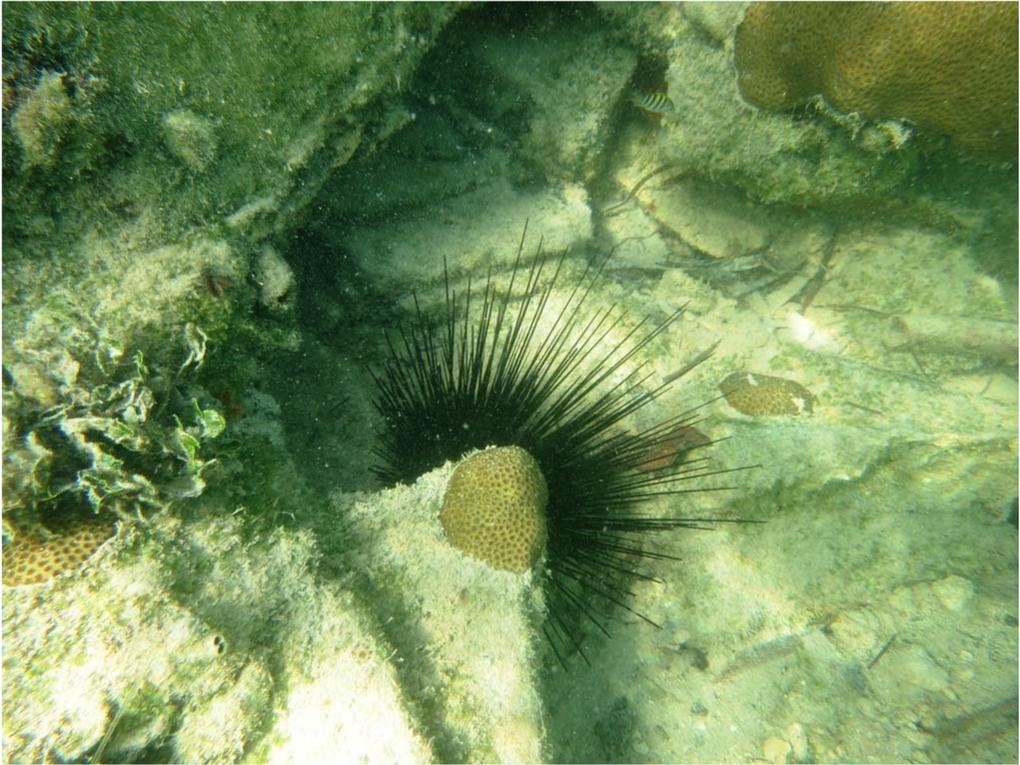
| Description: In many locations along the bulkhead the footer of the wall was undermined and broken which created crevices for long-spined urchins (<i>Diadema antillarum</i>). | | |

In many locations along the bulkhead, the footer of the wall was undermined and broken. These conditions created crevices for various juvenile fish, juvenile Caribbean spiny lobsters (*Panulirus argus*), ocellate swimming crabs (*Portunus sebae*), yellow-line arrow crab (*Stenorhynchus seticornis*), channel clinging crab (*Mithrax spinosissimus*), long-spined urchins (*Diadema antillarum*), and a green moray eel (*Gymnothorax funebris*). Additional photographs showing the condition of the bulkhead can be found in the Field Observation Report (Appendix D, Attachment 6).

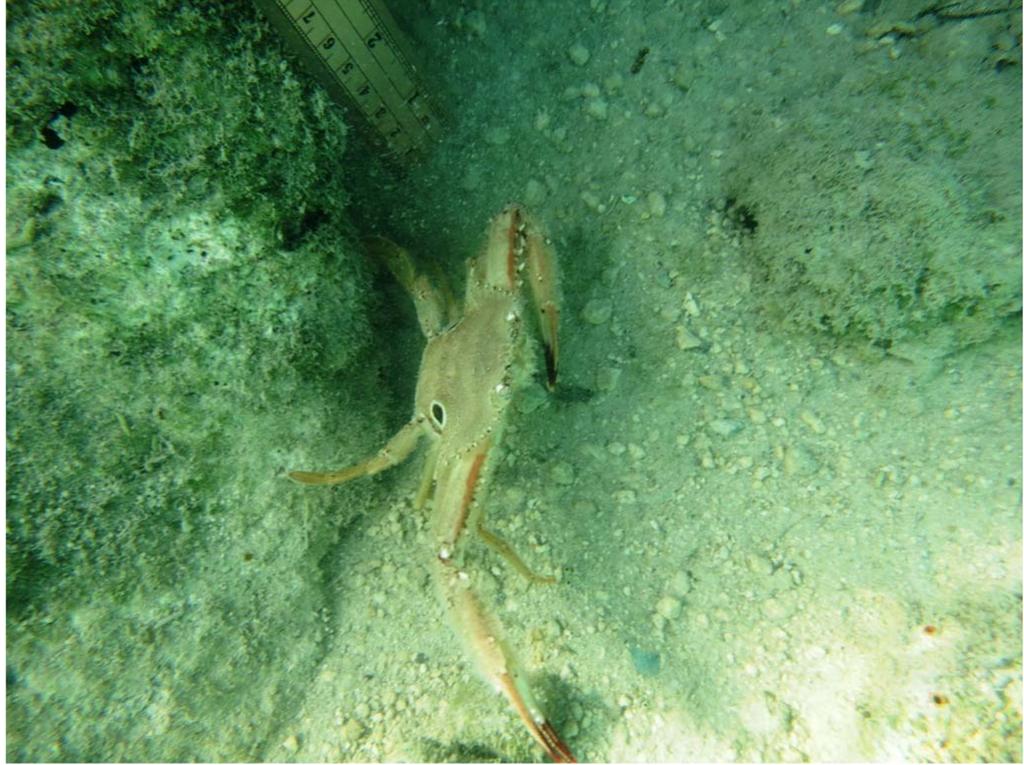
Description:
In many locations along the bulkhead the footer of the wall was undermined and broken which created crevices for various ocellate swimming crabs (*Portunus sebae*).

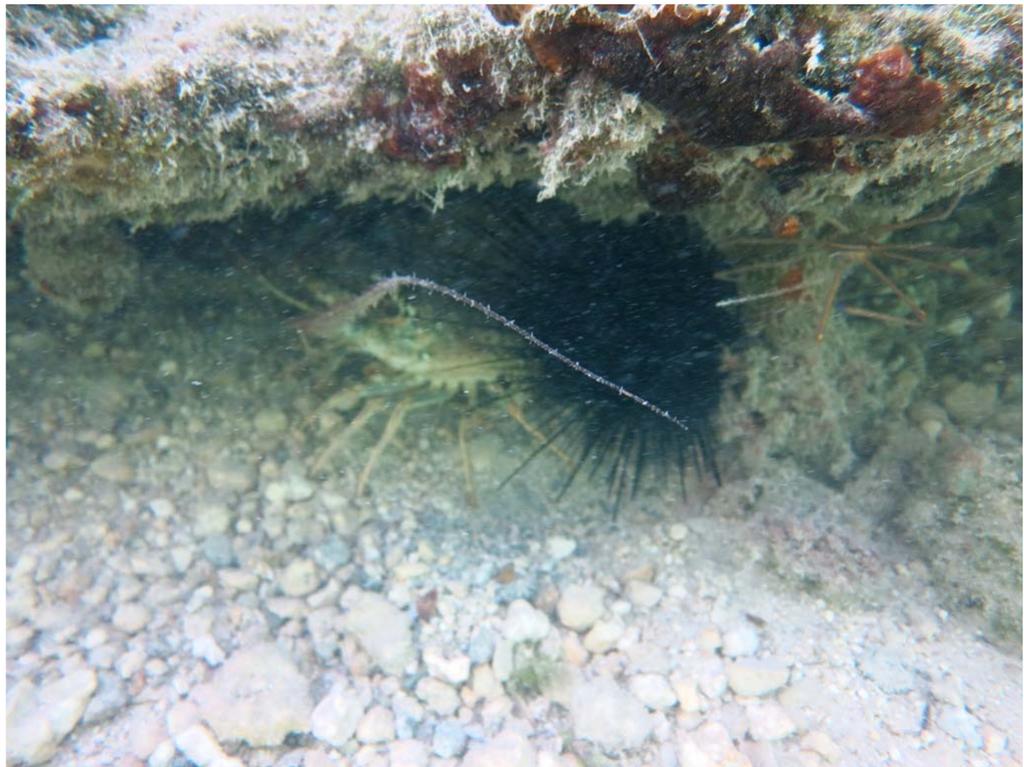
Description:
In many locations along the bulkhead the footer of the wall was undermined creating crevices for various juvenile Caribbean spiny lobsters (*Panulirus argus*), yellow-line arrow crab (*Stenorhynchus seticornis*), and long-spined urchins (*Diadema antillarum*).

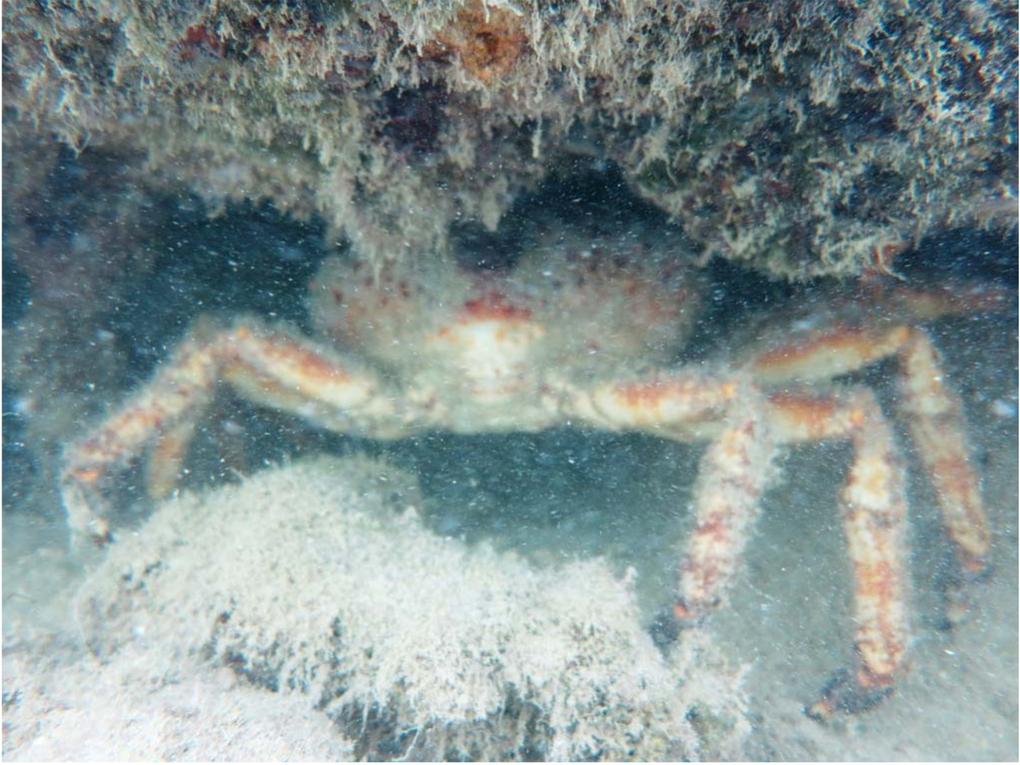
| Description: In many locations along the bulkhead the footer of the wall was undermined and broken which created crevices for channel clinging crab (<i>Mithrax spinosissimus</i>). | | |

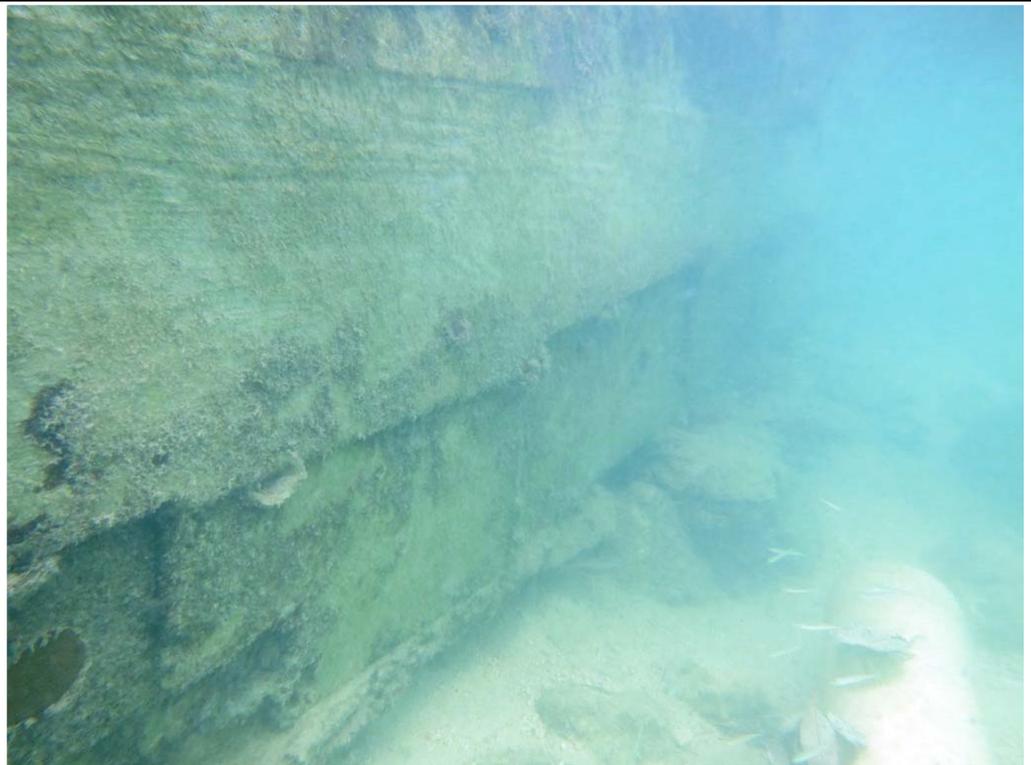
Description:
Most of the northern
bulkhead looks as it
does here with sparse
Siderastrea radians
growing at the base of
the wall.

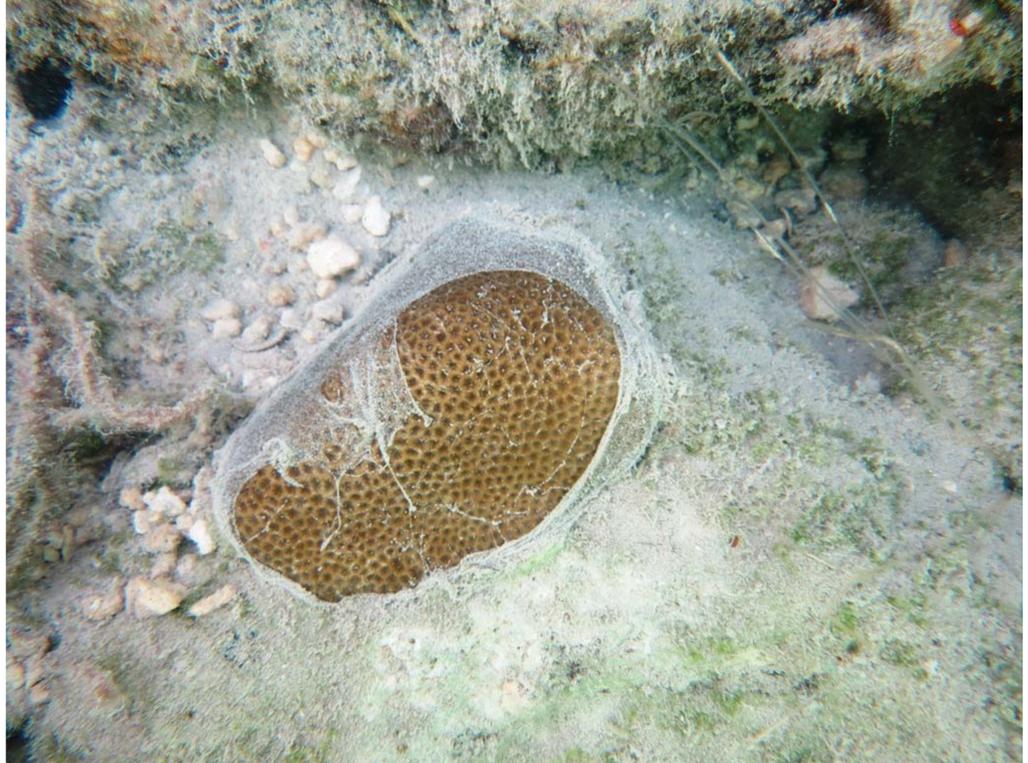
Description:
Siderastrea radians,
showing signs of
stress (mucus
covering) growing at
the base of the wall
towards the western
end of the bulkhead.

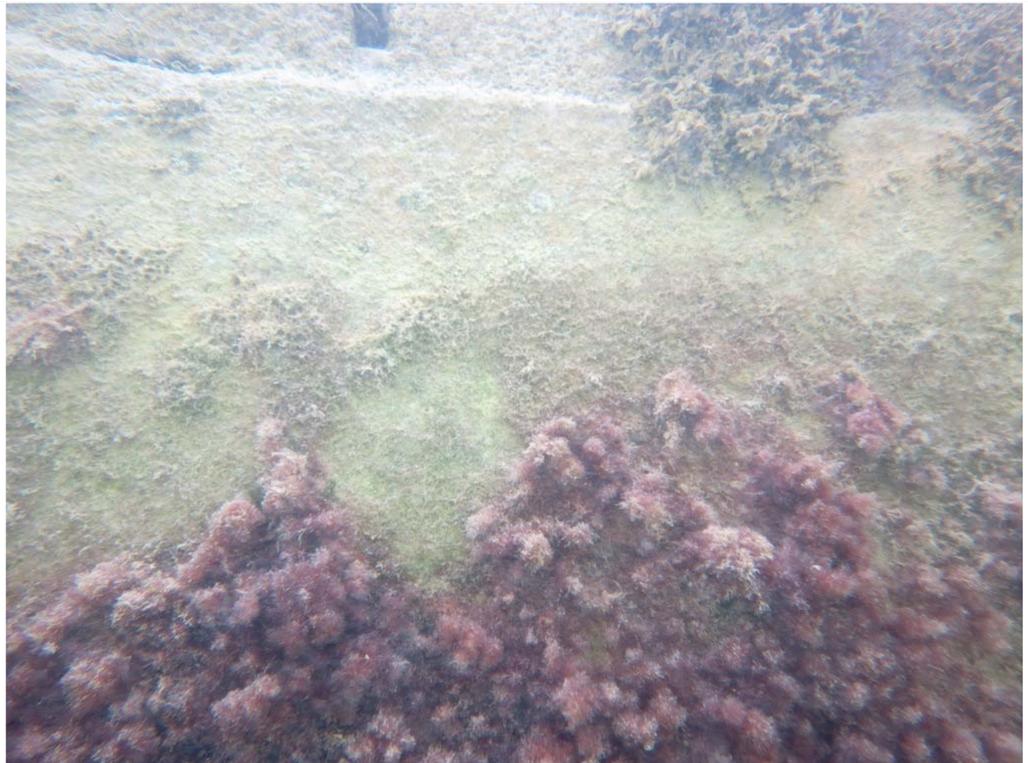
Photo No.
28

Description:
Cyanobacteria
growing on the
bulkhead.

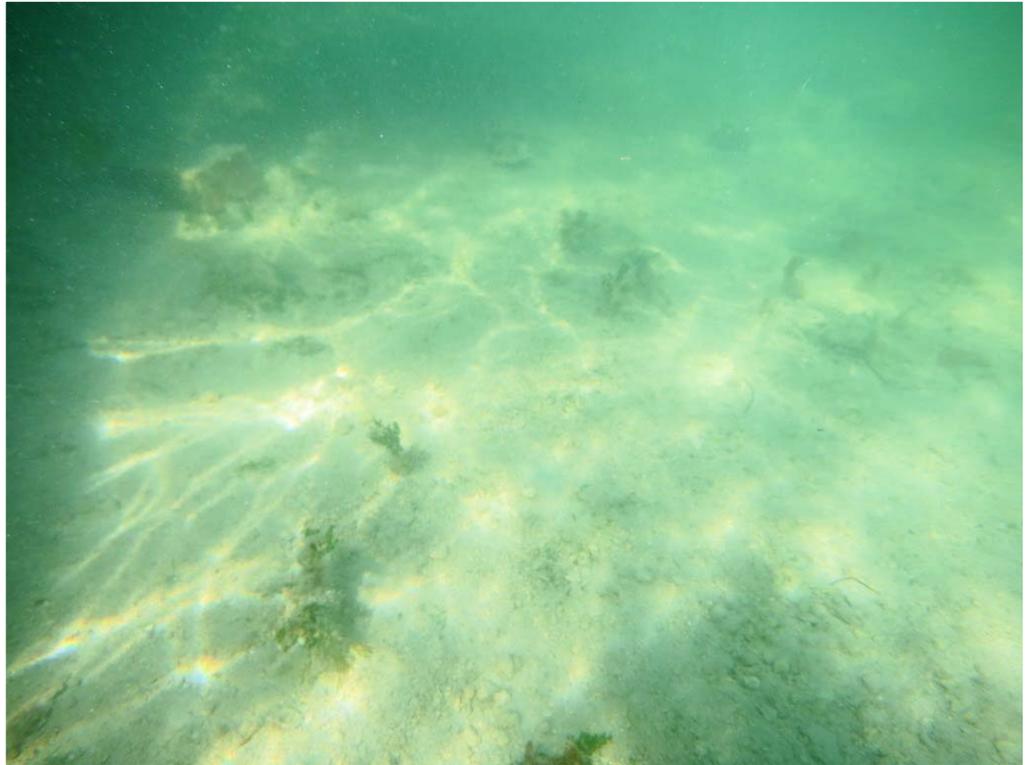
Description:
The submerged lands adjacent to the bulkhead consist mostly of sand with occasional rocks and debris from the footer of the wall.

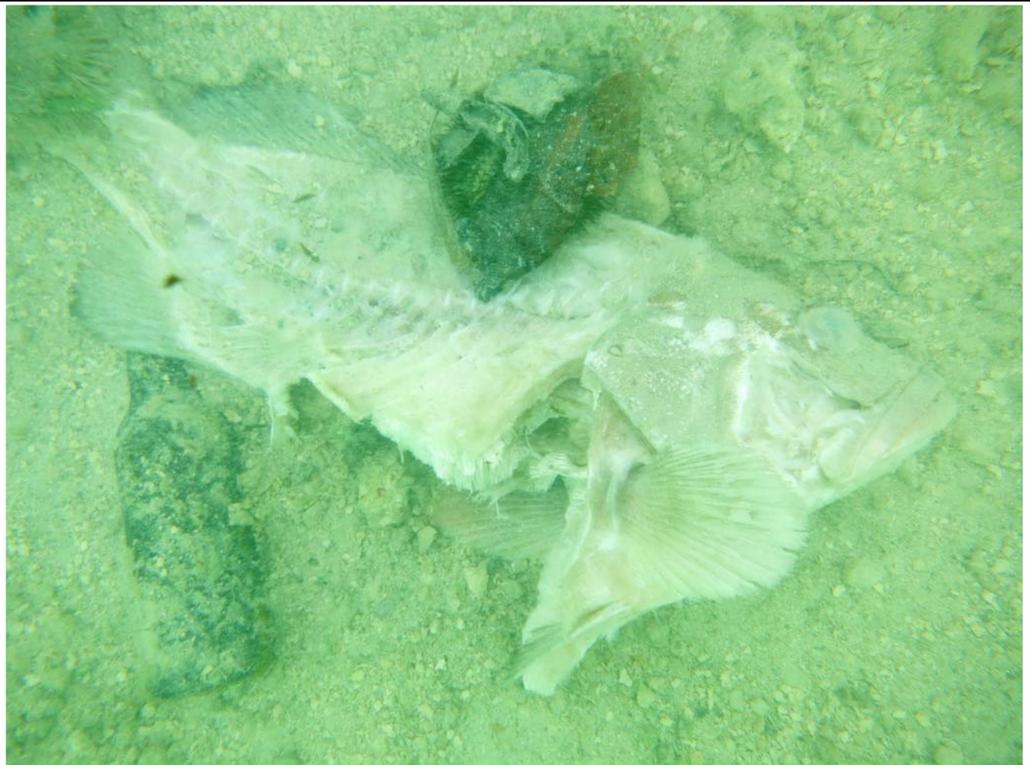
Photo No.
30

Description:
Fish carcasses were observed on the submerged lands behind several of the vessels.

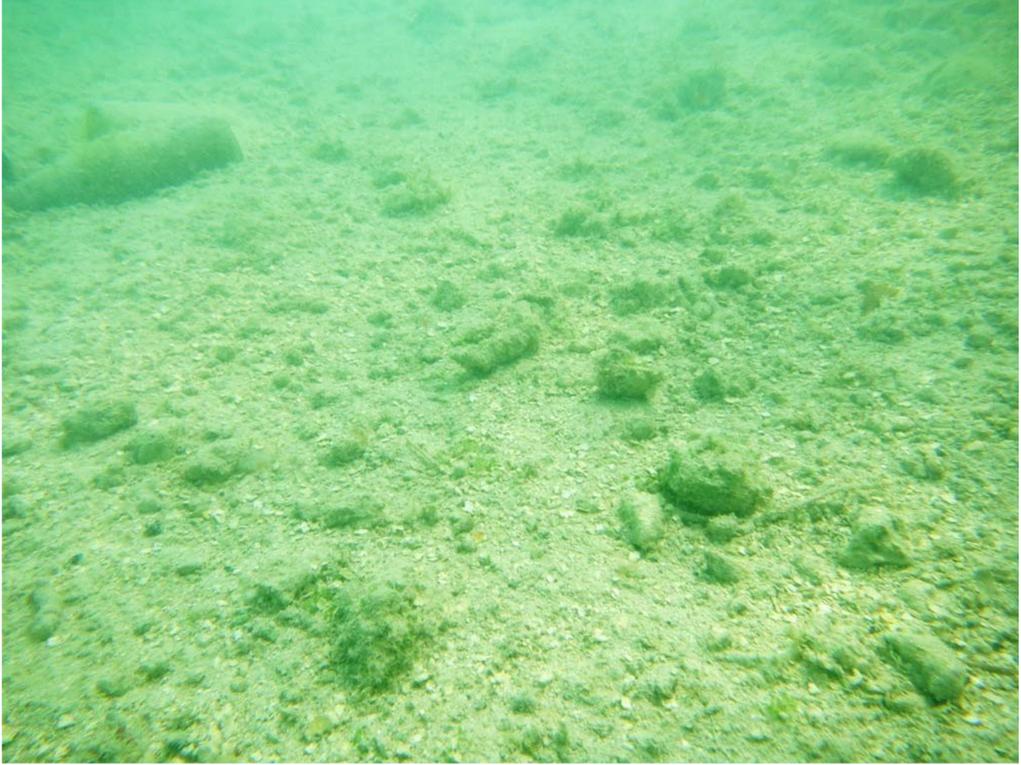
| Photo No. 31 | Date: 2/28/17 | |

| Description: The center of the channel consists mostly of sand and shell. | | |

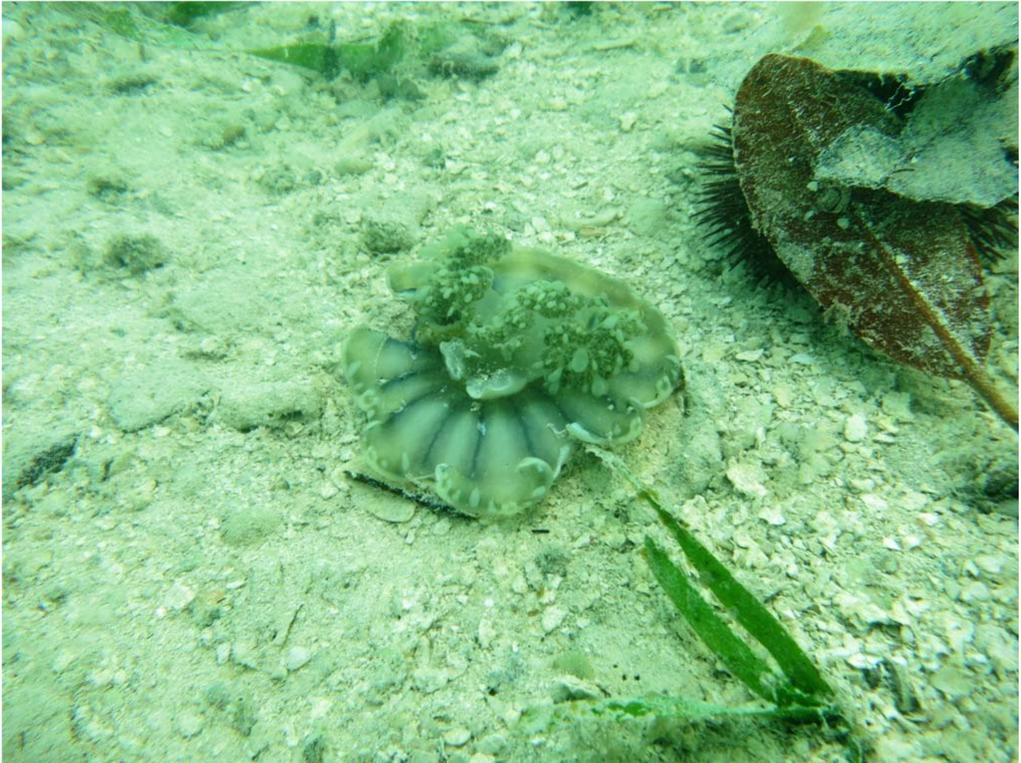
| Photo No. 32 | Date: 2/28/17 | |

| Description: Along the northern edge of the channel, adjacent to the mangrove island, the submerged lands consist of sand, shell, <i>T. testudinum</i> (approximately 1-25% density), <i>Cassiopea frondosa</i> and <i>Lytechinus variegates</i> . | | |

Once the marine resource survey was conducted along the bulkhead, the biologists swam an S pattern along the submerged bottom of the channel between the northern bulkhead at Gulf Seafood Peninsula and the mangrove island. During the survey the biologists noted any species observed and took representative photographs. The south side of the channel immediately adjacent to the northern bulkhead consists of sand, rock and debris from the bulkhead. Green macroalgae (*Halimeda* sp.), *L. variegates*, occasional sponges and upsidedown jellyfish (*Cassiopea frondosa*) were observed on the southern edge of the channel near the bulkhead. Fishing and boating debris (nets, traps, ropes, electrical cords, flashlights, steering wheels, radios, tools, stone crab claws, fish carcasses, etc) were observed near the vessels docked along the bulkhead along with trash such as glass bottles, cans, crates, cinderblocks etc. (Photographs 35-38 in Attachment 5). The center of the channel consists mostly of sand and shell with occasional sponges, *L. variegates*, upsidedown jellyfish (*Cassiopea frondosa*), giant anemones (*Condylactis gigantea*), and a few small patches of *T. testudinum* (Photograph 31 in Attachment 5). Along the northern edge of the channel, adjacent to the mangrove island, the submerged lands consist of sand, shell, *T. testudinum* (approximately 1-25% density), *Halimeda* sp., *C. frondosa*, *L. variegates*, spaghetti worm (*Eupolyornia crassicornis*), unidentified mantis shrimp, occasional sponges and leaf litter from the mangroves (Photographs 32-34 in Attachment 5).

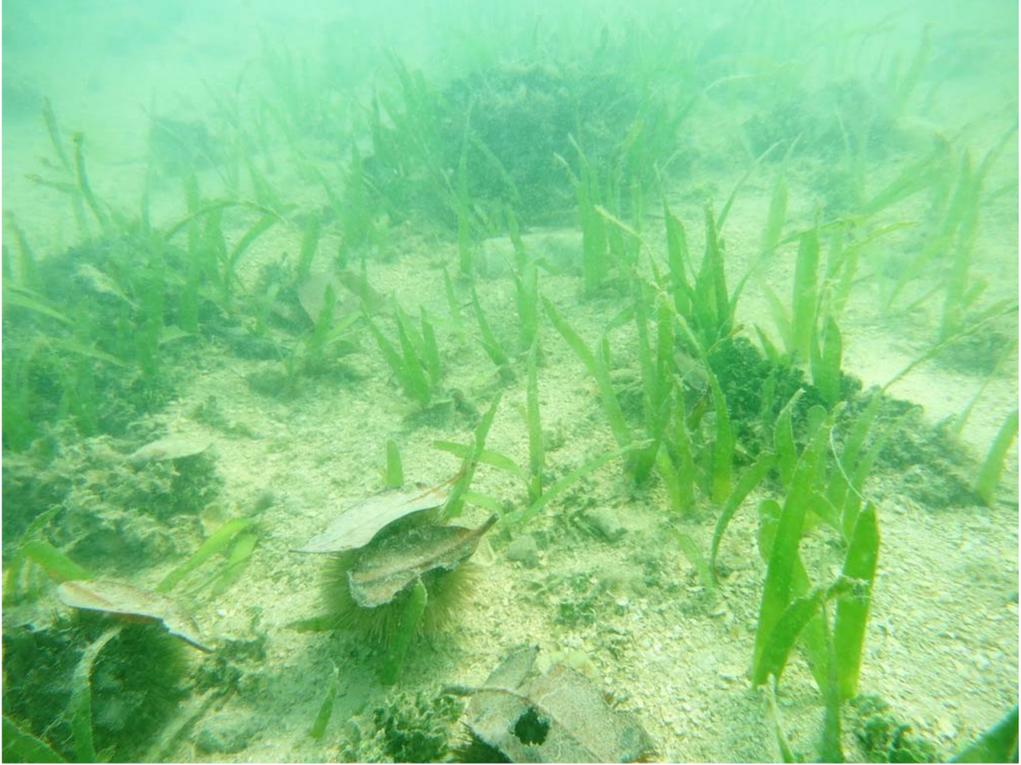
| Photo No. 33 | Date: 2/28/17 | |

| Description: Along the northern edge of the channel, adjacent to the mangrove island, the submerged lands consist of sand, shell, <i>T. testudinum</i> (approximately 1-25% density), <i>Halimeda sp.</i> and <i>Lytechinus variegates</i> . | | |

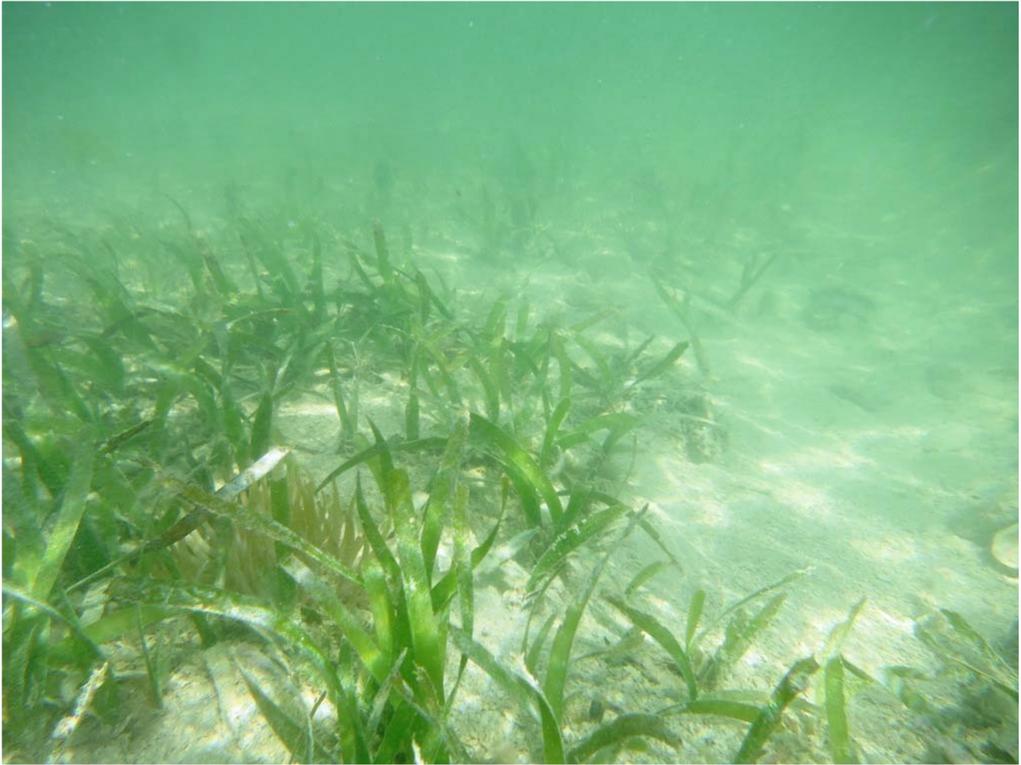
| Photo No. 34 | Date: 2/28/17 | |

| Description: Along the northern edge of the channel, adjacent to the mangrove island, the submerged lands consist of sand, shell, <i>T. testudinum</i> (approximately 1-25% density). | | |

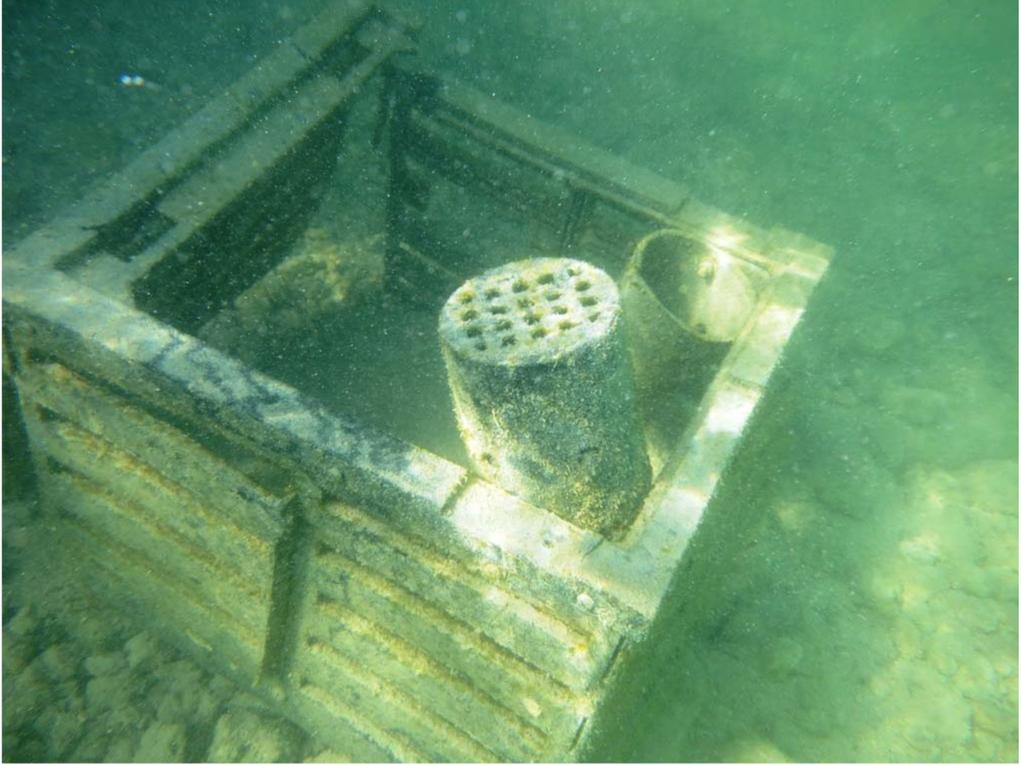
| Photo No. 35 | Date: 2/28/17 | |

| Description: Fishing debris was observed near the vessels docked along the bulkhead along with trash such as glass bottles, cans, crates, cinderblocks etc. | | |

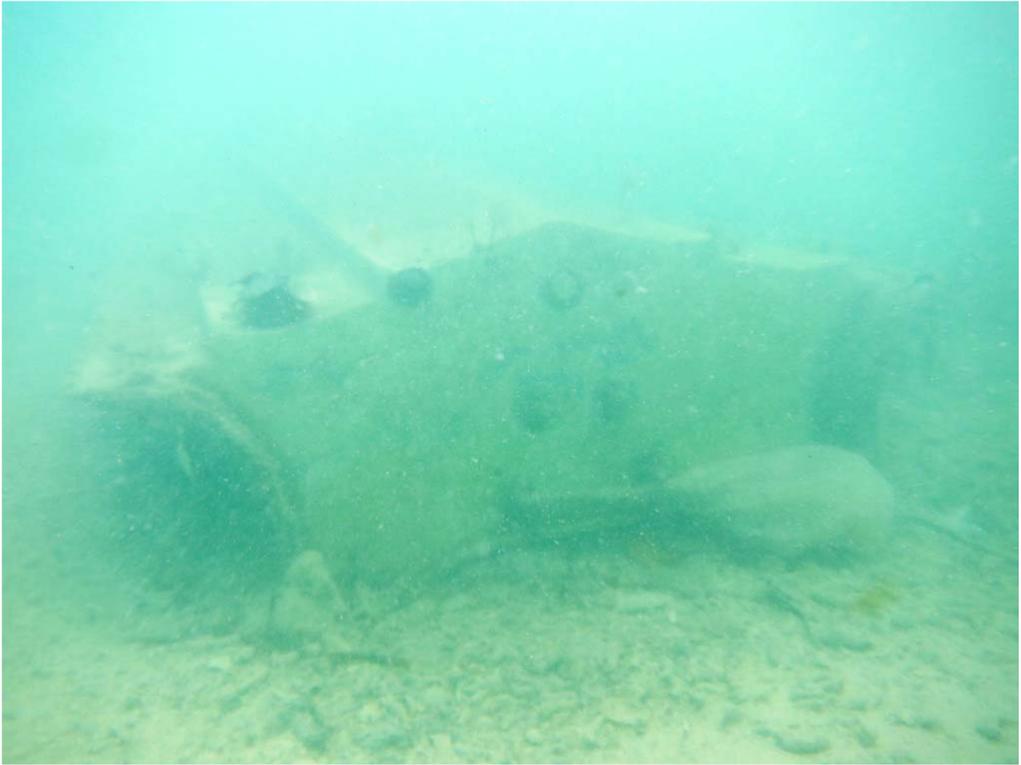
| Photo No. 36 | Date: 2/28/17 | |

| Description: Fishing and boating debris were observed near the vessels docked along the bulkhead along with trash such as glass bottles, cans, crates, cinderblocks etc. | | |

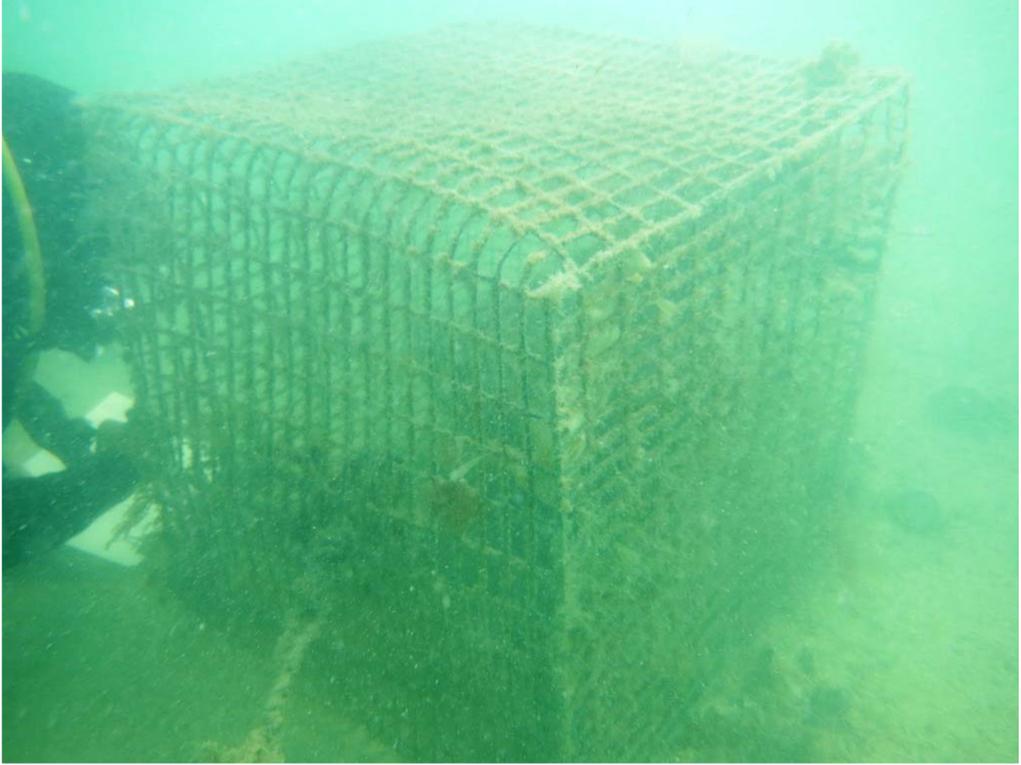
| Photo No. 37 | Date: 2/28/17 | |

| Description: Fishing and boating debris (nets, traps, ropes, electrical cords, flashlights, steering wheels, radios, tools, stone crab claws, fish carcasses, etc) were observed near the vessels docked along the bulkhead. | | |

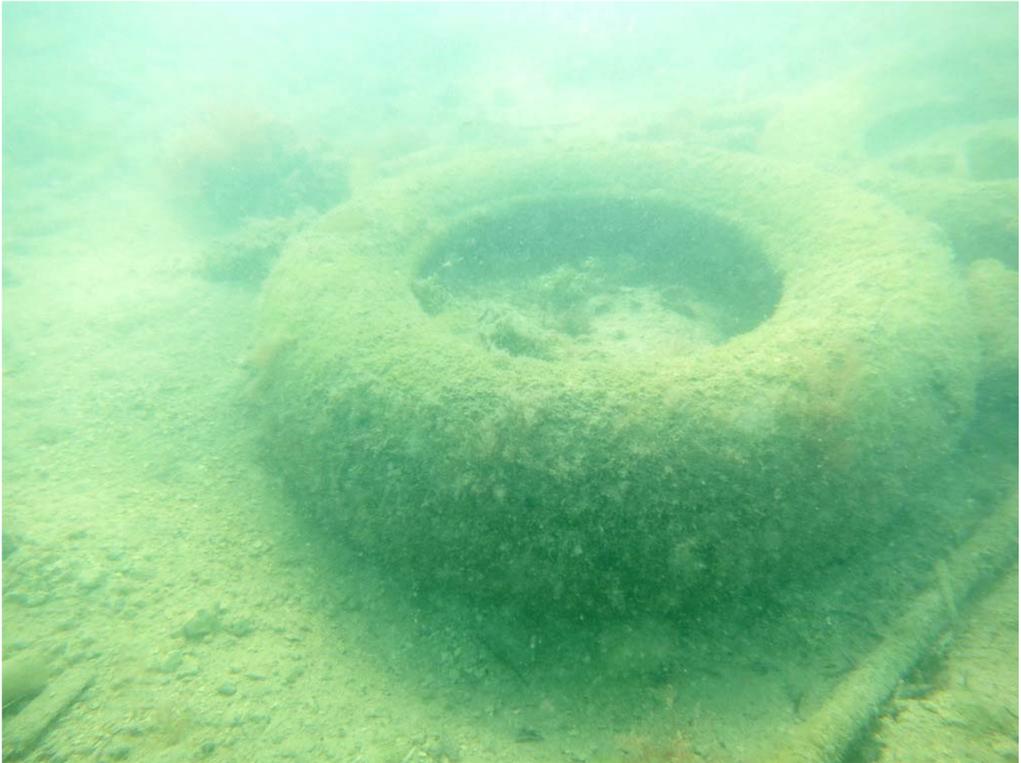
| Photo No. 38 | Date: 2/28/17 | |

| Description: Trash such as tires, glass bottles, cans, crates, cinderblocks etc. were observed near the vessels docked along the bulkhead. | | |

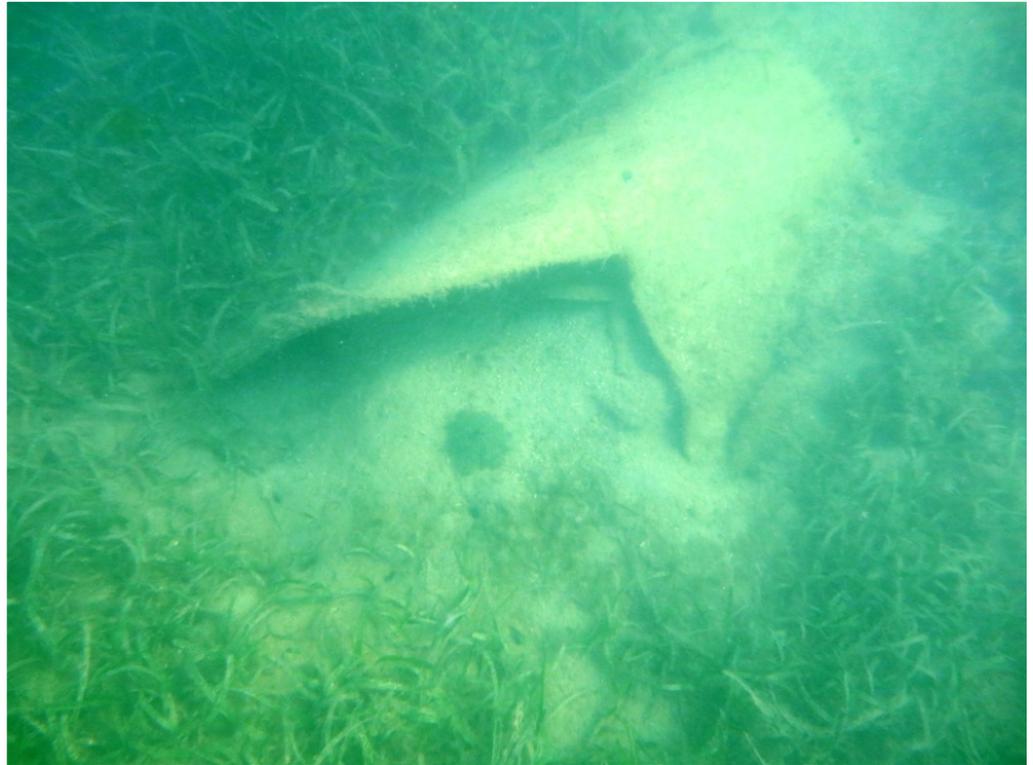
Description: D1
Boat Hull. No
resources on it.
Thalassia testudinum
surrounding debris.

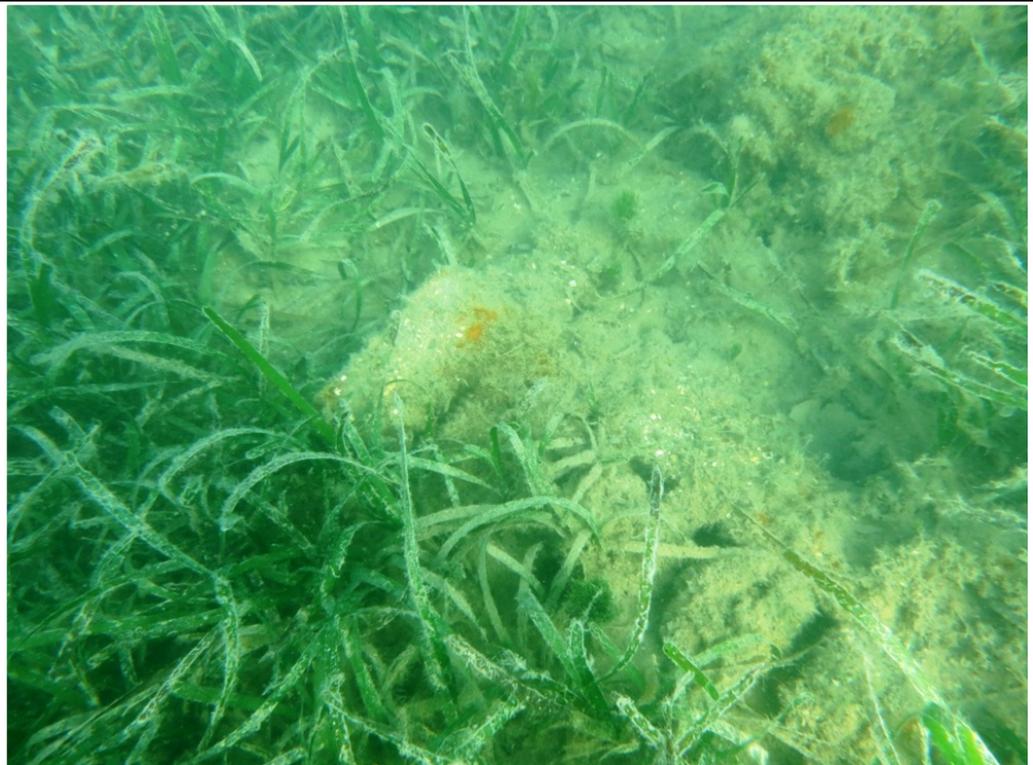
Photo No.
2

Description: D2
Engine. No resources
on. *Thalassia*
testudinum
surrounding debris.

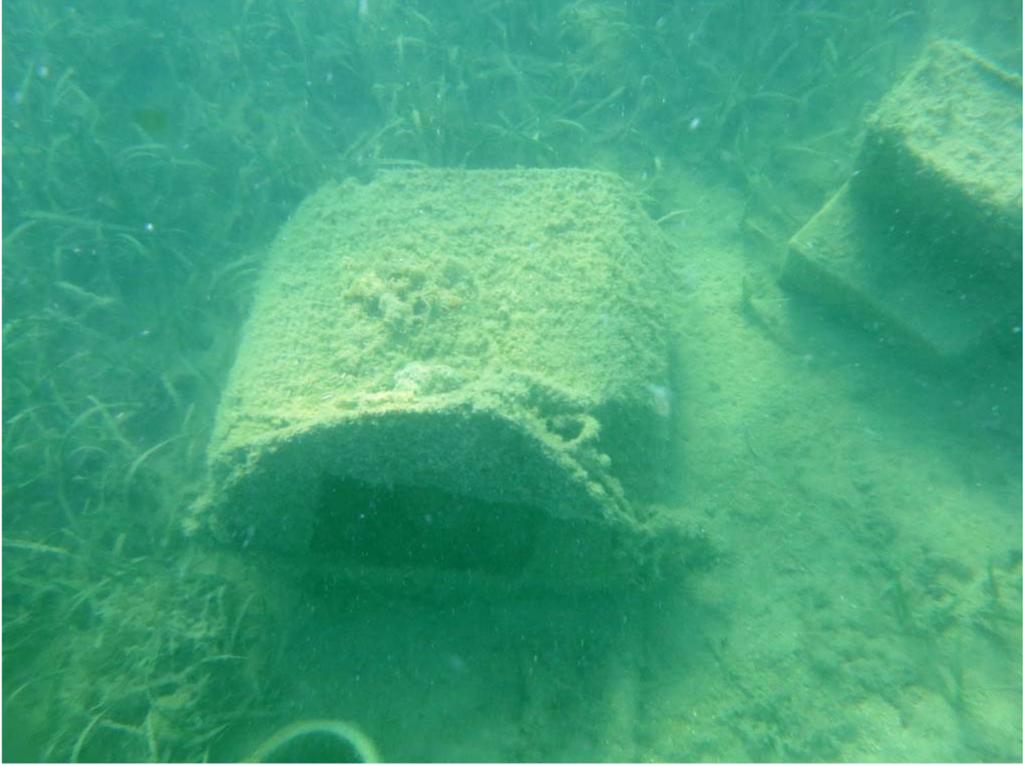
| Photo No. 3 | Date: 3/1/17 | |

| Description: D3 Bike, metal debris field, pipes etc. 2 Rose corals (<i>Manicina areolata</i>) each 9 cm on bike. Nurse shark and 3 juvenile lobsters. <i>Thalassia testudinum</i> surrounding debris. | | |
