Monroe County Boca Chica Mooring Field Detailed Feasibility Study

Coastal Systems International, Inc.
464 South Dixie Highway
Coral Gables, FL 33146

October 2017

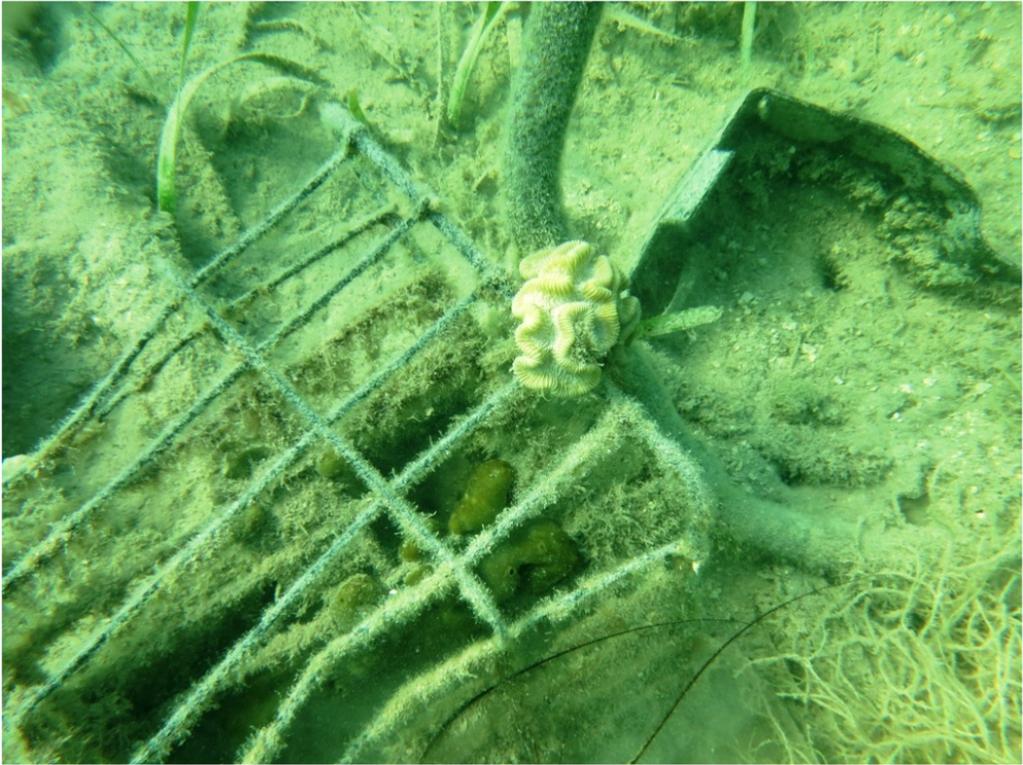
| Photo No. 4 | Date: 3/1/17 | |

| Photo Location: (81 43 45.35055, 24 34 23.27294) | | |
| Description: D3 Bike, metal debris field, pipes etc. 2 Rose corals (<i>Manicina areolata</i>) each 9 cm on bike. Nurse shark and 3 juvenile lobsters. <i>Thalassia testudinum</i> surrounding debris. | | |

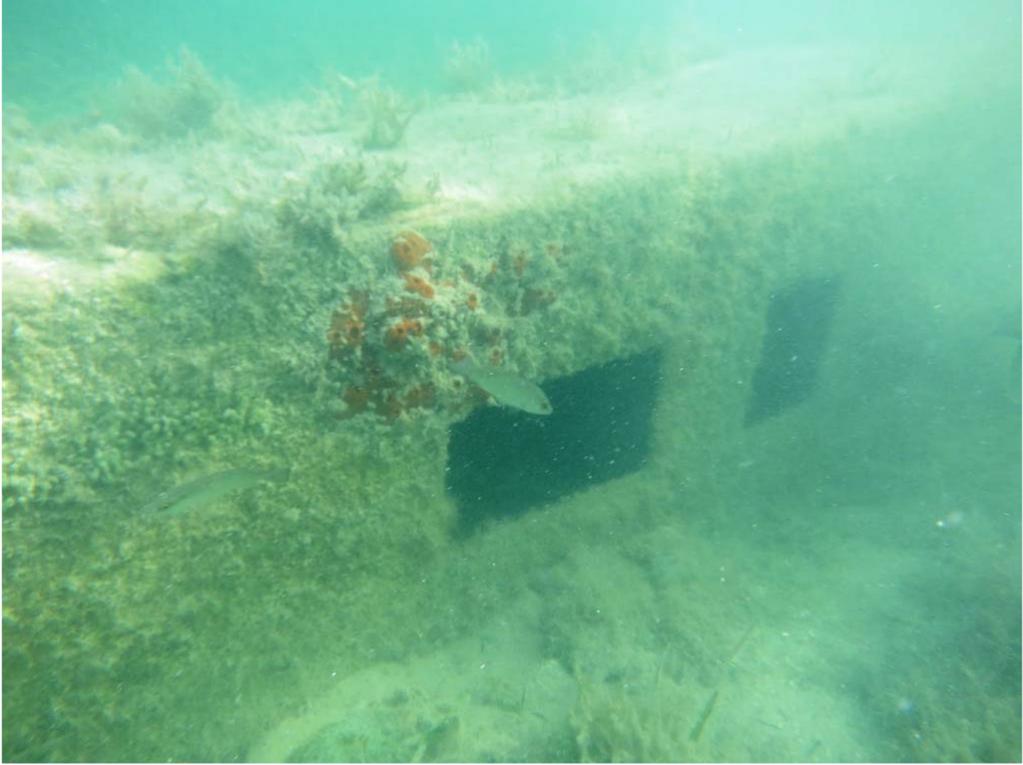
| Description: D4 2 large fiberglass pontoons (12' long rectangular) 1.5' below surface. Macroalgae and sponge growth observed. No coral growth on debris. | | |

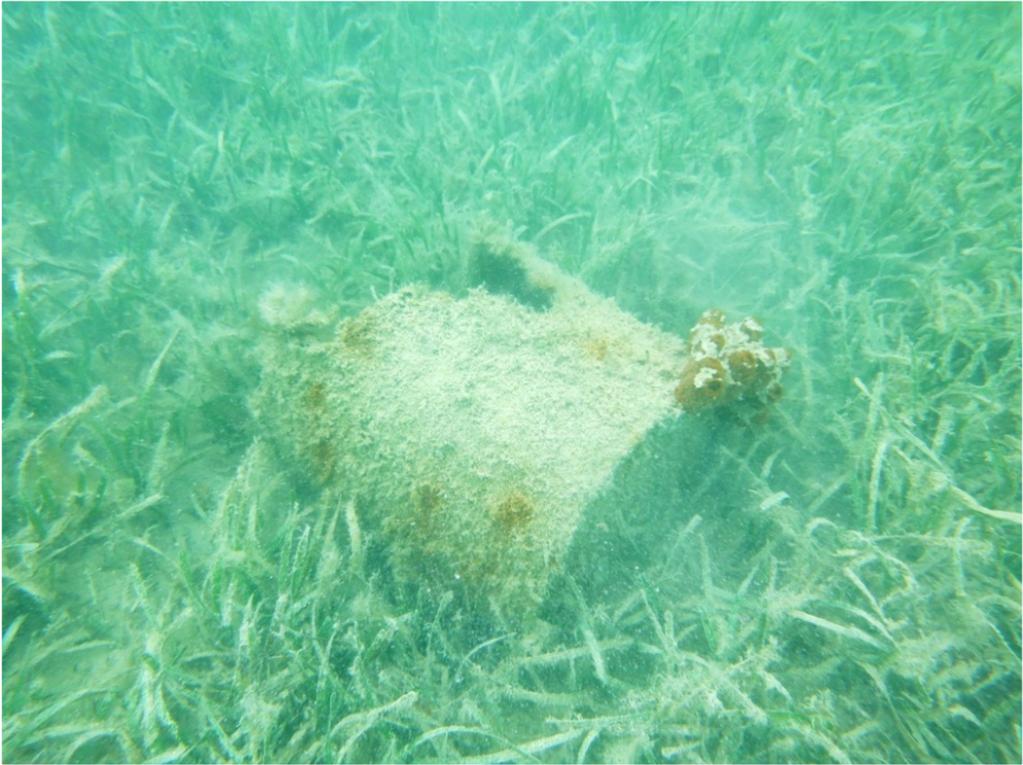
| Description: D4 2 large fiberglass pontoon (12' long rectangular) 1.5' below surface. <i>Thalassia testudinum</i> surrounding debris. Sponge growth observed. No coral growth on debris. | | |

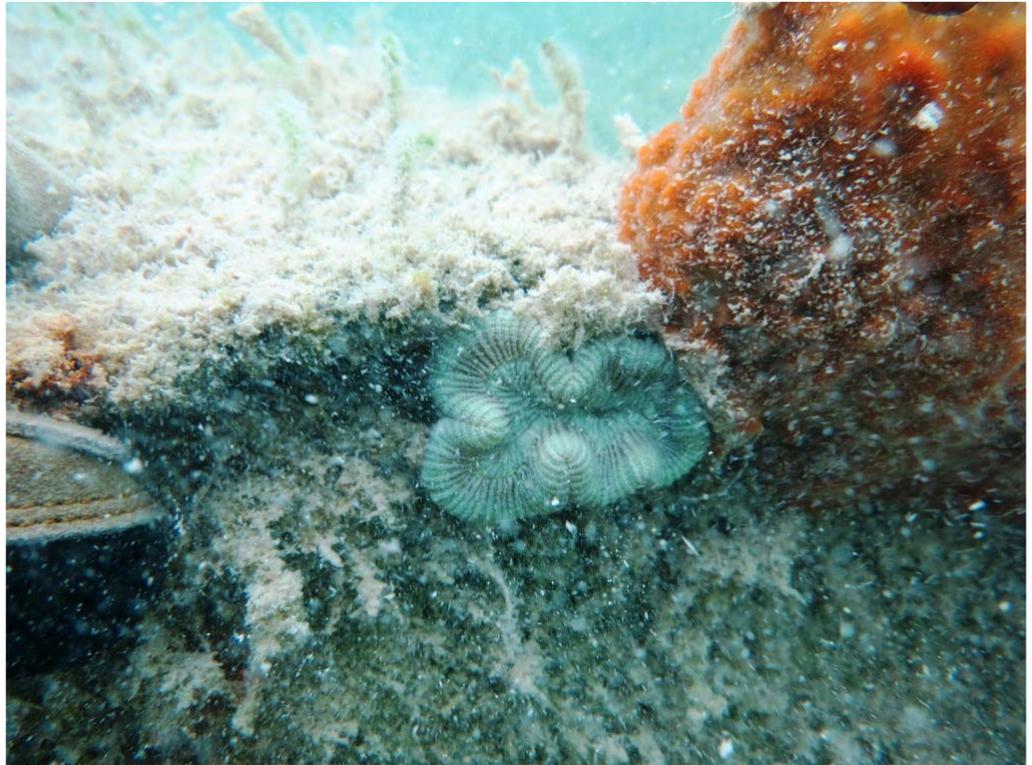
Photo Location:
 (81 43 41.36729,
 24 34 22.19597)

Description: D5
 Debris (barrel) near
 Quad #29. Rose coral
 (*Manicina areolata*) 6
 cm and Sponge (25
 cm) growing on
 debris.

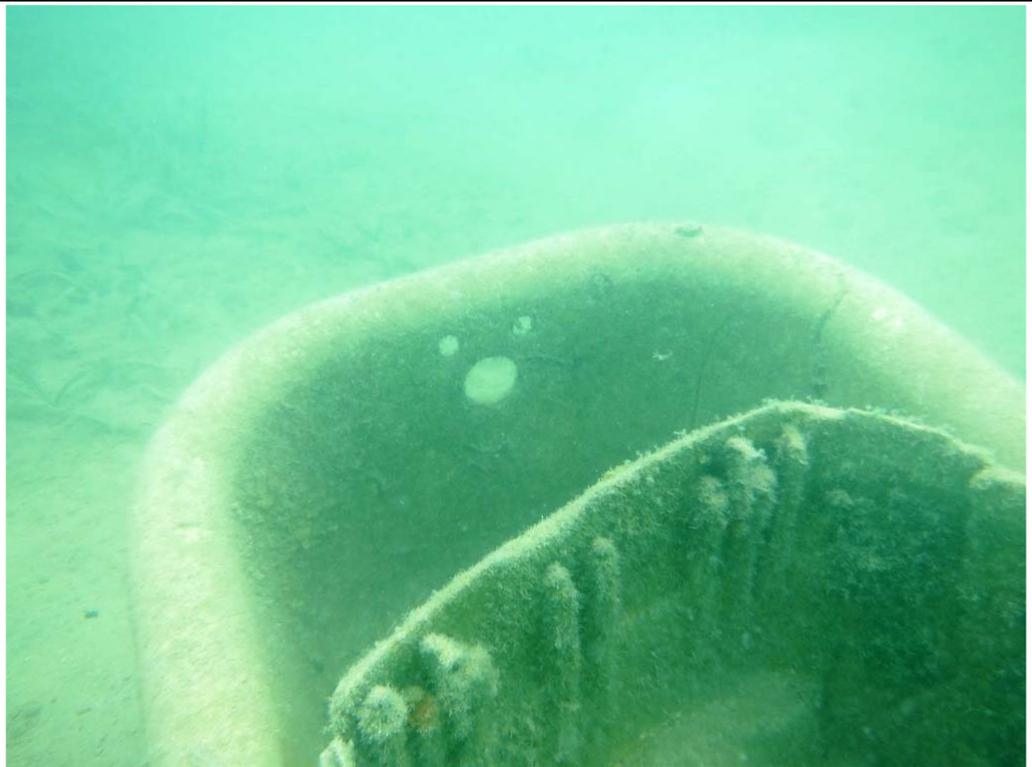
| Photo No. 8 | Date: 3/1/17 |

Photo Location:
 (81 43 43.79258,
 24 34 21.18727)

Description: D6
 Bathtub & motor
 cover. No coral
 growth on debris.

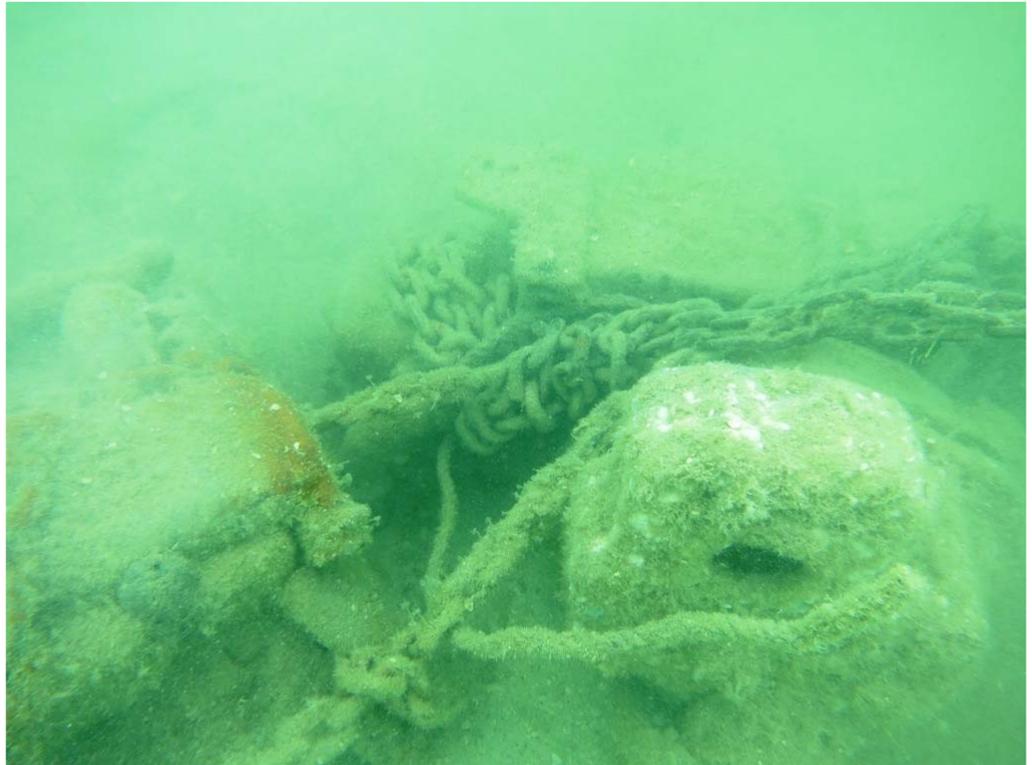
Photo Location:
(81 43 47.19589,
24 34 17.85298)

Description: D7
Metal rectangular box
with no resources on
debris. Seagrass
surrounding debris
pile.

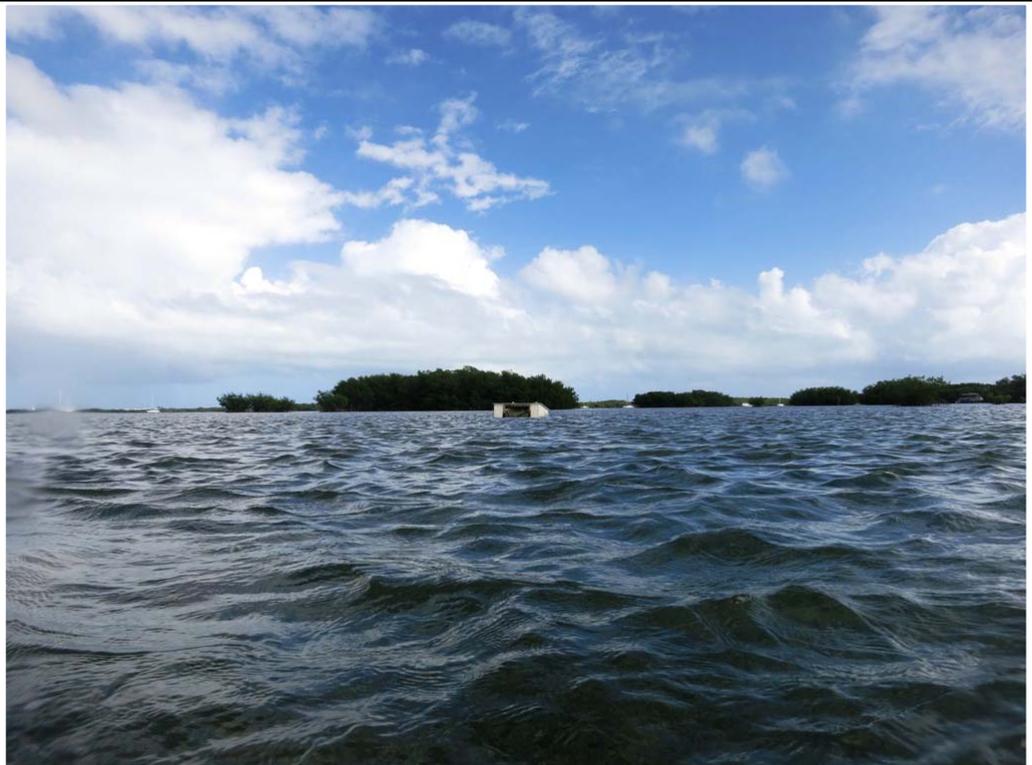
Photo No.
10

Photo Location:
(81 43 41.595,
24 34 8.81570)

Description: D8
Submerged hull - Top
of boat above water in
1' water.

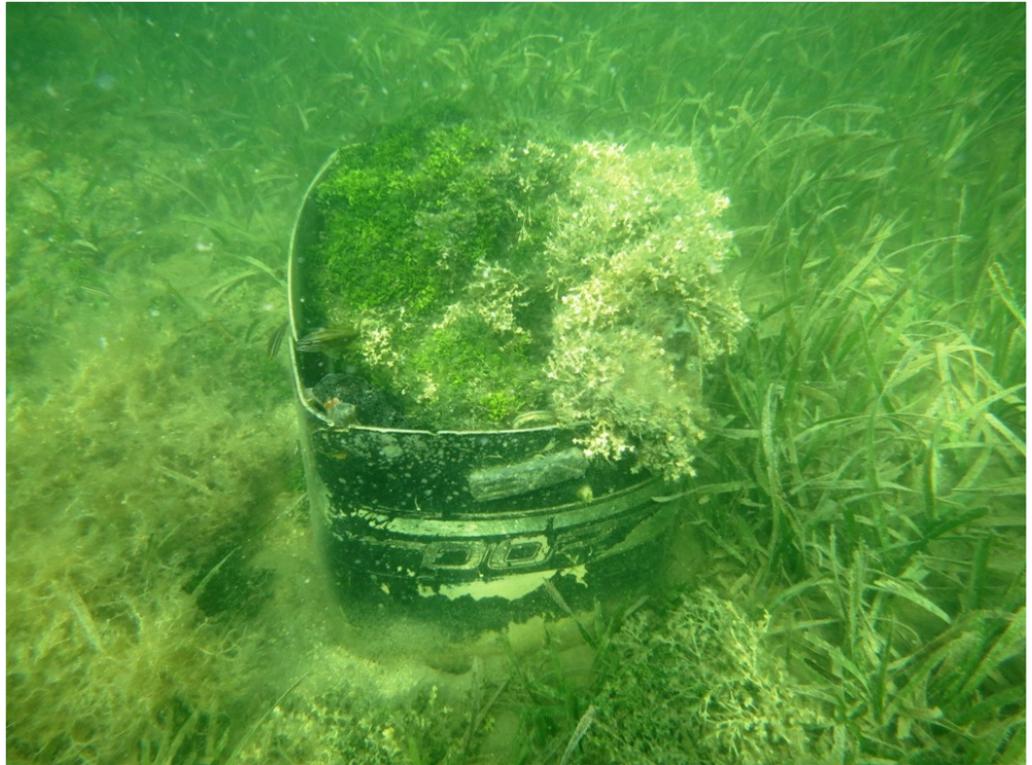
Photo Location:
(81 43 48.74364,
24 34 15.4645)

Description: D9
Motor cover, anchor chain and generator. Macroalgae and Sponge growth but no coral. *Thalassia testudinum* surrounding debris.

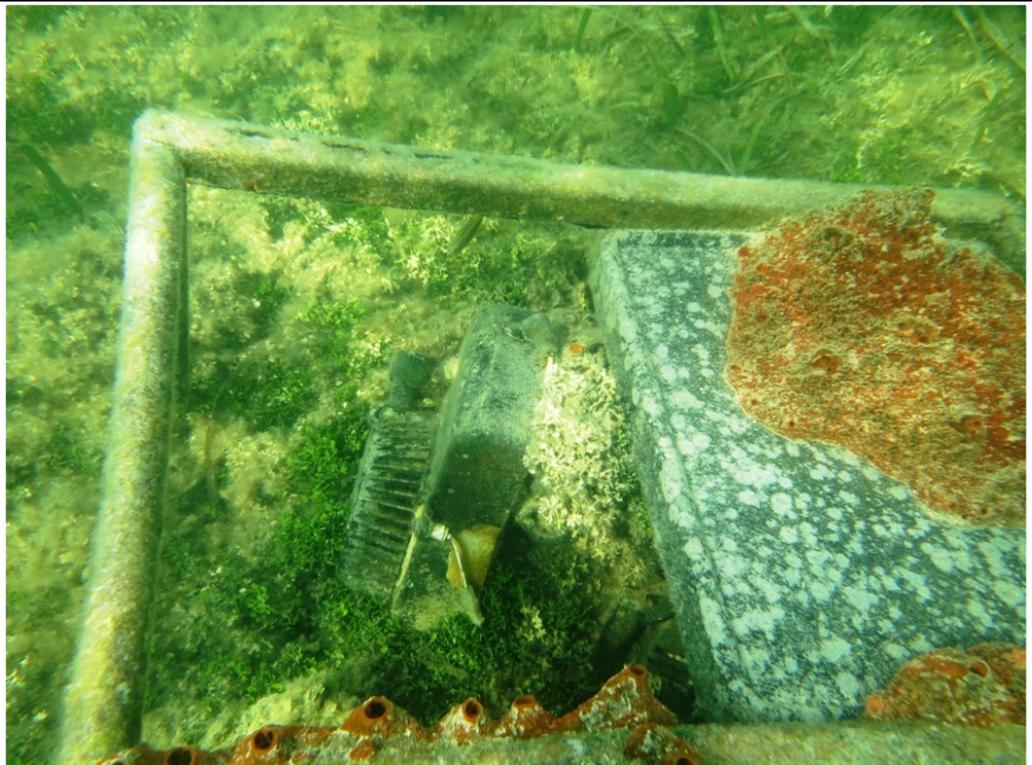
| Photo No. 12 | Date: 3/1/17 |

Photo Location:
(81 43 48.74364,
24 34 15.4645)

Description: D9
Motor cover, anchor chain and generator. Macroalgae and Sponge growth but no coral. *Thalassia testudinum* surrounding debris.

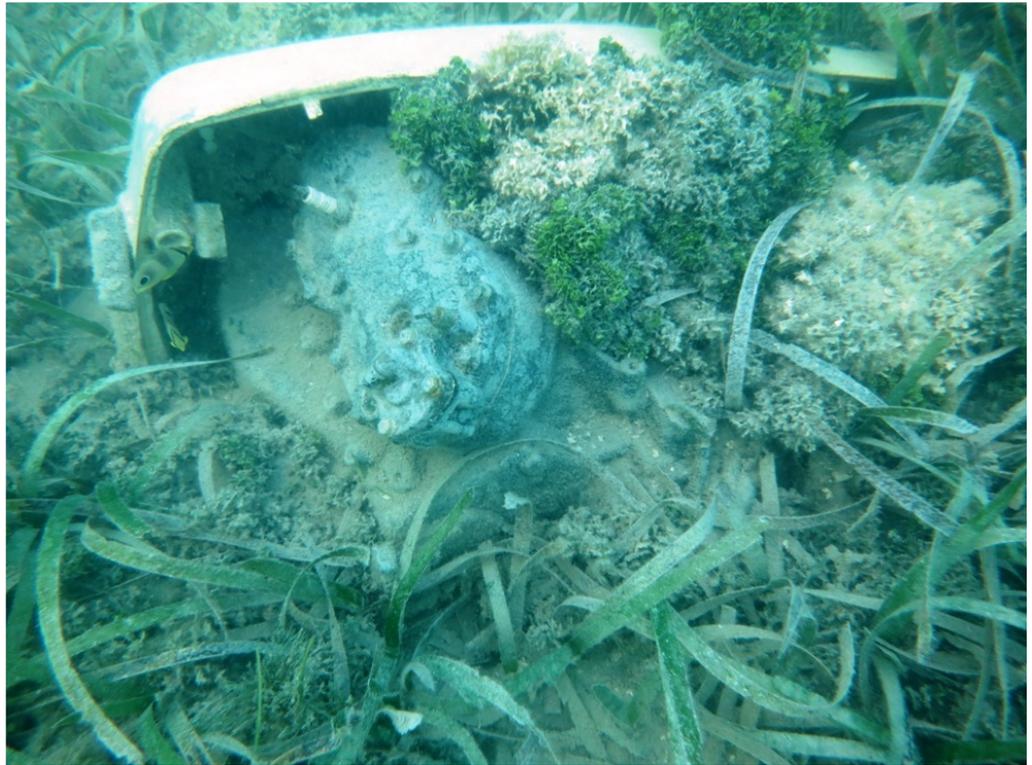
Photo Location:
(81 43 43.98409,
24 34 25.22931)

Description: D10
Generator, metal, and engine. No corals on debris. *Thalassia testudinum* and *Syringodium filiforme* around debris pile. Juvenile lobsters and green moral hiding in debris.

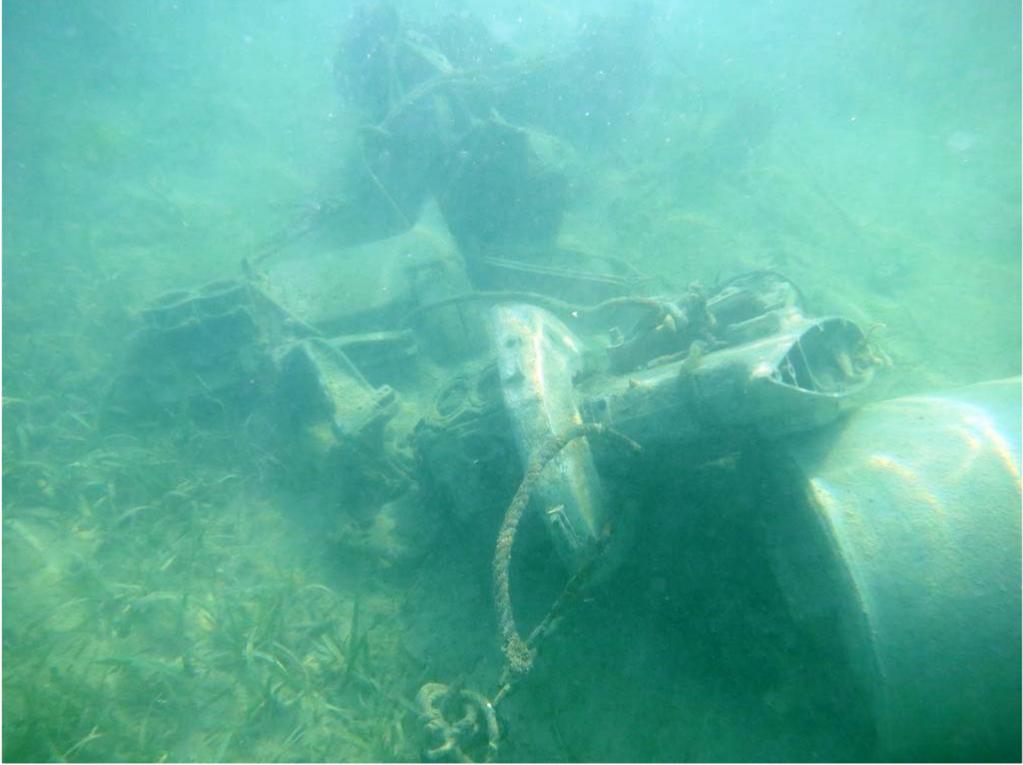
| Photo No. 15 | Date: 3/1/17 | |

| Photo Location: (81 43 38.09318, 24 34 15.96536) | | |
| Description: D12 55 gallon drum, 2 tires, engines, kitchen sink, chair, ropes and pipes. Debris is acting as a mooring for vessel (registration #FL3630DW). No resources on debris. Juvenile fish using the debris as shelter. <i>Thalassia testudinum</i> surrounding debris. | | |

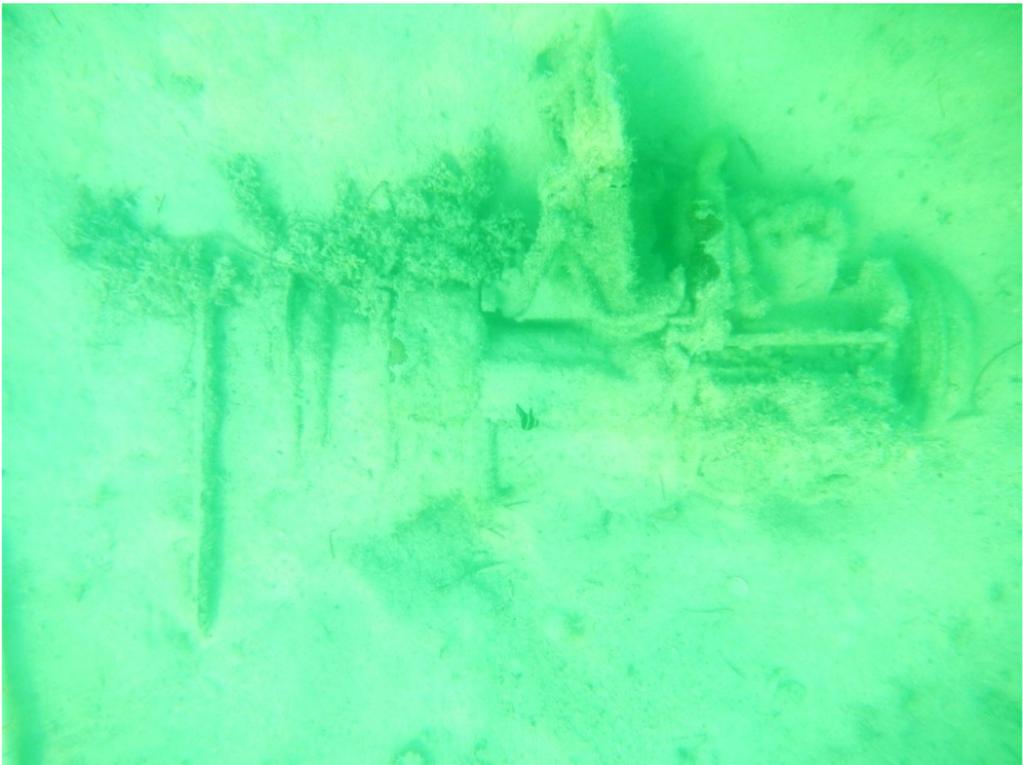
| Photo No. 16 | Date: 3/1/17 | |

| Photo Location: (81 43 24.83853, 24 34 17.83064) | | |
| Description: D13 Outboard engine. No coral growing on debris. | | |

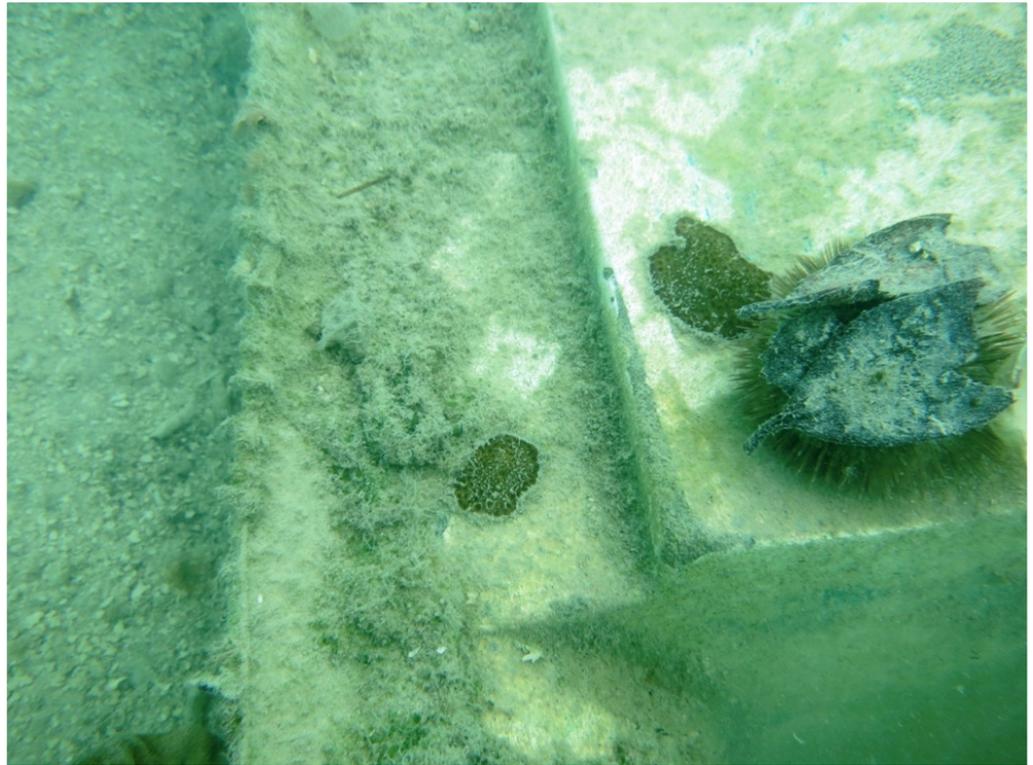
Photo Location:
(81 43 33.06711,
24 33 57.53759)

Description: D14
Hull of boat upside
down. Approximately
20 *Siderastrea radians*
corals, measuring 1-
7cm on hull.

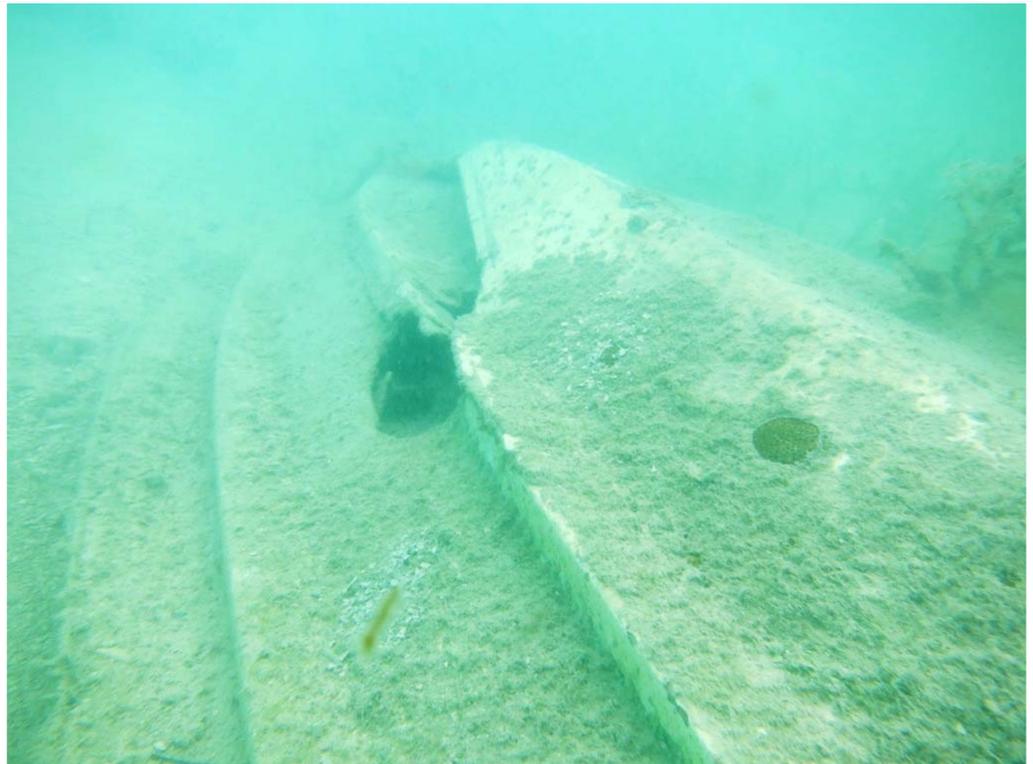
Photo No.
18

Photo Location:
(81 43 33.06711,
24 33 57.53759)

Description: D14
Hull of boat upside
down, Approximately
20 *Siderastrea radians*
corals, measuring 1-
7cm on hull.
