# WEST MARTELLO TOWERS HISTORIC AMMUNITION BUNKERS

## DAMAGE ASSESSMENT REPORT

January 2019

# Structural Condition Assessment West Martello Batteries and Ammunition Bunkers Key West, Florida

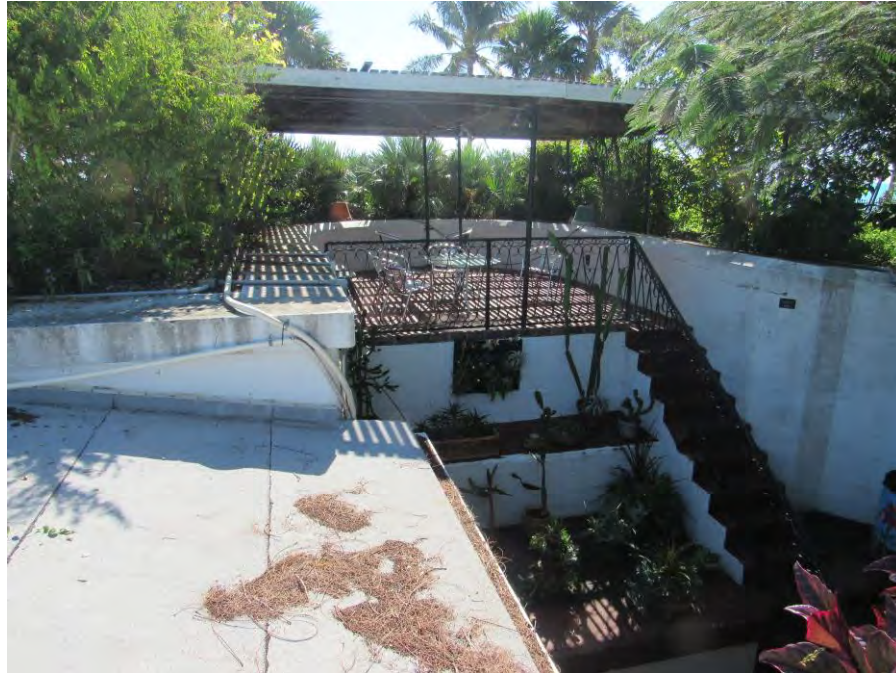
**Photograph 1**

The West Martello Batteries and Ammunition Bunkers are two (2) emplacements for light coastal artillery guns constructed on the original seaward casemates of the West Martello Tower ruins in 1904 (see Photographs 1 and 2). There are two (2) artillery gun emplacements with three (3) ammunition bunkers covered in earth. The artillery gun emplacements face the south on the east and west with the ammunition bunkers lined up in between. To the north of the bunkers, a meeting room has been added and the bunkers are currently being used as storage. The batteries are elevated concrete artillery gun emplacements with concrete walls 2'-0" to 3'-0" thick on the south-east and west sides, with concrete stairs and terraces leading down to the earth covered bunkers below. The bunkers consist of concrete roofs in excess of 4'-0" thick. The concrete walls between the bunkers are 2'-0" thick and the perimeter concrete walls are 3'-9" thick or thicker.

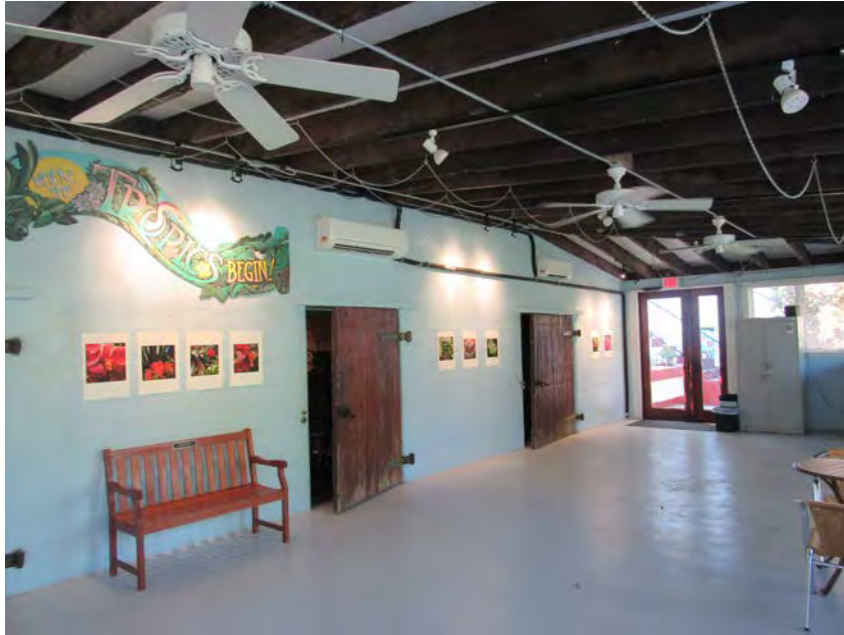
The ammunition bunkers today are surrounded by a contemporary meeting room building which was constructed in the 1970s. The large wood doors of the bunkers are still intact and in good condition.
