Americans with Disabilities Act Transition Plan Upper Keys

Volume 1 of 4

Monroe County

October 29, 2010

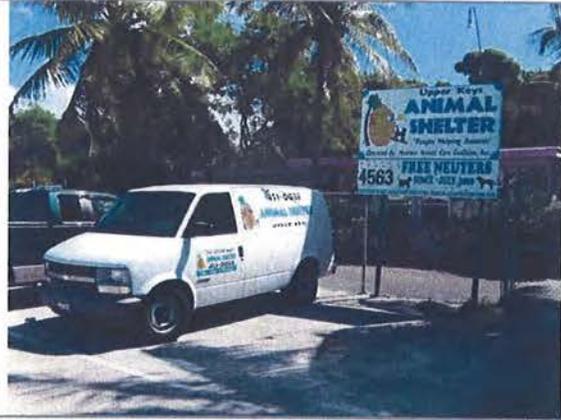
Street Parking and Front

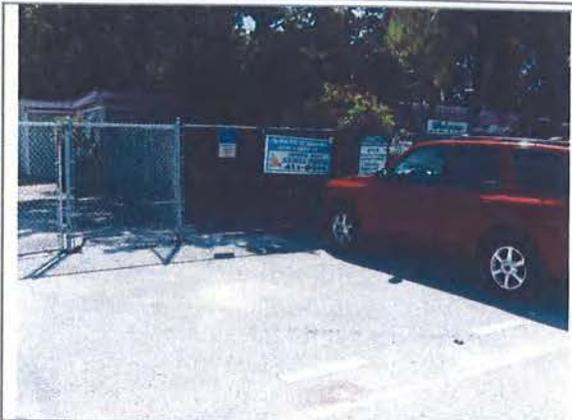
Accessible Parking Space

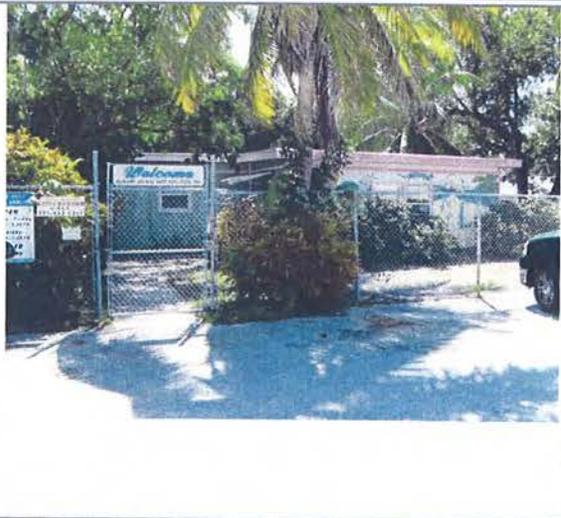
Front Entrance

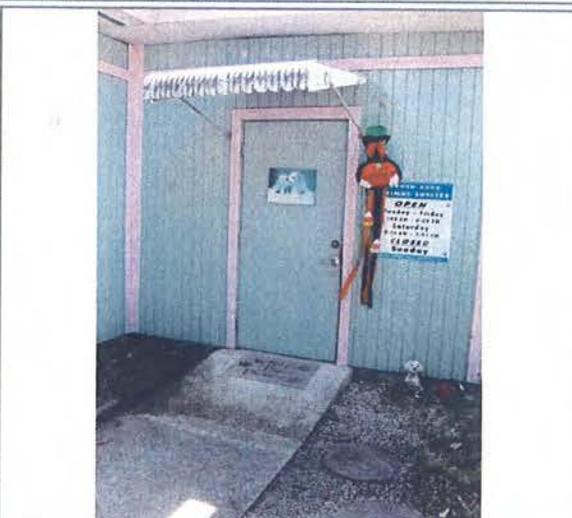
Front Door Ramp

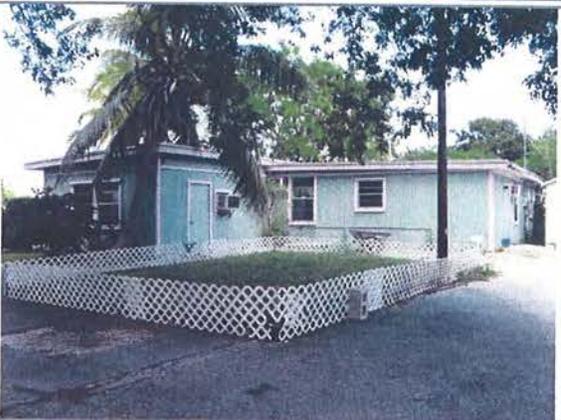
Rear of Office Building

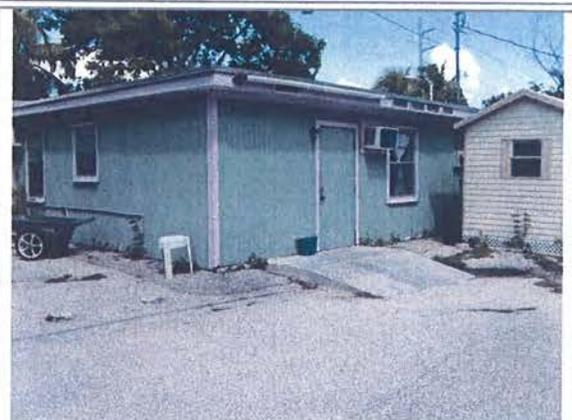
Rear door to Office Building

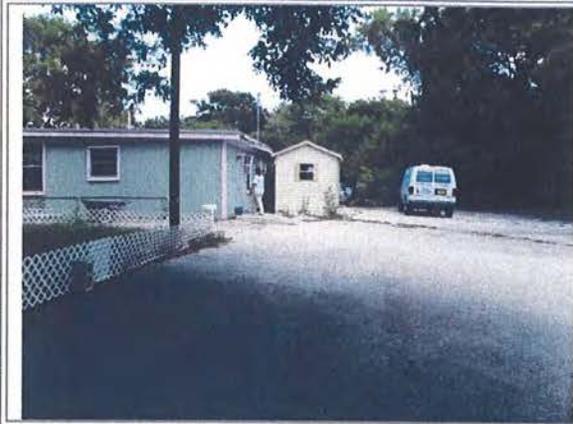
Routes to Kennels

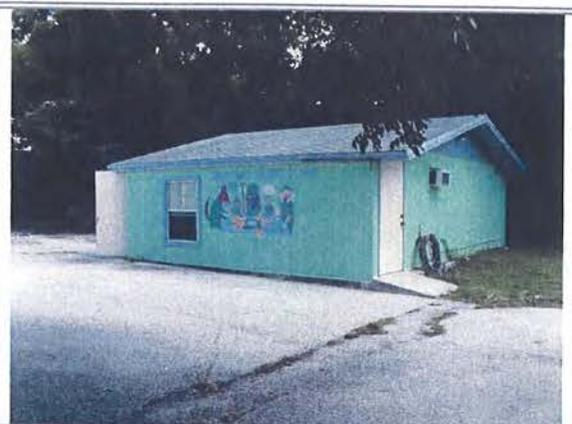
Puppy Kennel and Neuter Clinic

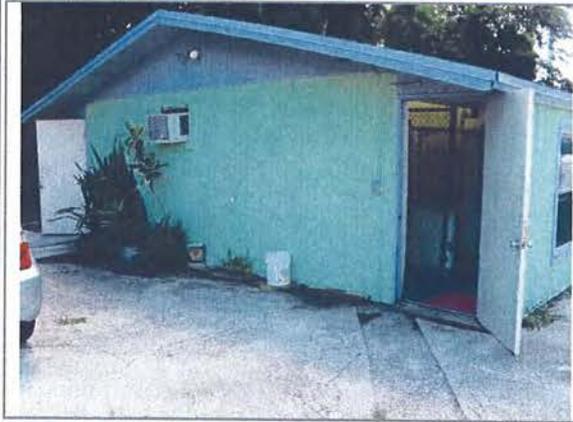
Puppy Kennel and Neuter Clinic

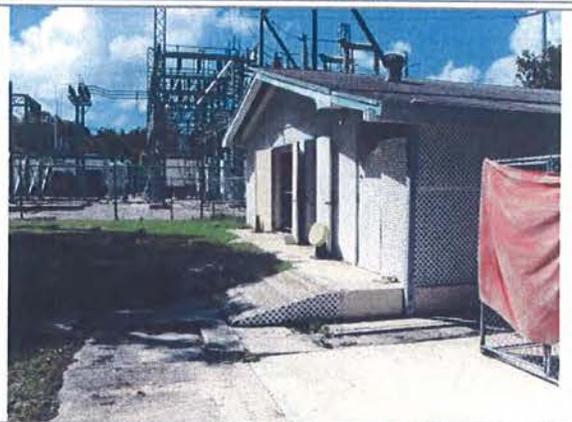
Rear Ramp to Dog Kennel

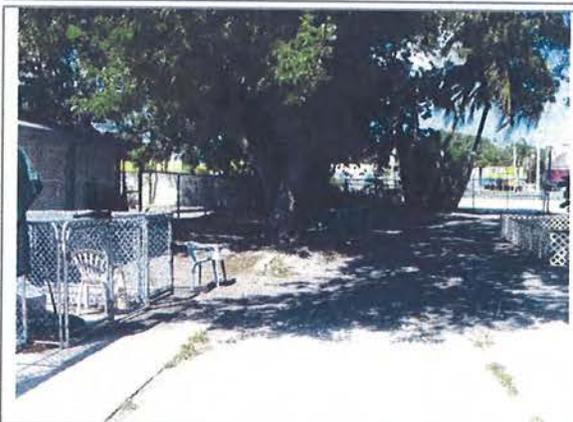
Route to Dog Kennel

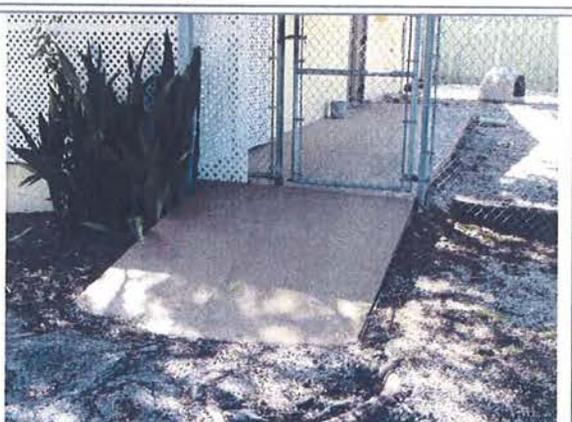
Ramp to Front of Dog Kennel

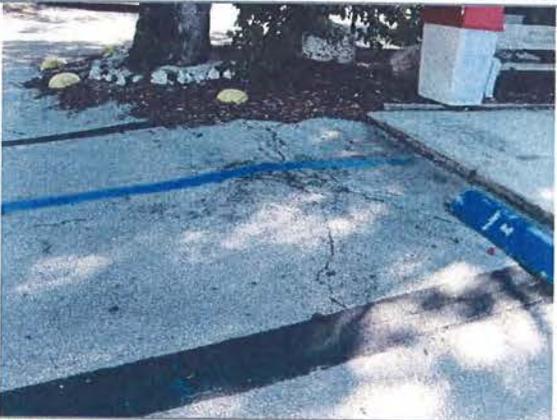
| 3.2 PHOTOS: PARKING AND ENTRANCES | |
|--|---|
| Roots disturbing pavement | Tree blocking HC space |

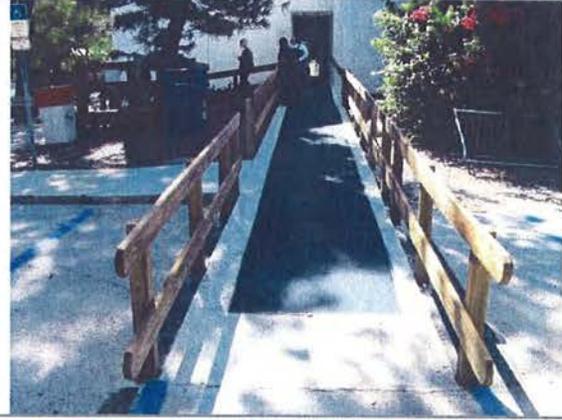
Ramp 1

| Inspection Area: | |
|---|--|
| <p>The accessible ramp from the parking area to the front entrance is not compliant. It is reportedly only used for emergency egress. Access to Courtroom B is through the main building security area.</p> <ul style="list-style-type: none"> ✓ The handrails are at 35" and are continuous. ✓ The ramp is 45" wide. However, ⊗ Handrails are rounded 2x4 wood mounted on a 2x6 and do not provide the proper grasp. They have a rough splintered surface. ⊗ At the bottom of the ramp the 2x4 handrails extend 18" but are not parallel to the ground. ⊗ The railings are mounted to 4x4 posts with no curb on the ramp between the posts. ⊗ The ramp surface is board decking and is rough and uneven. ✓ The slope is correct at 1:12 and cross slope is less than 1:50. The landing mid ramp is correct width and slope. | <p>LS-A55 - This ramp is non-compliant and should be removed and replaced to correct code requirements.</p> |

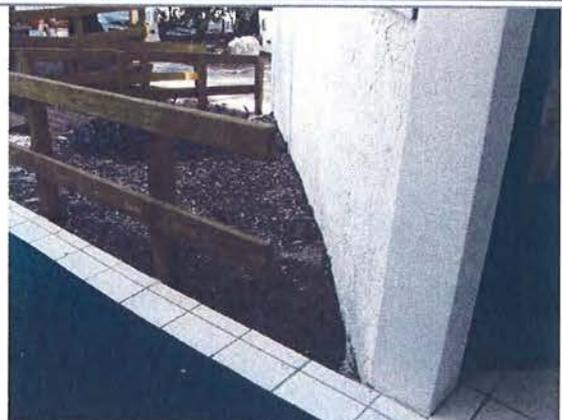
Left side handrail

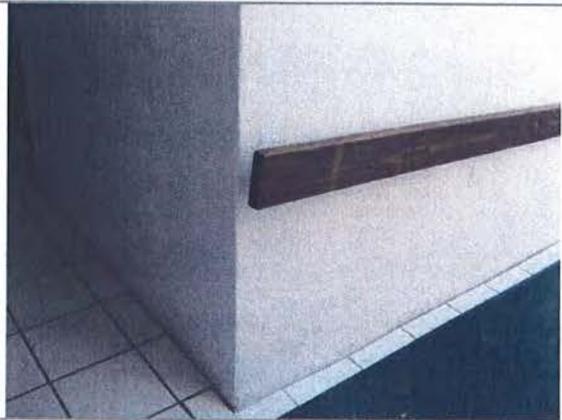
Right side handrail

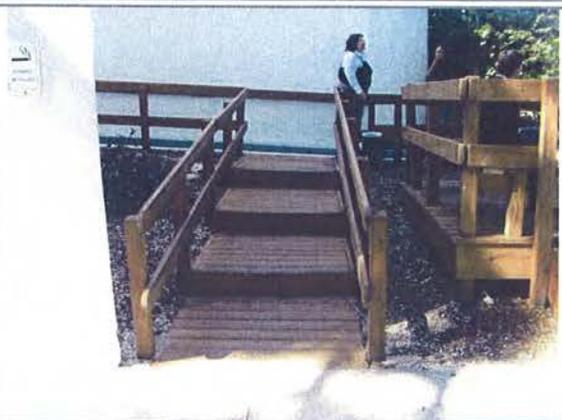
Steps to Ramp

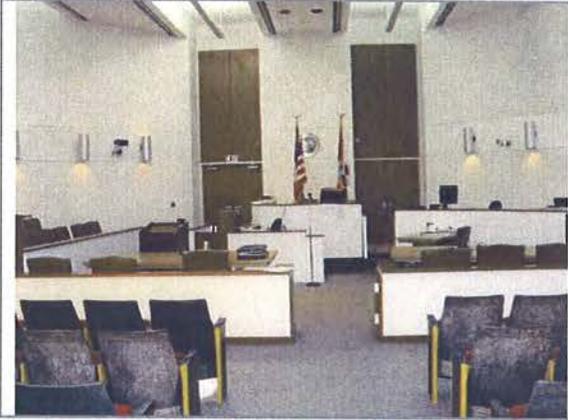
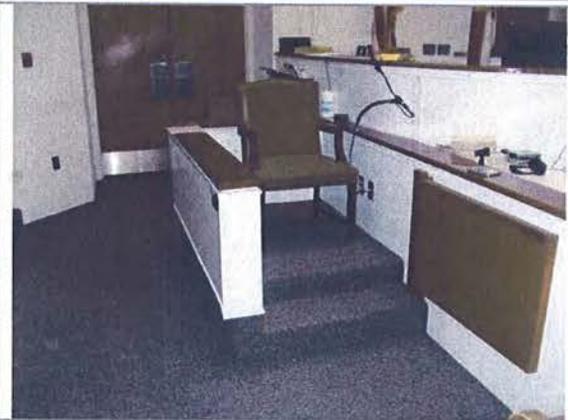
| Courtroom A | Witness Stand |

| ⊗ The Electronic Recorders area requires stepping up who risers and is not accessible. | AS - Make one level, or add ramp per ADAAG 4.3.8 |

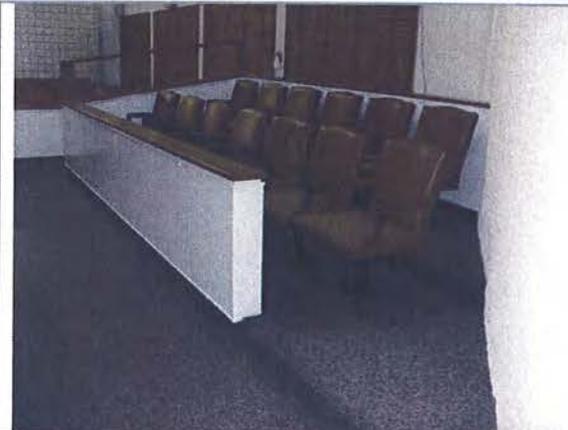
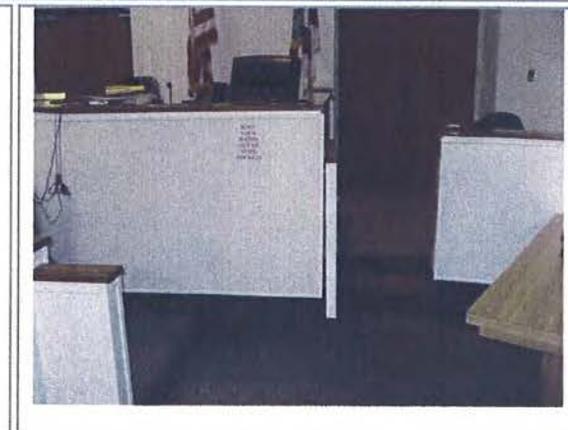
| Jury Box | Judge's Bench |

| <p>The Jury Assembly Room is non compliant:</p> <ul style="list-style-type: none"> ⊗ It is only accessible from a rear door that leads to wood steps and then to steps in the main building. ⊗ There is no restroom. ⊗ There is a riser from the room to the courtroom and then two more risers into the jury box. | <p>T1 - There is no immediate solution to this area within the confines of the structure.</p> |

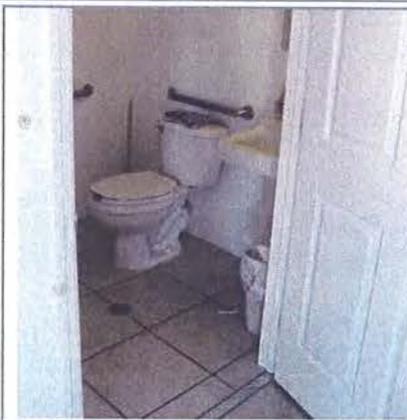
Staff Restroom

RA\$ - Cover pipes in accordance with FACBC 11-4.19.4

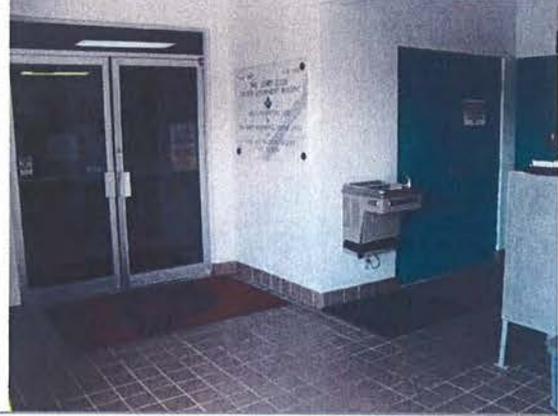
| P15 | Facility: MC Government Center Annex | | | Address: 88800 Overseas Hwy, Plantation Key | Yr. Blt: 1987 | ATP Priority: 1 | No. ECBA044-10090 | | |
|---|---|--|---|--|---|---|---|---|---|
| 0017 | Drinking Fountain by the Foyer - 1st Level | Drinking fountain is not a hi-low unit. | §4.1 | Replace fountain with hi-low unit or install additional unit and mount at 36" (914 mm) max. above the finished floor to the spout outlet (ADAAG Fig. 27). | 11 | \$3,125.71 | 4 | Sub-contractor | |

Entrance to Tax Collector and Fountain

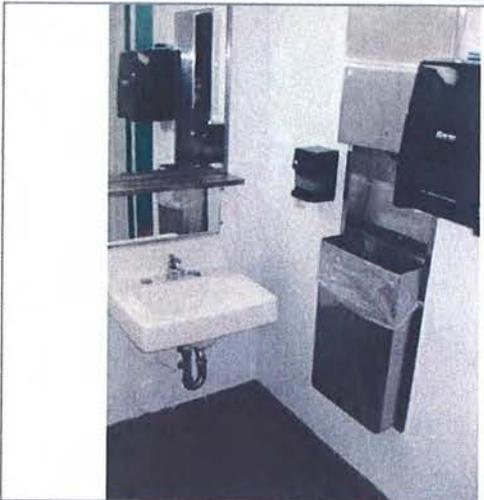
Obstructions in Public Restrooms

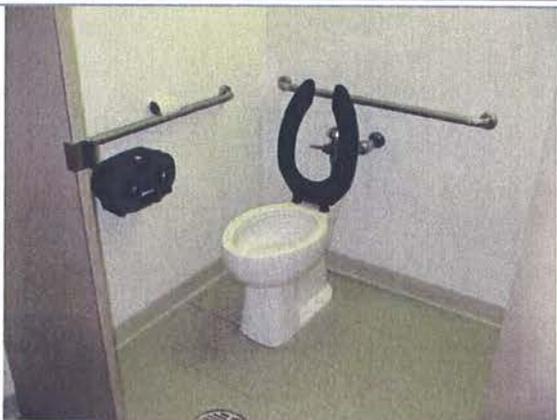
Typical Stall

- ⊗ The stall door does not have a self-closer and the latch is broken.
- ✓ The stall measures 60" x 96".
- ✓ Grab bars are correct.
- ⊗ The toilet is floor mounted 16" oc from the side wall, less than the 18" minimum allowed.
- ⊗ The flush handle is on the far side.

AS - Install self-closer and repair door latch in accordance with FACBC 11-4.17.3.

AS - Install a toilet valve with the flush handle on the approach side in accordance with FACBC 11-4.16.5.

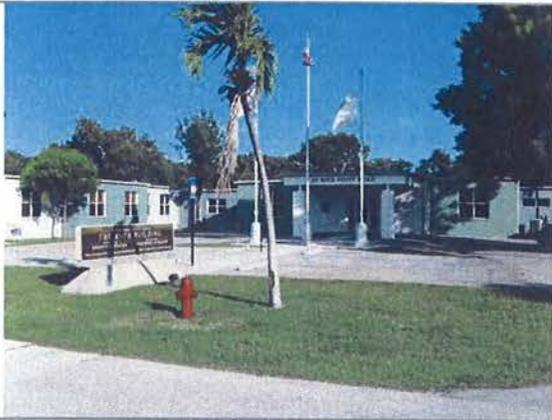
| <p>Main entrance</p> | <p>4 accessible spaces</p> |

| Inspection Area: 4.1 FRONT ENTRANCE AREA 1 | |
|--|---|
| ⊗ The front door is the primary accessible route from the accessible parking areas. It is not clearly marked. The route is not smooth or outlined. | See recommendations in Section 3.1 |

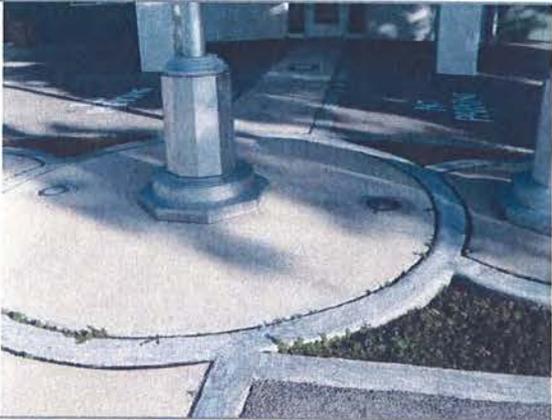
| <p>Accessible route around flag pole</p> | <p>Entrance to front door</p> |

| <p>✓ The accessible route is the proper width at all areas. ✓ The accessible route is marked with white diagonal stripes and outlined in white. It is smooth and without obstructions. However, ⊗ There are route markings that lead to a non-compliant ramp.</p> | <p>LS-RAS -Repaint the parking spaces in accordance with FACBC 11-4.6.3. Indicate the direction to the one accessible ramp.</p> |

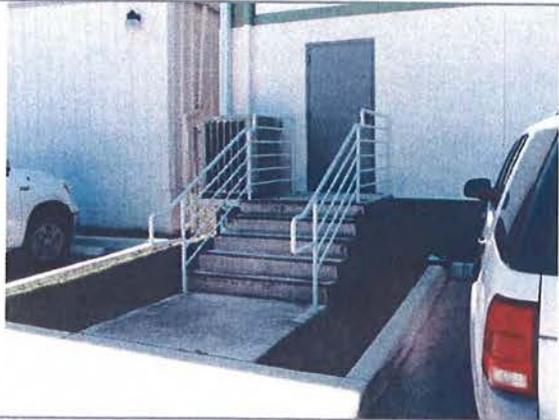
Rear Exit

| 1 Facility: Key Largo Branch Public Library | | | | Address: 101485 Overseas Hwy | | Yr. Blt: 1989 ATP Priority: 1 | | No. ECBA082-10067 | |
|---|---|--|---|--|---|---|---|---|---|
| 0008 | Rear Exit Doors | All rear exit doors have a non-compliant door opening force of more than 8 lbf. | FBC §11-4.13 | Adjust or replace door closer, maintain door hinges to provide an opening force not to exceed 8.5 lbf. | N/A | \$200.00 | 2 | Maintenance | |

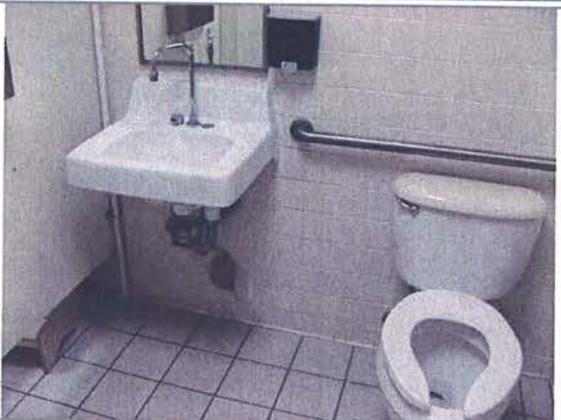
Men's Accessible Stall

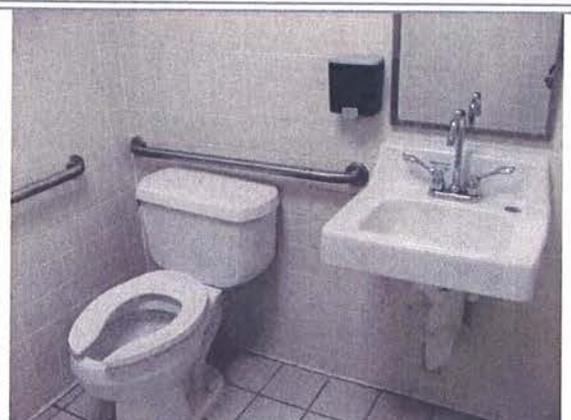
Women's Accessible Stall

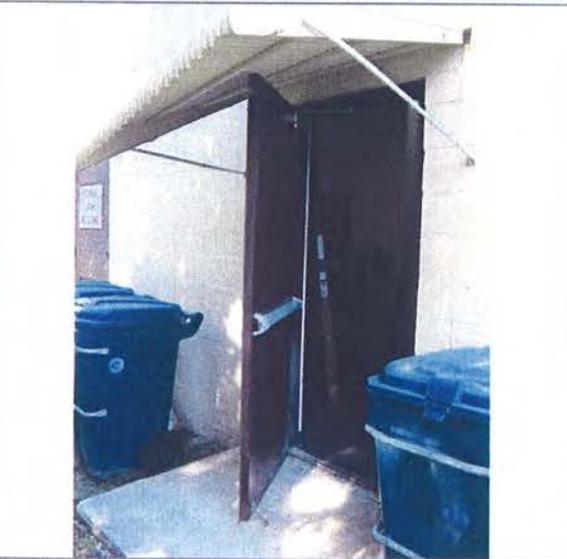
| <p>Employee Restroom This restroom is not accessible. It is measures 60" x 80" and is too small to be made accessible.</p> | <p>An accessible restroom exists in the building that is available to all employees.</p> |

Employee's Restroom

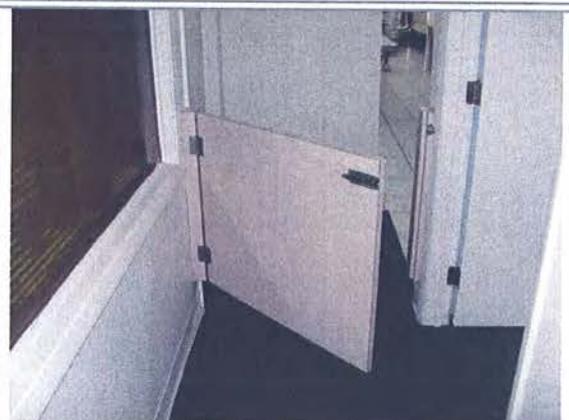
| 1 | Facility: Key Largo Branch Public Library | | | Address: 101485 Overseas Hwy | Yr. Blt: 1989 1 | ATP Priority: | | No. ECBA082-10067 | |
|---|---|--|---|--|---|---|---|---|---|
| 0032 | | Gate from public area to offices requires pinching, tight grasping or turning of the wrist to operate. | §4.27 | Replace or retrofit with system not requiring pinching, tight grasping or turning of the wrist to operate. | 13 | \$131.00 | 2 | Maintenance | |

Gate to Office Area

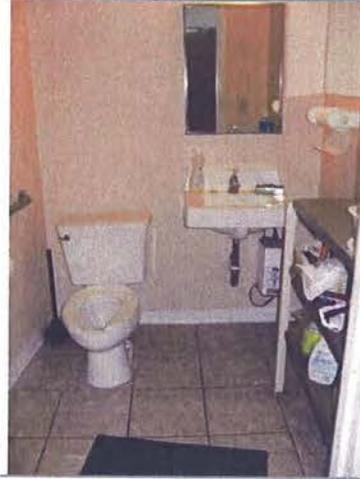
| Observation | Recommendations |
|--|--|
| <p>There is one restroom for employee use only.</p> <ul style="list-style-type: none"> ⊗ The room measures 65" x 67" and is too small to be accessible. ⊗ Door handles are twist knob style. ⊗ There is no signage. ⊗ Grab bars are incorrect. | <p>F\$\$ - Replace this restroom with a new accessible restroom in accordance with the Florida Building Code.</p> |

Non-accessible Restroom

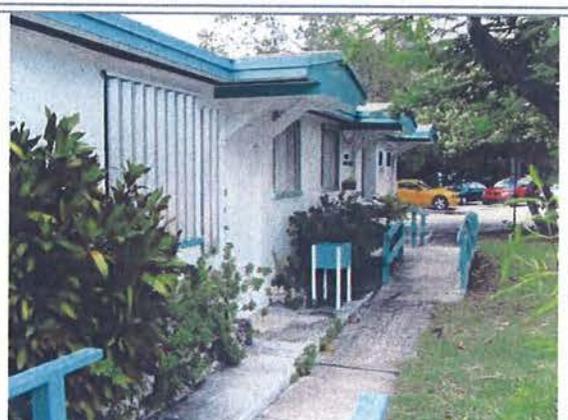
Path to Code Enforcement

| <ul style="list-style-type: none"> ⊗ The ramps leading to the Code Enforcement office are the same as above. ⊗ The far ramp leads to the parking lot. The landing at the bottom is rough and irregular paving. | |

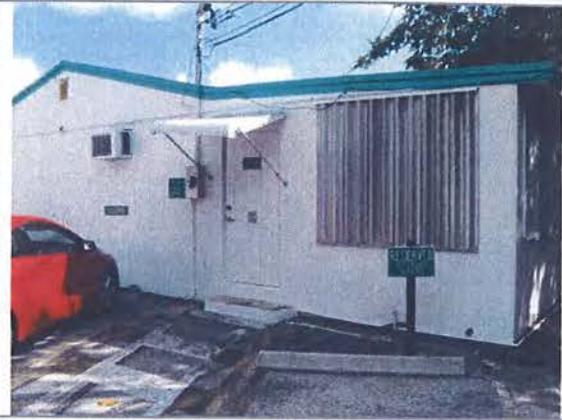
Entrance to the Marion Glass Center

| 1 Facility: Senior Center, Social Services and Code Enforcement | | | | Address: 88820 Overseas Hwy | | Yr. Blt: 1958 ATP Priority: 1 | | No. ECBA112-10107 | |
|--|---|---|---|--|---|---|---|---|---|
| 0043 | | Marion Glass Center permanent room identifying signage does not have Braille characters and is mounted on the door leaf. | §4.30 | Rework/replace existing signage with signage displaying raised characters on non-glare contrasting surface, Grade 2 Braille text of same information and mount on wall adjacent to latch side of door at 60" (1524 mm) above the finished floor to centerline. | 12 | \$149.36 | 2 | Maintenance | |

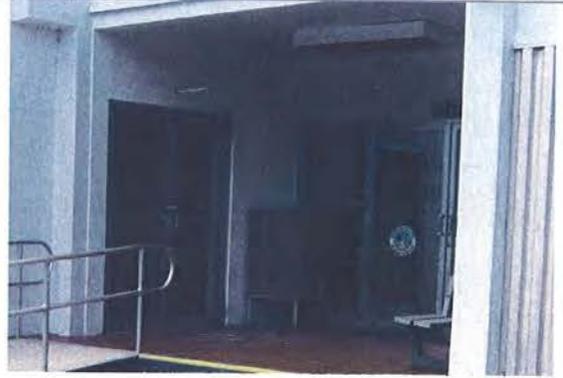
| 5.5 PHOTOS: INTERIORS | |
|---|--|
| Front Entrance Doors | Front Desk |

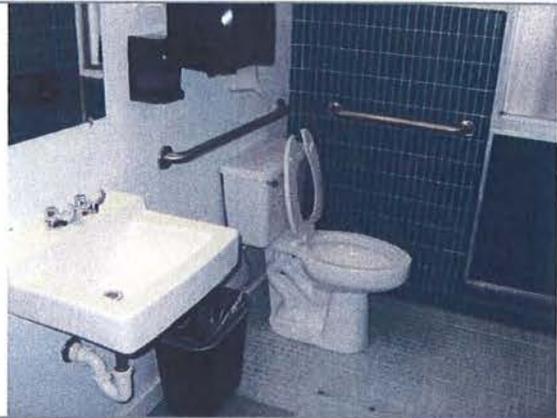
| 3B | Facility: Public Works Facilities | | | Address: 88770 Overseas Hwy | Yr. Blt: 1960 | ATP Priority: 2 | No. ECBA615-10099 | | |
|--|--|---|---|---|---|---|---|---|---|
| 0025 | Public Works Men's Accessible Restroom | Permanent room identifying signage does not have Braille characters and is mounted on the door leaf. | §4.30 | Rework/replace existing signage with signage displaying raised characters on non-glare contrasting surface, Grade 2 Braille text of same information and mount on wall adjacent to latch side of door at 60" (1524 mm) above the finished floor to centerline. | 11 | \$149.36 | 3 | Sub-contractor | |
| 0026 | | Non-compliant door opening force exceeds 5 lbf. | §4.13 | Adjust or replace door closer, maintain door hinges to provide an opening force not to exceed 5 lbf. | 11 | \$50.00 | 3 | Maintenance | |

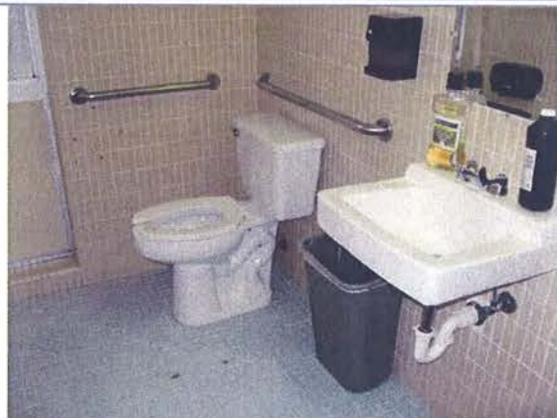
| 3B | Facility: Public Works Facilities | | | Address: 88770 Overseas Hwy | Yr. Blt: 1960 | ATP Priority: 2 | No. ECBA615-10099 | | |
|---|--|---|---|---|---|---|---|---|---|
| 0032 | Public Works Women's Accessible Restroom | Permanent room identifying signage does not have Braille characters and is mounted on the door leaf. | §4.30 | Rework/replace existing signage with signage displaying raised characters on non-glare contrasting surface, Grade 2 Braille text of same information and mount on wall adjacent to latch side of door at 60" (1524 mm) above the finished floor to centerline. | 11 | \$149.36 | 3 | Sub-contractor | |

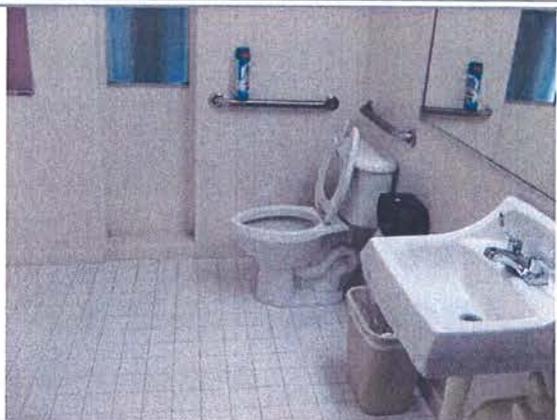
Growth Mgmt. Accessible Restroom

| Inspection Area: 5.4 GROWTH MANAGEMENT RESTROOMS | |
|---|--|
| <p>Unisex Accessible Restroom</p> <ul style="list-style-type: none"> ⊗ There is no signage. ⊗ The door does not have a self-closer. ✓ The door handles are lever style. ✓ There is no hot water so the pipes of the lavatory are not required to be wrapped. ✓ Sink has lever style handles. ⊗ Toilet flush handle is on the far side. ⊗ Grab bar on wall side is only 33" long due to the window. ✓ There is an emergency strobe. ⊗ Toilet paper dispenser is on the rear wall instead of the side wall. ⊗ Hand dryer protrudes more than 4" and is more than 27" above the floor. It forms an obstruction. | <ul style="list-style-type: none"> RAS - Provide proper signage in accordance with FACBC 11-4.6.4. AS - Relocate the toilet paper dispenser to the side wall in accordance with FACBC 11-4.16.6 AS - Install a toilet tank with the flush handle on the wide side in accordance with FACBC 11-4.16.5. AS - Install grab bar on the wall that passes the window in accordance with FACBC 11-4.16.4 AS - Install a paper towel dispenser in accordance with FACBC 11-4.27. |

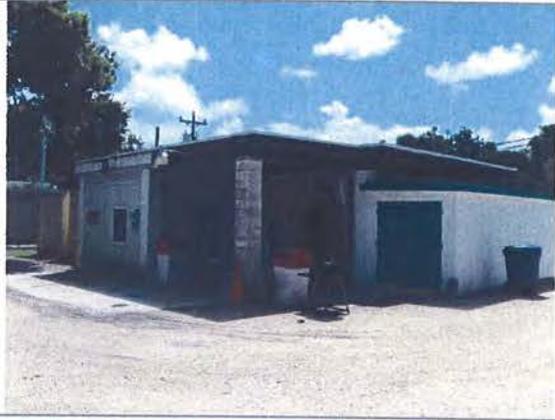
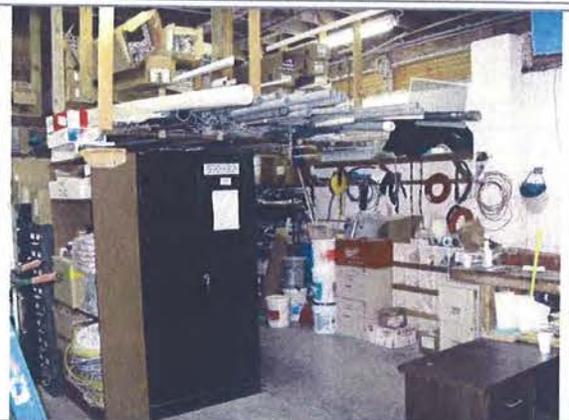
| Storage Building | Interior of Storage Building |

- ✓ The doors to the storage area and the shop are shed style doors that are not compliant but could be operated from a wheelchair.
- ✓ A short tapered ramp is at the entrance to the storage area.

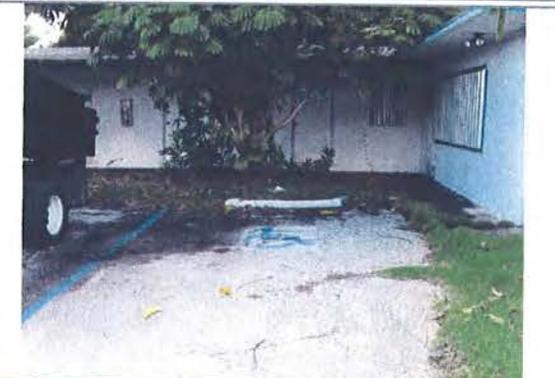
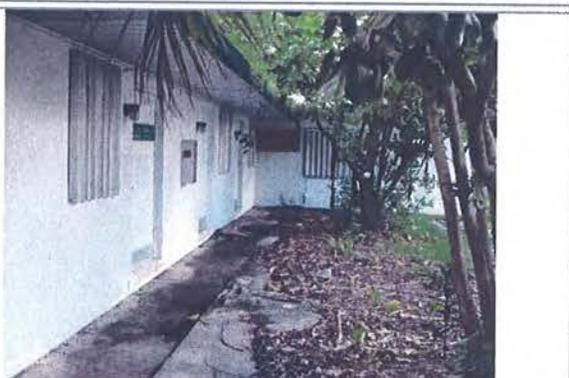
| Accessible Parking | Exterior of Old Public Works Building |

Summary: This building once housed the offices and sign shop for Public Works. Entrance to this building is off Key Heights Drive. It is now used for storage. Due to the use and deteriorated condition of this building, a survey was not conducted of the interior spaces. None of this building is accessible or compliant.

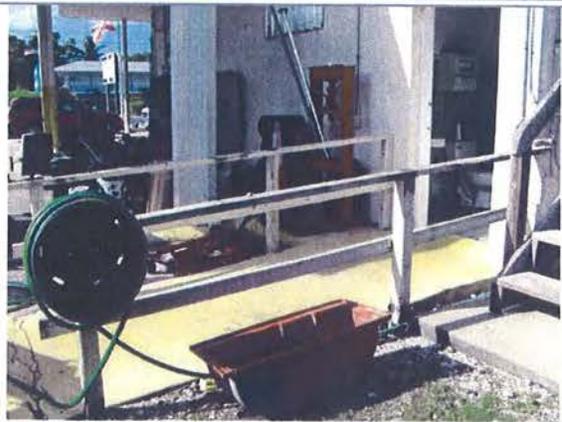
Ramp to Exterior Restroom

| 3B | Facility: Public Works Facilities | | | Address: 88770 Overseas Hwy | Yr. Blt: 1960 | ATP Priority: 2 | No. ECBA615-10099 | | |
|---|---|--|---|---|---|---|---|---|---|
| 0056 | | Ramp from a parking/work area to the public unisex restroom does not have the required handrails. | §4.26 | Replace handrails to provide a 1.25" to 1.5" (32 mm to 38 mm) wide gripping surface (ADAAG Fig. 39). COST INCLUDED ABOVE. | 18 | \$0.00 | 3 | Sub-contractor | |

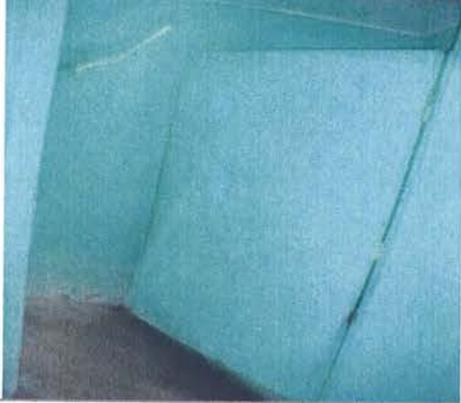
| Facility: Parks and Beaches - Friendship Park | | | | Address: MM 100, Hibiscus Drive | | Yr. Blt: | ATP Priority: 1 | | No. ECBA091-10052 | |
|---|--|---|---|--|---|---|---|---|---|--|
| 0023 | | Stall door hardware requires pinching, tight grasping or turning of the wrist to operate. | §4.27 | Replace or retrofit with system not requiring pinching, tight grasping or turning of the wrist to operate. | 14 | \$131.00 | 3 | Sub-contractor | | |

| Women's Stall Door (Ballpark) | Women's Restroom Sink (Beach) |

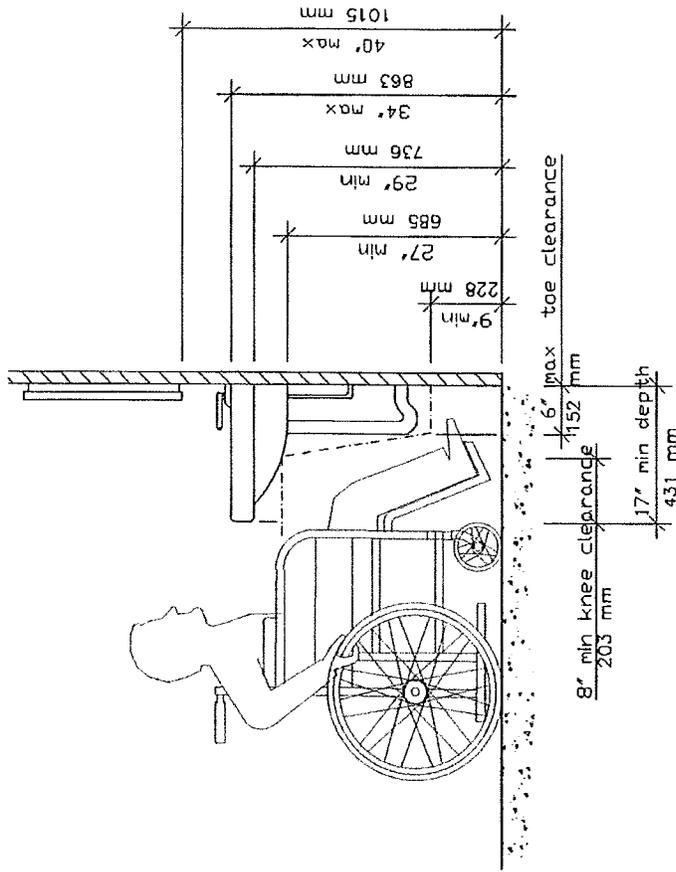
FIG. 31

| Facility: The Roth Building | | | | Address: 50 Highpoint Road, Plantation key | Yr. Blt: 1970 | ATP Priority: 1 | No. ECBA613-10104 | | |
|---|---|--|---|---|---|---|---|---|---|
| 0018 | Private Restroom | Lavatory mirror is mounted at 42" (1067 mm) above the finished floor to bottom edge of its reflecting surface. | §4.19 | Lower lavatory mirror to 40" (1016 mm) max. above the finished floor to bottom edge of its reflecting surface (ADAAG Fig. 31). | 20 | \$131.00 | 3 | Maintenance | |

| Facility: Monroe County Detention Facility - Plantation Key | | | | Address: Highpoint Road. | Yr. Blt. N/A | ATP Priority 2 | No. ECBA044-10037 | | |
|--|---|--|---|--|---|---|---|---|---|
| 0033 | | Lavatory mirror is mounted at 46" (1168 mm) above the finished floor to bottom edge of its reflecting surface. | §4.19 | Lower lavatory mirror to 40" (1016 mm) max. above the finished floor to bottom edge of its reflecting surface (ADAAG Fig. 31). | 13 | \$131.00 | 3 | Maintenance | |

| 3B | Facility: Public Works Facilities | | | Address: 88770 Overseas Hwy | Yr. Blt: 1960 | ATP Priority: 2 | No. ECBA615-10099 | | |
|---|--|---|---|---|---|---|---|---|---|
| 0031 | | Lavatory mirror is mounted over 40" (1016 mm) above the finished floor to bottom edge of its reflecting surface. | §4.19 | Lower lavatory mirror to 40" (1016 mm) max. above the finished floor to bottom edge of its reflecting surface (ADAAG Fig. 31). | 11 | \$131.00 | 3 | Maintenance | |
| 0037 | | Lavatory mirror is mounted over 40" (1016 mm) above the finished floor to bottom edge of its reflecting surface. | §4.19 | Lower lavatory mirror to 40" (1016 mm) max. above the finished floor to bottom edge of its reflecting surface (ADAAG Fig. 31). | 11 | \$131.00 | 3 | Maintenance | |

| 3B | Facility: Public Works Facilities | | | Address: 88770 Overseas Hwy | Yr. Blt: 1960 | ATP Priority: 2 | No. ECBA615-10099 | | |
|---|---|--|---|---|---|---|---|---|---|
| 0062 | | Lavatory mirror is mounted over 40" (1016 mm) above the finished floor to bottom edge of its reflecting surface. | §4.19 | Lower lavatory mirror to 40" (1016 mm) max. above the finished floor to bottom edge of its reflecting surface (ADAAG Fig. 31). | 18 | \$131.00 | 3 | Maintenance | |

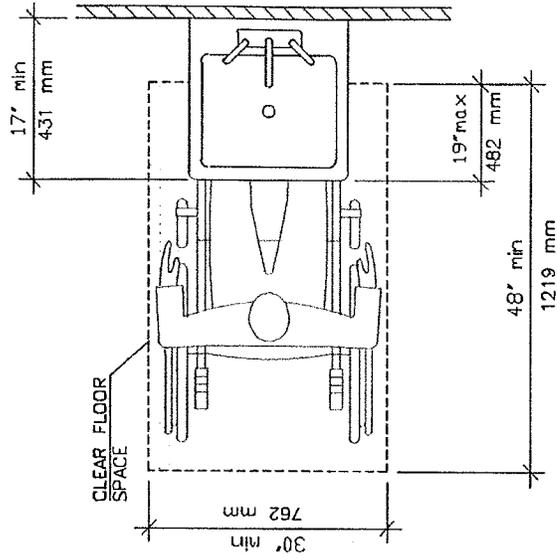
FIG. 32

| 1 | Facility: Key Largo Branch Public Library | | | Address: 101485 Overseas Hwy | Yr. Blt: 1989 | ATP Priority: | | No. ECBA082-10067 | |
|---|---|--|---|--|---|---|---|---|---|
| 0027 | | Door swings into lavatory clear floor space. | §4.22 | Reverse door swing or reconfigure fixtures and/or offset partitions to provide a 30" by 48" (762 mm by 1219 mm) min. lavatory clear floor space (ADAAG Fig. 32). | 11 | \$898.74 | 3 | Sub-contractor | |

| Facility: Monroe County Detention Facility - Plantation Key | | | | Address: Highpoint Road. | | Yr. Blt. N/A ATP Priority 2 | | No. ECBA044-10037 | |
|---|---|--|---|---|---|---|---|---|---|
| 0027 | | Water closet encroaches into lavatory clear floor space. | §4.22 | Relocate lavatory or reconfigure fixtures and/or offset partitions to provide a 30" by 48" (762 mm by 1219 mm) min. lavatory clear floor space (ADAAG Fig. 32). | 12 | \$500.00 | 3 | A/E | |

| Facility: Monroe County Detention Facility - Plantation Key | | | | Address: Highpoint Road. | Yr. Blt. N/A | ATP Priority 2 | No. ECBA044-10037 | | |
|--|---|--|---|--|---|---|---|---|---|
| 0030 | | Door swings into lavatory clear floor space and does not have the maneuvering clearance on the pull side of the door.. | §4.22 | Reverse door swing or reconfigure fixtures and/or offset partitions to provide a 30" by 48" (762 mm by 1219 mm) min. lavatory clear floor space (ADAAG Fig. 32). | 13 | \$898.74 | 3 | A/E | |

| Facility: Parks and Beaches - Friendship Park | | | | Address: MM 100, Hibiscus Drive | | Yr. Blt: ATP Priority: 1 | | No. ECBA091-10052 | |
|---|--|--|---|--|---|---|---|---|---|
| 0025 | | Stall partition encroaches over lavatory clear floor space. | §4.19 | Relocate lavatory to provide a 30" by 48" (762 mm by 1219 mm) min. lavatory clear floor space (ADAAG Fig. 32). | 14 | \$650.00 | 3 | Sub-contractor | |

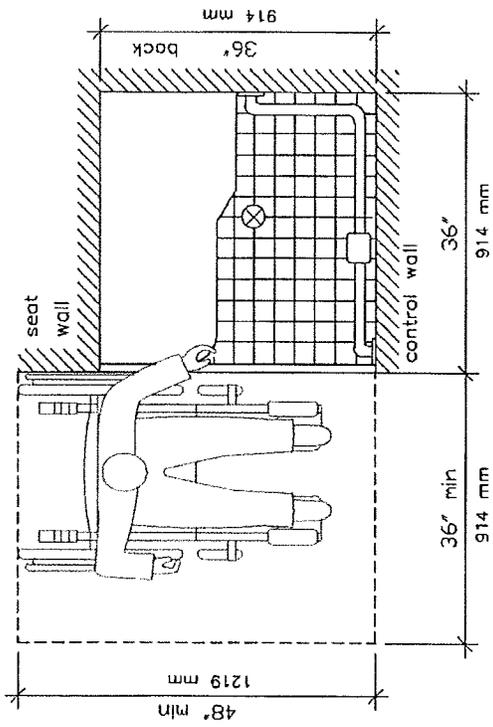
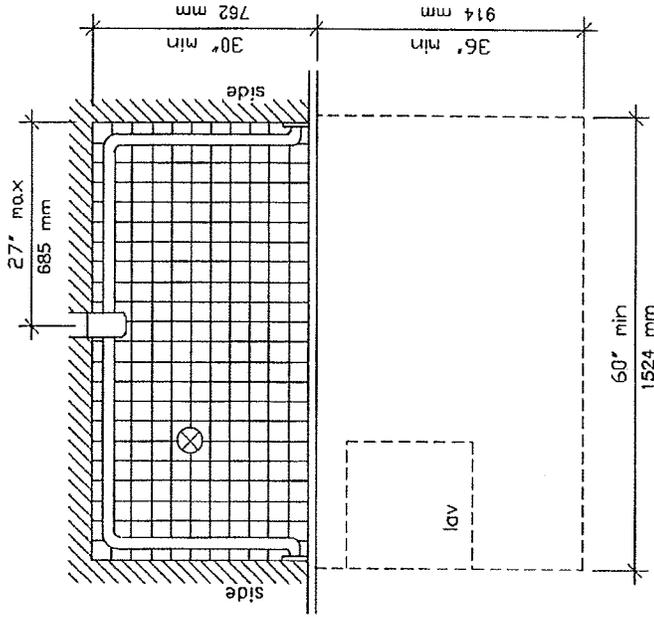
| 3B | Facility: Public Works Facilities | | | Address: 88770 Overseas Hwy | Yr. Blt: 1960 | ATP Priority: 2 | No. ECBA615-10099 | | |
|---|---|--|---|---|---|---|---|---|---|
| 0072 | | Transfer shower curb is too high. | §4.21 | Reconfigure room's fixtures and/or offset partitions to provide a 30" by 60" (762 mm by 1524 mm) min. shower stall with the required 36" by 60" (914 mm by 1524 mm) min. clear floor space without curb (ADAAG Fig. 35). | 19 | \$5,645.00 | 3 | Sub-contractor | |
