Americans with Disabilities Act Transition Plan Middle Keys

Volume 2 of 4

Monroe County

October 29, 2010

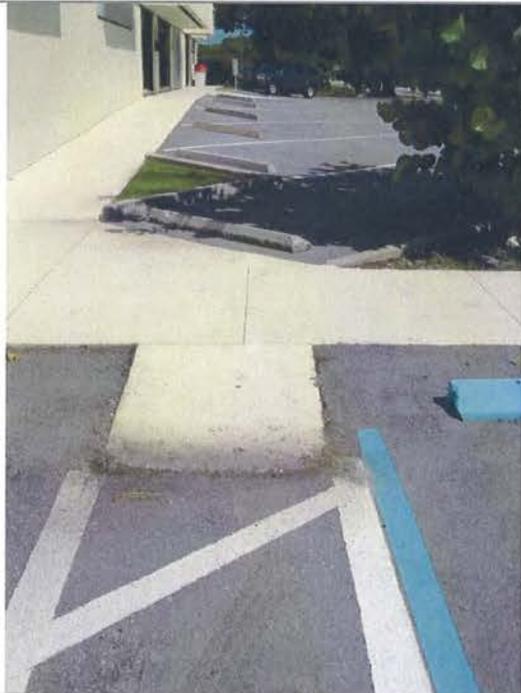
Non-Compliant Curb Ramp (02)

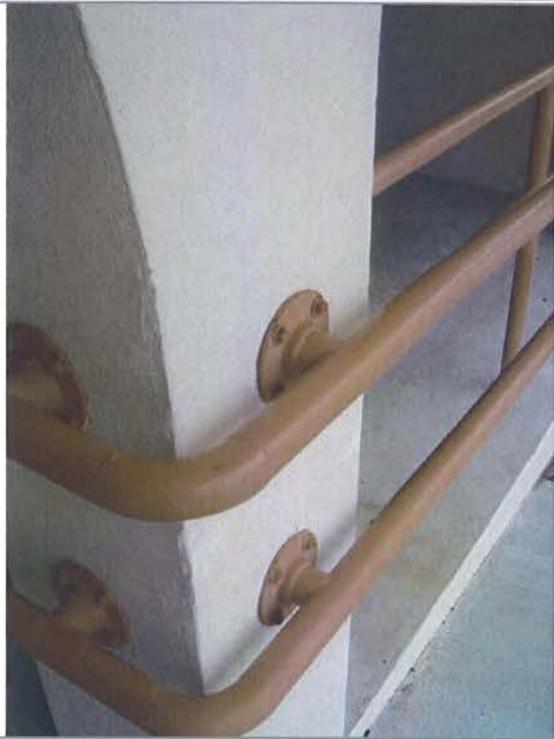
Non-Continuous Handrails

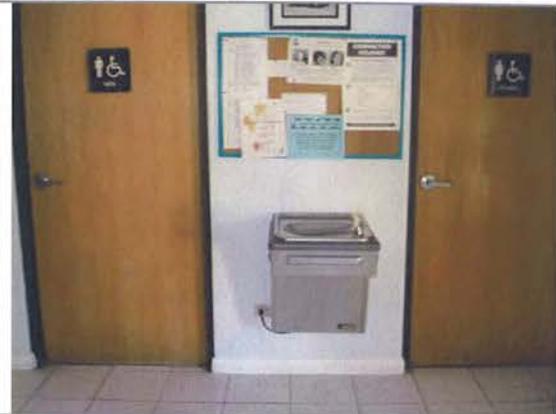
Item No.	Area/ Room	Physical Obstacle	ADA Code	Method/ Proposed Correction	Photo Page	Cost	Schedule/ Priority	Official Responsible	Status	03/27/10	
0030	Drinking Fountain at Waiting	Drinking fountain spout outlet (orifice height) is mounted at 38" (965 mm) above the finished floor.	§4.1	Replace fountain with hi-lo unit or install additional unit and mount at 36" (914 mm) max. above the finished floor to the spout outlet (ADAAG Fig. 27).	21	\$3,137.43	4	Sub-contractor			
0031	Drinking Fountain at Corridor	Drinking fountain spout outlet (orifice height) is mounted at 38" (965 mm) above the finished floor.	§4.1	Replace fountain with hi-lo unit or install additional unit and mount at 36" (914 mm) max. above the finished floor to the spout outlet (ADAAG Fig. 27).	21	\$3,137.43	4	Sub-contractor			
0032	Waiting Room	Counter is mounted at 42" (1067 mm) above the finished floor to top.	§7.2	Rework (cut out) a portion of the main counter 36" (914 mm) max. above the finished floor to top and 36" (914 mm) min. in length.	19	\$850.00	4	Sub-contractor

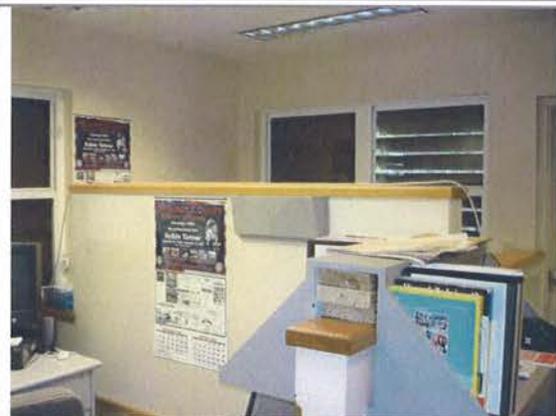
0033	Workstations at Detectives Area	Half-height partition encroaches into passage width, reducing it to less than 36" (914 mm).	§4.2	Relocate half-height partition to provide a 36" (914 mm) min. clear width continuously (ADAAG Fig. 1 and Fig. 24 e).	19	\$1,008.00	4	Sub-contractor			
0034	Corridor at Kitchenette	Corridor is 33" (838 mm) wide.	§4.2	Rework to provide a 36" (914 mm) min. clear width continuously (ADAAG Fig. 1 and Fig. 24 e).	21	\$2,500.00	2	A/E			
0035	Conference Room	Permanent room identifying has a non-compliant signage.	§4.30	Rework/replace existing signage with signage displaying raised characters on non-glare contrasting surface, Grade 2 Braille text of same information and mount on wall adjacent to latch side of door at 60" (1524 mm) above the finished floor to centerline.	20	\$149.36	2	Maintenance			
*0036	Emergency Exit Door at Clerks Area	The door does not have the required maneuvering clearance on the pull side of the door.	§4.13	Rework door side partition to provide the required 18" (457 mm) min. maneuvering clearance on the pull side of the door beyond the latch side and 60" (1524 mm) min. deep clear floor area (ADAAG Fig. 25).	20	\$1,150.00	2	A/E

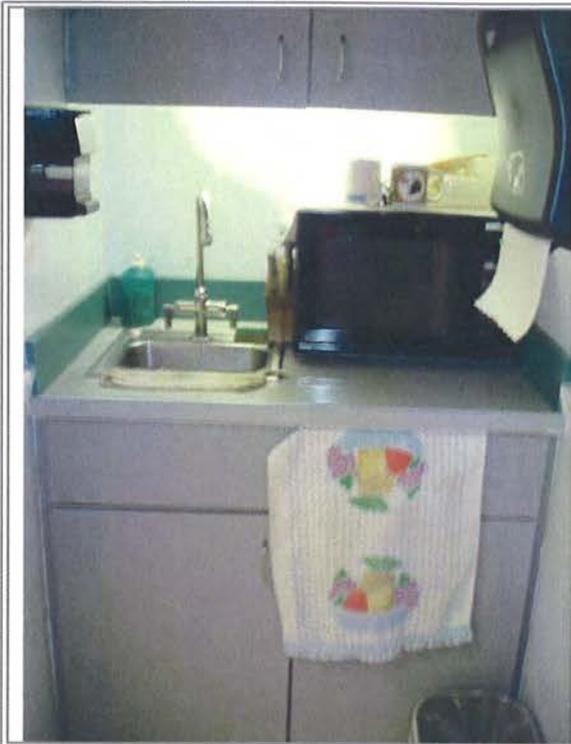
6.2 SHERIFF SUBSTATION INTERIOR ROUTES											
0028	Kitchenette	Sink does not have the required knee clearance.	§4.24	Rework sink to provide a knee clearance of at least 27" (685 mm) high, 30" (762 mm) wide and 19" (482 mm) deep.	21	\$1,200.00	4	Maintenance			
0029		Kitchen counter is mounted at 36" (914 mm) above the finished floor to the top.	§4.32	Replace counter to be mounted at 28" to 34" (711 mm to 863 mm) above the finished to the top.	21	N/A	N/A	N/A

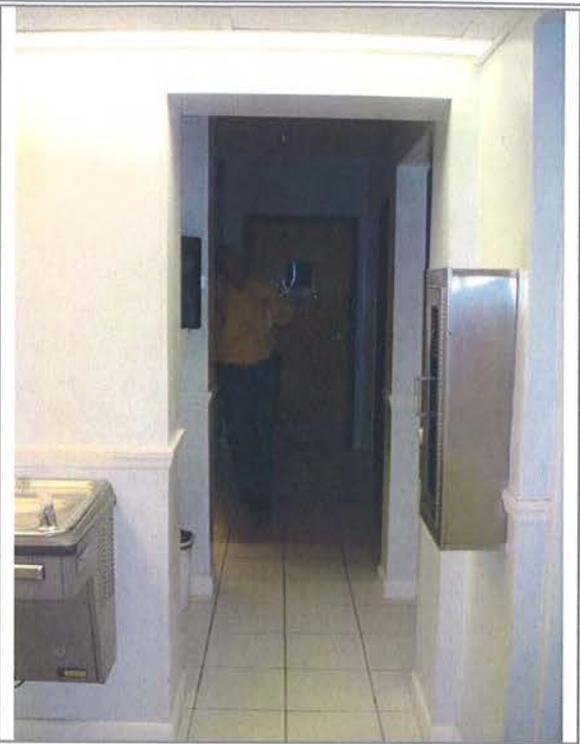
Reduced Corridor width at Kitchenette

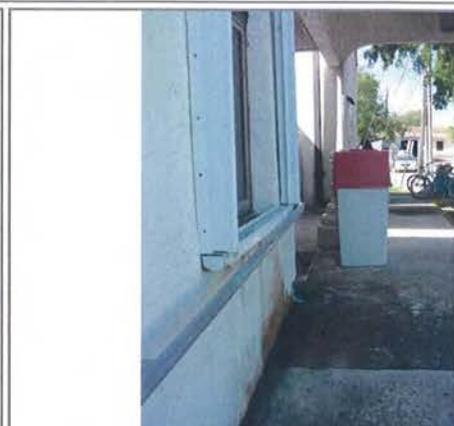
Handrail Obstruction at Storm Shutter

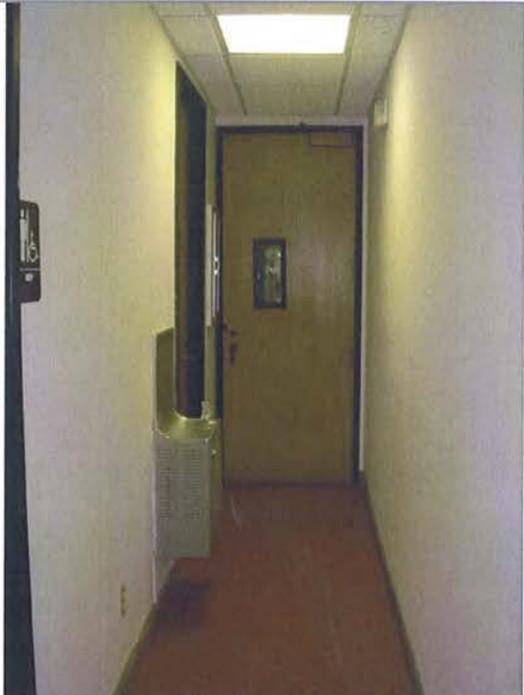
Drinking Fountain adjacent to Restrooms

5.2 Interior Routes									
0030	Restroom Vestibule	Drinking fountain spout outlet (orifice height) is mounted at 33" (838 mm) above the finished floor.	§4.1	Replace fountain with hi-lo unit or install paper cup dispenser and mount at the required reach range allowed for approach provided, for people who have difficulty bending or stooping.	15	\$110.00	4	Maintenance	
0031		Drinking fountain water flow is 3" (76 mm) high.	§4.15	Adjust to provide a flow of water at least 4" (101 mm) high so as to allow the insertion of a cup under it.	15	\$80.50	4	Sub-contractor	
0032		Drinking fountain control requires more than 5 lbf. to operate.	§4.27	Adjust drinking fountain control and operating mechanism to operate with a force no greater than 5 lbf (22.2 N).	15	\$50.00	4	Maintenance	
0033	Corridor Adjacent to Main Stacks	The drinking fountain does not have a clear floor space.	§4.2	Provide a 30" by 48" (762 mm by 1219 mm) min. wheelchair clear floor space for the drinking fountain (ADAAG Fig. 27). (RECESS REQUIRED)	15	\$750.00	2	Maintenance

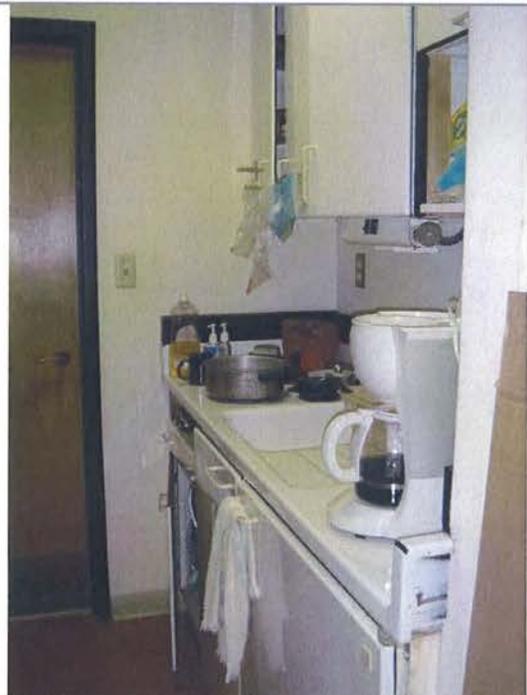
0044	Kitchenette	Counters tops are mounted at 36" (914 mm) above the finished floor to the top.	§4.32	Replace counter to provide at least one accessible counter mounted at 28" to 34" (711 mm to 863 mm) above the finished to the top.	15	\$372.14	4	Sub-contractor	
0045		Lavatory knob-type faucet requires pinching and tight grasping to operate.	§4.19	Replace or retrofit lavatory controls with paddle-operated, push-type or electronically-controlled mechanism.	15	\$200.00	3	Maintenance	
0046	Meeting Room	The Emergency Exit door does not have permanent room identifying signage provided.	§4.30	Provide signage displaying raised characters on non-glare contrasting surface, Grade 2 Braille text of same information and mount on wall adjacent to latch side of door at 60" (1524 mm) above the finished floor to centerline.	16	\$149.36	2	Maintenance	
0047		The maneuvering clearance of the door is non-compliant	§4.13	Rework door side partition to provide the required maneuvering clearance in compliance with ADAAG Fig. 25.	16	\$1,150.00	2	A/E

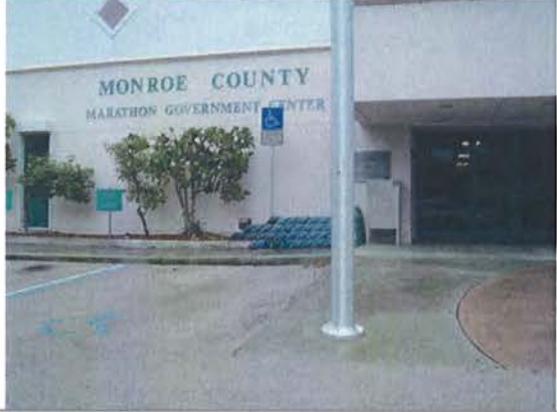
Sidewalk at Flagpole	Non-compliant Running Slopes

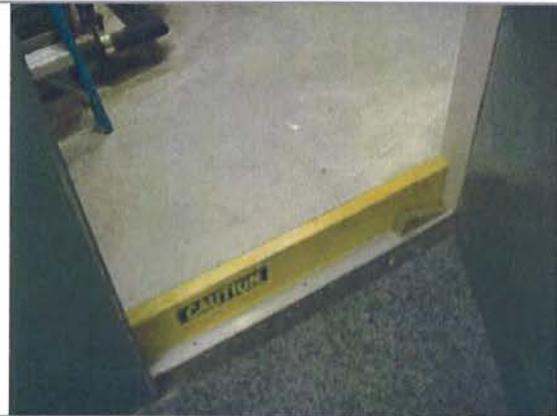
Water Stop at Mechanical Room Door

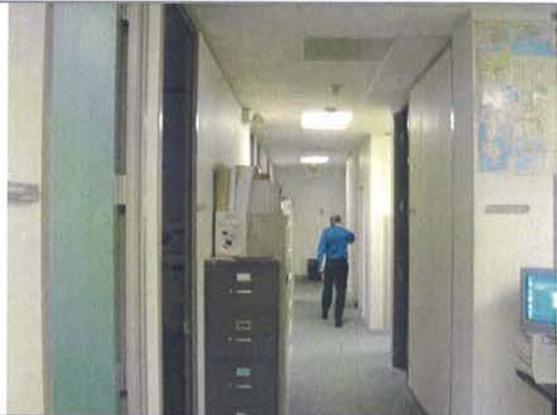
Non-compliant Maneuvering Clearances

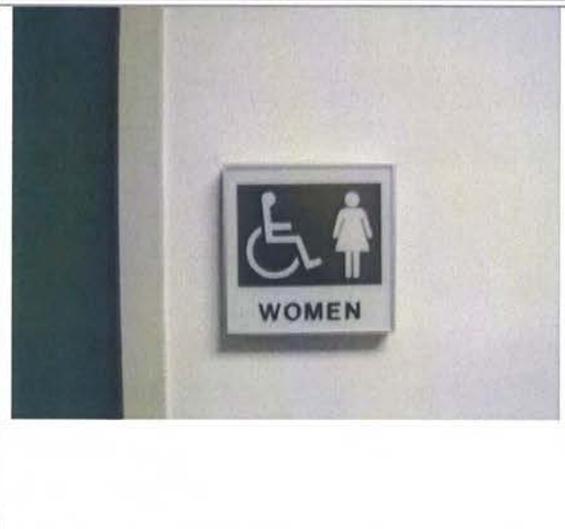
Non-compliant Signage

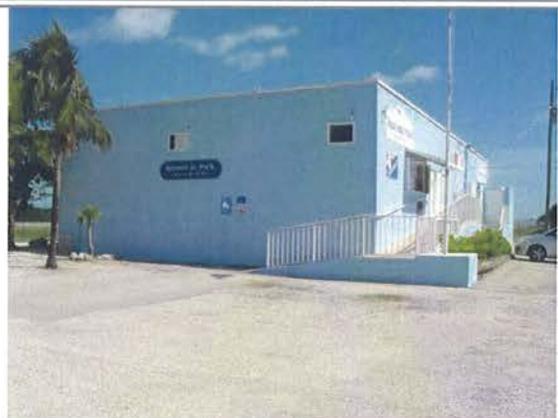
Accessible Parking and Entrance Ramp

Ramp handrails do not have extensions.	§4.8	Provide handrails extensions 12" (304 mm) min. beyond the top and bottom of the ramp segment (ADAAG Fig. 17). INCLUDED	6	\$0.00	1	Sub-contractor	
		The mid landing is less than the required 60" x 60" minimum at a change in direction.	§4.8	Rework ramp to provide 60" (1524 mm) min. long landings for runs rising over 30" (762 mm) (ADAAG Fig. 16). INCLUDED	6	\$0.00	1	A/E	
0003	Main Entrance	There is no signage at the main entrance.	§4.30	Rework/replace existing signage with signage displaying raised characters on non-glare contrasting surface, Grade 2 Braille text of same information and mount on wall adjacent to latch side of door at 60" (1524 mm) above the finished floor to centerline.	6	\$149.36	2	Maintenance	
		Non-compliant knob-type door hardware, requiring grasping and turning of the wrist to operate.	§4.13	Replace knob-type door hardware with lever or loose grip pull handle.	6	\$291.64	2	Maintenance

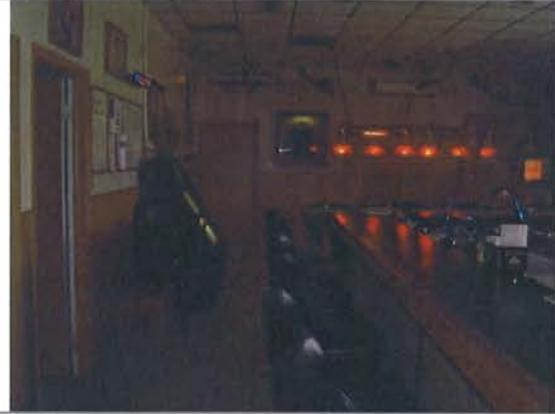
0004	Bar	Accessible seating is not provided at the bar or accessory tables.	§7.2	Rework (cut out) a portion of the main bar 36" (914 mm) max. above the finished floor to top and 36" (914 mm)	10	\$640.44	4	A/E	
0005	Meeting Room	Door from the bar has a non-compliant knob-type door hardware, requiring grasping and turning of the wrist to operate.	§4.13	Replace knob-type door hardware with lever or loose grip pull handle.	10	\$291.64	2	Maintenance

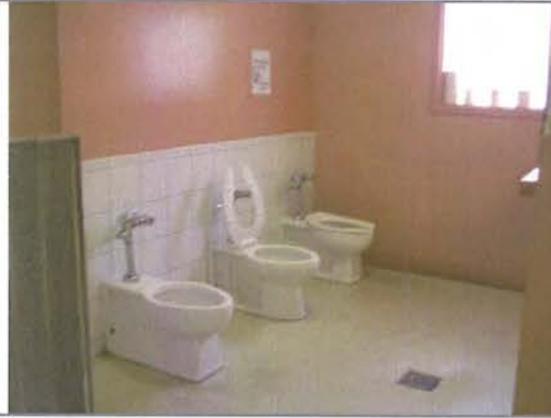
Inspection Area: 5.3 RESTROOMS	
Observation	Recommendations
<p>Restroom 1 This restroom is for employee use only. ⊗ It is not accessible in any way.</p> <p>Dorm A & B Restroom and Shower Area The shower area is not accessible: ⊗ A 6" curb connects the shower area with the adjacent floor area and an internal curb divides the shower area.</p> <p>The lavatory area is not accessible: ⊗ The lavatory counters are mounted at 36" above finish floor. ⊗ Knee clearances are not provided at the lavatories.</p> <p>The toilet area is not accessible: ⊗ Grab bars are not provided.</p>	<p>TI - Due to the building constraints, it is technically infeasible to rebuild the restroom in accordance with the Florida Building Code 2007.</p> <p>AS - Rebuild the shower area to provide an accessible transition from the shower to the adjacent floor area in accordance with FACBC 11-4.21.</p> <p>AS - Provide an accessible lavatory in accordance with FACBC 11-4.19. AS - Install compliant plumbing and accessory fixtures in accordance with FACBC 11-4.</p>

Toilets Dorm A

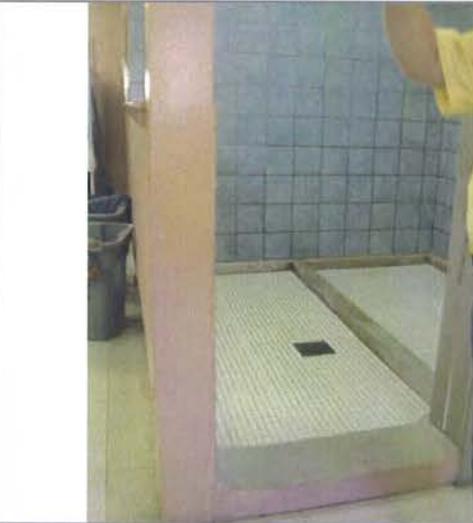
Showers Dorm A

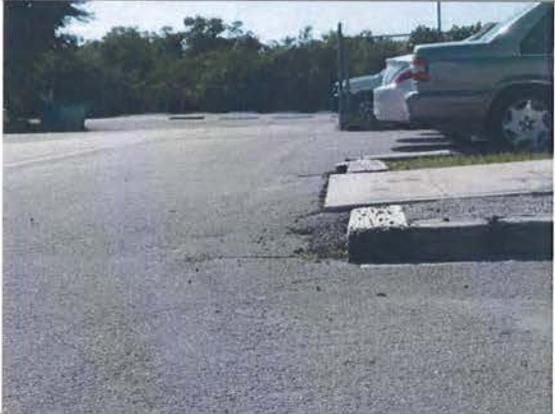
Accessible Parking Area	Steep ramp to sidewalk

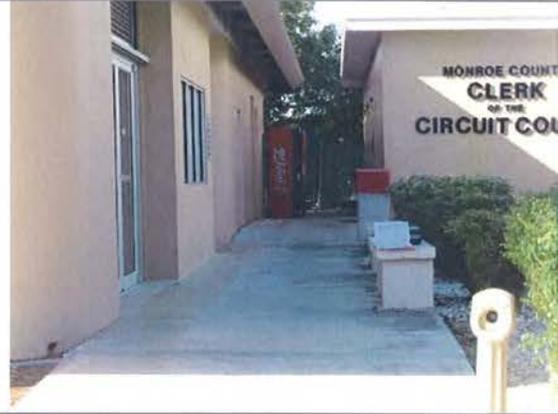
4.2 Courthouse Main Entrance Area 1									
0004	Main Entrance	Non-compliant door opening force of 15 lbf.	FBC§4.13	Adjust or replace door closer, maintain door hinges to provide an opening force not to exceed 8.5 lbf.	9	\$50.00	2	Maintenance	
0005	Security Area	Non-compliant door opening force of 15 lbf.	§4.13	Adjust or replace door closer, maintain door hinges to provide an opening force not to exceed 5 lbf.	9	\$50.00	2	Maintenance

Main Entrance Door

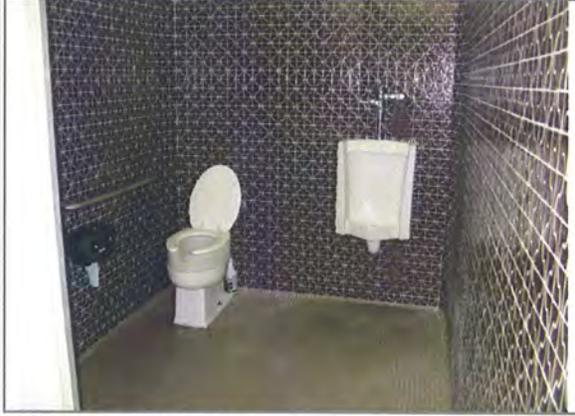
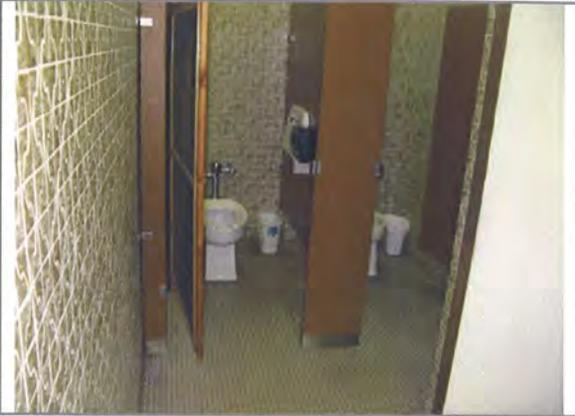
Men's Public Restroom	Women's Public Restroom

Observation	Recommendations
There are compliant signs indicating the restrooms with raised letters and Braille. However,	RA\$ - Relocate the signs to the latch side of the door, centered at 60" high.

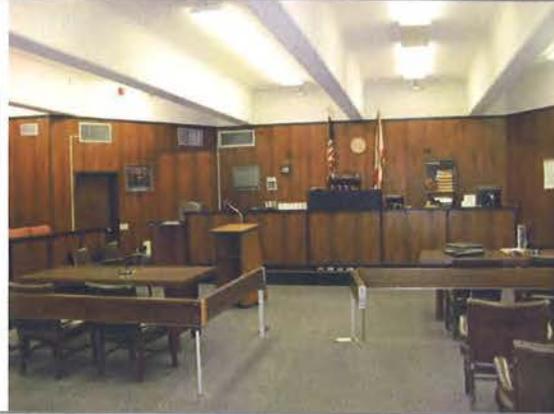
Courtroom

Inspection Area:	
6.1 COURTROOM AREA 3	
Observation	Recommendations
The courtroom is approximately 40' x 43', or 1700 sf.	
<ul style="list-style-type: none"> ⊗ Double doors from the hall to courtroom are each 33" clear, require 15 lbs to open and close >3 seconds. ⊗ Signage is high up and large print. There are no signs in Braille. 	<ul style="list-style-type: none"> RAS - Adjust the door in accordance with FACBC 11-4.13.11 AS - Provide proper signage in accordance with FACBC 11-4.30.6.
<p>There are 49 fixed seats and no HC seating area.</p> <ul style="list-style-type: none"> ⊗ There is room for wheelchairs, but there is no identified seating area requiring the wheelchair to be in the hall or rear areas. ✓ There are accessible routes throughout the courtroom. ✓ Doors are acceptable. ✓ There are speakers mounted on the walls, emergency lighting, and a fire alarm with strobe. Fire pull and fire extinguishers are on the rear wall. All are acceptable. ⊗ The bar gate open toward the viewer's area and has 36" clear. It would not be possible to open from a wheelchair. ⊗ There are no assisted listening devices. 	<ul style="list-style-type: none"> RAS - Provide wheelchair location in accordance with FACBC 11-4.1.3. AS - Reconfigure bar gate to allow opening from a wheelchair. AS - Install listening devices.

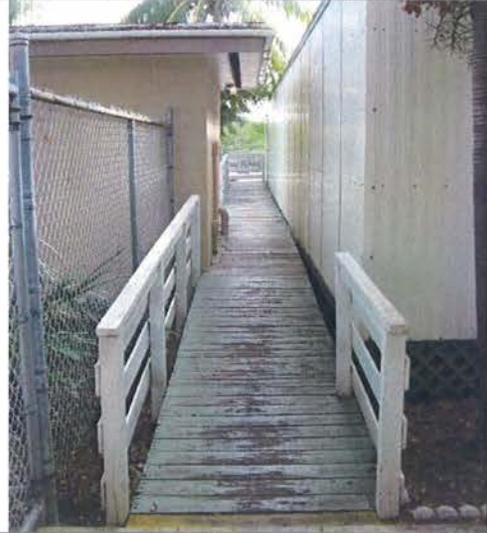
Entrance to Drug Court

Observation	Recommendations
<ul style="list-style-type: none"> ⊗ There is no accessible route because of the door from the courtroom. ⊗ There is no accessible restroom. ⊗ There is no fire alarm. ⊗ There is no accessible emergency exit. ✓ The table is acceptable. 	<ul style="list-style-type: none"> RAS - Adjust the door in accordance with FACBC 11-4.13.11 FSS - Provide accessible restroom that is available to judge and jury with separate entrances. LSS - Reconfigure exit doors through security waiting room. LSS - Add fire alarms with strobe.

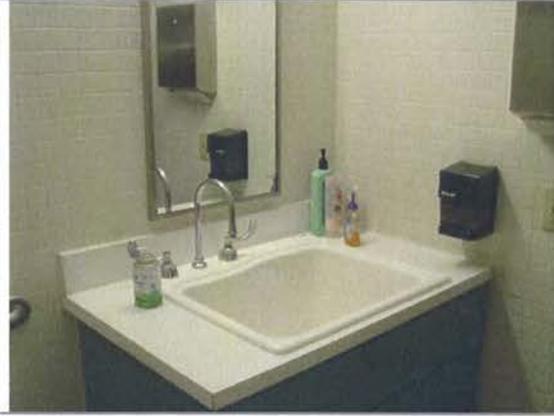
0031	Employee Restroom	Permanent room identifying signage does not have hardware	\$4.30	Rework/replace existing signage with signage displaying raised characters on non-glare contrasting surface, Grade 2 Braille text of same information and mount on wall adjacent to latch side of door at 60" (1524 mm) above the finished floor to centerline.	11	\$149.36	2	Maintenance	
0032		Non-compliant door opening force of greater than 5 lbf.	\$4.13	Adjust or replace door closer, maintain door hinges to provide an opening force not to exceed 5 lbf.	11	\$50.00	2	Maintenance	
0033		No emergency visual notification device in room.	\$4.28	Install a visual alarm at 80" (2032 mm) above the highest floor level within the space or 6" (152 mm) below the ceiling, whichever is lower, and integrate to existing facility alarm system (hard-wire).	11	\$278.36	2	Sub-contractor	
0034		Water closet centerline is non-compliant	\$4.16	Relocate water closet and center at 18" (457 mm) from side wall (ADAAG Fig. 28).	11	\$0.00	3	Sub-contractor

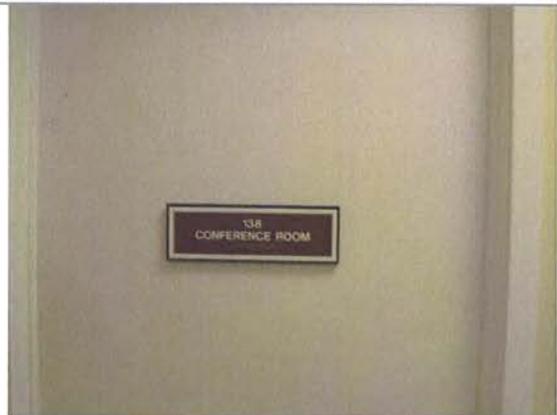
Non-Compliant Signage

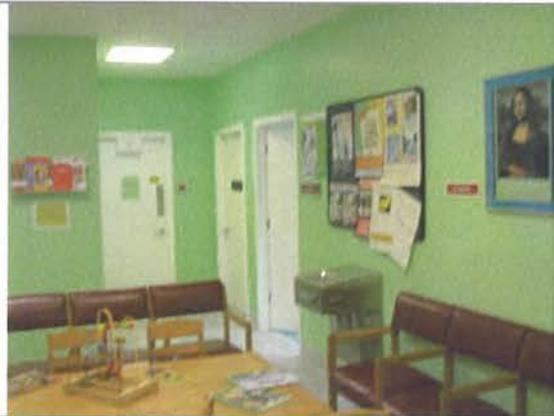
5.2 Interior Routes									
0010	Corridor Drinking Fountain	Drinking fountain water flow is 3" (76 mm) high.	\$4.15	Adjust to provide a flow of water at least 4" (101 mm) high so as to allow the insertion of a cup under it.	11	\$80.50	4	Subcontractor	
0011		There is only one accessible drinking fountain.	\$4.1	Replace fountain with hi-lo unit or install paper cup dispenser and mount at the required reach range allowed for approach provided, for people who have difficulty bending or stooping.	11	\$110.00	4	Maintenance	
0012	Exam Rooms	Sink is mounted at 36" (914 mm) above the finished floor to the top.	\$4.24	Rework/relocate sink and mount at 34" (863 mm) max. above the finished floor to the top.	11	\$500.00	3	Sub-contractor	
0013		Sink does not have the required knee clearance.	\$4.24	Rework sink to provide a knee clearance of at least 27" (685 mm) high, 30" (762 mm) wide and 19" (482 mm) deep. INCLUDED.	11	\$0.00	3	Sub-contractor

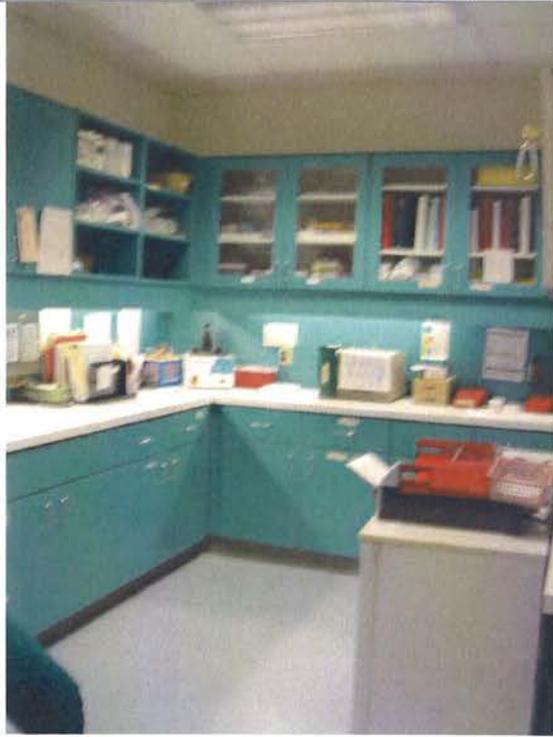
Laboratory Work Surface

0014	Laboratory	Tables and/or top counters are mounted at 36" (914 mm) above the finished floor to the top.	\$4.32	Replace tables and/or counter to provide 5% or at least one accessible table or counter mounted at 28" to 34" (711 mm to 863 mm) above the finished to the top.	11	\$640.44	4	Sub-contractor	
0015	Lounge	Tables and/or top counters are mounted at 36" (914 mm) above the finished floor to the top.	\$4.32	Replace tables and/or counter to provide 5% or at least one accessible table or counter mounted at 28" to 34" (711 mm to 863 mm) above the finished to the top.	11	\$287.08	4	Sub-contractor	
0016		Refrigerator encroaches into accessible route clear width.	\$4.3	Relocate refrigerator to provide a 36" (914 mm) min. clear width at accessible route (ADAAG Fig. 7).	11	\$87.75	3	Maintenance	
0017	Reception	Counter is mounted at 41.5" (1054 mm) above the finished floor to top.	\$7.2	Rework (cut out) a portion of the main counter 36" (914 mm) max. above the finished floor to top and 36" (914 mm) min. in length.	11	\$372.14	4	Sub-contractor

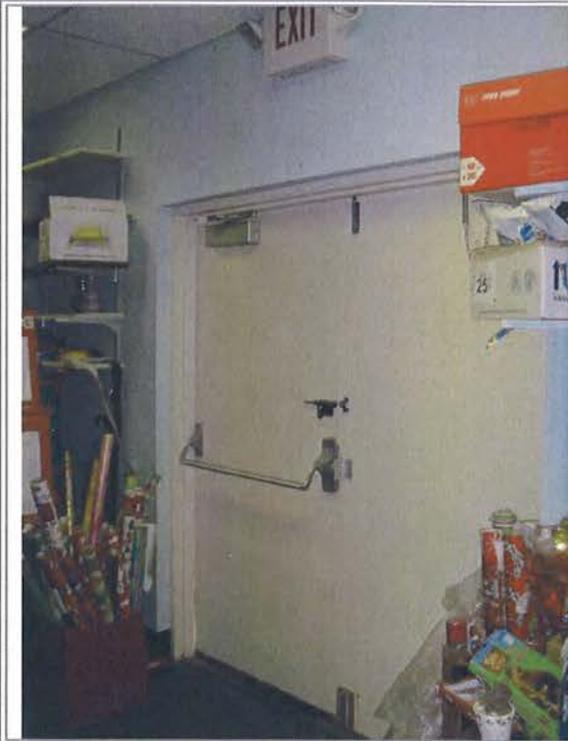
Storage Room 2 Emergency Exit Door

0031	Storage 2 to File Room	Furniture encroaches over maneuvering clearance on the pull side of the door.	§4.13	Relocate furniture item to provide the required 18" (457 mm) min. maneuvering clearance on the pull side of the door (ADAAG Fig. 25).	16	\$80.50	2	Maintenance	
0032	Storage 3	Door requires pinching, tight grasping or turning of the wrist to operate.	§4.27	Replace door hardware or retrofit with system not requiring pinching, tight grasping or turning of the wrist to operate.	N/A	\$131.00	4	Maintenance

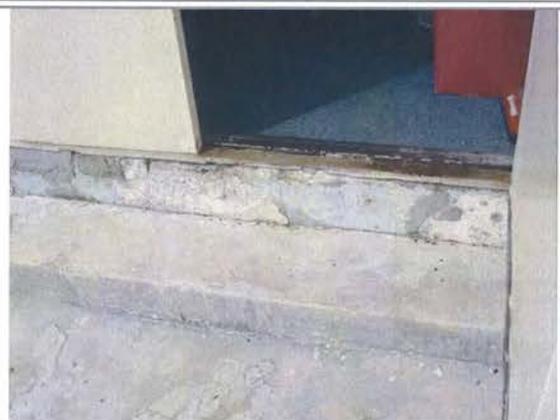
Storage Room 2 Emergency Exit Door Step

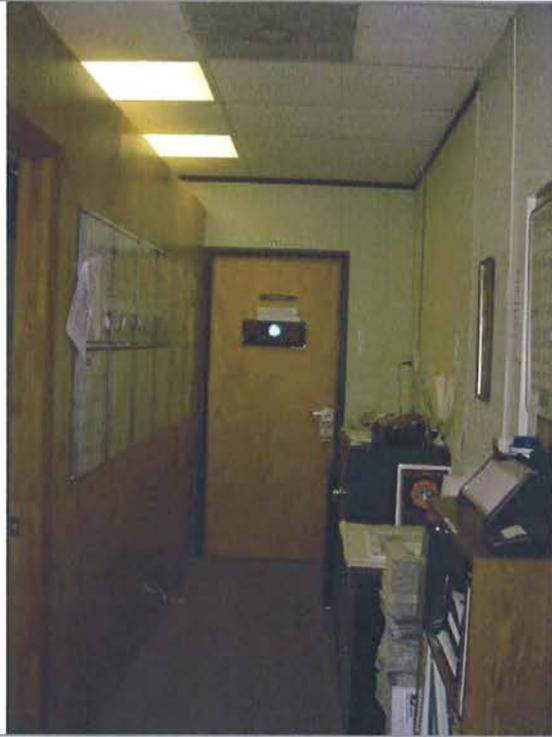
0024	Reception	Furniture encroaches into passage width, reducing it to less than 36" (914 mm).	§4.2	Relocate furniture and items to provide a 36" (914 mm) min. clear width continuously (ADAAG Fig. 1 and Fig. 24 e).	17	\$80.50	2	Maintenance	
0025	Multi-Purpose Room	Table and chairs encroach into accessible route clear width.	§4.3	Relocate table and chairs to provide a 36" (914 mm) min. clear width at accessible route (ADAAG Fig. 7).	17	\$80.50	2	Maintenance	
0026	EMS Supply Room	Non-compliant knob-type door hardware, requiring grasping and turning of the wrist to operate.	§4.13	Replace knob-type door hardware with lever or loose grip pull handle.	17	\$291.64	2	Maintenance	
0027		Furniture encroaches over maneuvering clearance on the pull side of the door.	§4.13	Relocate furniture item to provide the required 18" (457 mm) min. maneuvering clearance on the pull side of the door (ADAAG Fig. 25).	17	\$80.50	2	Maintenance

Reception Storage Clearance Issue

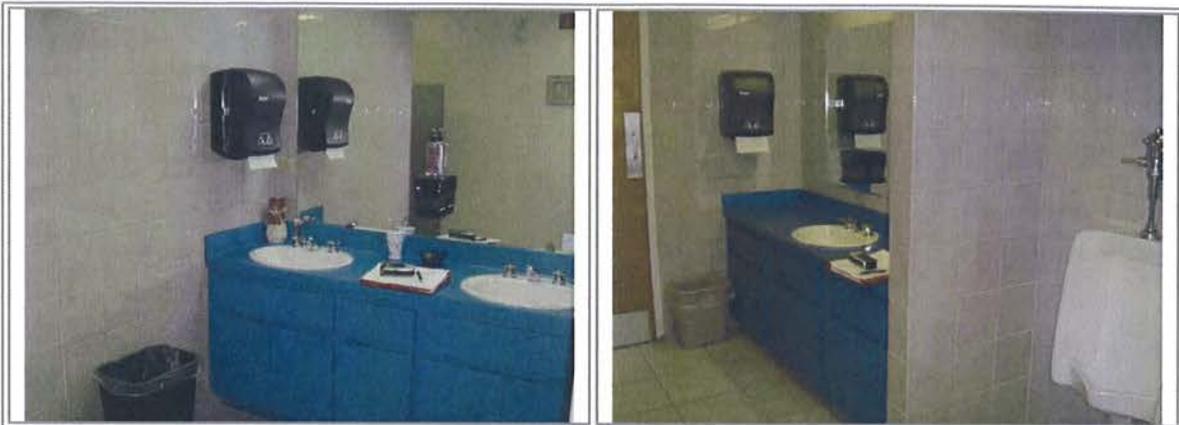
Women's Restroom Vanity

Men's Restroom Vanity

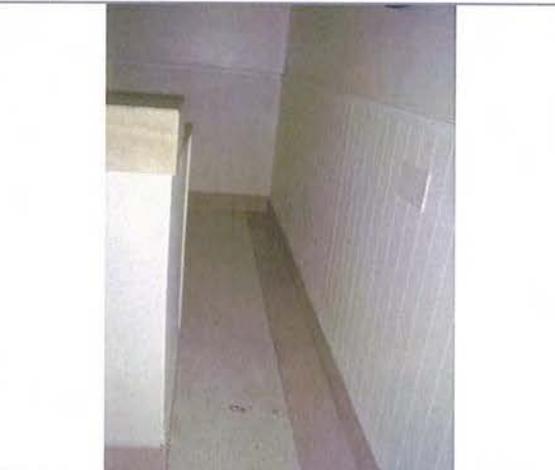
Reduced Access at Ticket Counter

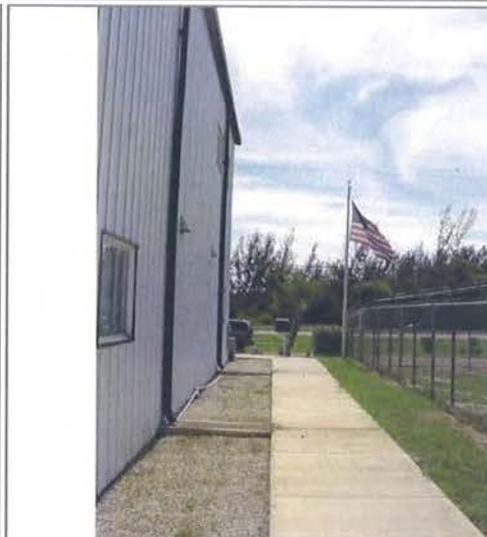
Sidewalk

5.2 Sheriff's Hanger / Exterior Routes									
0035	Exterior Routes	Accessible route has intermittent 0.5" (13 mm) vertical changes in level.	§4.3	Rework area and provide a 0.5" (12 mm) max. change of level, beveled with a slope no greater than 1:2, or mitigate condition by means of a curb ramp or ramp (ADAAG Fig. 7 c, d).	18	\$500.00	1	A/E

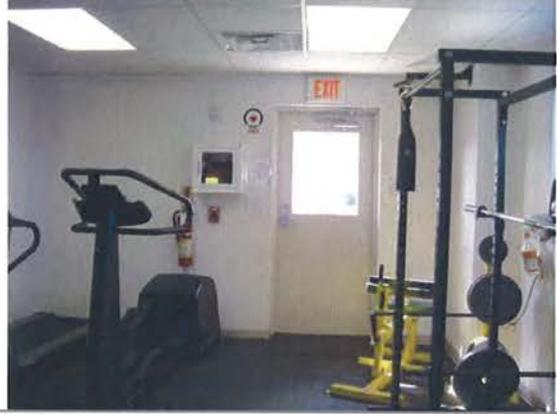
<p>Emergency Exit at Work-out</p>	<p>Utility Sink at Office 1</p>

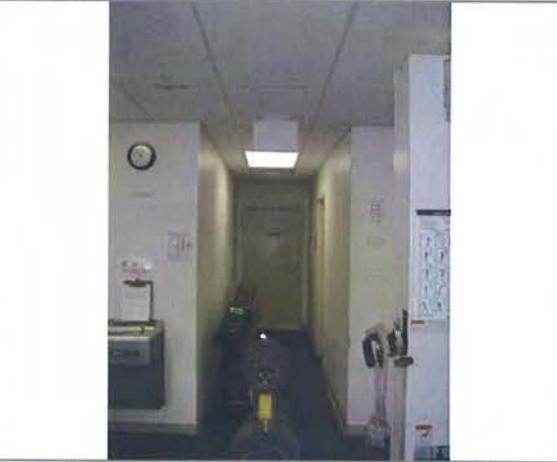
<p>Reduced Corridor Width at Work-out</p>	<p>Accessible Shower in Locker Rooms</p>

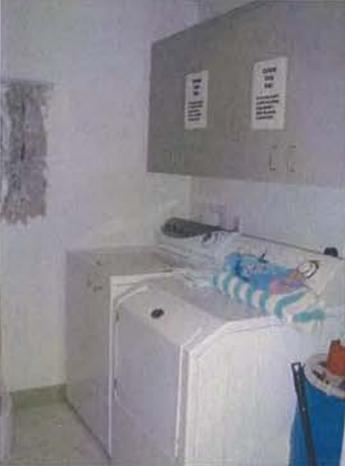
<p>Storage under Stairs</p>	<p>Non-compliant Laundry Equipment</p>

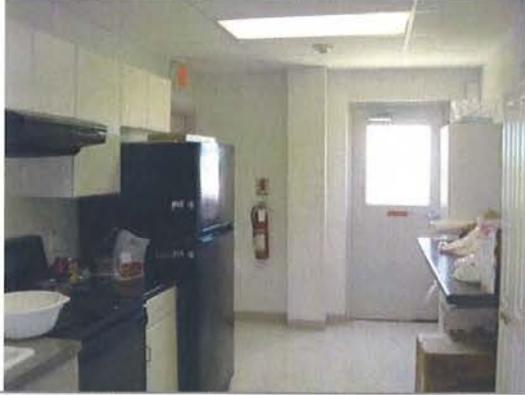
0054	Interior Rooms Corridor 2	Wall mounted counter protrudes into walkway, projecting more than 4" (102 mm) from back wall.	§4.4	Relocate or recess wall mounted counter so that it does not project more than 4" (101 mm) from back wall to outer leading edge (ADAAG Fig. 8).	26	\$293.14	4	Maintenance	
0055	Interior Rooms Elevators	Elevator door reopening device causes elevator doors to remain open for 6 seconds.	§4.10	Adjust elevator door reopening device to remain open for at least 20 seconds.	26	\$398.00	2	Sub-contractor	
0056	Emergency Exit Doors - Work Out to Exterior	Non-compliant door opening force of 12 lbf.	FBC §11-4.13	Adjust or replace door closer, maintain door hinges to provide an opening force not to exceed 8.5 lbf.	25	\$291.64	2	Maintenance	
0057		Defibrillator cabinet encroaches over maneuvering clearance on the push side of the door.	§4.13	Relocate defibrillator cabinet to provide the required 12" (304 mm) min. maneuvering clearance on the push side of the door handle side (ADAAG Fig. 25).	25	\$293.14	2	Sub-contractor

<p>Protruding Object in Corridor 02 / Access to Deck</p>	<p>Non-compliant Maneuvering Clearances to Office 2</p>

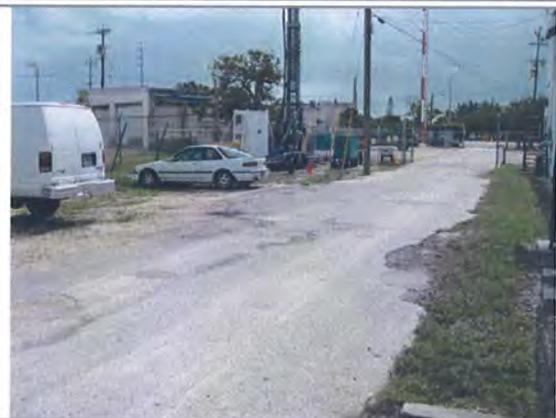
Parking Area

Observation	Recommendations
Parking is available on the NE side, just inside the access gate, on Shark Street. It is gravel and asphalt with no markings. ☒ There are no accessible parking spaces. ✓ There is no signage to indicate an accessible route to the side entrances or the hanger bay door.	A\$\$ - Pave the parking area and add an accessible parking space, access aisle, and accessible route in accordance with FACBC 11-4.6. A\$ - Install accessible parking sign in accordance with FACBC 11-4.6.4.
There are two exterior stairs leading to the interior trailer office and restroom areas. Although not part of this inspection, it was noted that the interior access to these raised trailers have the same designs as noted on the outside. ☒ The stairs are open riser steel with incorrectly designed railings. ☒ There is no landing at the bottom of the stairs. ☒ The doors at the top of the stairs have twist knob style handles.	A\$ - Replace the stairs with ones that are in accordance with FACBC 11-4.9, including the proper room at the top and a landing at the bottom. A\$ - Install new lever type door handles to be in accordance with FACBC 11-4.13.9

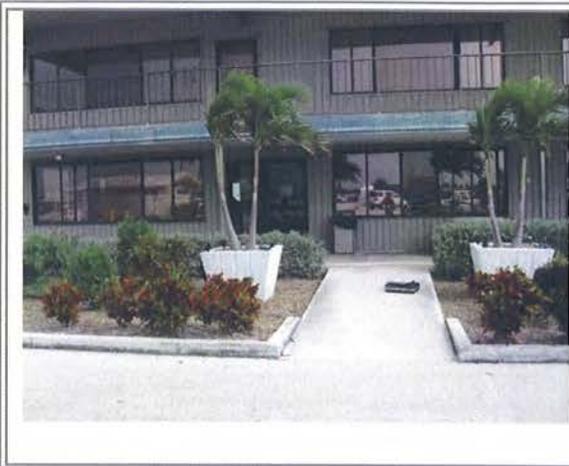
Ramp to Terminal Lobby

<p>A ramp leads from the parking area to the main entrance doors of the terminal lobby.</p> <ul style="list-style-type: none"> ⊗ The slope is between 7% and 8.3%, greater than the 5% allowed without handrails. ⊗ There are no handrails. ✓ The surface is firm concrete with a cross slope less than 2%. ✓ The landing at the top and bottom is correct. <p>There is an entrance to the terminal lobby from the tarmac.</p> <ul style="list-style-type: none"> ⊗ There are no railings at the steps leading up to the door. ⊗ The door opens out onto a landing that is too small. ⊗ There is a security gate from the parking area directly to the 	<ul style="list-style-type: none"> A\$ - Install handrails on each side of the ramp in accordance with FACBC 11-4.8.5. A\$ - Install a properly sized landing with stair handrails in accordance with FACBC 11-4.9.4, or install a ramp to meet the

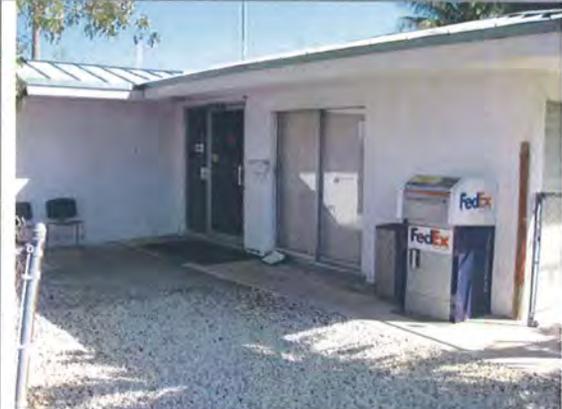
<p>Main Front Door The main entrance is an out swing door.</p> <ul style="list-style-type: none"> ⊗ The landing in front of the door is irregular concrete leading to uneven asphalt. It is not large enough to provide minimum maneuvering space. ⊗ The threshold is greater than 1 ½". ⊗ The door opens with more than 15 lbs of pressure. ⊗ It closes in less than the required 3 seconds. 	<p>AS - Install new a new landing at the front door to correct the height differences in accordance with FACBC 11-4.13. RAS - Adjust the door for the proper pressure and closing time in accordance with FACBC 11-4.13. AS - Install new lever type door locks to be in accordance with FACBC 11-4.13.9</p>
<p>Rear Doors There are two sets of doors leading to the tarmac area. At each entrance:</p> <ul style="list-style-type: none"> ⊗ The doors have a small twist lock handle on the inside that cannot be used with a closed fist. ⊗ The doors open with more than 15 lbs of pressure. ⊗ It closes in less than the required 3 seconds. 	<p>RAS - Adjust the doors for the proper pressure and closing time in accordance with FACBC 11-4.13. AS - Install new lever type door locks to be in accordance with FACBC 11-4.13.9</p>

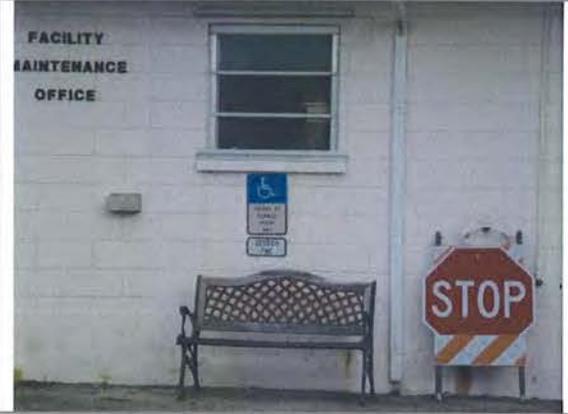
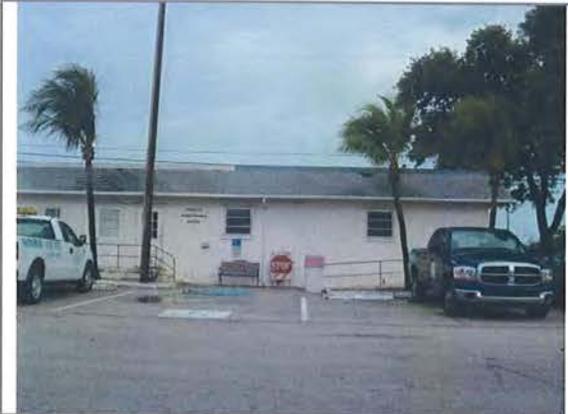
3.2 PHOTOS: PARKING

<p>⊗ The ordinance associated with the parking fine is not indicated on the sign.</p>	
---	--

Accessible Parking Sign	Accessible Parking Space

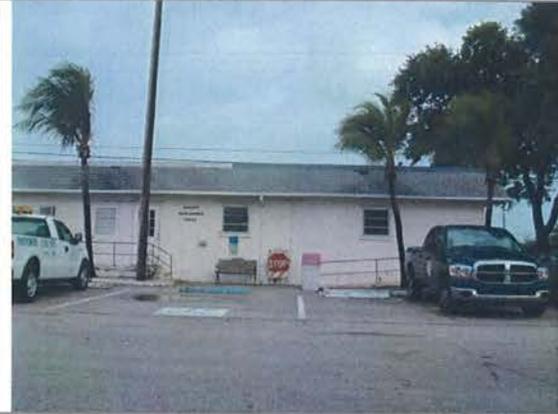
4.2 PHOTOS: EXTERIOR

Observation	Recommendations
<p>Building Entrance</p> <p>An Accessible Route is not provided from the parking lot to the building entrance.</p> <p>Ramp at Main Entrance Door</p> <ul style="list-style-type: none"> ✓ The clear width is 4'-6", greater than the 36" minimum required. ⊗ The handrail height is 25 ½" above ramp surface, less than the 34"-38". ⊗ Handrail extensions are not provided at the top and bottom of the ramp. ⊗ A handrail is not provided on this inside of the ramp. ⊗ The mid landing is less than the minimum 5'-0" required. ⊗ The landing at the top of the ramp does not provide the required door clearances and is less than the minimum 5'-0" required. 	<p>AS - Rebuild the ramp to meet the requirements of FBC 11-4.8, including proper slope, railings, and landings.</p>

Ramp and Accessible Parking Space

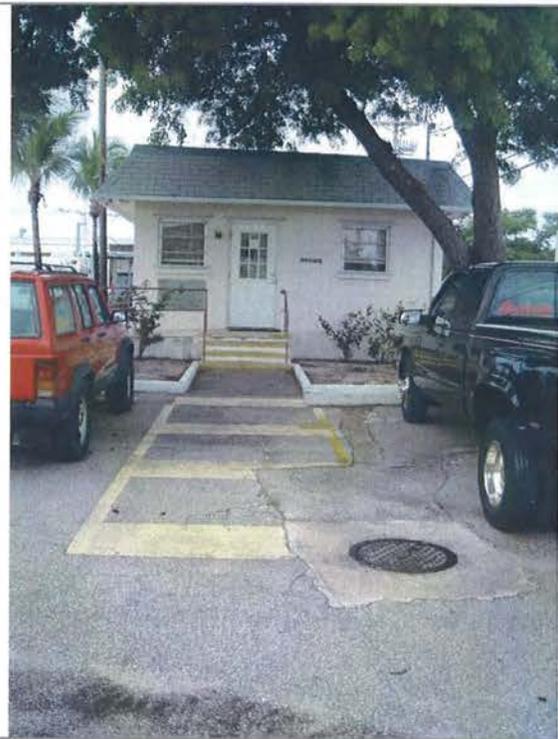
Main Entrance

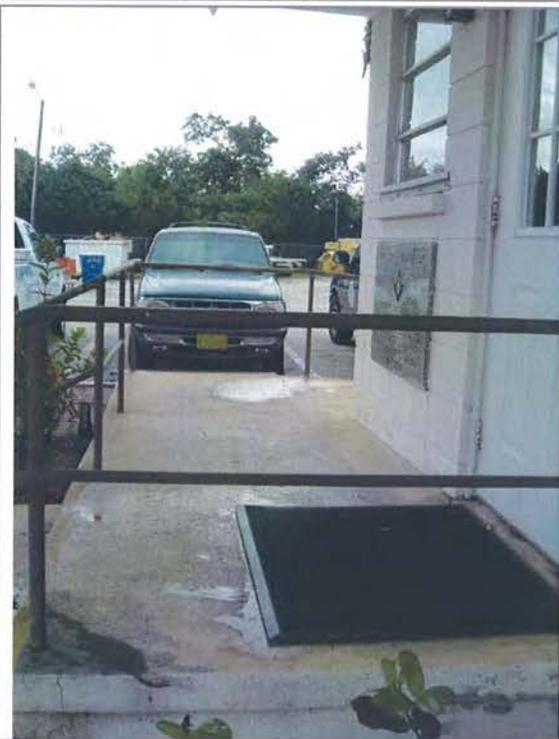
Ramp Mid Landing

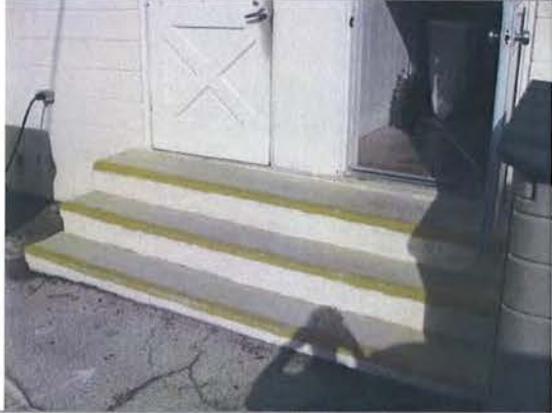
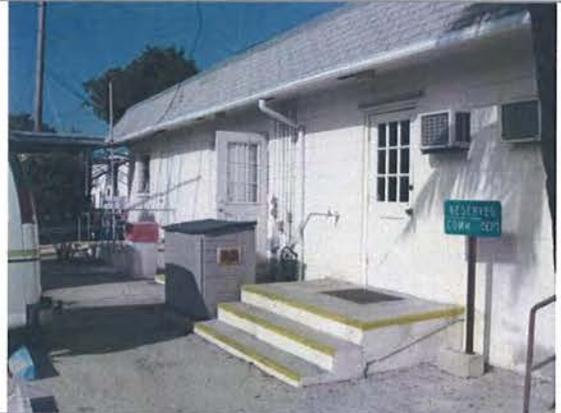
Steps and Entrance to Locker Room and Shop

Steps and Entrance to Office

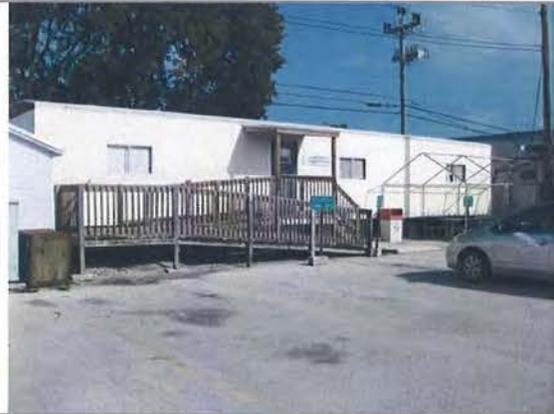
10.2 PHOTOS: EXTERIOR

Observation	Recommendations
<p>The Accessible Ramp runs from the parking lot level to the entrance level of the trailer. The ramp is non-compliant.</p> <ul style="list-style-type: none"> ✓ The ramp lands at the bottom on a concrete bib that has the correct size and slope. ⊗ The ramp has a slope of 8 to 10% on the bottom segment. ⊗ The handrails are wood, only on one side of the ramp, the incorrect style, and do not extend beyond the slope or the bottom landing. ✓ The landing at the entrance door is a correct size and the door has adequate room to open. <p>A set of deck Steps leads to the entrance landing, opposite the upper section of the ramp.</p> <ul style="list-style-type: none"> ⊗ The steps are wood with open risers. ⊗ The handrails are wood, only on one side, the incorrect style, and do not extend beyond the top or bottom landing. 	<p>AS - Remove the ramp and rebuild it to have a proper slope, handrails and landings in accordance with FACBC 11-4.8.</p> <p>AS - Remove the steps and rebuild it to have a proper handrails and landings in accordance with FACBC 11-4.9.</p>

Ramp to Trailer

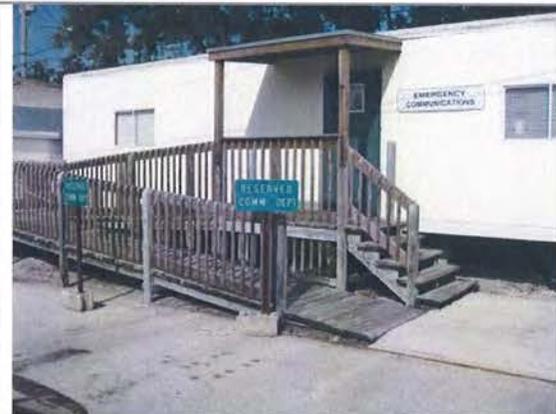
<ul style="list-style-type: none"> ⊗ The door opens toward the steps without sufficient clearance on the landing. 	
<ul style="list-style-type: none"> ⊗ The Entrance Door has a threshold and step up of more than 3/4". ⊗ The door has knob style handles. ✓ The door has 34" clearance. 	<p>AS - Install new lever type door handles to be in accordance with FACBC 11-4.13.9</p>

Ramp and Steps

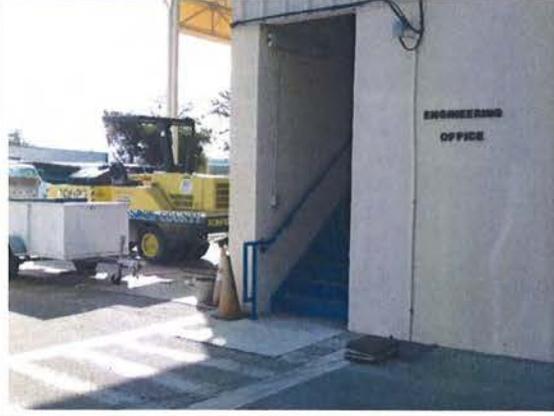
Stairs to Engineering Office

Inspection Area: 18.6 ROUTES AND ENTRANCE	
Observation	Recommendations
<p>A set of Stairs leads from the parking lot grade level to a second floor landing. The stairs are covered but not enclosed. There is no elevator.</p> <ul style="list-style-type: none"> ⊗ The stairs are steel with diamond pattern treads. However, the treads are only 10" deep. ⊗ The handrails are steel pipe and extend at the top and bottom on one side only. The right side stops at the first and last riser. 	<p>TI – It is not feasible to reconfigure the stairs within the constraints of the building structure. The stairs are an integral part of the fleet maintenance building and significant changes to the structure would be required.</p> <p>F\$\$ - It would be possible to add an elevator to the exterior of the existing building in accordance with the FBC.</p>
