Americans with Disabilities Act Transition Plan Lower Keys - Part 1

Volume 3 of 4

Monroe County

October 29, 2010

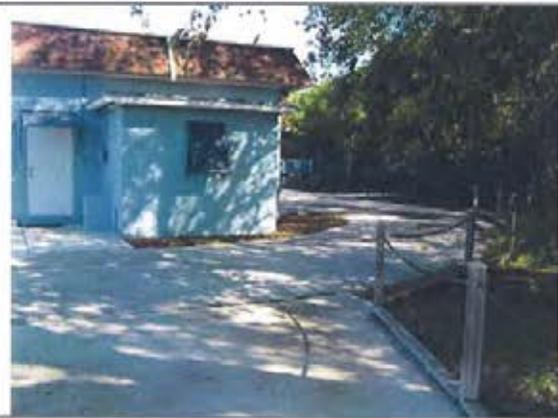
3.2 Exterior Routes									
0004	Exterior Routes	There are several areas where gaps greater than ½" (12.7 mm) vertical change in level. (Approx. 130' x 2')	§4.3	Rework area and provide a 0.5" (12 mm) max. change of level, beveled with a slope no greater than 1:2, or mitigate condition by means of a curb ramp or ramp (ADAAG Fig. 7 c, d).	7	\$350.00	1	A/E

Typical Route and Gap

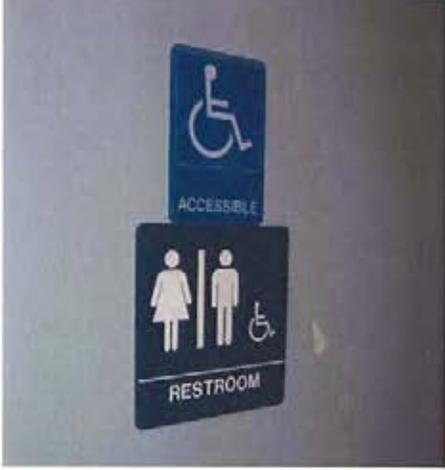
A photograph of a long, narrow hallway with a light-colored floor and a blue stripe down the center. There are doors on both sides and a handrail on the right side.
<p>Accessible Sign on Door</p>	<p>Interior Hall to Rooms</p>

5.1 Entrances											
0004	Main Entrance Door	Permanent room identifying signage does not have Braille or raised characters.	§4.30	Rework/replace existing signage with signage displaying raised characters on non-glare contrasting surface, Grade 2 Braille text of same information and mount on wall adjacent to latch side of door at 60" (1524 mm) above the finished floor to centerline.	10	\$149.36	2	Maintenance			
0005		Door closing time is less than 3 seconds.	§4.13	Provide a sweep period of 3 seconds min. measured from 70° open position to 3" (76 mm) from door latch.	10	\$50.00	2	Maintenance			
0006		Non-compliant door opening force of 12 lbf.	FBC§4.13	Adjust or replace door closer, maintain door hinges to provide an opening force not to exceed 8 lbf.	10	\$50.00	2	Maintenance			
0007	Rear Entrance Door	Door closing time is less than 3 seconds.	§4.13	Provide a sweep period of 3 seconds min. measured from 70° open position to 3" (76 mm) from door latch.	10	\$50.00	2	Maintenance

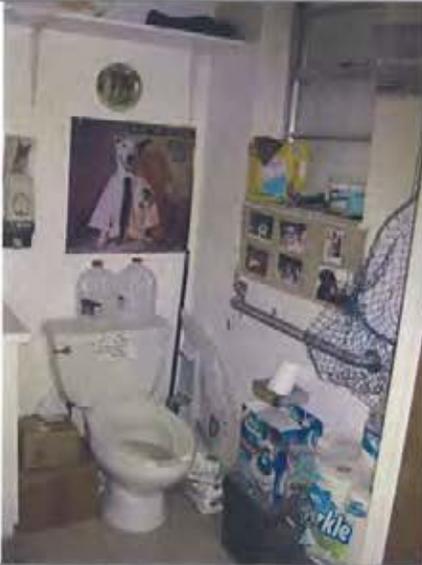
Restroom in Clinic

FSS - The entire second floor could be remodeled to provide the required room for an office, clinic, and restroom. A lift could be added to reach this floor.

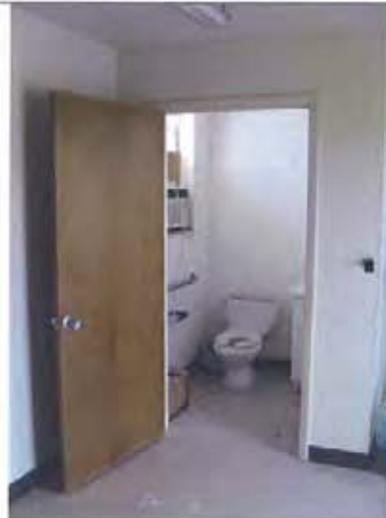
Vacant side Restroom

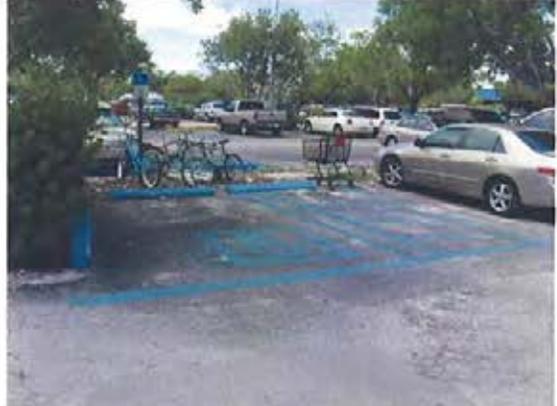
Observation	Recommendations
<p>Front Parking Lot</p> <ul style="list-style-type: none"> ✓ The Accessible Parking Space slope is less than 2%. ✓ It is located close to the entrance. ⊗ The space is 11' long x 15' wide, less than the 12' width and 18' length required. ⊗ The pavement markings are incorrect. ⊗ Pavement is rough and irregular. ⊗ The Access Aisle is incorrectly striped. ⊗ There is no Accessible Route from the parking area to the accessible ramp. ⊗ The Sign is 66" high, less than the required 84", and it does 	<ul style="list-style-type: none"> AS - Reconfigure the front accessible parking space to be the proper size and have the proper access aisle in accordance with FACBC 11-4.6. AS - Reconfigure the accessible parking sign in accordance with FACBC 11-4.6.4.

<p>Public Accessible Parking in Front</p>	<p>Front Ramp</p>

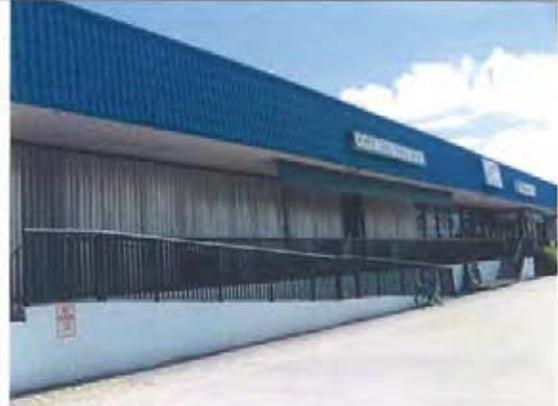
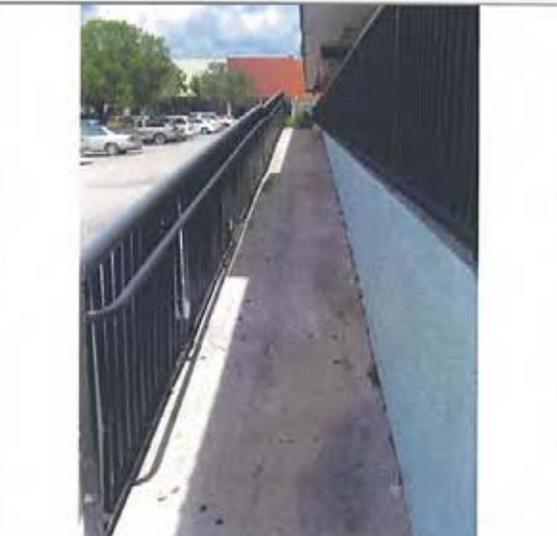
<p>emergency egress.</p> <ul style="list-style-type: none"> ⊗ At the top of the ramp, the landing does not provide enough room to safely open the rear door with a latch-side approach. <p>There is a set of Steps near the ramp for the rear office door.</p> <ul style="list-style-type: none"> ⊗ The handrail on the steps does not extend at the bottom or top. ⊗ The handrail is only on one side of the steps. 	<p>AS - Reconfigure the step handrails in accordance with FACBC 11-4.9.</p>
--	--

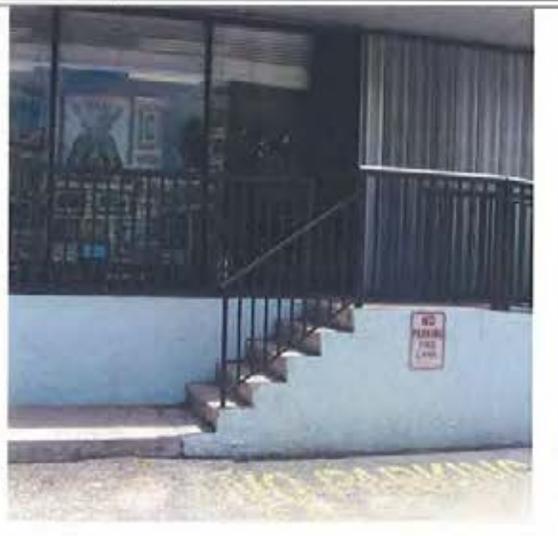
<p>Front Ramp</p>	<p>Typical Front Steps</p>

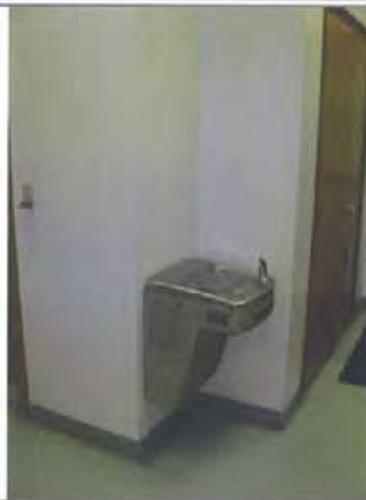
0012	Fountain	Drinking fountain spout outlet (orifice height) is mounted at correct height above the finished floor, but it is not hi-lo unit.	FBC §4.15.4	Reconfigure the storage closet area to allow the installation of a high/low unit in accordance with FACBC 11-4.15.4. or install additional unit and mount at 36" (914 mm) max. above the finished floor to the spout outlet (FBC Fig. 27).	10	\$3,137.43	4	Sub-contractor	
Big Pine Library Building: 5.2 Restrooms									
0013	Men's Accessible Restroom	Permanent room identifying signage is mounted on the door leaf.	§4.30	Rework/replace existing signage with signage displaying raised characters on non-glare contrasting surface, Grade 2 Braille text of same information and mount on wall adjacent to latch side of door at 60" (1524 mm) above the finished floor to centerline.	11	\$55.00	2	Maintenance	
0014		Non-compliant knob-type door hardware, requiring grasping and turning of the wrist to operate.	§4.13	Replace knob-type door hardware with lever or loose grip pull handle.	11	\$291.64	2	Maintenance

Fountain

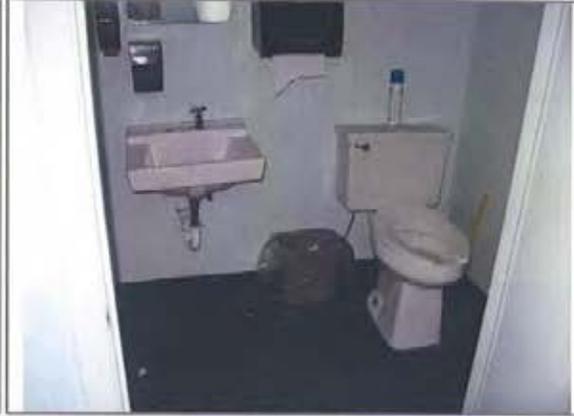
Non-accessible Restroom

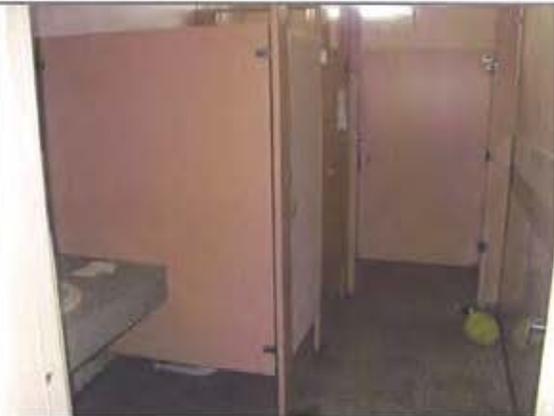
Women's Restroom with inaccessible stall door

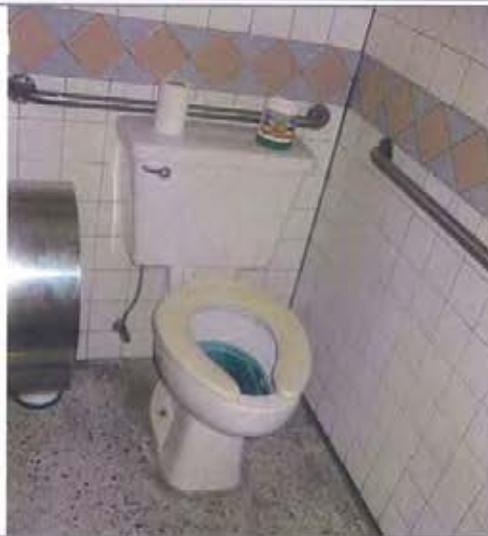
Non-compliant Stall

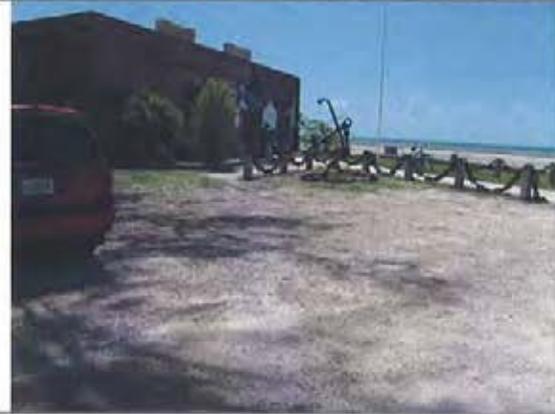
Front Parking Area

- ✓ The sidewalk from the parking area to the front entrance is new concrete and in good condition. However,
- ⊗ The sidewalk at the driveway has a slope of 7-9%, and runs more than 72", more than the 5% allowed without being considered a ramp.

AS - Rebuild this sidewalk with the proper slope to the parking area not to exceed 5%.

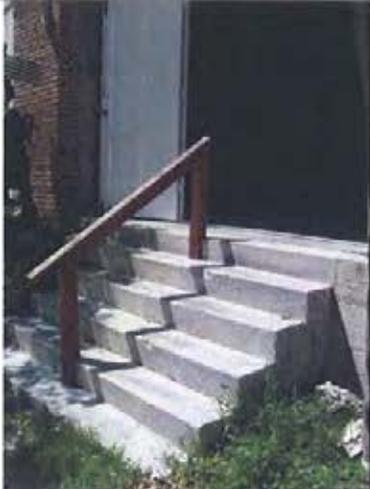
Steps from Ticket to Courtyard

4.3 Interior Routes									
0006	Gift Shop Courtyard	Stair do not have correct handrails.	§4.9	Install handrails on both sides of stair and mount between 34" and 38" (863 mm - 965 mm) above the finished floor to top of gripping surfaces. Handrails shall extend 12" (304 mm) min. beyond the top and bottom of the stair segment (ADAAG Fig. 19).	9	\$800.00	1	A/E	
0007	Courtyard	The surface of the route is unstable and has loose material.	§4.5	Rework to provide a stable, firm, and slip-resistant floor surface.	9	\$3,000.00	1	A/E

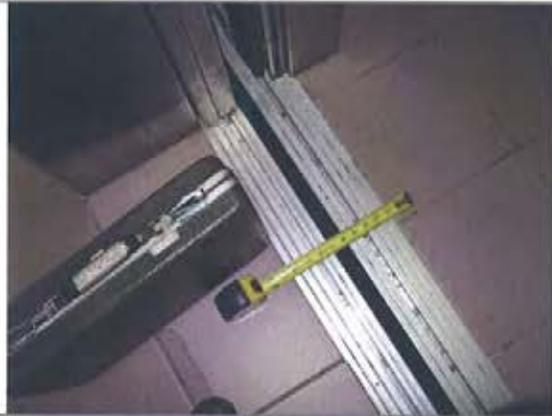
Inspection Area: 4.2 ELEVATOR	
Observation	Recommendations
<p>The Elevator is the only public access to the floors above. It is the proper size. The elevator is compliant except,</p> <ul style="list-style-type: none"> ⊗ The audio direction indicator only works on some floors. ⊗ The floor audio indicator does not work. ⊗ The doors close in 4 seconds following an obstruction or call. ⊗ There is a floor gap greater than 1" at the door opening. 	<ul style="list-style-type: none"> AS - Adjust door timing. AS - Correct audio signals. AS - Adjust car in hoistway to eliminate gap.

Gap at Elevator Door

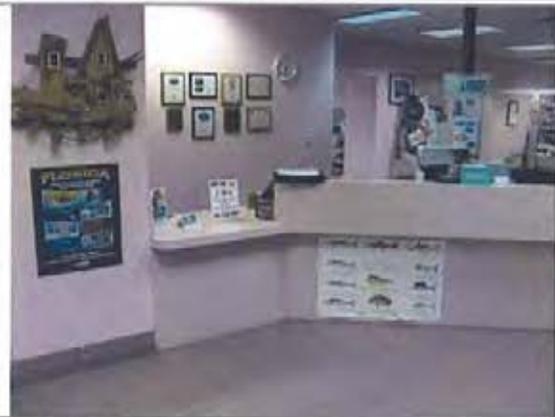
5.3 Service Area											
0025	Tax Collectors Service Area	The service counter protrudes into walkway.	§4.4	Relocate or recess so that it does not project more than 4" (101 mm) from back wall to outer leading edge (ADAAG Fig. 8).	12	\$293.14	2	Maintenance			
0026		Non-compliant door opening force of 10 lbf.	§4.13	Adjust or replace door closer, maintain door hinges to provide an opening force not to exceed 5 lbf.	12	\$50.00	2	Maintenance

Service Counter

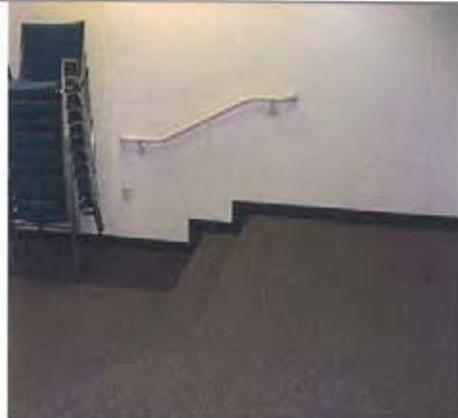
Steps to Commissioner's Seating

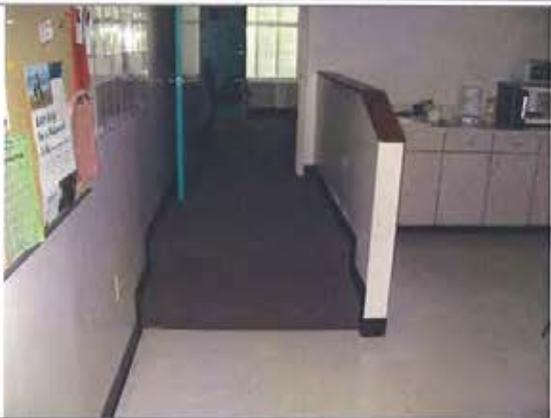
Steps to Commissioner's Lounge

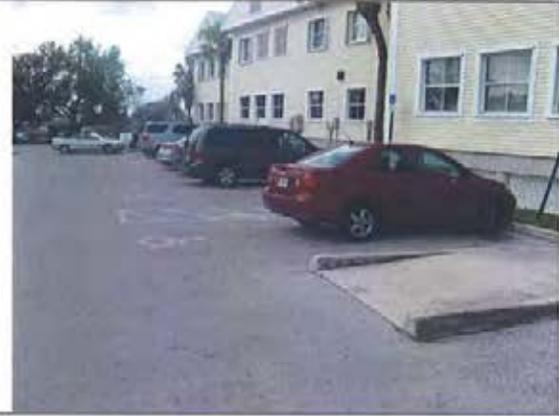
Parking extending into Driveway

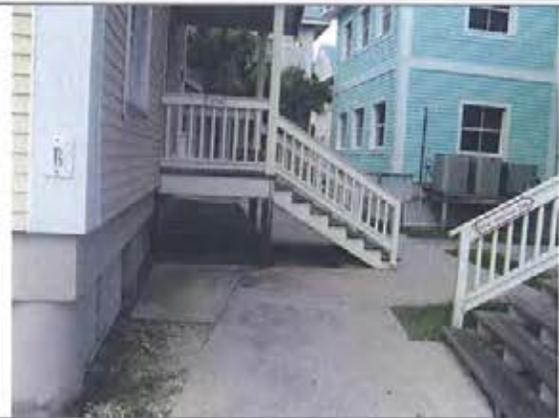
Main Entrance Steps

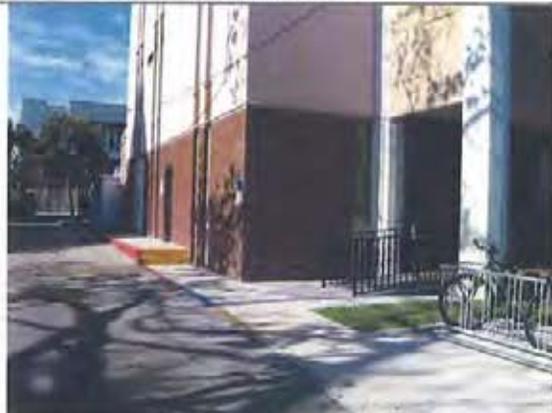
Main Entrance and Side Ramp

The Entrance Foyer	
<p>⊗ The security checkpoint has a metal detector with 28" clearance. Guards report no problem with wheelchair access.</p> <p>⊗ There is no other access for wheelchairs.</p> <p>✓ The conveyor and examining desk are at acceptable heights.</p>	<p>No action required.</p>
<p>✓ There are fire alarms with strobes.</p> <p>⊗ The fire alarm pull in the hallway is not accessible due to desk and chairs in front of it.</p> <p>⊗ A sign in the security area states the only accessible restroom is on the first floor. It is not in Braille, the height is incorrect, and it does not indicate the direction.</p>	<p>RAS - Ensure the areas in front of all fire pulls are kept clear.</p> <p>RAS - Replace signs with one that meets ADAAG 4.1.6.</p>

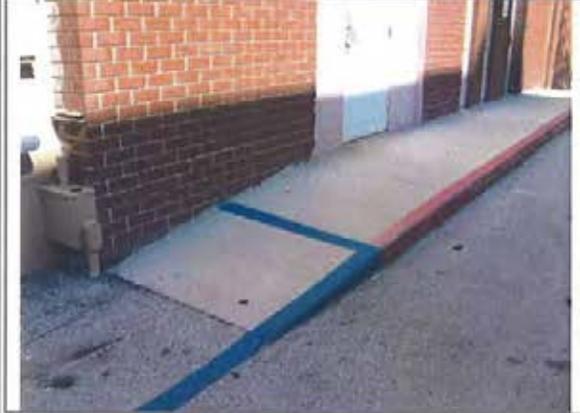
A photograph of a side ramp with a blue and red curb, leading to a brick building.

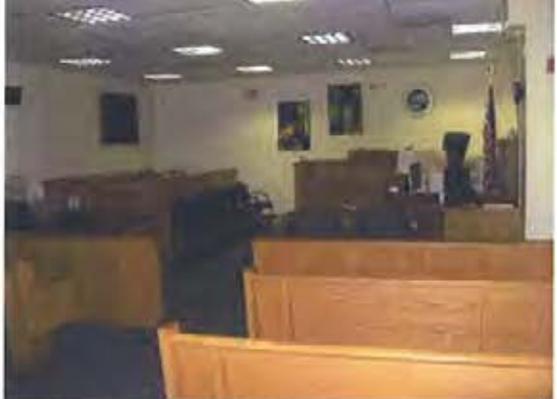
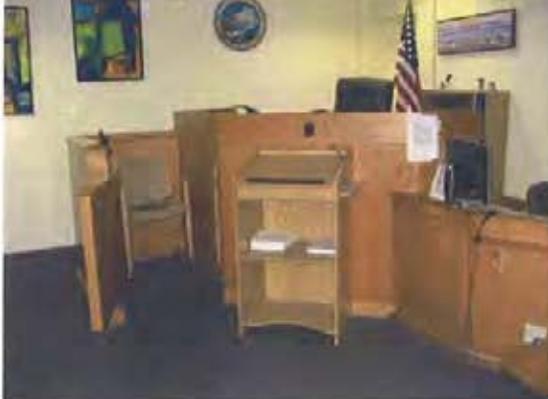
<p>5.7 PHOTOS: COURTROOM D</p>

<p>The Jury Box is not accessible.</p> <ul style="list-style-type: none"> ⊗ It has two levels and requires at least one riser must be used. ⊗ There is no area for a wheel chair other than directly in front of Jury Box. 	<p>AS - Add ramp to part of Jury Box per ADAAG 4.2.4 ASS - Add a lift to one side of the Jury Box.</p>
<ul style="list-style-type: none"> ⊗ The Witness Stand requires stepping up one riser and is not accessible. There is no provision for a wheelchair. 	<p>AS - Make one level, or add ramp per ADAAG 4.3.8</p>
<ul style="list-style-type: none"> ⊗ The door from the Judge's Bench to the chamber area has 27" clear and is not accessible. ⊗ There is no accessible route from the courtroom to the jury room. Opening behind bench is 35". ⊗ The door to the jury room is 25" clear. 	<p>TI - This item cannot be corrected within the confines of the existing structure.</p>

Courtroom	Bench and Witness Stand

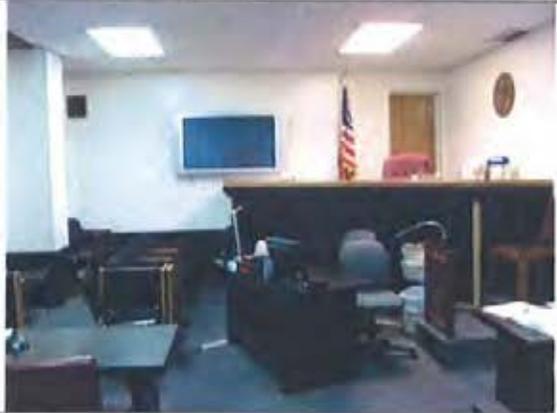
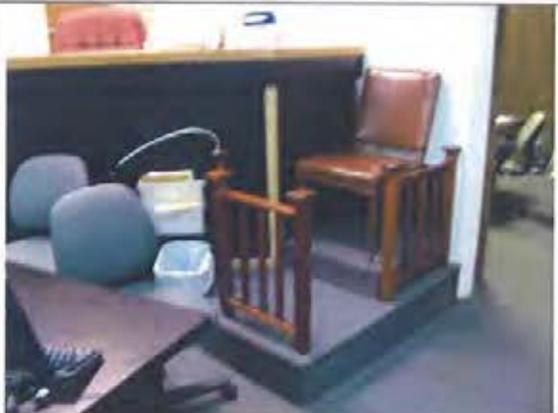
7.7 PHOTOS: COURTROOM C

wheelchair. ⊗ There are no assisted listening devices.	AS - Add assisted listening devices
Judge's Bench is not accessible: ⊗ It is up three risers to the platform from chambers side. ⊗ The door is 26" clear.	ASS - Configure Bench area in accordance with ADAAG 4.3.8 ASS - Add a lift that services each level of the judge's area.
The Jury Box could accommodate a wheelchair except the maneuvering room is very limited. ⊗ It has two levels and requires at least one riser must be used.	AS - Make one level, or add ramp per ADAAG 4.3.8
⊗ The Witness Stand requires stepping up two risers and is not accessible. There is no provision for a wheelchair.	AS - Make one level, or add ramp per ADAAG 4.3.8
⊗ The door from the Judge's Bench to the chamber area has 27" clear and is not accessible. ✓ The door to the jury room is 32" clear and acceptable.	TI - These items cannot be corrected within the confines of the existing structure.

Courtroom C	Bench and Witness Stand

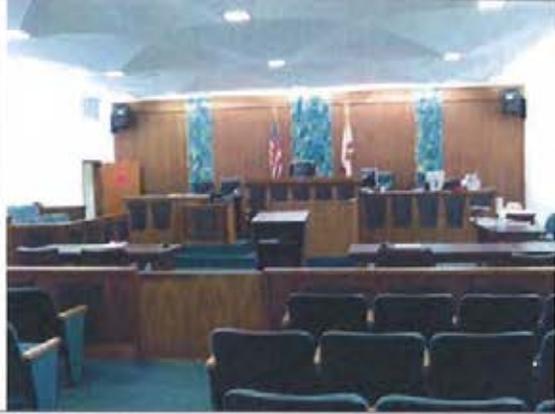
Courtroom B

Inspection Area: 7.9 COURTROOM B	
Observation	Recommendations
The courtroom is approximately 34' x 47'.	
<p>Main entry doors are off the front balcony. They open out onto the balcony.</p> <p>⊗ The door on the left requires > 12 lbs to open and closes in < 3 seconds.</p> <p>⊗ The door on the right is very hard to open at the jamb, but beyond this point, it is acceptable.</p> <p>⊗ Signage is high up and large print. No symbols or Braille.</p>	<p>RAS - Adjust the door in accordance with FACBC 11-4.13.11.</p> <p>RAS - Replace or add signage in compliance with ADAAG 4.30.4</p>
<p>There are seating for approximately 60 people and no HC seating area.</p> <p>⊗ There is room for wheelchairs, but there is no identified seating area requiring the wheelchair to be in the hall or rear areas.</p> <p>✓ There are accessible routes throughout the courtroom.</p> <p>✓ The carpets are firm. Thresholds are acceptable</p> <p>✓ There are speakers mounted on the walls, emergency</p>	<p>RAS - Provide wheelchair location in accordance with FACBC 11-4.1.3.</p>

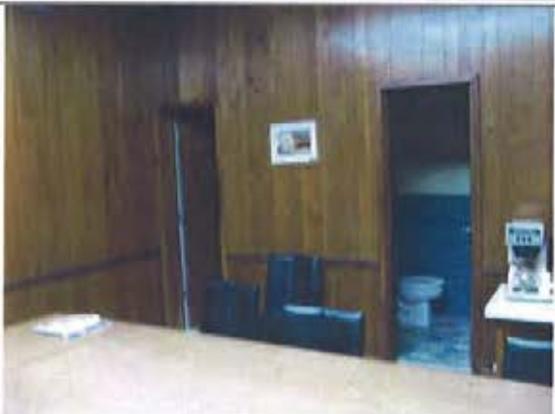
Restrooms in Jury Room

Inspection Area: 8.7 JURY ROOM A	
Observation	Recommendations
Jury room has accessible routes, however, ☒ There are two inaccessible restrooms that measure 51" x 55" and cannot be compliant. ☒ The restroom doors have 21" clear. ☒ There are no fire alarms or strobes in the jury room. ☒ The door has a knob handle.	TI – These restrooms cannot be corrected within the confines of the existing structure. AS - Add alarms and strobes. AS - Replace door hardware with lever style.

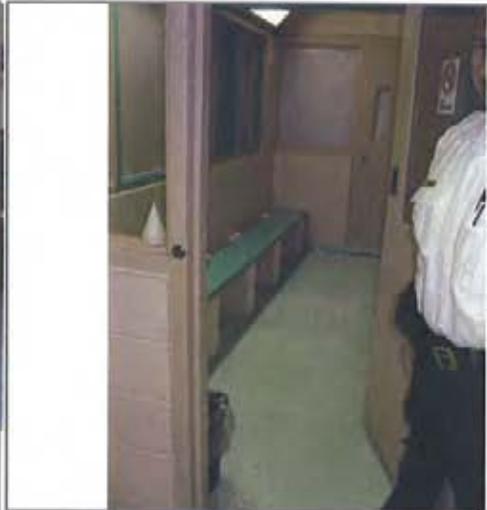
Single Holding Cell

Inspection Area: 8.8 HOLDING CELL	
Observation	Recommendations
The holding cell is accessed from the rear hallway and the elevator to the Sheriff's area. ☒ There is nothing about the holding cell that is accessible. It does not have adequate floor space for a wheelchair to maneuver and the doors cannot be opened without assistance.	TI – These items cannot be corrected within the confines of the existing structure.

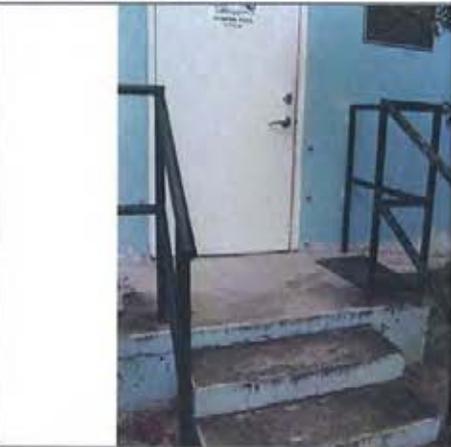
Front Entrance

Inspection Area: 5.1 ENTRANCES	
Observation	Recommendations
<p>Front and Rear Office Doors</p> <p>✓ These doors open out and close in less than 3 seconds, faster than the minimum allowed.</p> <p>Other doors do not have self-closers.</p>	<p>RA\$ - Adjust the doors in accordance with FACBC 11-4.13.</p>

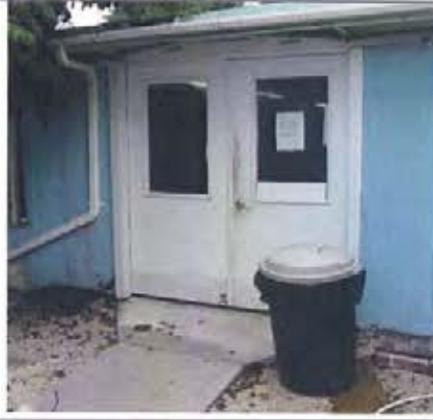
Entrance to Dog Kennel

Inspection Area: 6.0 INTERIOR ROUTES	
Observation	Recommendations
<p>✓ Routes throughout most of the buildings are flat and firm.</p> <p>However,</p> <ul style="list-style-type: none"> ⊗ The buildings are very small and have very restricted maneuvering room. ⊗ In some locations, such as food prep, bathing, and kennels, there is a step or gutter, prohibiting wheelchair access. ⊗ Entrance to the Dog Kennel is through accessible double doors. The landing outside these doors does not provide adequate maneuvering room to open the doors. ⊗ Entrance to the Cat House is restricted by two turns. 	<p>TI - The size of the buildings, and the design of the kennels makes it infeasible to make these areas fully accessible. In addition, ADAAG Scoping 203.12 exempts these areas from accessible requirements.</p> <p>AS - Reconfigure the entrance landing to provide proper maneuvering room.</p>

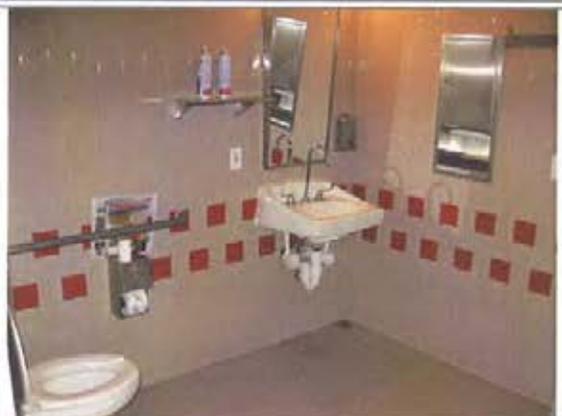
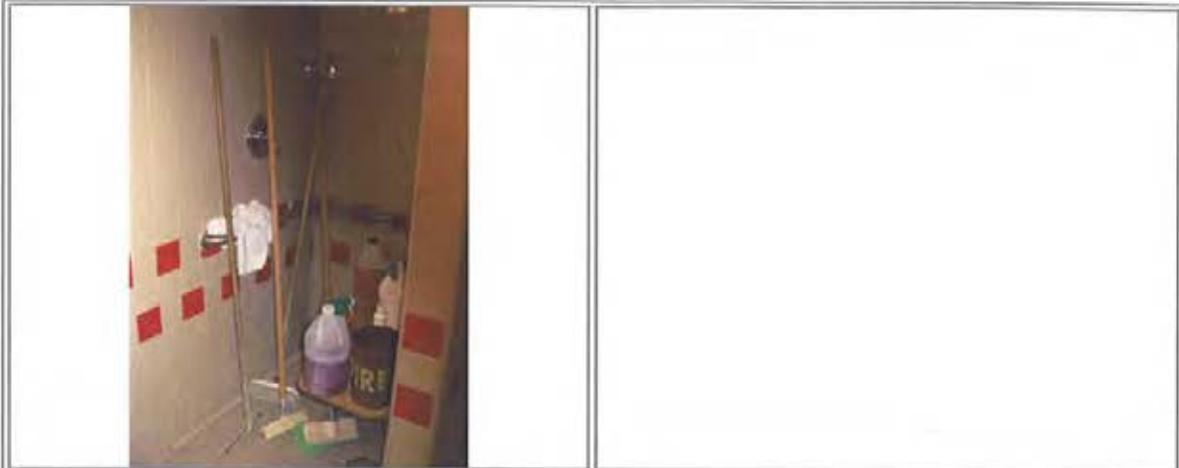
Restroom 2

<p>⊗ Shelf at sink is higher than allowed for front approach.</p> <p>The shower is not accessible.</p>	<p>AS - Reinstall shelf at 48" in accordance with FACBC 11-4.2.</p>
<p>Restroom 2</p> <p>⊗ Signage provided is incorrect and mounted on the door instead of the side wall. The restroom is not indicated as men or women.</p> <p>⊗ There is no closer on the door.</p> <p>✓ Fire alarm device with strobe is provided.</p> <p>✓ All plumbing and accessory fixtures are compliant, with the exception of the following:</p> <ul style="list-style-type: none"> ⊗ The side grab bar at the toilet extends 50" from the rear wall and is centered at 32" above the floor. ⊗ Self at sink is higher than allowed for front approach. <p>Shower</p> <p>⊗ The accessible shower is only 34" x 36".</p> <p>⊗ It has a lever handle at the correct height, but no wand.</p> <p>✓ Grab bars and seat are compliant.</p>	<p>RAS - Provide proper signage in accordance with FACBC 11-4.30.6.</p> <p>AS - Install a door closer in accordance with FACBC 11-4.17.</p> <p>AS - Install grab bars in accordance with FACBC 11-4.16.4</p> <p>AS - Reinstall shelf at 48" in accordance with FACBC 11-4.2.</p> <p>AS - Enlarge the shower stall in accordance with FACBC 11-4.21.</p> <p>RAS - Provide a shower wand in accordance with FACBC 11-4.21.</p> <p>RA - Remove storage items from the shower.</p>

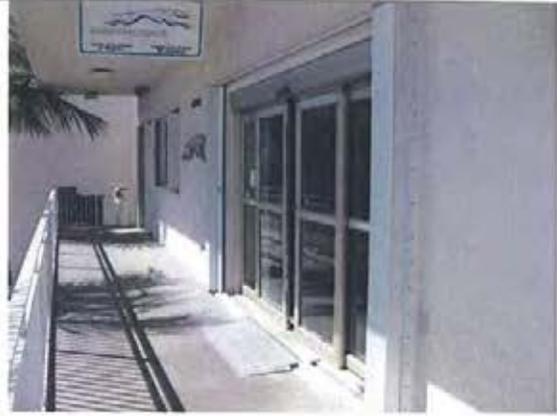
Bus Terminal Entrance

5.5 Greyhound Bus Terminal Interior Routes									
0056	Main Entrance	Permanent room identifying signage does not have Braille or raised characters and is mounted over the door frame.	§4.30	Rework/replace existing signage with signage displaying raised characters on non-glare contrasting surface, Grade 2 Braille text of same information and mount on wall adjacent to latch side of door at 60" (1524 mm) above the finished floor to centerline.	26	\$149.36	2	Maintenance	
0057	Service Counter	Counter is mounted at 49" (1245 mm) above the finished floor to top.	§7.2	Rework (cut out) a portion of the main counter 36" (914 mm) max. above the finished floor to top and 36" (914 mm) min. in length.	26	\$372.14	4	Maintenance	
0058	Greyhound Bus Terminal Drinking Fountain	Drinking fountain water flow is 3" (76 mm) high.	§4.15	Adjust to provide a flow of water at least 4" (101 mm) high so as to allow the insertion of a cup under it.	27	\$80.50	4	Sub-contractor

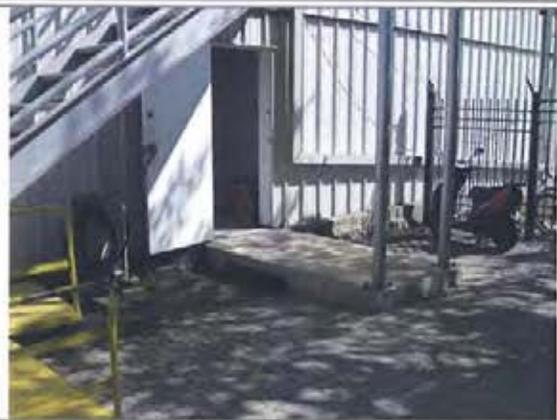
Stairs on side of Hanger

AS - Rebuild the stairs to meet the requirements of FACBC 11-4.9, including proper steps, railings, and landings.
AS - Install an accessible route from the steps to the parking lot in accordance with FACBC 11-4.3.

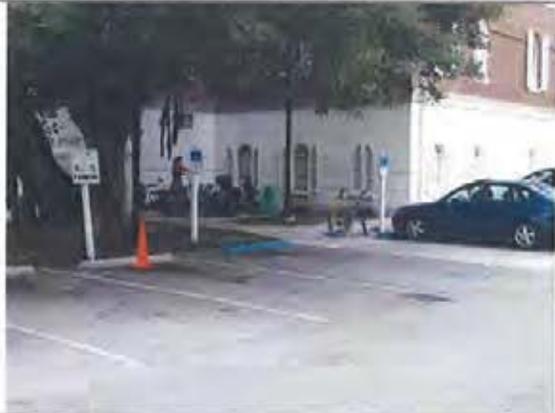
<p>✓ The route from the Accessible Parking to the front entrance is smooth and flat. The slope is 1:20. The route from the parking to the side entrance is not accessible.</p>	
<p>The front route from Old Courthouse the crosses the driveway on the right side of the Lester Building.</p> <p>✓ The route is a min. of 36" wide and concrete or flat, firmly set brick.</p> <p>✓ There is a sign indicating the direction to the accessible front entrance.</p> <p>⊗ There is no tactile detectible warning or indication that the ramp is crossing a driveway.</p>	<p>AS - Add detectible warnings in accordance with FACBC 11-4.7.7.</p>
<p>The side route from the Old Courthouse crosses the driveway on the right side of the Lester Building. This is the only way to access the side entrance.</p> <p>✓ The route is a min. of 36" wide and concrete or flat, firmly set brick.</p> <p>✓ There is a sign indicating the direction to the accessible front entrance.</p> <p>⊗ The ramp from the driveway to the front sidewalk is greater than 1:20, with a run of 9' and a rise > 6".</p> <p>⊗ The route across the driveway is a continuation of the ramp on each side with a slope greater than 1:20.</p> <p>⊗ There is no tactile detectible warning or indication that the ramp is crossing a driveway.</p>	<p>AS - Replace ramp with one that has a maximum slope of 1:10 in accordance with the special provisions of FACBC 11-4.1.6 (3)(a) or,</p> <p>AS - Add handrails to the ramp in accordance with ADAAG 4.8.5., or</p> <p>AS - Reform as an inset curb cut.</p> <p>FSS - Repave and relay the bricks to eliminate the sloped route.</p> <p>AS - Add detectible warnings in accordance with FACBC 11-4.7.7.</p>

Accessible Parking

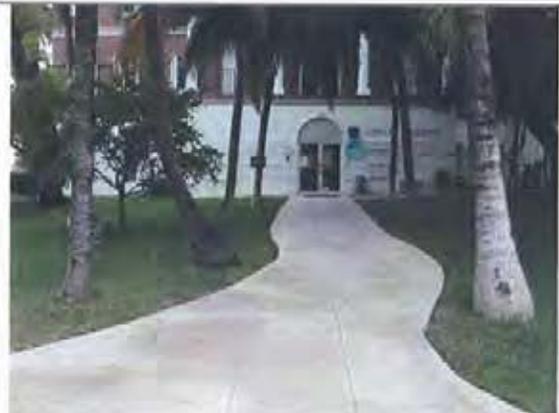
Accessible route from Whitehead St

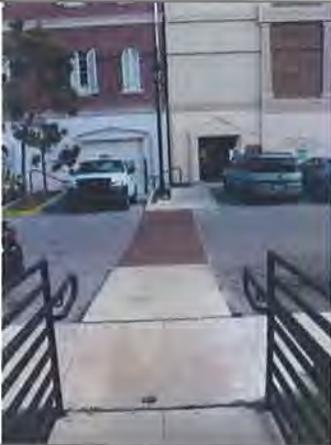
Accessible Route from Old Courthouse

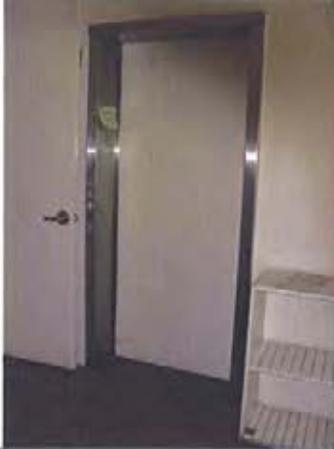
Inspection Area:	
4.3 ELEVATORS	
Observation	Recommendations
<p>The Front Elevator is located inside the front foyer, opposite the steps.</p> <ul style="list-style-type: none"> ⊗ Call buttons are not at the correct height. ✓ The signage is acceptable. Side floor indicators are appropriate. ✓ The floor indicator lights up. Direction light is acceptable. The chimes are correct. ✓ The floors are level. The car size is accessible. ✓ The door opening and closing times are correct. However, ⊗ Door closes after 3 seconds when obstructed instead of the required 20. 	<ul style="list-style-type: none"> AS - Change location of call buttons in accordance with ADAAG 4.10.3. AS - Adjust open and close times.

Front Elevator

4.3 Elevators									
011	Front Elevator located inside the front foyer	Elevator hall call button is not mounted at 42" (1067 mm) above the finished floor to centerline.	§4.10	Relocate elevator hall call button and mount at 42" (1066 mm) above the finished floor to centerline (ADAAG Fig. 20).	10	\$585.00	2	Sub-contractor	
012		Elevator door reopening device causes elevator doors to remain open for 3 seconds.	§4.10	Adjust elevator door reopening device to remain open for at least 20 seconds.	10	\$398.00	2	Sub-contractor	
013	Rear Elevator	Elevator hall call button is not mounted at 42" (1067 mm) above the finished floor to centerline.	§4.10	Relocate elevator hall call button and mount at 42" (1066 mm) above the finished floor to centerline (ADAAG Fig. 20).	10	\$585.00	2	Sub-contractor	
014		Audible position indicator in elevator car does not sound as the car passes or stops at floors served by the elevator.	§4.10	Provide an audible car position indicator device in elevator car. Audible signal shall sound as the car passes or stops at floors served by the elevator.	10	\$783.00	2	Sub-contractor

015		The visual position indicator in elevator car do not light up on all floors.	§4.10	Provide a visual car position indicator mounted above the car control panel or over the door. Numerals shall illuminate as the car passes or stops at floors served by the elevator.	10	\$783.00	2	Sub-contractor	
016		Elevator door reopening device causes elevator doors to remain open for 3 seconds.	§4.10	Adjust elevator door reopening device to remain open for at least 20 seconds.	10	\$398.00	2	Sub-contractor

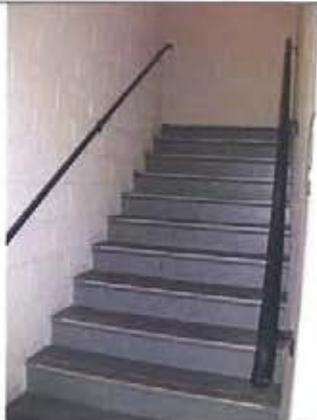
Front Stairs

021		Stairs have a 10" (254 mm) tread and open risers.	§4.9	Rework stairs to provide a flight of stairs with closed risers, uniform riser height and treads no less than 11" (280 mm) wide (ADAAG Fig. 19).	10	\$8,500.00	2	A/E	
022		Stair handrails do not have the correct diameter.	§4.26	Replace stair handrails to provide a 1.25" to 1.5" (32 mm to 38 mm) wide gripping surface (ADAAG Fig. 39).	10	\$866.64	2	Sub-contractor	
023	Rear Stairs	Stair handrails extensions do not extend beyond the top and bottom steps.	§4.9	Provide handrails extensions 12" (304 mm) min. beyond the top and bottom of the stair segment (ADAAG Fig. 17).	10	\$160.00	1	Sub-contractor

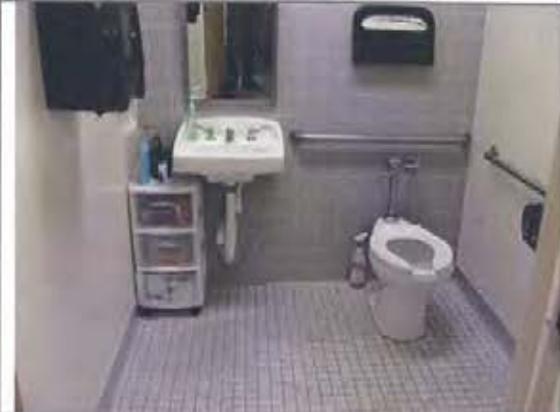
Unisex Restroom in Clerk's Area

5.3 Restrooms									
026	Accessible Restroom	Non-compliant door opening force of 12 lbf.	§4.13	Adjust or replace door closer, maintain door hinges to provide an opening force not to exceed 5 lbf.	14	\$50.00	3	Maintenance	
027		Door closing time is less than 3 seconds.	§4.13	Provide a sweep period of 3 seconds min. measured from 70° open position to 3" (76 mm) from door latch.	14	\$50.00	2	Maintenance

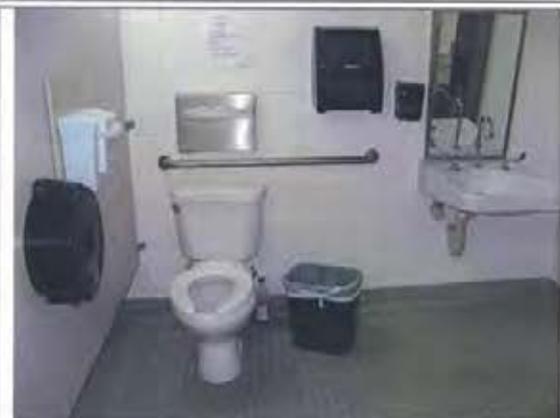
Women's Restroom in Hallway

035	Women's Accessible Restroom	Non-compliant door opening force of 22 lbf.	§4.13	Adjust or replace door closer, maintain door hinges to provide an opening force not to exceed 5 lbf.	14	\$50.00	3	Maintenance	
036		Door closing time is less than 3 seconds.	§4.13	Provide a sweep period of 3 seconds min. measured from 70° open position to 3" (76 mm) from door latch.	14	\$50.00	2	Maintenance	
037		Water closet is centered at 17" (432 mm) from side wall.	§4.16	Relocate water closet and center at 18" (457 mm) from side wall (ADAAG Fig. 28).	14	\$1,029.03	3	Sub-contractor	
038		Water closet does not have a side wall grab bar.	§4.16	Install a 42" (1066 mm) min. long side wall grab bar at 54" (1371 mm) min. perpendicular from rear wall to centerline of outer flange and mount between 33" and 36" (838 mm - 914 mm) above the finished floor to centerline (ADAAG Fig. 29 a, b).	14	\$380.20	3	Maintenance	
039		Toilet tissue dispenser is mounted at more than 36" (914 mm) from rear wall to outer leading edge.	§4.17	Relocate toilet tissue dispenser at 36" (914 mm) max. (perpendicular) from back wall to outer leading edge (ADAAG Fig. 30 d).	14	\$110.00	3	Maintenance

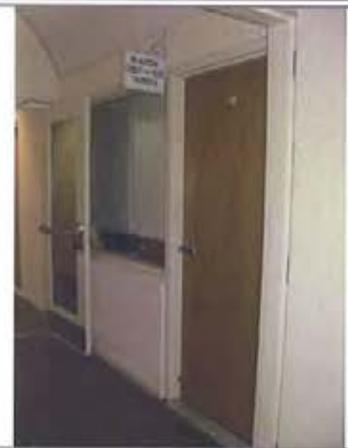
ADA Inspection Item: 5.6 COMMISSIONER'S OFFICE	
Summary: The Commissioner's office is immediately past the elevator on the right.	
Observation	Recommendations
<ul style="list-style-type: none"> ⊗ The entrance door and all interior doors require more than 10 lbs to open. ⊗ The fire extinguisher in the storage room is an obstruction. The general office space has open pathways and firm flooring. 	<p>RAS - Adjust the doors in accordance with FACBC 11-4.13.11</p> <p>AS - Install low profile fire extinguishers that do not protrude more than 4" from the wall, or relocate out of the path of travel and add a detectable warning beneath the fire extinguisher.</p>

Door to Commissioner's Office

5.6 Commissioner's Office									
045	Entrance door and all interior doors	Non-compliant door opening force of 12 lbf.	§4.13	Adjust or replace door closer, maintain door hinges to provide an opening force not to exceed 5 lbf.	17	\$50.00	3	Maintenance	
046		Fire extinguisher protrudes into walkway, projecting 4" (102 mm) from back wall.	§4.4	Relocate or recess fire extinguisher so that it does not project more than 4" (101 mm) from back wall to outer leading edge (ADAAG Fig. 8).	17	\$239.14	2	Maintenance

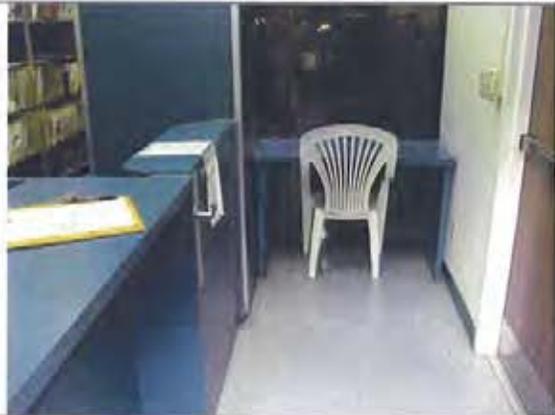
Observation	Recommendations
<p>⊗ There are no compliant signs or Braille signage at the entrance door.</p> <p>✓ The double doors are accessible.</p> <p>The center counter is at 41" and does not have knee space or the proper writing area. However, side tables are provided that are 30" high and have 27" clear. The counter gate is 34" clear with a lever handle.</p> <p>✓ There are no obstructions in the entry or hallways.</p> <p>✓ There are alarm strobes and exit signs.</p> <p>⊗ The door to the evidence room has round handles and a cipher lock.</p> <p>✓ The tile floors are in good condition.</p> <p>✓ The rear emergency door is accessible.</p>	<p>AS -Install signage in accordance with ADAAG 4.30.6.</p> <p>AS – Install lever type door handles.</p>
<p>The room is full of mechanical file stacks. The stacks operate with large wheel handles and open to 36" wide. Upper shelves are non-accessible, but the racks themselves are accessible.</p>

File Room Counter

8.2 Interior Routes									
*064	Reception area	Counter is mounted at 43" (1041 mm) above the finished floor to top.	§7.2	Rework (cut out) a portion of the main counter 36" (914 mm) max. above the finished floor to top and 36" (914 mm) min. in length.	N/A	\$372.14	4	Sub-contractor	
*065	Single Door	Doorway opening has a clear width of 29" (737 mm).	§4.13	Rework doorway (partition) to provide the required 32" (812 mm) min. clear door or entryway width (ADAAG Fig. 24).	N/A	\$1,583.36	2	A/E	
066		Non-compliant door opening force of 10 lbf.	§4.13	Adjust or replace door closer, or provide an automatic door opener to maintain door hinges to provide an opening force not to exceed 5 lbf.	N/A	\$1,500.00	2	Sub-contractor	
067		Door closing time is less than 3 seconds.	§4.13	Provide a sweep period of 3 seconds min. measured from 70° open position to 3" (76 mm) from door latch.	N/A	\$50.00	2	Maintenance

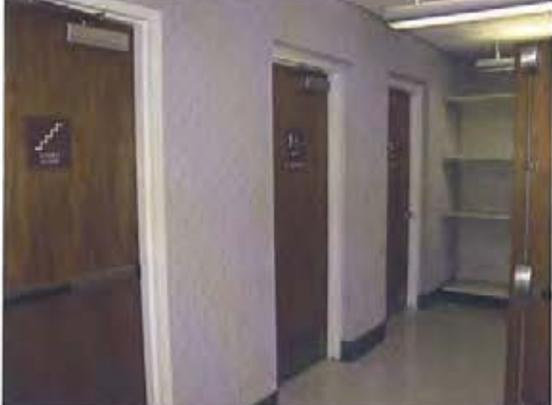
<p>Entrance to Restrooms and Stairs</p>	<p>Women's Restroom</p>

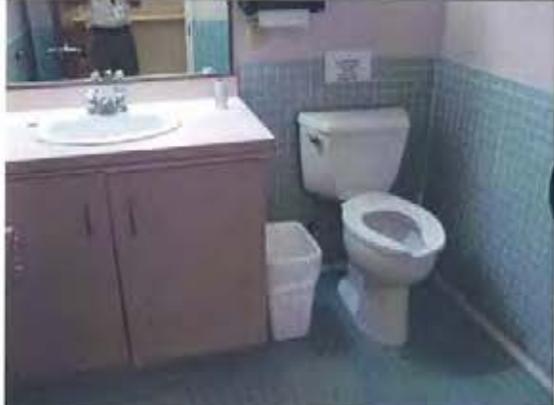
discussed above.	
<p>Restrooms</p> <p>⊗ There are two restrooms in this area, one for men, and one for women. They are marked as accessible (with incorrect signage). However, neither restroom is accessible. There is inadequate floor space to make these rooms accessible.</p>	<p>TI – These restrooms cannot be made accessible within the confines of the building.</p> <p>RAS – Change the existing signage to indicate non-accessible restroom.</p>

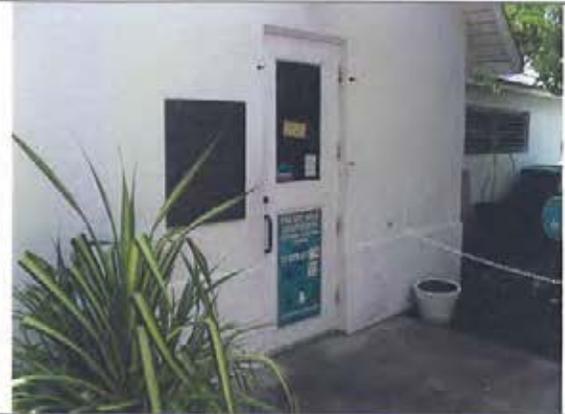
Main Entrance

Observation	Recommendations
<p>Main Entrance Door</p> <ul style="list-style-type: none"> ⊗ This door has 31" clear and opens out. ⊗ It requires more than 20 lbs of force to open. ⊗ There is no Braille signage indicating the entrance. 	<p>RA\$ - Provide proper signage in accordance with FACBC 11-4.6.4.</p> <p>RA\$ - Adjust the door to have an opening pressure less than 8.5 lbs per FACBC 11-4.13.</p>
<p>Parking Lot Door</p> <p>This double door acts as the primary accessible entrance to the gift shop area.</p> <ul style="list-style-type: none"> ⊗ Although the entrance is within sight, there is no sign indicating it as an accessible entrance. ⊗ There is no Braille signage at the door. ⊗ The door requires more than 15 lbs to open. 	<p>RA\$ - Provide proper signage in accordance with FACBC 11-4.6.4.</p> <p>RA\$ - Adjust the door to have an opening pressure less than 8.5 lbs per FACBC 11-4.13.</p>

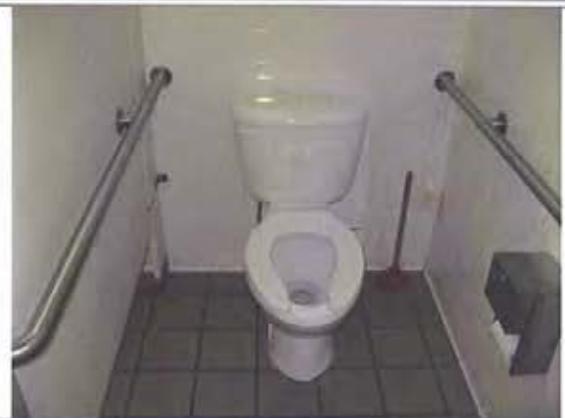
Typical Inaccessible Stall

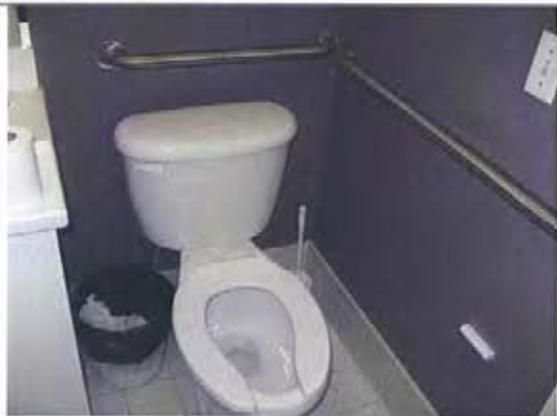
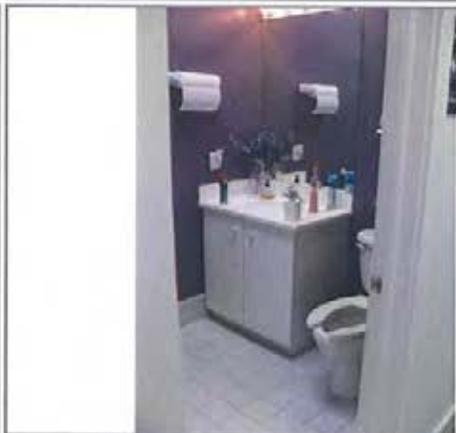
Unisex Restroom

Inspection Area: 2.11 PUBLIC RESTROOMS	
Observation	Recommendations
<p>Women's Room This restroom is not accessible and is not marked as such. It is too small to be made accessible. ☒ The door has only 30" clear.</p>	<p>TI – This room cannot be made accessible within the confines of the structure.</p>
<p>Men's Restroom This restroom is not accessible and not marked as such. ☒ The door has only 30" clear. The room is 11'-0" x 6'-11" and large enough to be reconfigured as an accessible unisex restroom.</p>	<p>ASS - It is recommended that this room be reconfigured to be the accessible unisex restroom.</p>

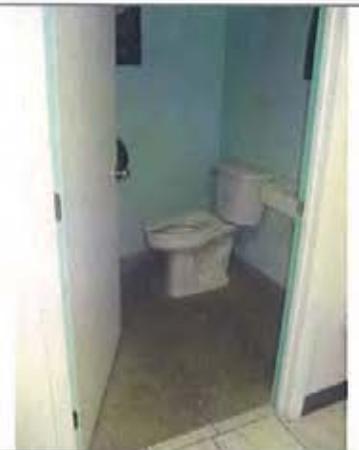
Non-Accessible Restroom

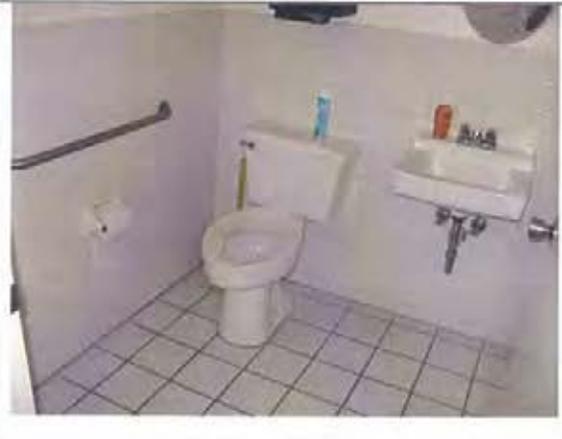
<p>Unisex Accessible Restroom</p> <ul style="list-style-type: none"> ⊗ There is no sign for accessible restrooms. ⊗ The room is 5'-5" x 5'-10" and does not have the proper clear floor area. ⊗ The door opens in. The door has 34" clear and does not have a self-closure. It has twist type handles. ✓ The toilet is compliant. ⊗ The grab bar is on the side wall only. ⊗ Paper towel dispenser is not compliant. ⊗ The sink is 34" high and has twist type faucet handles. ⊗ Water pipes are not covered. 	<p>Some efforts can be undertaken to make the restroom more accessible.</p> <p>RAS - Add the proper signage in accordance with ADAAG 4.1.6</p> <p>RAS - Replace the door handles with lever type.</p> <p>AS - Install grab bars in accordance with FACBC 11-4.16.4</p> <p>RAS - Apply protective wrap to the hot water supply lines.</p>
<p>A restroom near the Technical Office is completely inaccessible and too small to be reconfigured.</p>

<p>Stairs</p>	<p>Unisex Restroom</p>

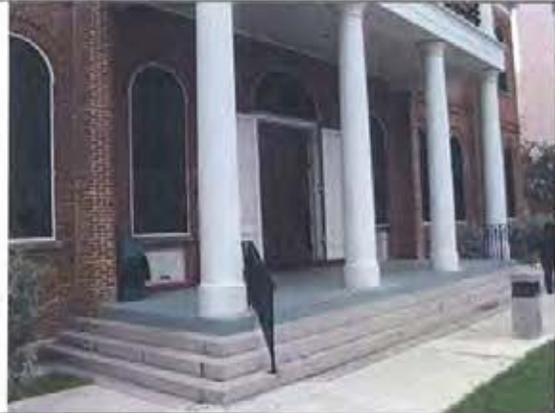
Main Entrance

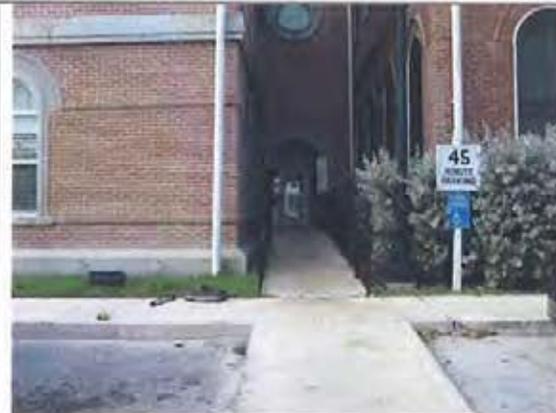
Left Accessible Entrance

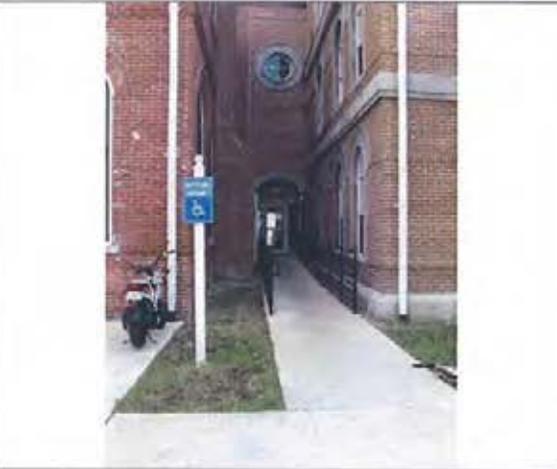
<p>accessible entrance. This sign faces the route from the Lester Building.</p>	
<p>Right Side Entrance (Jefferson Browne side)</p> <ul style="list-style-type: none"> ⊗ The door has 33" clear, closes in > 3 seconds, but requires 12 lbs to open. ✓ The door has a panic bar on the inside and lever handles on the outside. ✓ The threshold is < ½". ⊗ The door opens onto a level area that has a gap adjoining the ramp area > ½". 	<p>RAS - Adjust the door in accordance with FACBC 11-4.13.11, or</p> <p>AS - Add an automatic door opener.</p> <p>RAS - Fill the gap with grout to obtain a smooth surface, or gaps not greater than ½".</p>
<p>The Right Entrance Ramp begins just beyond the covered door area.</p> <ul style="list-style-type: none"> ✓ The slope is 1:12. ✓ The railings are inside a higher railing and at 34". ✓ The railings extend at the top and bottom of the ramp. ✓ The ramp ends on a level landing area that extends to the sidewalk. ⊗ There is a sign at the bottom of the ramp indicating the accessible entrance. This sign faces the street and not the accessible route. 	<p>RAS - Change the sign so that it can be seen from the front of the building.</p>

<p>Right Accessible Entrance</p>

022	Right side entrance (Jefferson Browne side)	Door has a non-compliant door opening force of 12 lbf.	FBC§11-4.13	Adjust or replace door closer, maintain door hinges to provide an opening force not to exceed 8.5 lbf.	10	\$1,500.00	2	Sub-contractor	
023		Doorway has a vertical change in level greater than 0.5" (13 mm).	§4.5	Rework area and provide a 0.5" (12 mm) max. change of level, beveled with a slope no greater than 1:2 or mitigate condition by means of a ramp (ADAAG Fig. 7 c, d).	9	\$137.13	2	Sub-contractor

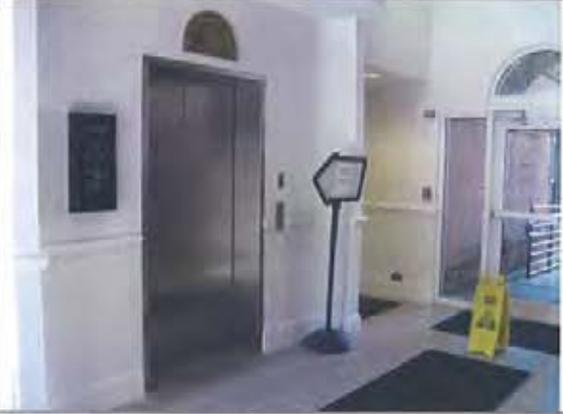
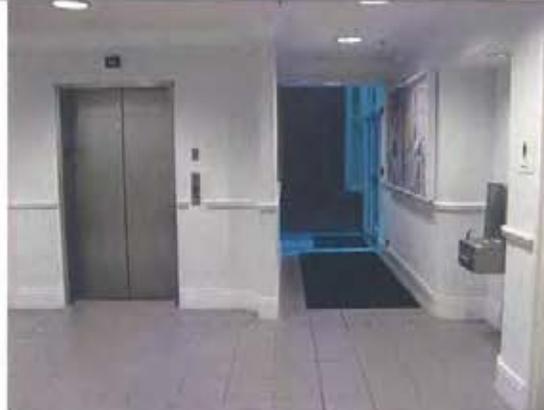
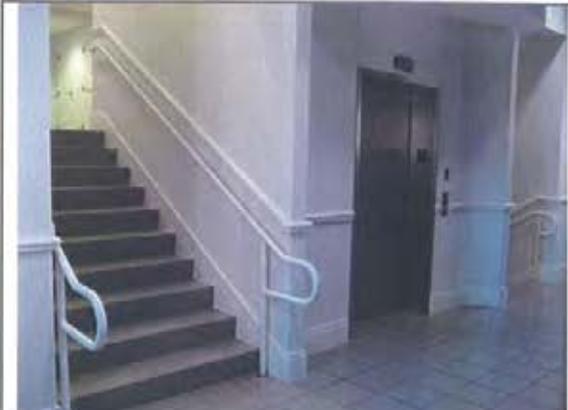
<p>Inspection Area: 4.3 ELEVATORS</p>	
<p>Observation</p>	<p>Recommendations</p>
<p>The elevator is located in the rear building section and is accessible from all areas. It has doors that open on two sides because the rear building second and third floors are half a floor off the front section of the Courthouse.</p> <ul style="list-style-type: none"> ✓ Call buttons area acceptable height with arrows as required. ✓ The signage is acceptable. Side floor indicators are appropriate. ✓ The floors are level. The car size is accessible. ✓ The door opening and closing times are correct. However, ⊗ Door closes after 7 seconds when obstructed instead of the required 20. ⊗ The floor indicators do not light up on all floors. 	<ul style="list-style-type: none"> AS - Adjust open and close times. AS - Adjust or repair the lights and chimes to meet code.

Front Historic Stairs	Front of Elevator at First Floor

Rear of Elevator at First Floor	Elevator and Stairs at Third Floor

4.3 Elevators									
024	Elevator located in the rear building section	Elevator door reopening device causes elevator doors to remain open for 7 seconds.	§4.10	Adjust elevator door reopening device to remain open for at least 20 seconds.	12	\$398.00	2	Sub-contractor	
025		Audible position indicator in elevator car does not sound as the car passes or stops at floors served by the elevator.	§4.10	Provide an audible car position indicator device in elevator car. Audible signal shall sound as the car passes or stops at floors served by the elevator.	12	\$783.00	2	Sub-contractor
