Americans with Disabilities Act Transition Plan Lower Keys - Part 1

Volume 3 of 4

Monroe County

October 29, 2010

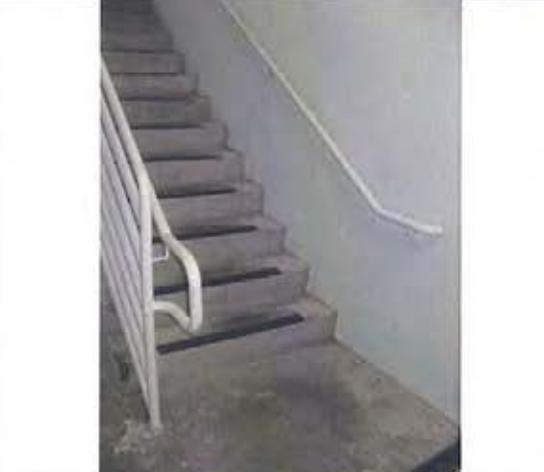
Inspection Area:	
4.4 STAIRS	
Observation	Recommendations
The Main Stairs in the central hall are historic and not accessible.	No action required.
<p>The Rear Stairs are located beyond the elevator. Access to that hall area is through a non-compliant door.</p> <ul style="list-style-type: none"> ✓ The stairs are new and completely compliant. ✓ The railings are correct. ✓ The treads are correct. The steps are the correct size. ✓ There are emergency lights at each level. 	
<p>The Center Stairs are located on each side of the elevator on the second to fourth floors. The stairs are new and completely compliant.</p> <ul style="list-style-type: none"> ✓ The railings are correct. ✓ The treads are correct. The steps are the correct size.

Rear Stairs

5.2 Interior Routes									
027	Rear door to the stairs and rear emergency exit	Door has a non-compliant door opening force of 20 lbf.	FBC§11-4.13.11	Adjust or replace door closer, maintain door hinges to provide an opening force not to exceed 8.5 lbf.	9	\$50.00	2	Maintenance

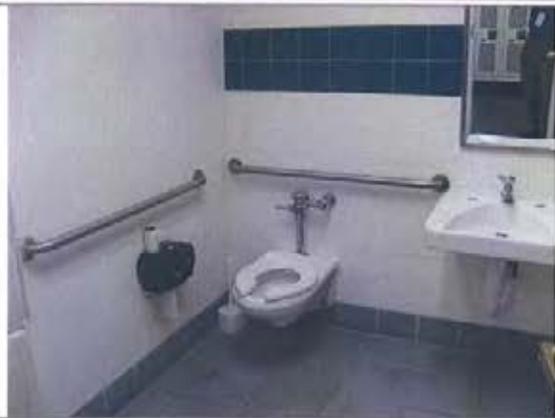
Men's Restroom

6.4 Restrooms									
064	Men's Restroom	Non-compliant door opening force of more than 10 lbf.	§4.13	Adjust or replace door closer, maintain door hinges to provide an opening force not to exceed 5 lbf.	21	\$100.00	3	Maintenance	
065		Restroom does not provide the required diameter wheelchair turnaround space in room due to boxes.	§4.2	Relocate boxes that obstruct the maneuvering clearance to provide the required clear 60" (1524 mm) min. diameter wheelchair turnaround space or a T-shaped space (ADAAG Fig. 3).	21	\$50.00	3	Maintenance	
066	Women's Restroom	Non-compliant door opening force of more than 10 lbf.	§4.13	Adjust or replace door closer, maintain door hinges to provide an opening force not to exceed 5 lbf.	21	\$50.00	3	Maintenance	
067		Water closet is centered at 21" (533 mm) from side wall.	§4.16	Relocate water closet and center at 18" (457 mm) from side wall (ADAAG Fig. 28).	21	\$1,029.03	3	Sub-contractor

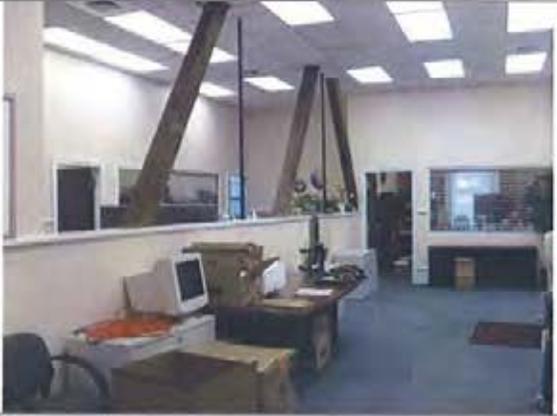
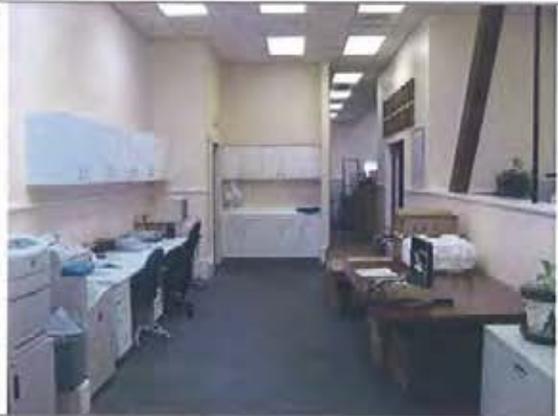
Clerk's Office Area	Clerk's Office Area

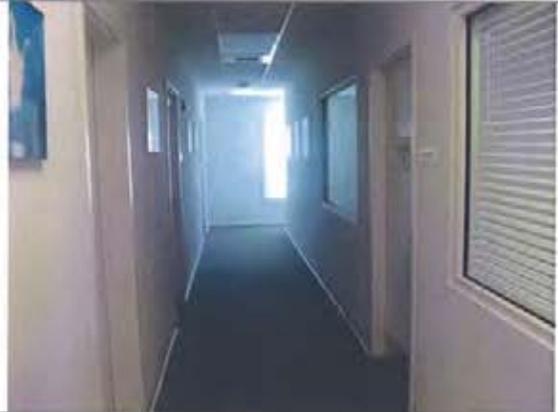
Inspection Area: 8.3 GIS AREA	
Observation	Recommendations
The Graphic Information Systems Department occupies the left side of the third floor of the annex.	
<p>⊗ The double main doors require more than 12 lbs to open and close in less than 3 seconds.</p> <p>All routes are clear, firm, and flat. All signage is correct.</p> <p>⊗ All 7 interior doors with self-closers close in less than 3 seconds or require more than 5 lbs of pressure to open.</p>	<p>RAS - Adjust the doors in accordance with FACBC 11-4.13.11.</p>

Entrance to Appraiser's Office	Hallway in GIS area

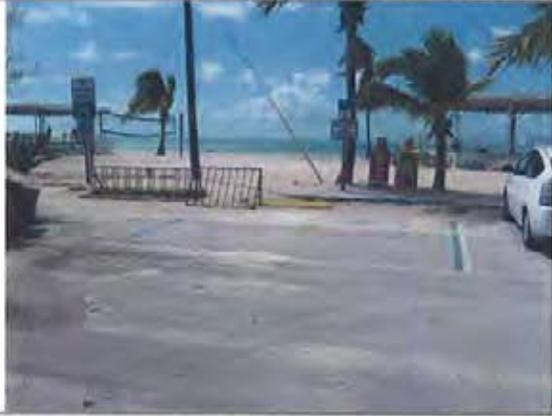
<p>and 14' long.</p> <ul style="list-style-type: none"> ⊗ It has incorrect pavement markings. ⊗ The sign is not at the correct height, and it does not have the fine indication sign. ⊗ There is no access aisle. ⊗ There is no accessible route marked to the door. ⊗ There are no signs indicating the direction to an accessible entrance. ✓ The parking space slope is less than 2% and acceptable. ✓ It is located close to the entrance. 	<p>RAS - Repaint the accessible parking area with the proper markings in accordance with FACBC 11-4.6.</p> <p>RAS - Provide proper signage in accordance with FACBC 11-4.6.4.</p>
---	---

Accessible Parking	Route to Main Entrance

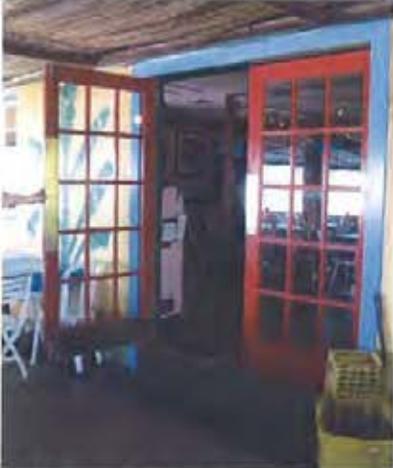
<p>Inspection Area: 4.1 ENTRANCES</p>	
Observation	Recommendations
<ul style="list-style-type: none"> ⊗ Main Entrance Door to the bar area has a 8" step up. ⊗ Door to Outside Dining has a threshold more than 3/4", a large gap, and ramps down to the floor. ⊗ Doors from Outside Dining to Bar are double doors that swing each direction. There is an 8" step. ⊗ Kitchen to Exterior has a small transition ramp that is too steep. ✓ Beach to Outside Dining this is a gate that is open during business hours and could be considered accessible 	<p>RAS - Provide proper signage to the accessible beach entrance.</p> <p>RAS - Fill the gap and smooth the threshold at the door to the outside dining.</p> <p>TI - Add a landing and ramp to the bar area in accordance with FACBC 11-4.6.4.</p>

Door from Outside Dining to Bar	Step up

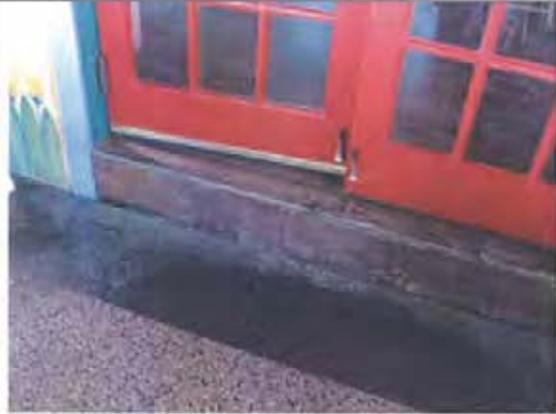
Inspection Area:	
5.0 INTERIOR ROUTES	
Observation	Recommendations
<p>Interior routes are all compliant, with the following exception:</p> <ul style="list-style-type: none"> ⊗ The floor in front of the bar has a change in elevation greater than the ½" allowed. ⊗ The route to the rear office area has a step down and the route is not accessible. <p>✓ There is a transition slope from the bar to the kitchen that is acceptable.</p>	<p>AS - Install a new transition to the bar area.</p> <p>TI - It is not possible to make these areas accessible without rebuilding major portions of the building.</p>

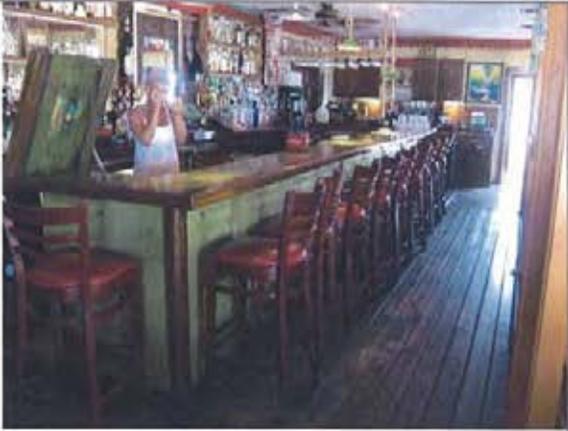
Bar area with raised floor	Non-compliant Swing doors with ramp

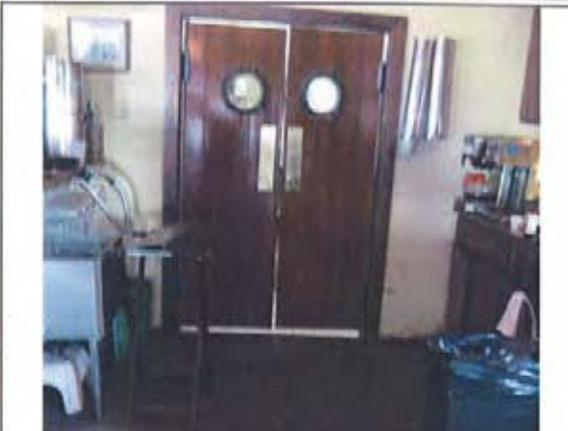
Inspection Area:	
5.1 RESTROOMS	
Observation	Recommendations
<p>There are 2 restrooms in an adjacent structure, neither of which is accessible:</p> <ul style="list-style-type: none"> ⊗ Both restrooms are out a door with an 8" step down onto a small landing. ⊗ Both restrooms doors swing out onto a non-compliant ramp. ⊗ Both restrooms have narrow turns inside to reach the toilet area. ⊗ Toilet areas are completely inaccessible. 	<p>FSS - Rebuild the restrooms to be accessible, including a new door and landing at the bar area. Provide access to the restrooms from the accessible dining area.</p>

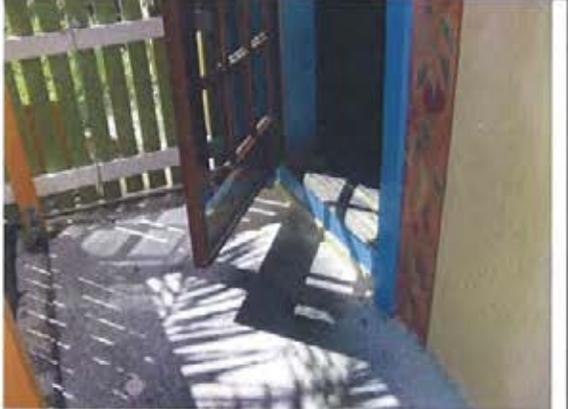
Door from bar to Restroom Area	Typical Restroom Entrance

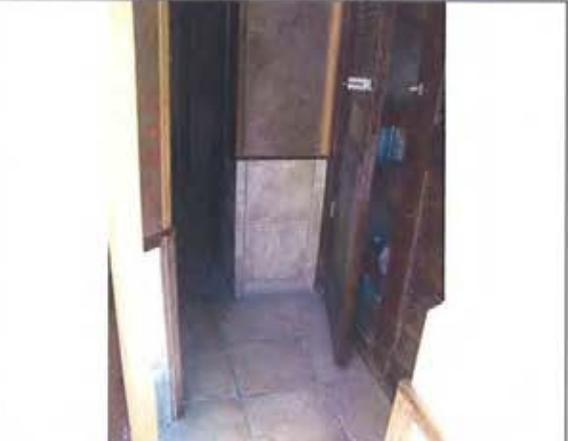
Typical Restroom Interior Route

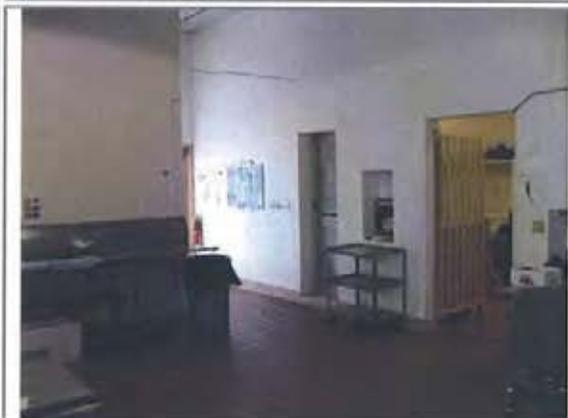
<p>system in the building.</p> <ul style="list-style-type: none">⊗ This exit is not marked with an exit sign.⊗ The sink and prep counter area in the kitchen is not accessible for wheelchair use.⊗ In general, signs are lacking and none are in Braille.	<p>access a sink and prep counter.</p> <p>AS - Install an emergency exit sign over the door from the kitchen area.</p>
--	---

Kitchen Area

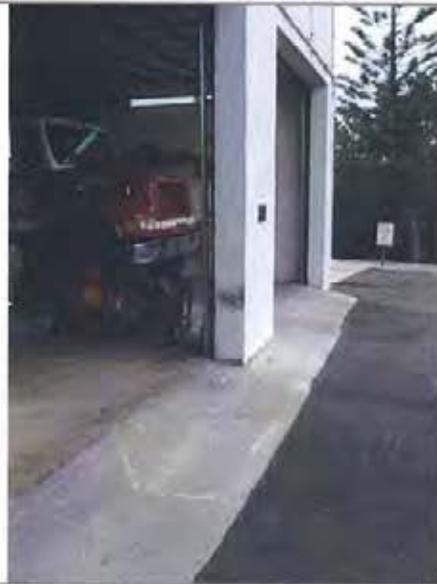
Bib with slope > 10%

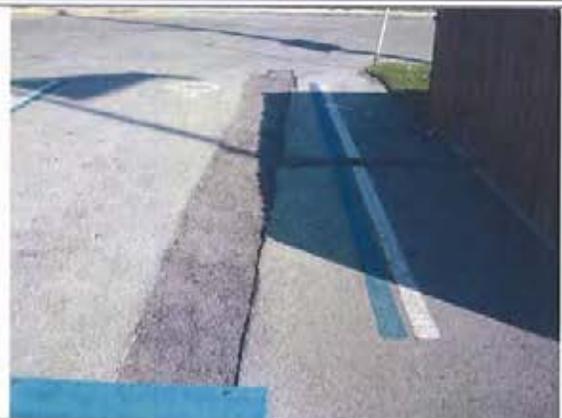
Uneven Surface at Accessible Parking

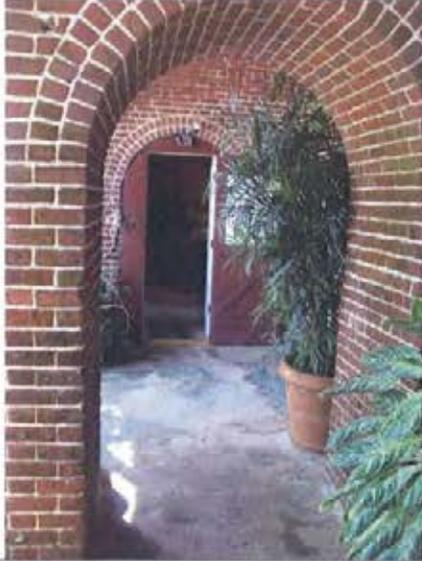
Main Entrance

Inspection Area: 4.1 ENTRANCE	
Observation	Recommendations
<p>Main Entrance Door</p> <ul style="list-style-type: none"> ⊗ The door to the Reception area is 28" wide. ⊗ It has a threshold greater than the ¾" allowed. ⊗ There is no Braille signage indicating the entrance, or interior features of the fort. 	<p>TI - This door cannot be made wider without adversely affecting the historic fabric of the building. Employee policy is to direct wheelchair visitors to a side entrance.</p> <p>RAS - Provide proper signage in accordance with FACBC 11-4.6.4.</p>

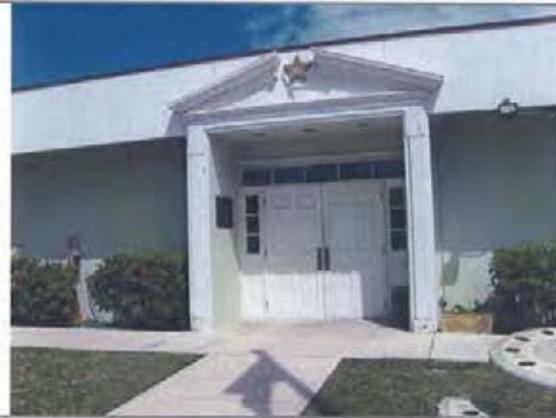
Sheriff's Entrance

5.1 Entrances									
0007	Sheriff's Main Entrance Door	Non-compliant door opening force of 11 lbf.	FBC§4.13	Adjust or replace door closer, maintain door hinges to provide an opening force not to exceed 8.5 lbf.	7	\$50.00	2	Maintenance	
0008	Sheriff's Rear Door	Non-compliant knob-type door hardware, requiring grasping and turning of the wrist to operate.	§4.13	Replace knob-type door hardware with lever or loose grip pull handle.	7	\$291.64	2	Maintenance	
0009		Door has a 6" (152 mm) vertical change in level.	§4.3	Rework area and provide a 0.5" (12 mm) max. change of level, beveled with a slope no greater than 1:2, or mitigate condition by means of a curb ramp or ramp (ADAAG Fig. 7 c, d).	7	\$3,125.71	2	A/E	
0010		Non-compliant door opening force of 15 lbf.	FBC§4.13	Adjust or replace door closer, maintain door hinges to provide an opening force not to exceed 8.5 lbf.	7	\$50.00	2	Maintenance	
0011	Fire Rescue Main Entrance	Non-compliant door opening force of 10 lbf.	FBC§4.13	Adjust or replace door closer, maintain door hinges to provide an opening force not to exceed 8.5 lbf.	7	\$50.00	2	Maintenance

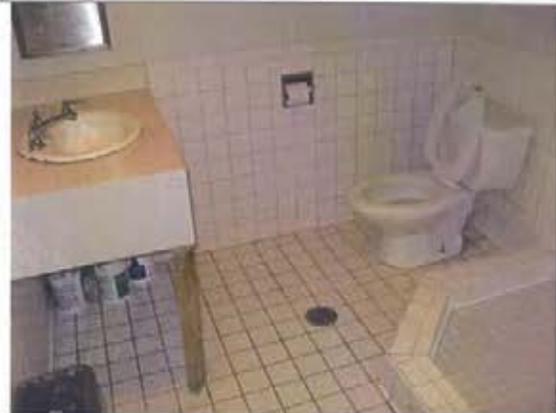
Sheriff's Common Restroom

6.1 Sheriff's Restrooms									
*0018	Common Restroom	Common restroom is not accessible.	§4.13	Reconfigure room's fixtures and/or offset partitions to provide the required 48" by 66" (1219 mm by 1676 mm) min. clear floor space for a forward approach (ADAAG Fig. 28).	N/A	\$6,052.63	3	A/E	
0019	Men and Women's Accessible Restroom	Permanent room identifying signage does not have Braille or raised characters.	§4.30	Rework/replace existing signage with signage displaying raised characters on non-glare contrasting surface, Grade 2 Braille text of same information and mount on wall adjacent to latch side of door at 60" (1524 mm) above the finished floor to centerline.	11	\$149.36	2	Maintenance	
0020		Non-compliant door opening force of 10 lbf.	§4.13	Adjust or replace door closer, maintain door hinges to provide an opening force not to exceed 5 lbf.	11	\$50.00	2	Maintenance
