Monroe County Watershed Management Plan

Draft report by:

August 2019

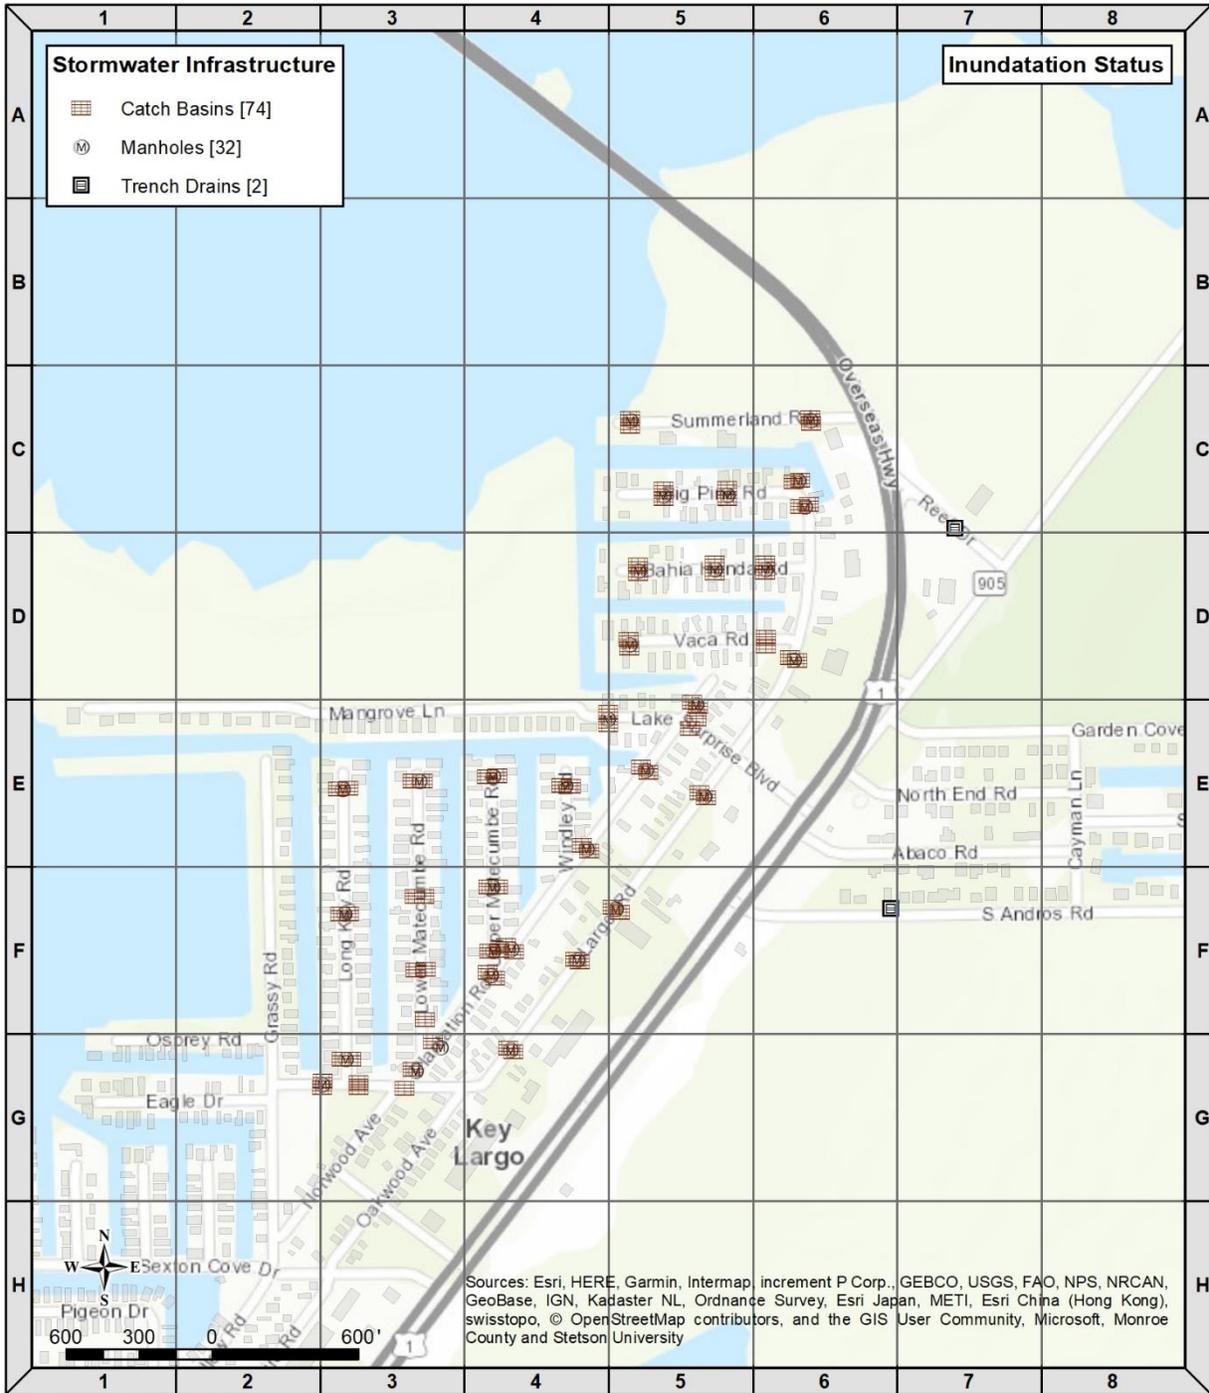
Map Series 1: Monroe County Stormwater Infrastructure Inventory with Vulnerability to Existing Tidal Flooding, 1992 – 2010 Sea Level

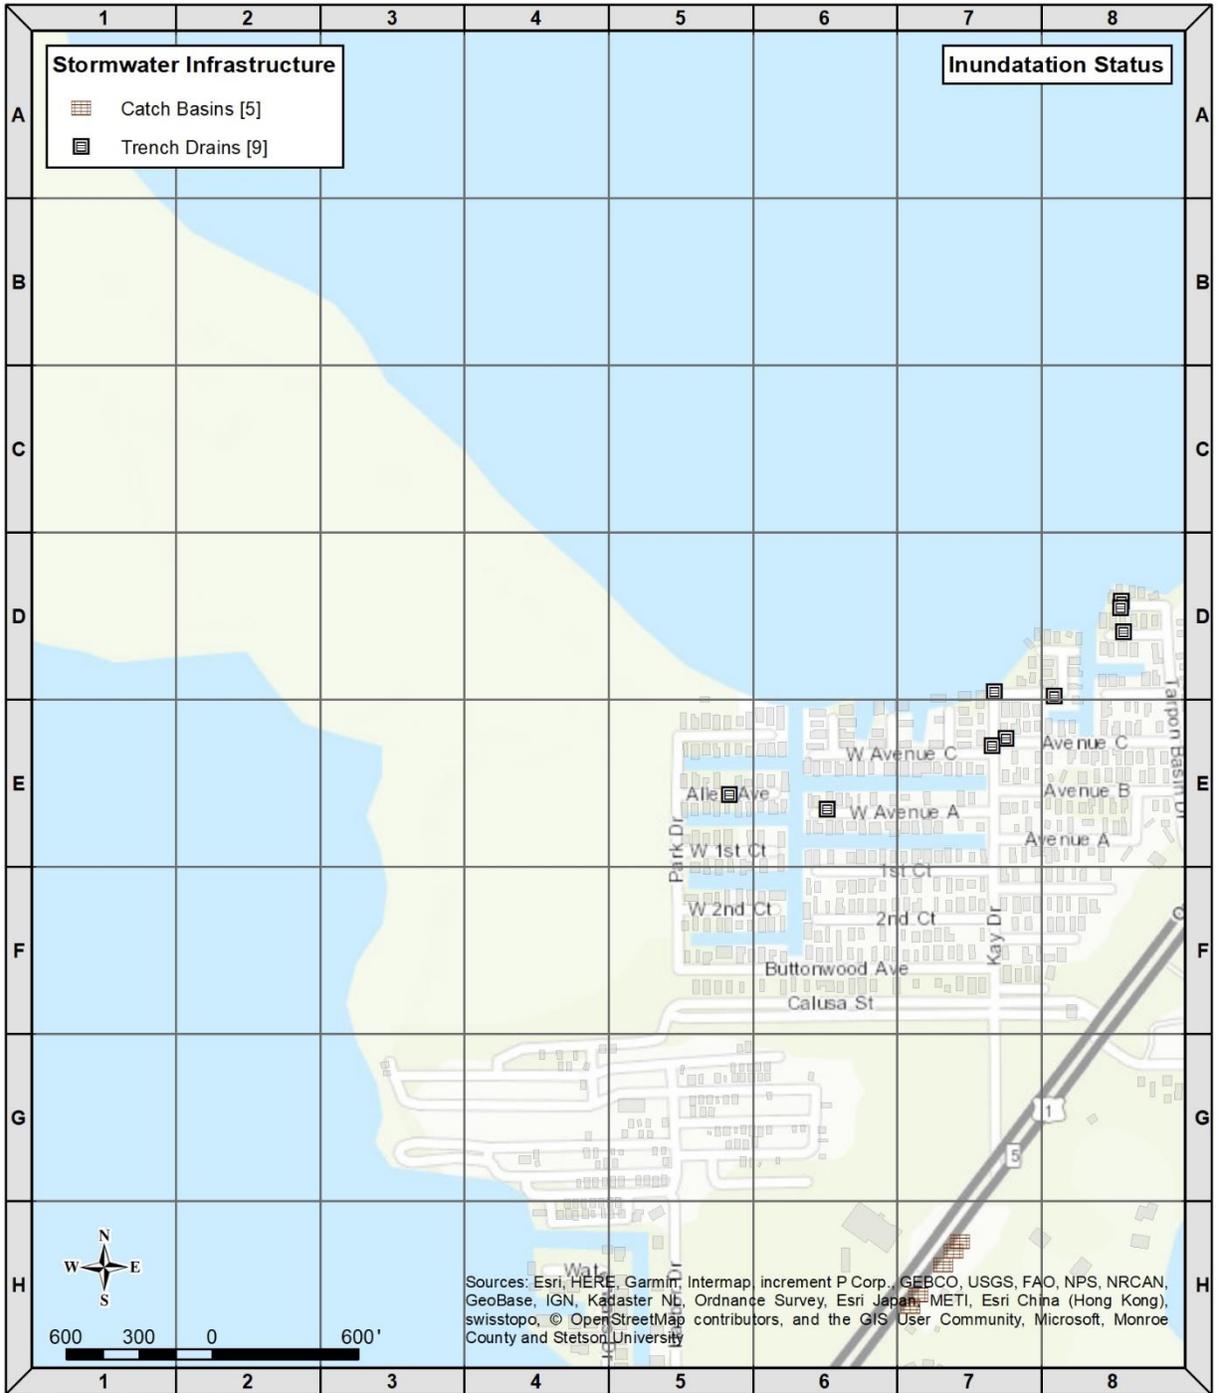
**Map Series 1: Monroe County Stormwater Infrastructure Inventory with
Vulnerability to Existing Tidal Flooding, 1992 – 2010 Sea Level**

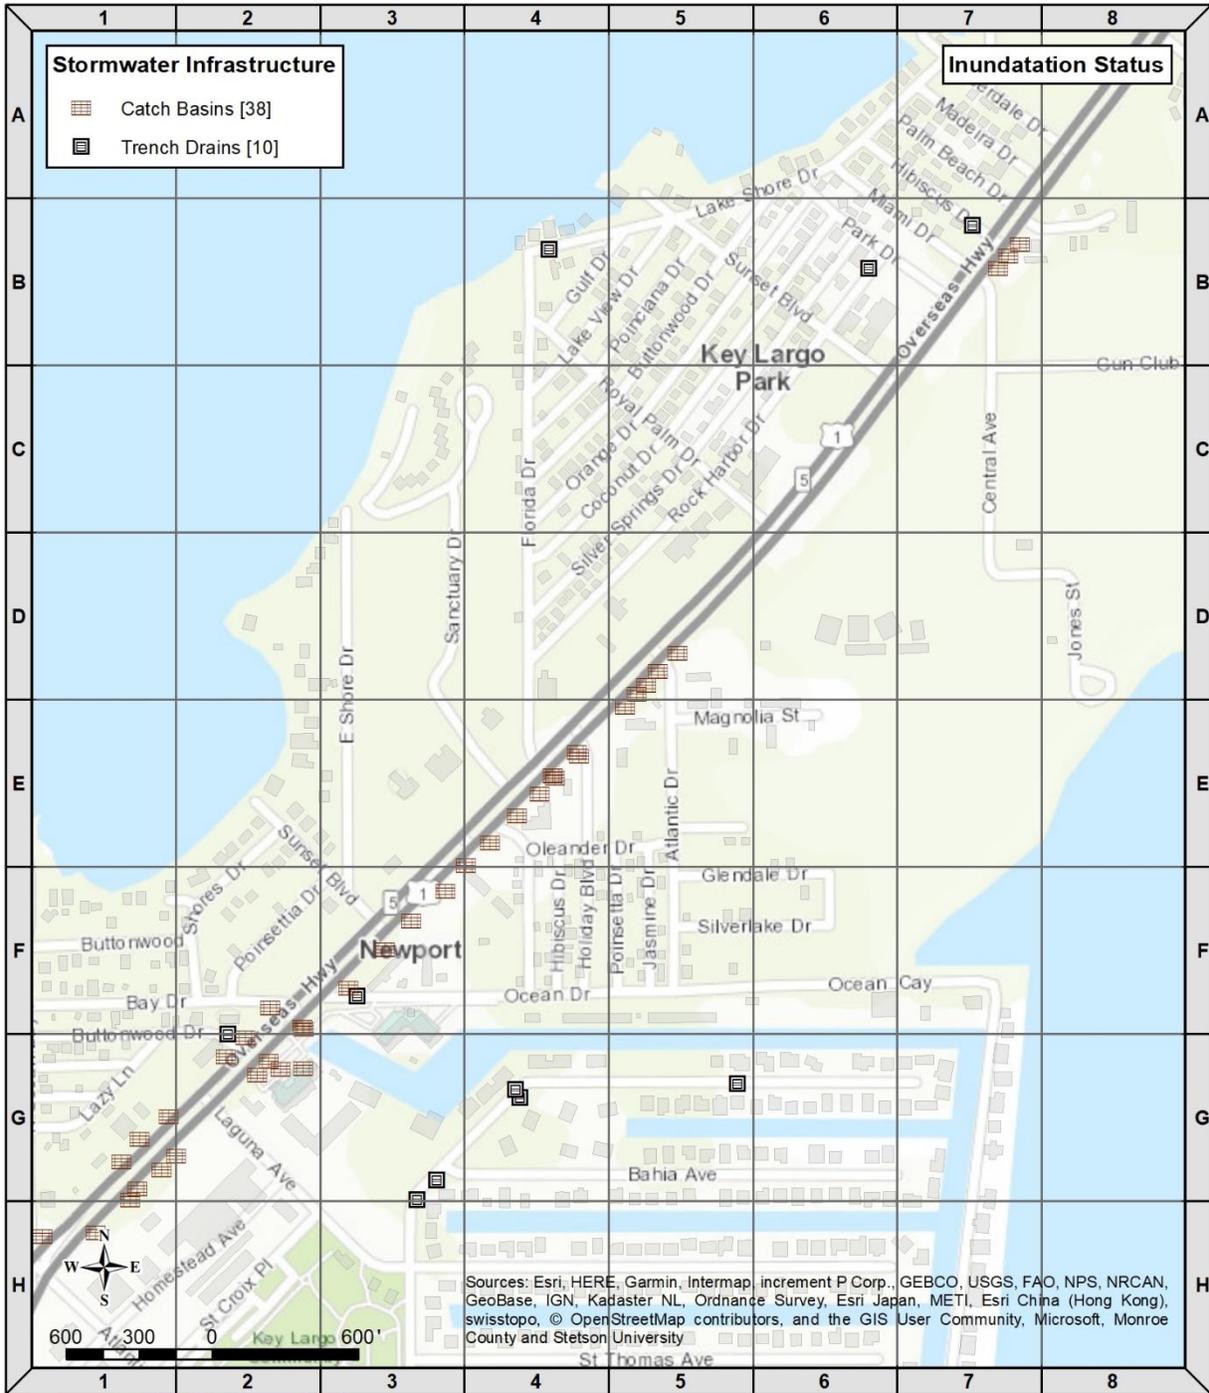
Map Series 1: Monroe County Stormwater Infrastructure Inventory with Vulnerability to Existing Tidal Flooding, 1992 – 2010 Sea Level

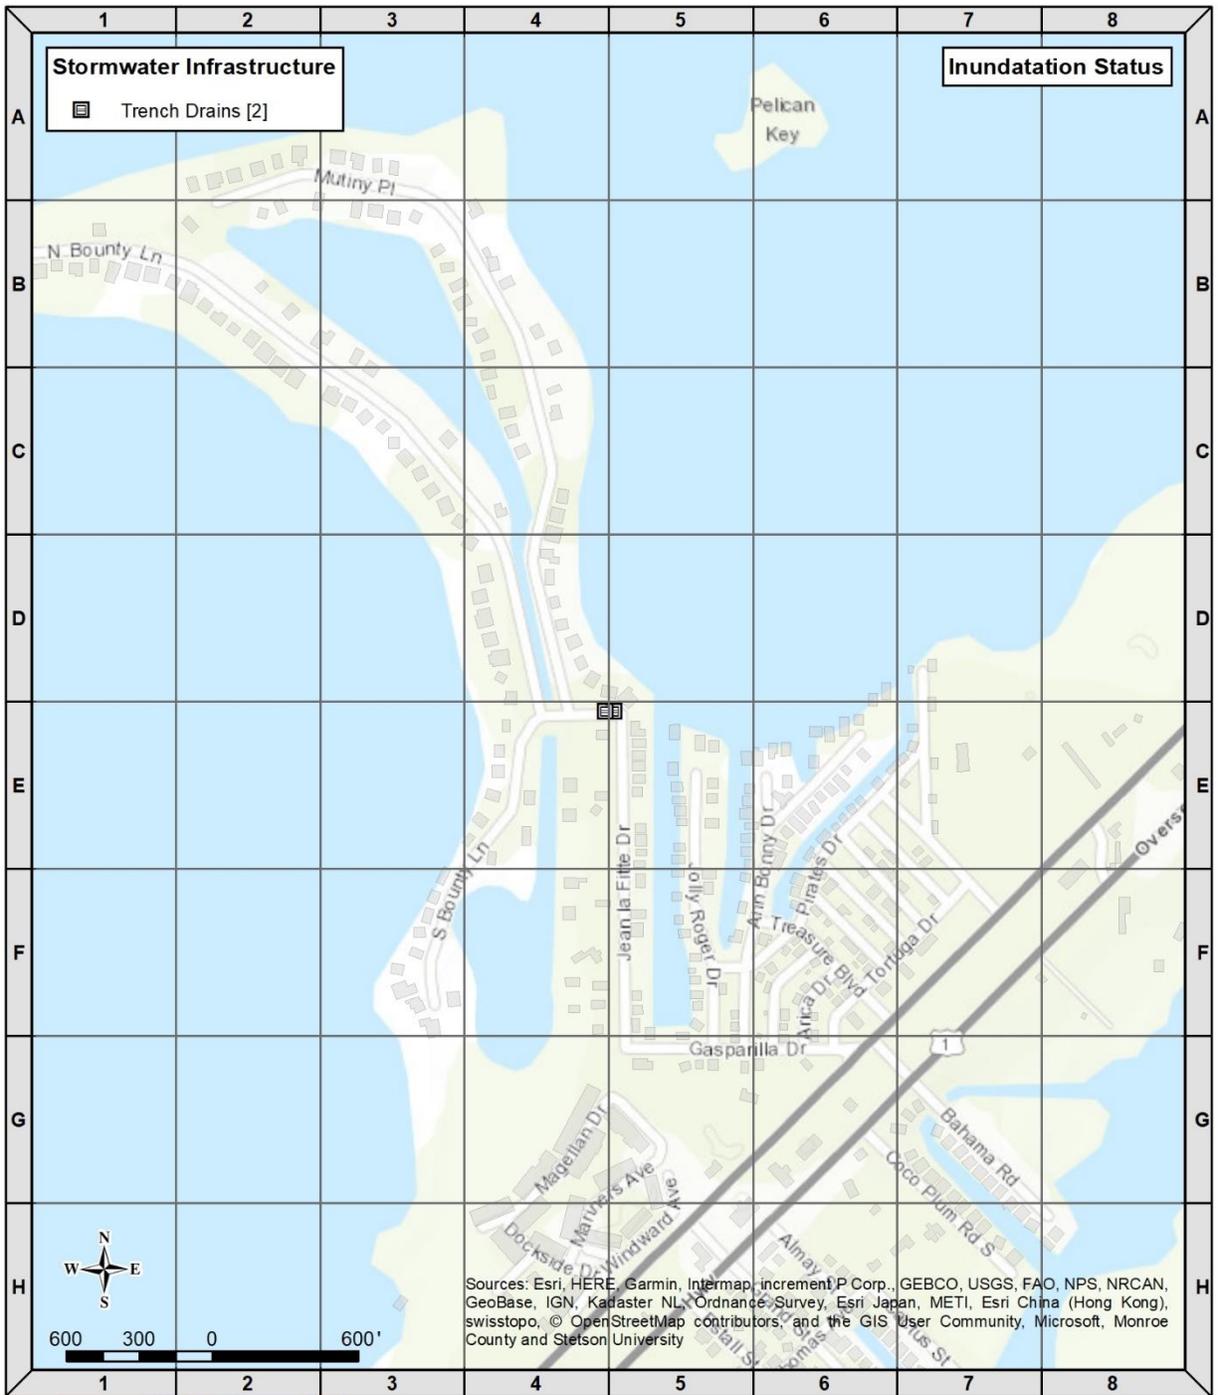
Map Series 1: Monroe County Stormwater Infrastructure Inventory with Vulnerability to Existing Tidal Flooding, 1992 – 2010 Sea Level

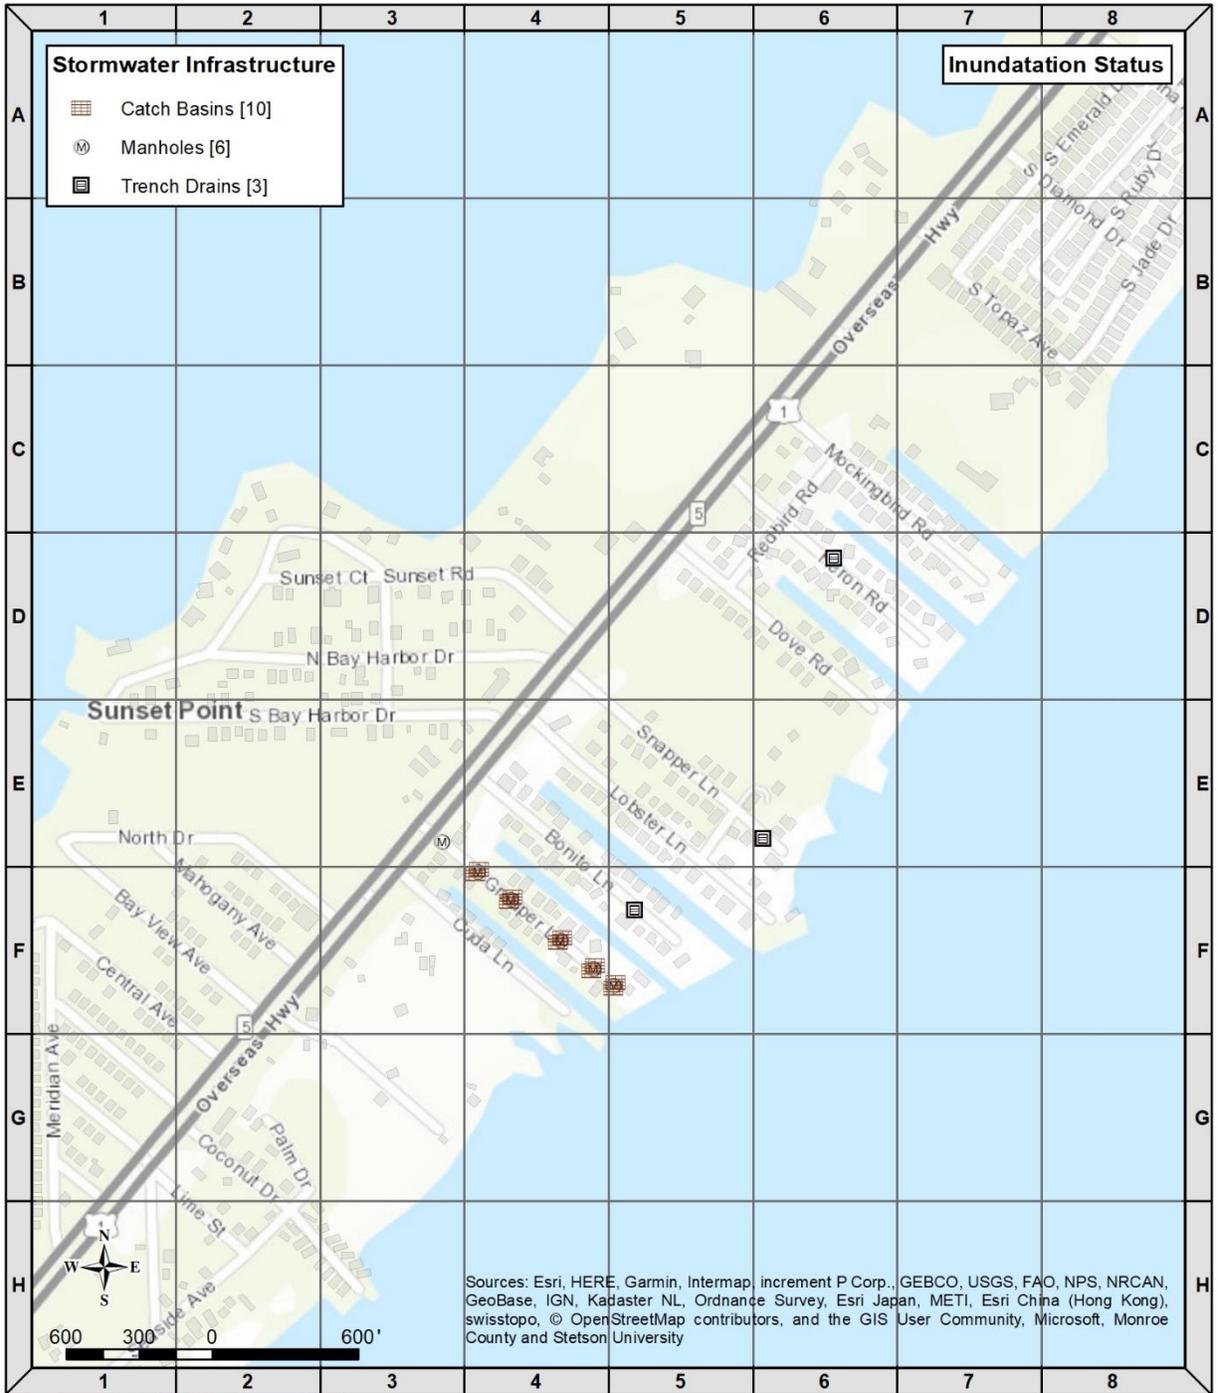
Map Series 1: Monroe County Stormwater Infrastructure Inventory with Vulnerability to Existing Tidal Flooding, 1992 – 2010 Sea Level

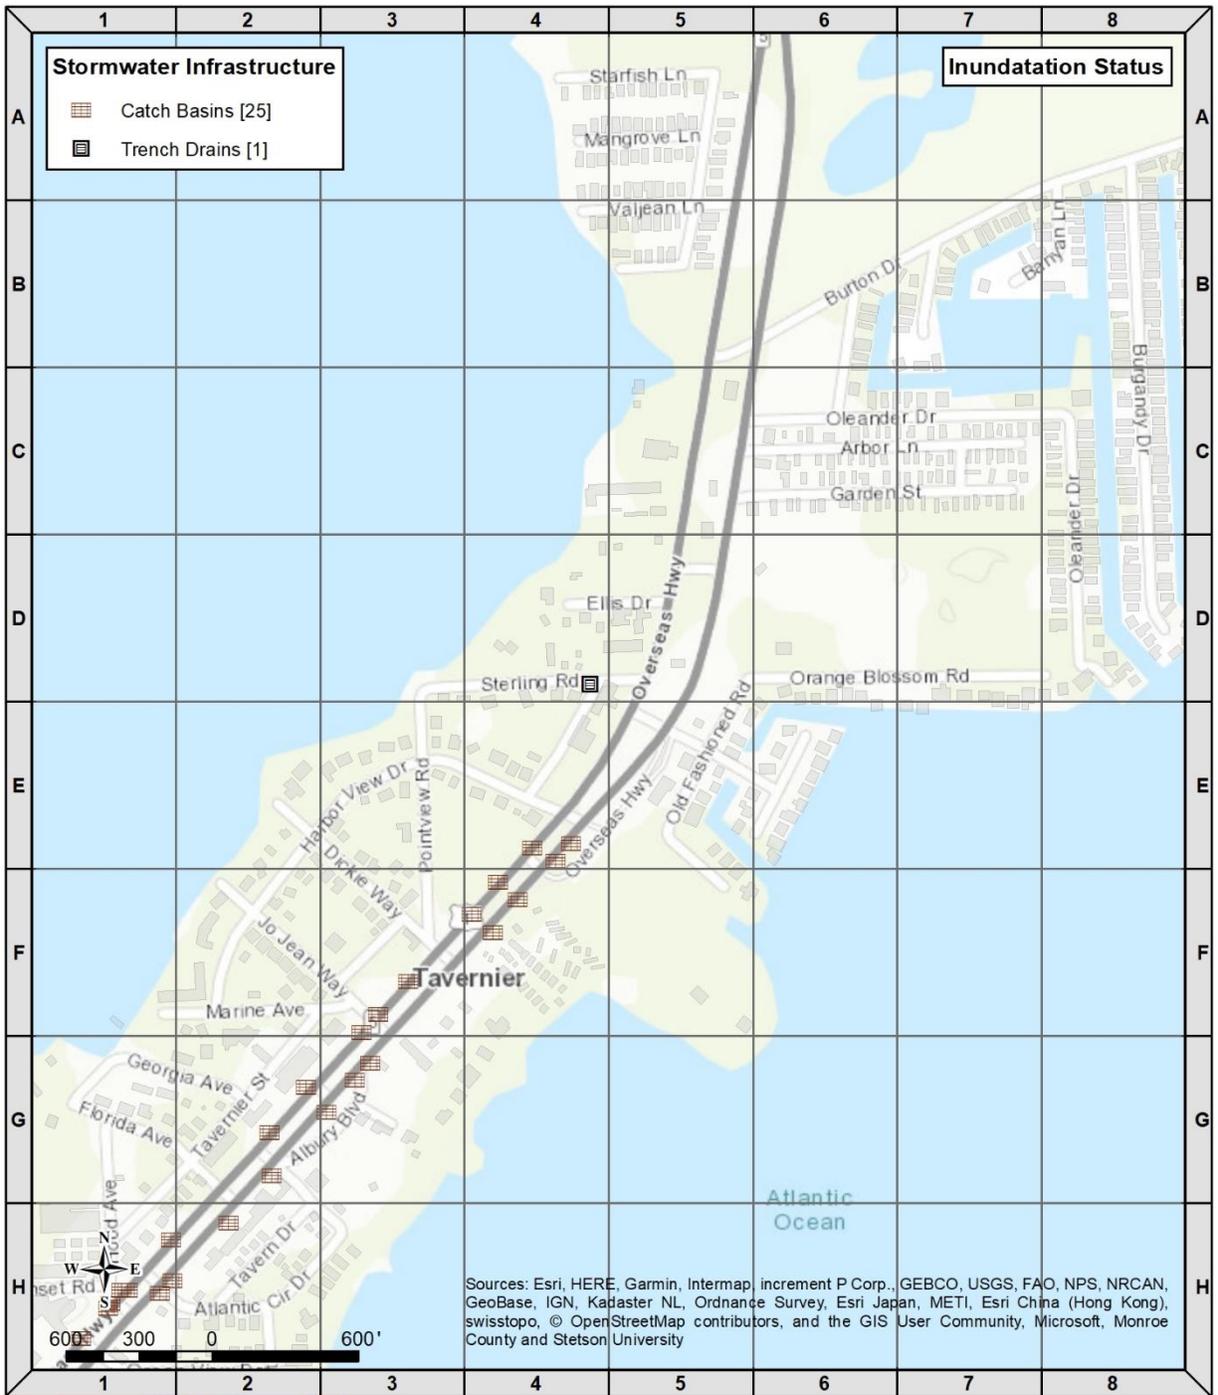
Map Series 1: Monroe County Stormwater Infrastructure Inventory with Vulnerability to Existing Tidal Flooding, 1992 – 2010 Sea Level

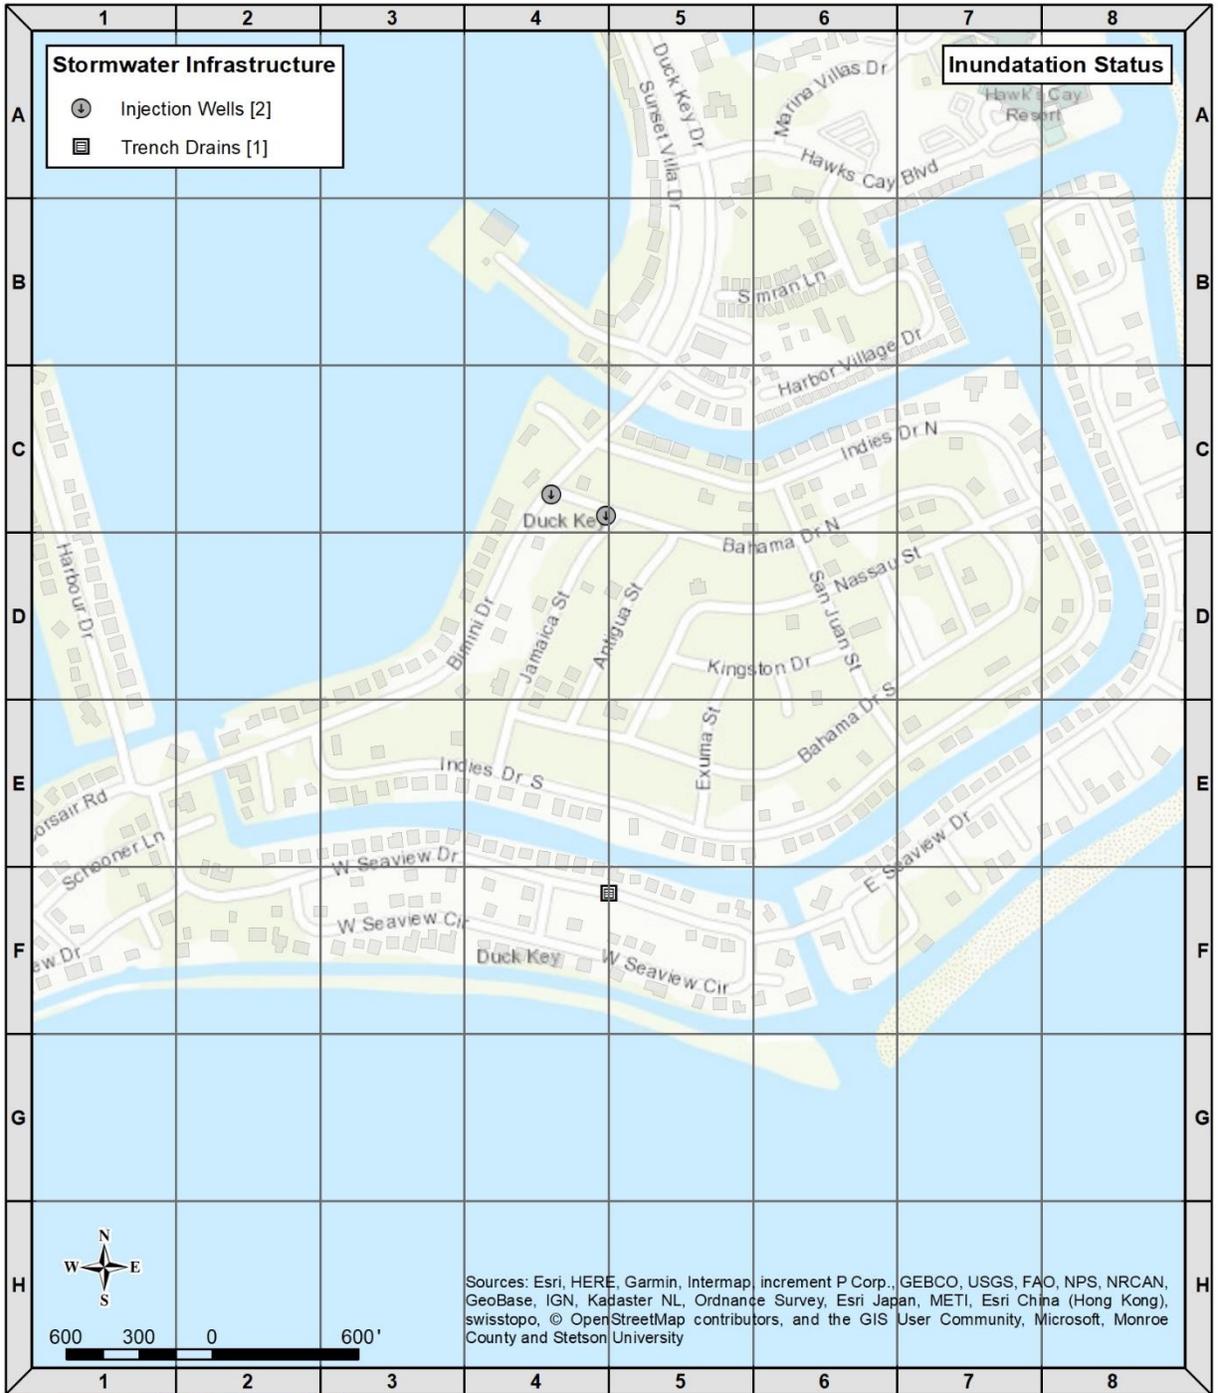
Map Series 1: Monroe County Stormwater Infrastructure Inventory with Vulnerability to Existing Tidal Flooding, 1992 – 2010 Sea Level

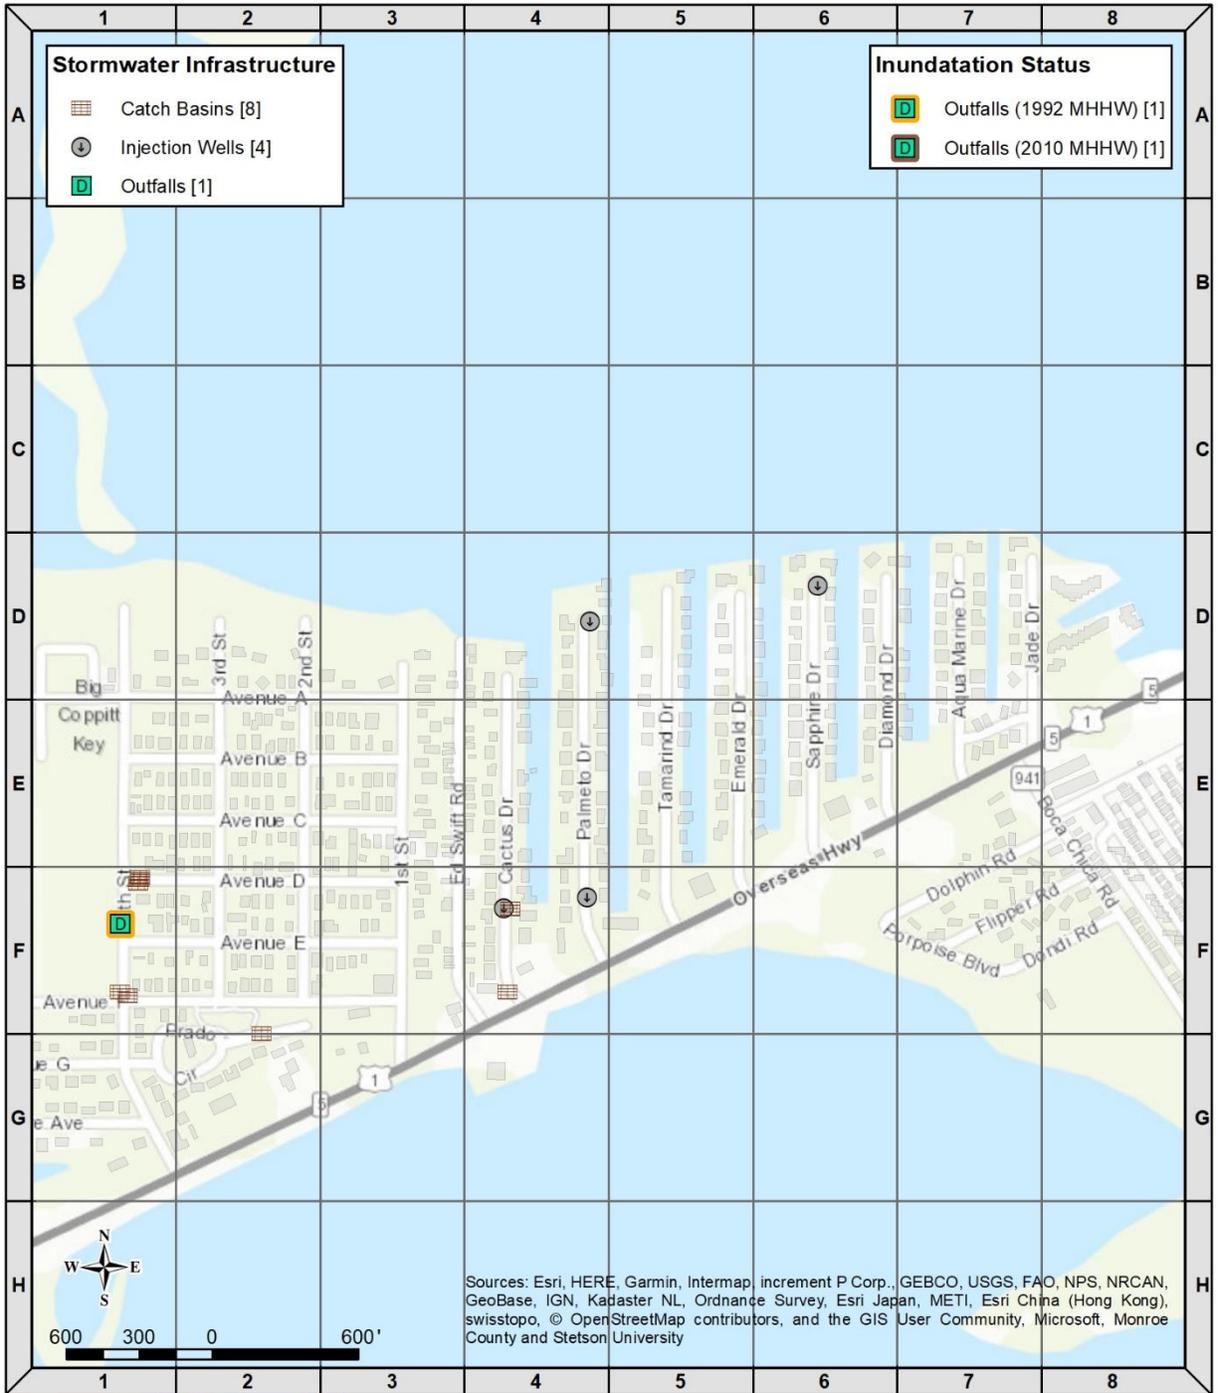
Map Series 1: Monroe County Stormwater Infrastructure Inventory with Vulnerability to Existing Tidal Flooding, 1992 – 2010 Sea Level

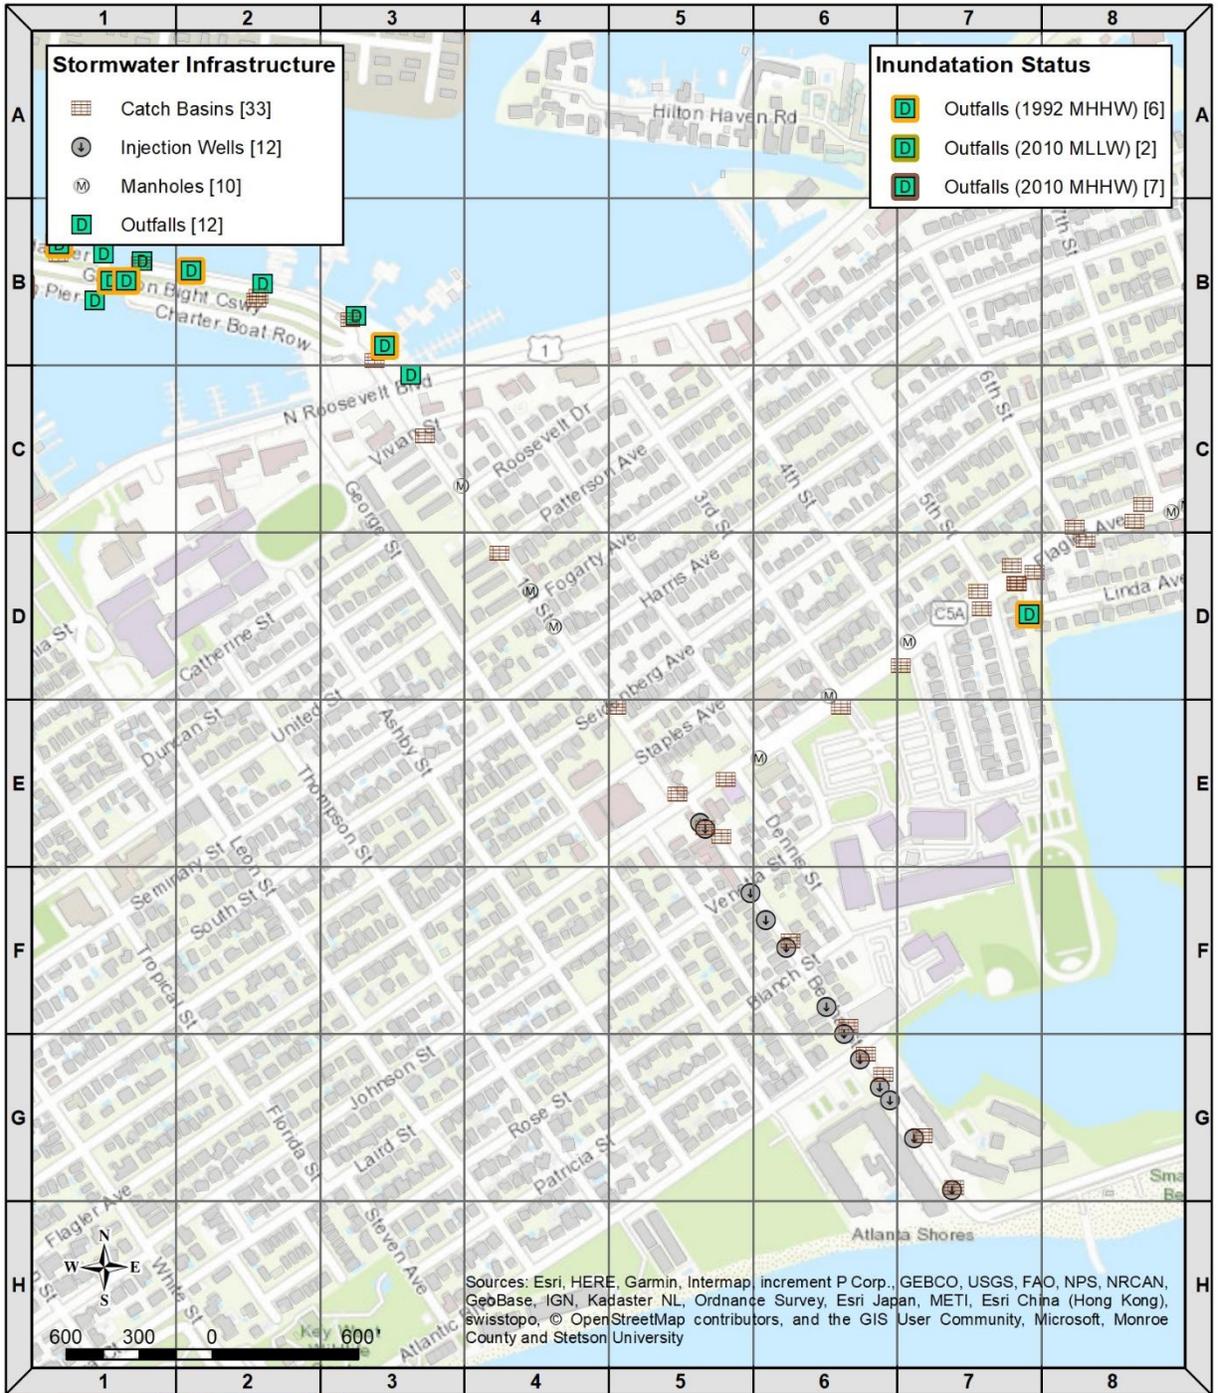
Map Series 1: Monroe County Stormwater Infrastructure Inventory with Vulnerability to Existing Tidal Flooding, 1992 – 2010 Sea Level

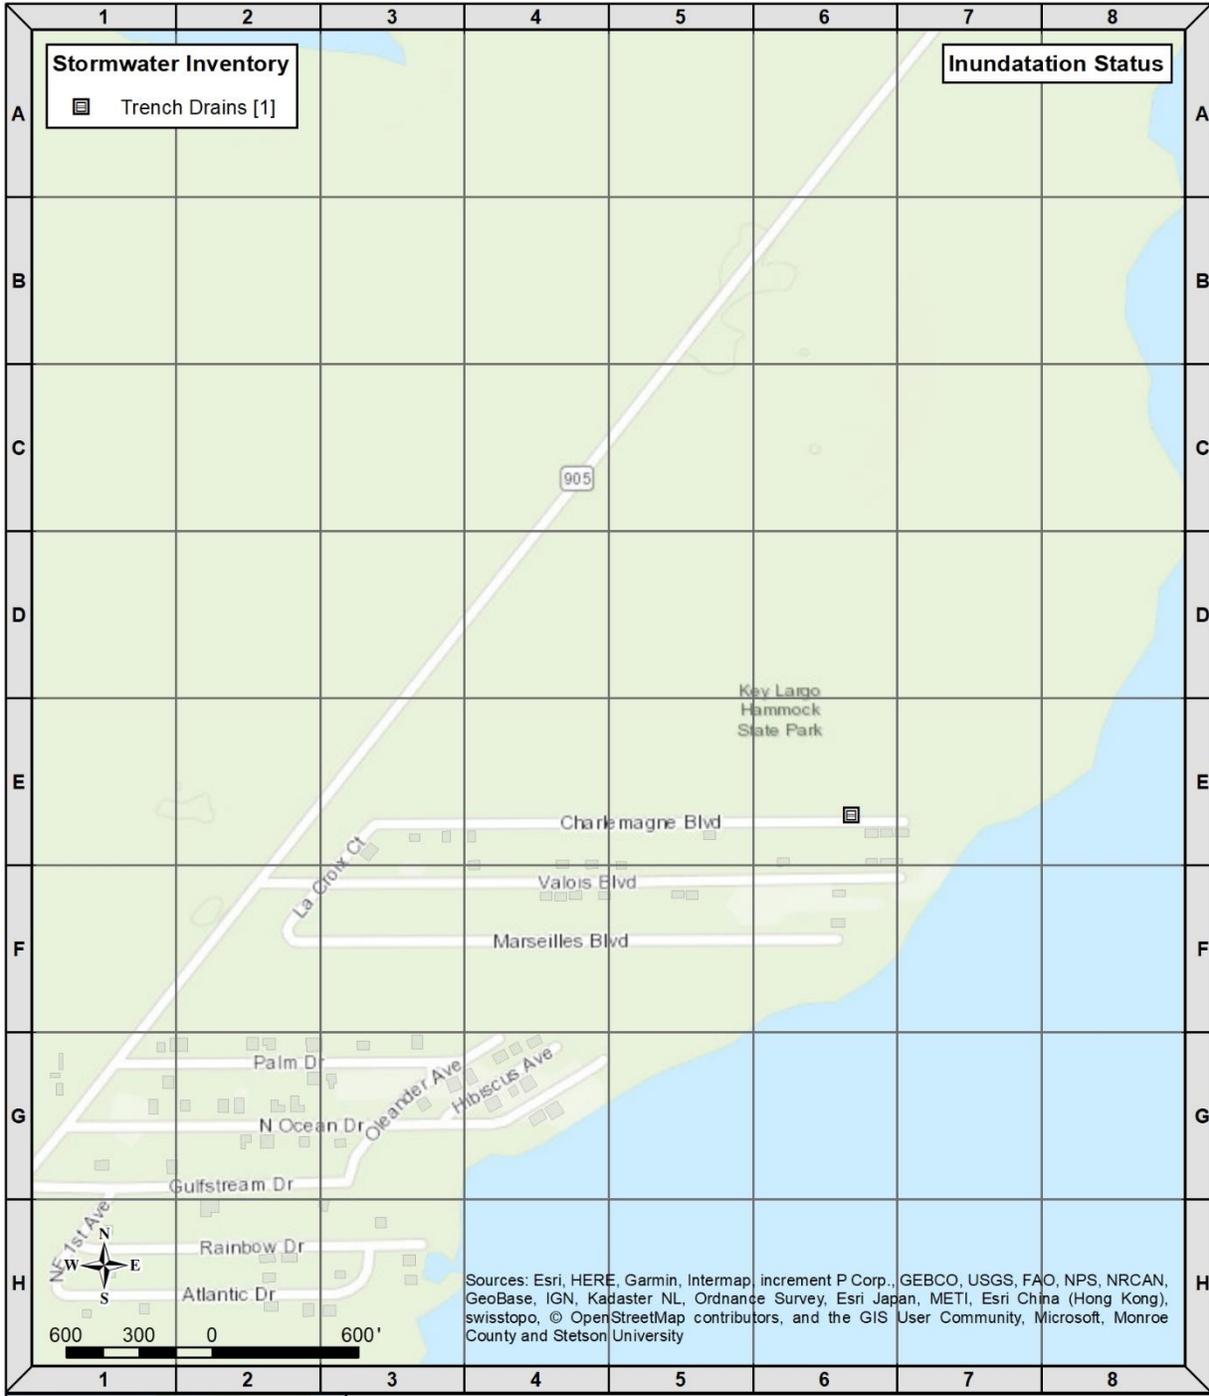
Map Series 2: Monroe County Stormwater Infrastructure Inventory with Potential Future Vulnerability to Tidal Flooding, 2030 Low (6") and 2030 High (10") Sea-Level Rise

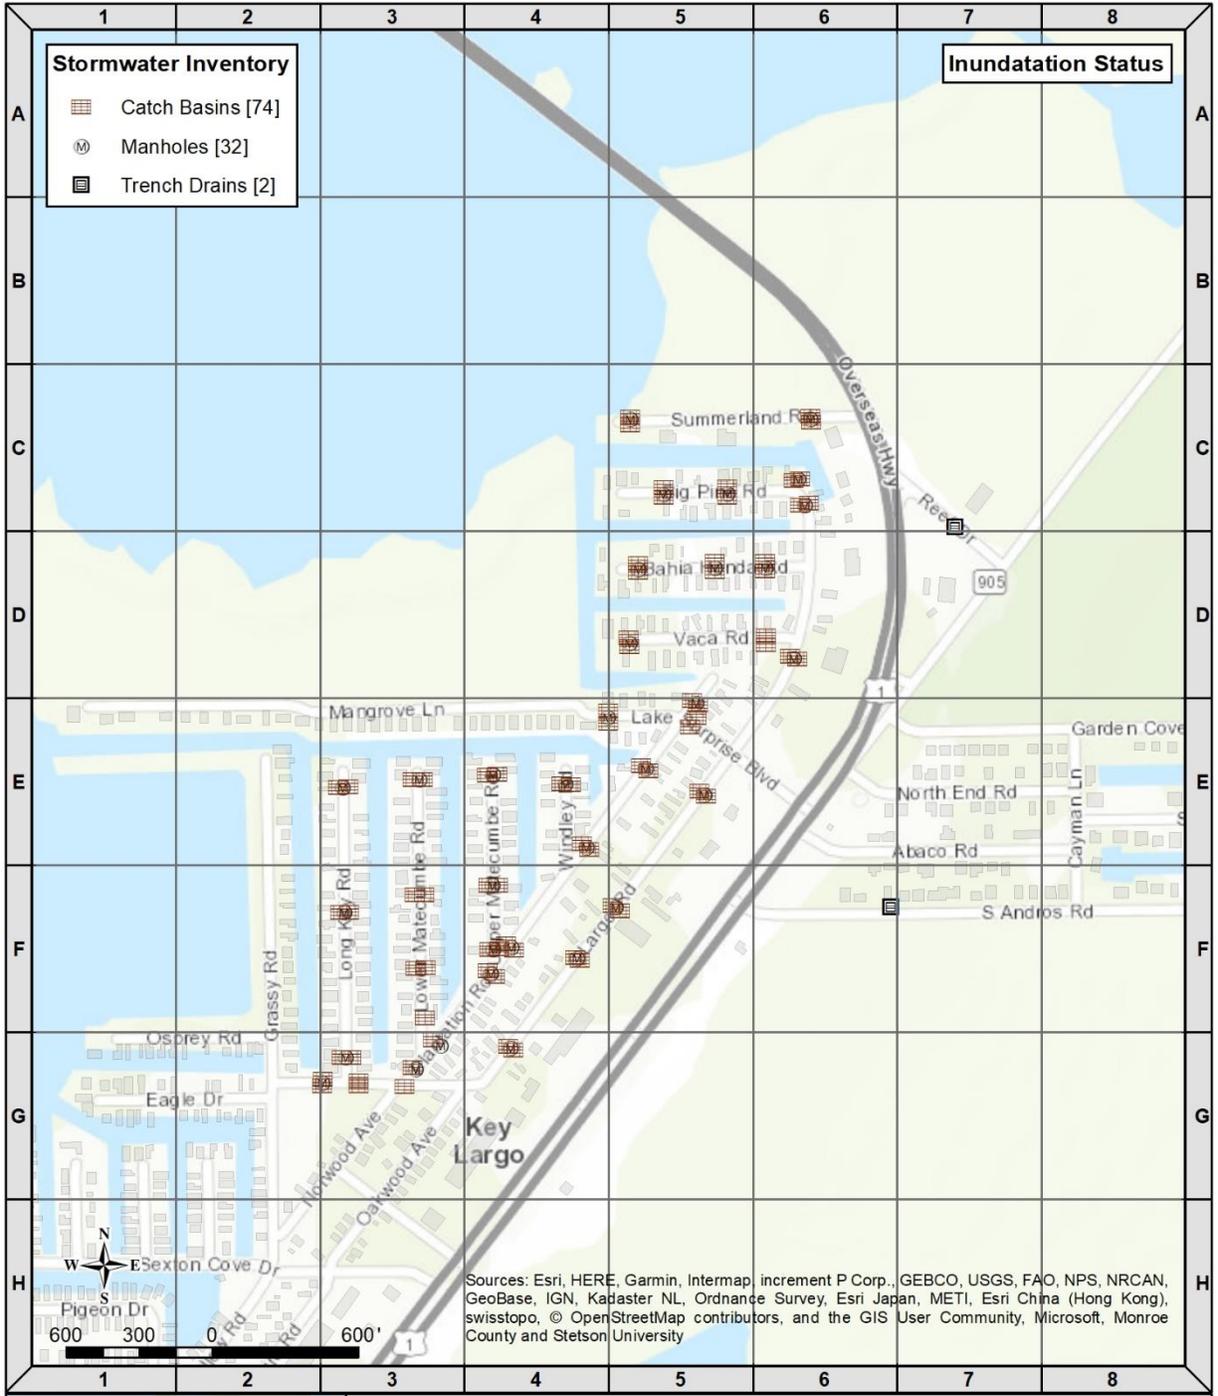
Map Series 2: Monroe County Stormwater Infrastructure Inventory with Potential Future Vulnerability to Tidal Flooding, 2030 Low (6") and 2030 High (10") Sea-Level Rise

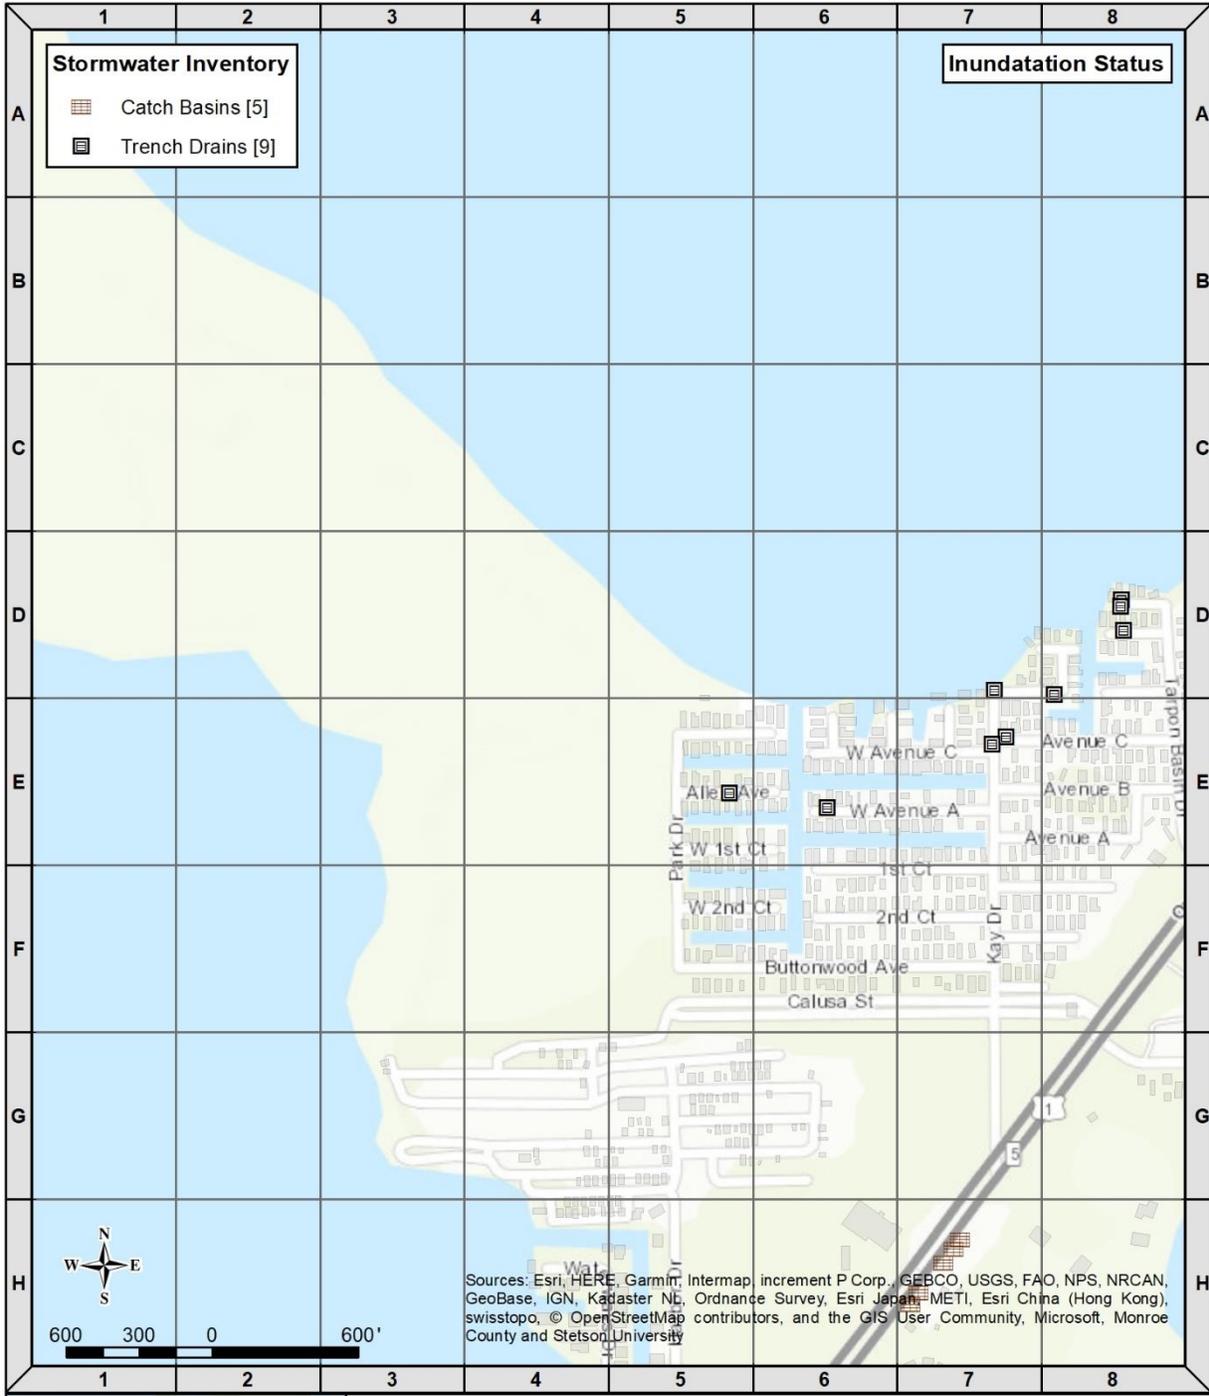
Map Series 2: Monroe County Stormwater Infrastructure Inventory with Potential Future Vulnerability to Tidal Flooding, 2030 Low (6") and 2030 High (10") Sea-Level Rise

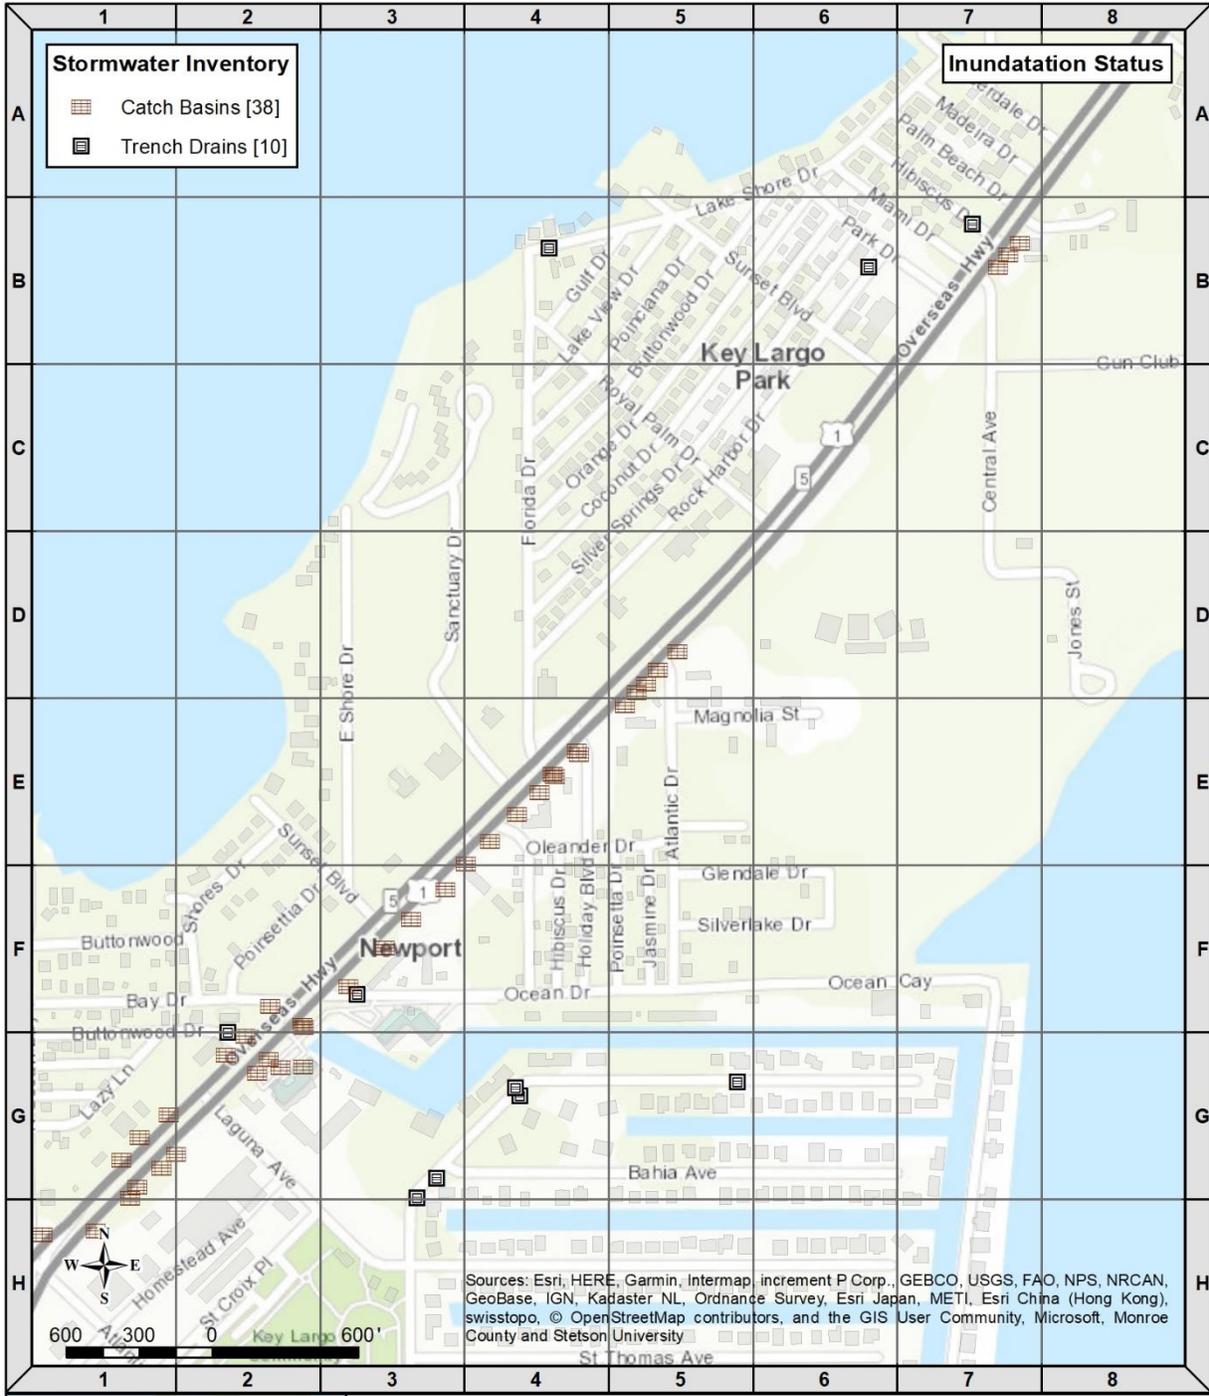
Map Series 2: Monroe County Stormwater Infrastructure Inventory with Potential Future Vulnerability to Tidal Flooding, 2030 Low (6") and 2030 High (10") Sea-Level Rise
