Monroe County Watershed Management Plan

Draft report by:

August 2019

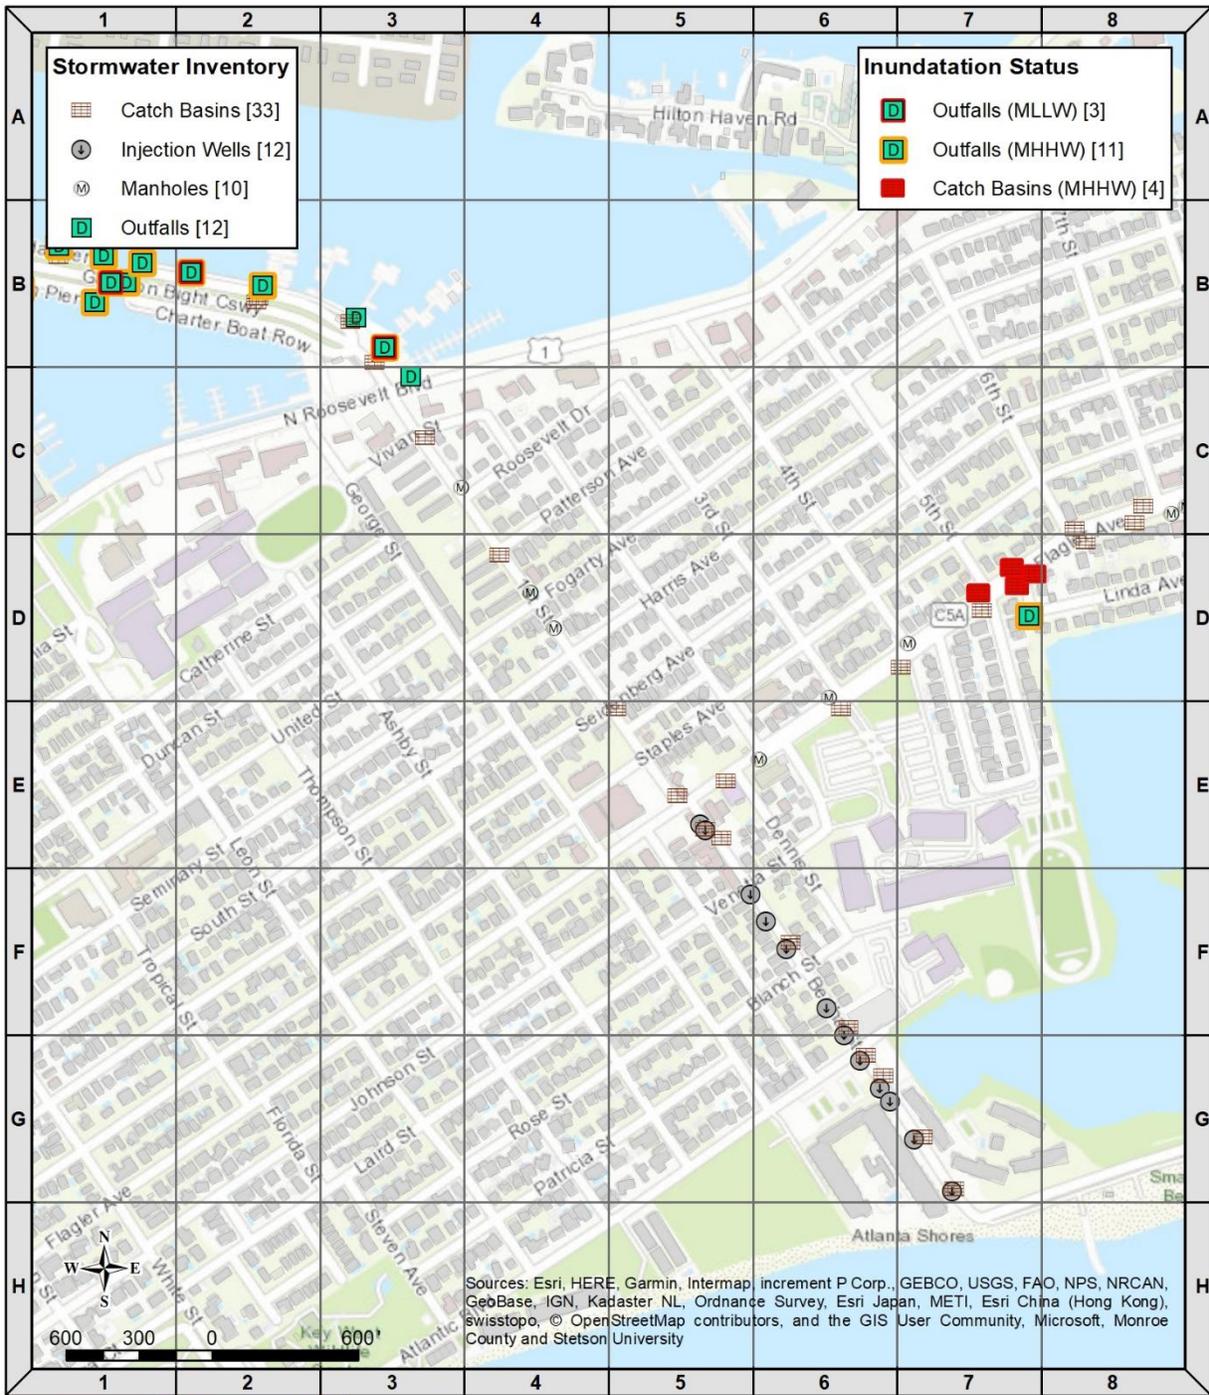
Map Series 2: Monroe County Stormwater Infrastructure Inventory with Potential Future Vulnerability to Tidal Flooding, 2030 Low (6") and 2030 High (10") Sea-Level Rise

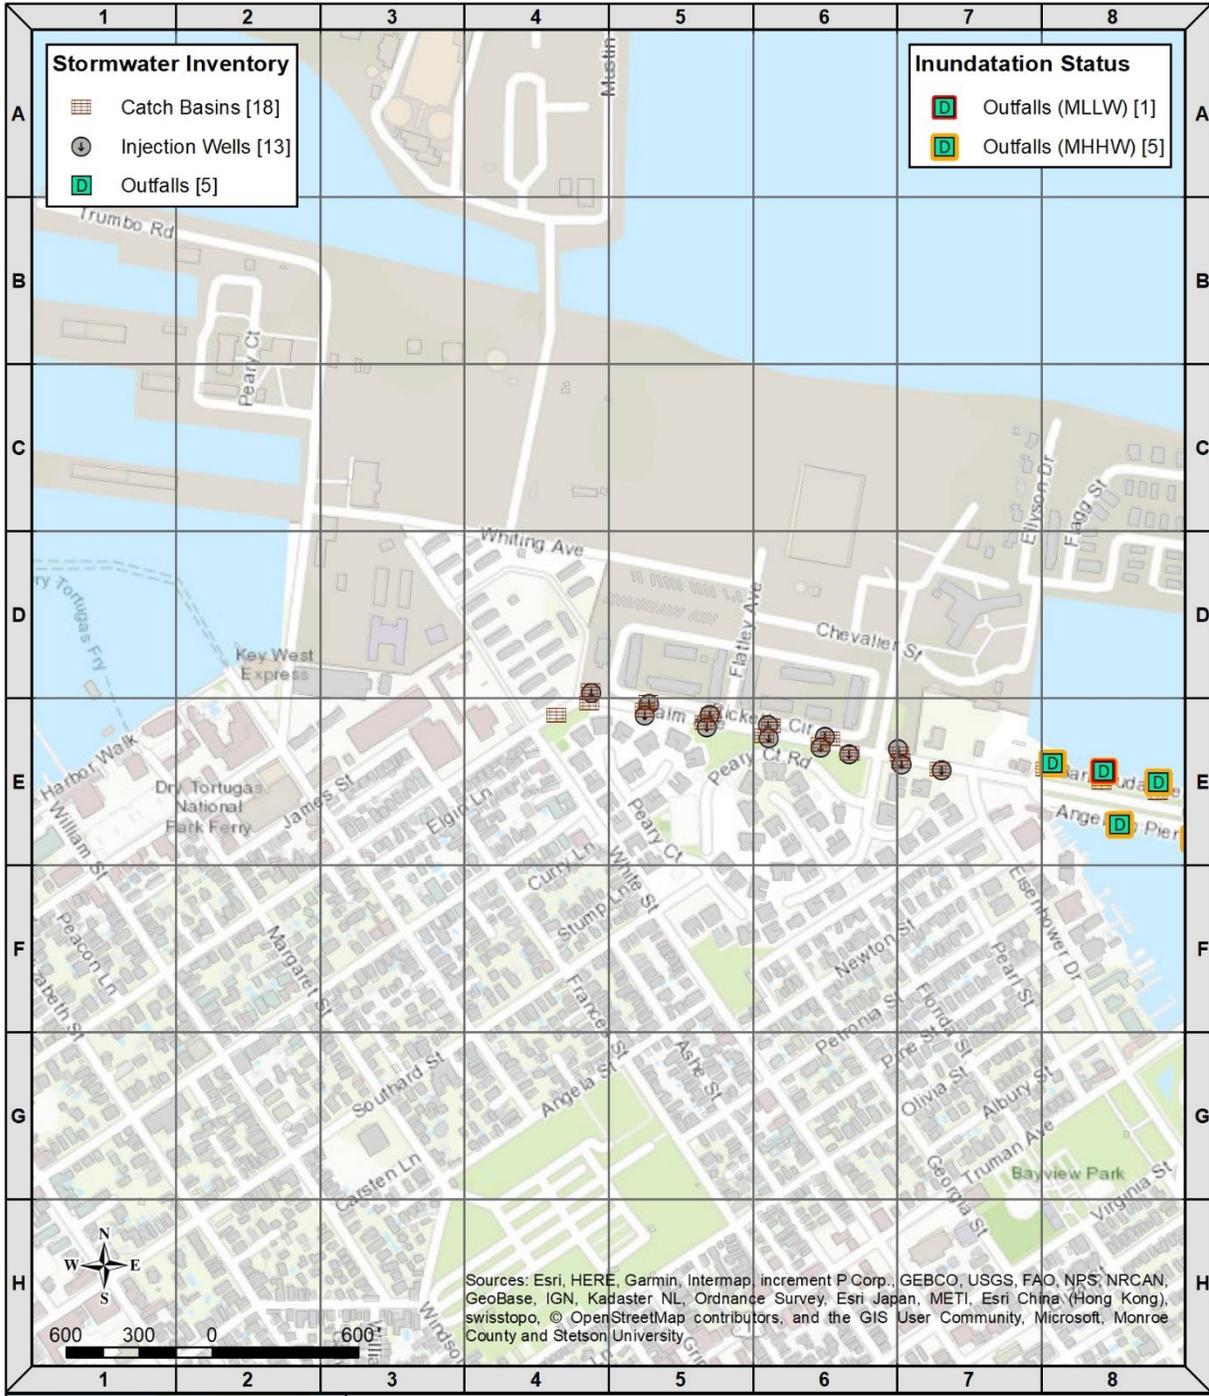
Map Series 2: Monroe County Stormwater Infrastructure Inventory with Potential Future Vulnerability to Tidal Flooding, 2030 Low (6") and 2030 High (10") Sea-Level Rise

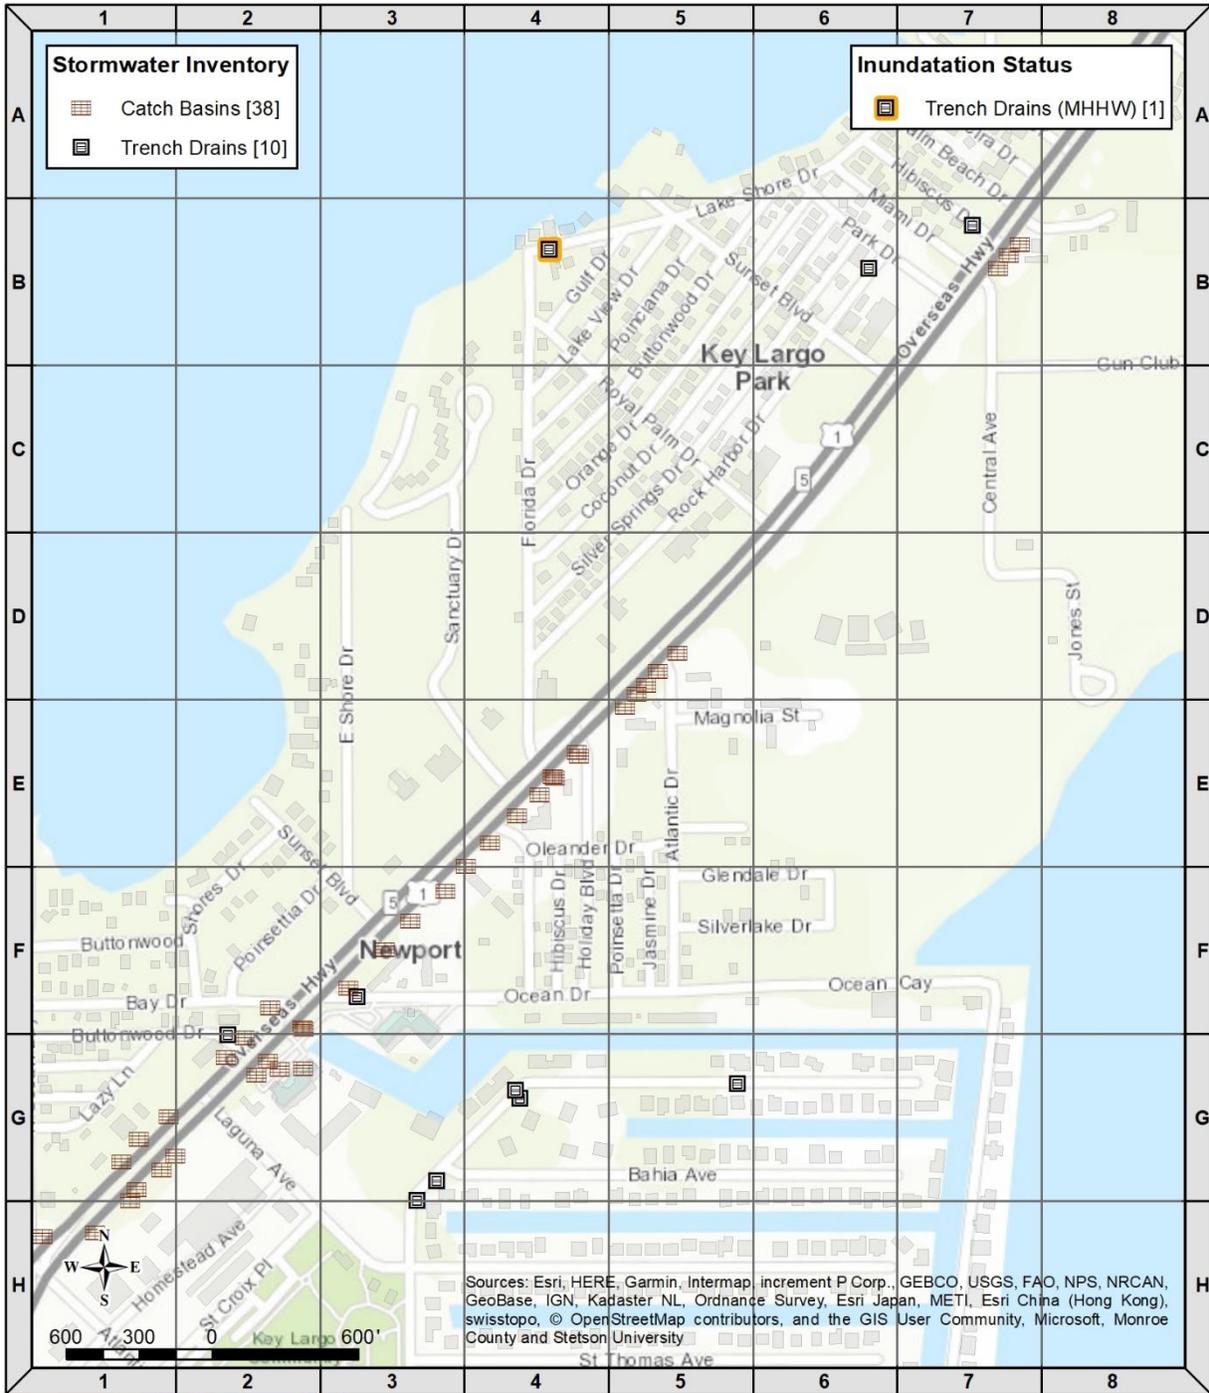
Map Series 3: Monroe County Stormwater Infrastructure Inventory with Potential Future Vulnerability to Tidal Flooding, 2060 Low (14") and 2060 High (26") Sea-Level Rise

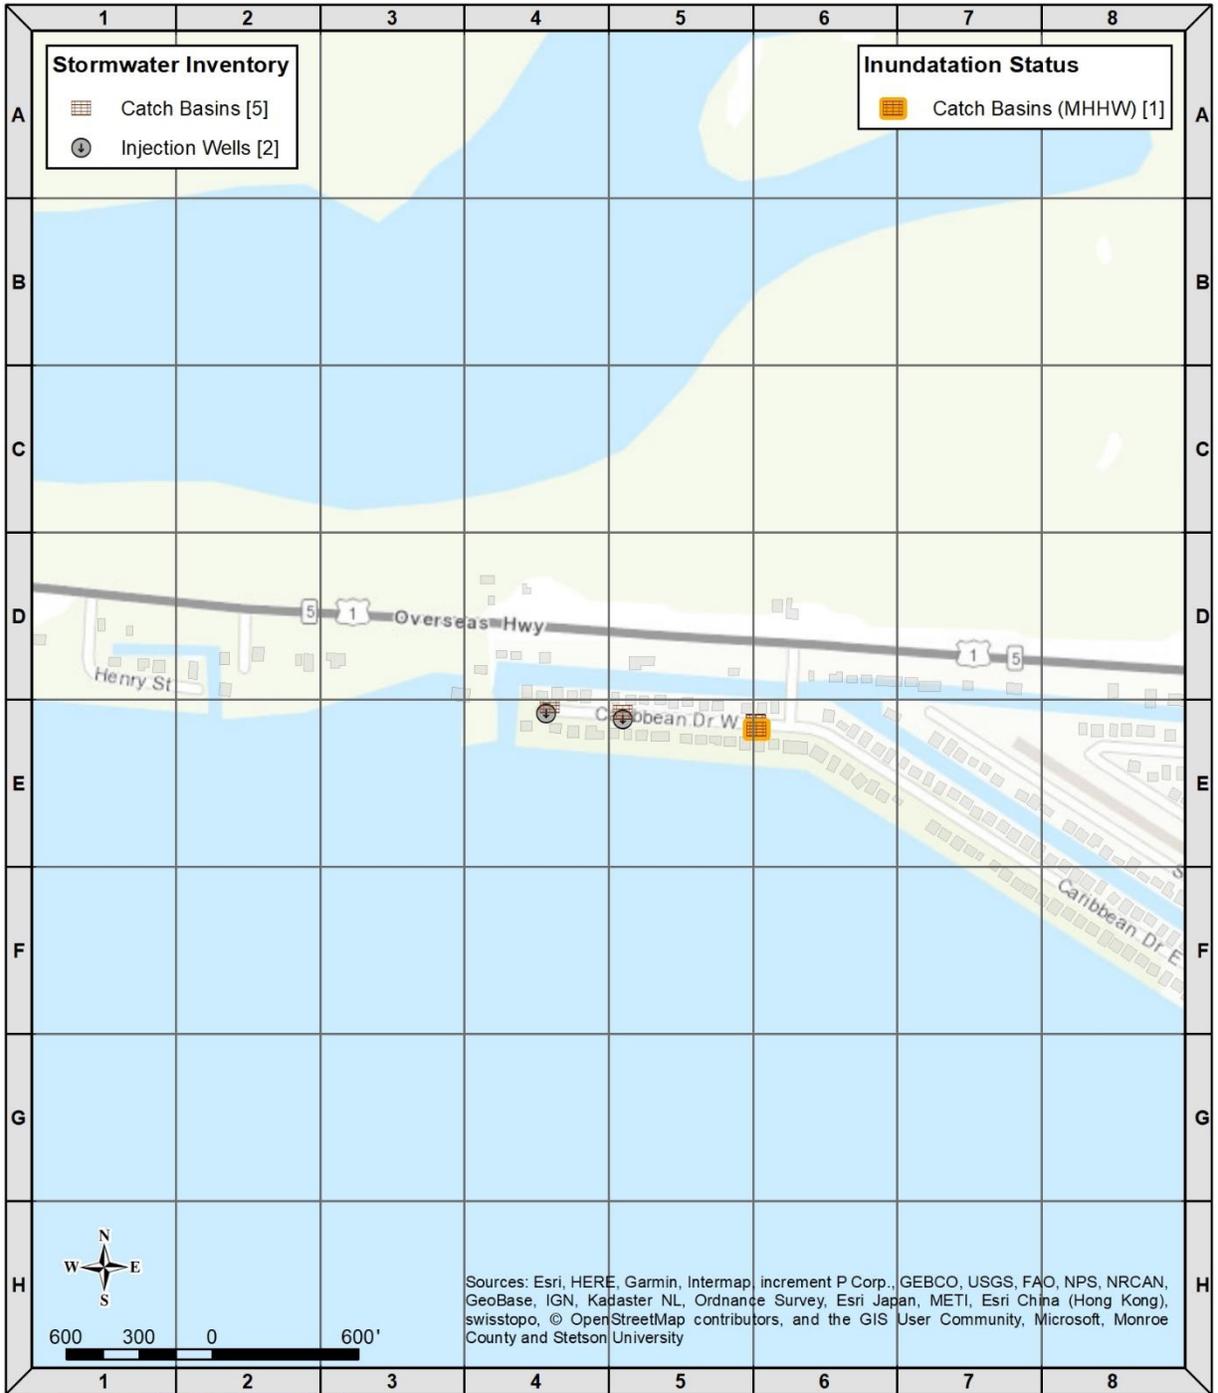
Map Series 3: Monroe County Stormwater Infrastructure Inventory with Potential Future Vulnerability to Tidal Flooding, 2060 Low (14") and 2060 High (26") Sea-Level Rise

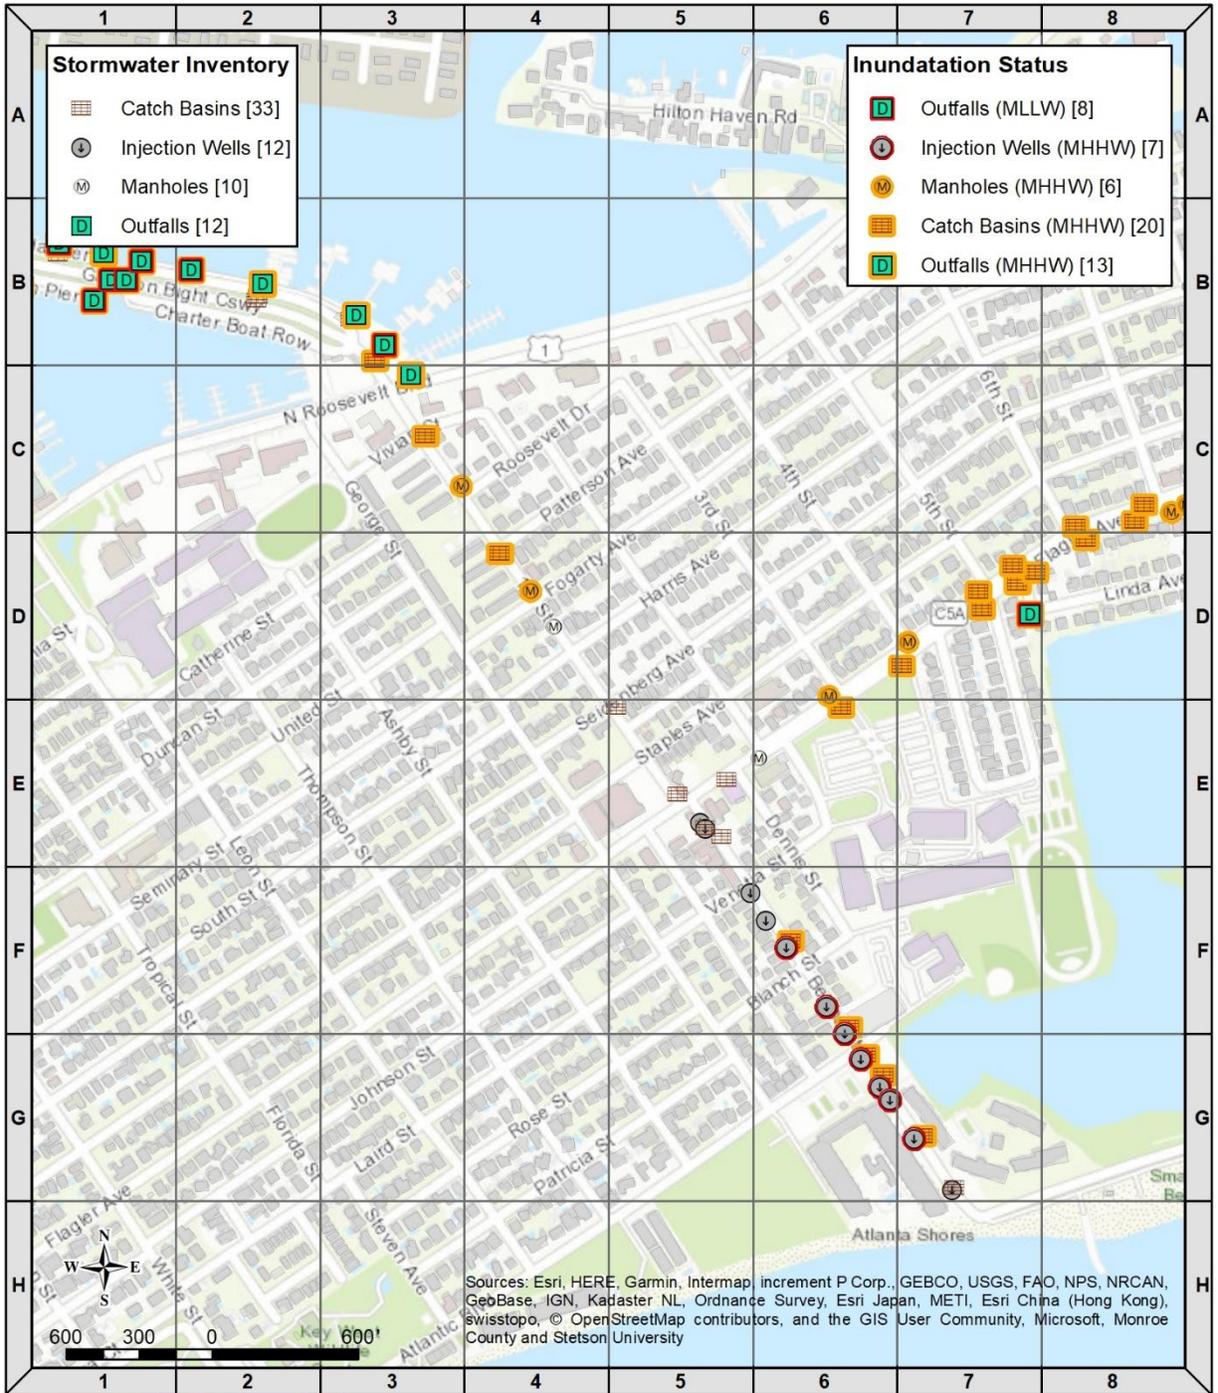
Map Series 3: Monroe County Stormwater Infrastructure Inventory with Potential Future Vulnerability to Tidal Flooding, 2060 Low (14") and 2060 High (26") Sea-Level Rise

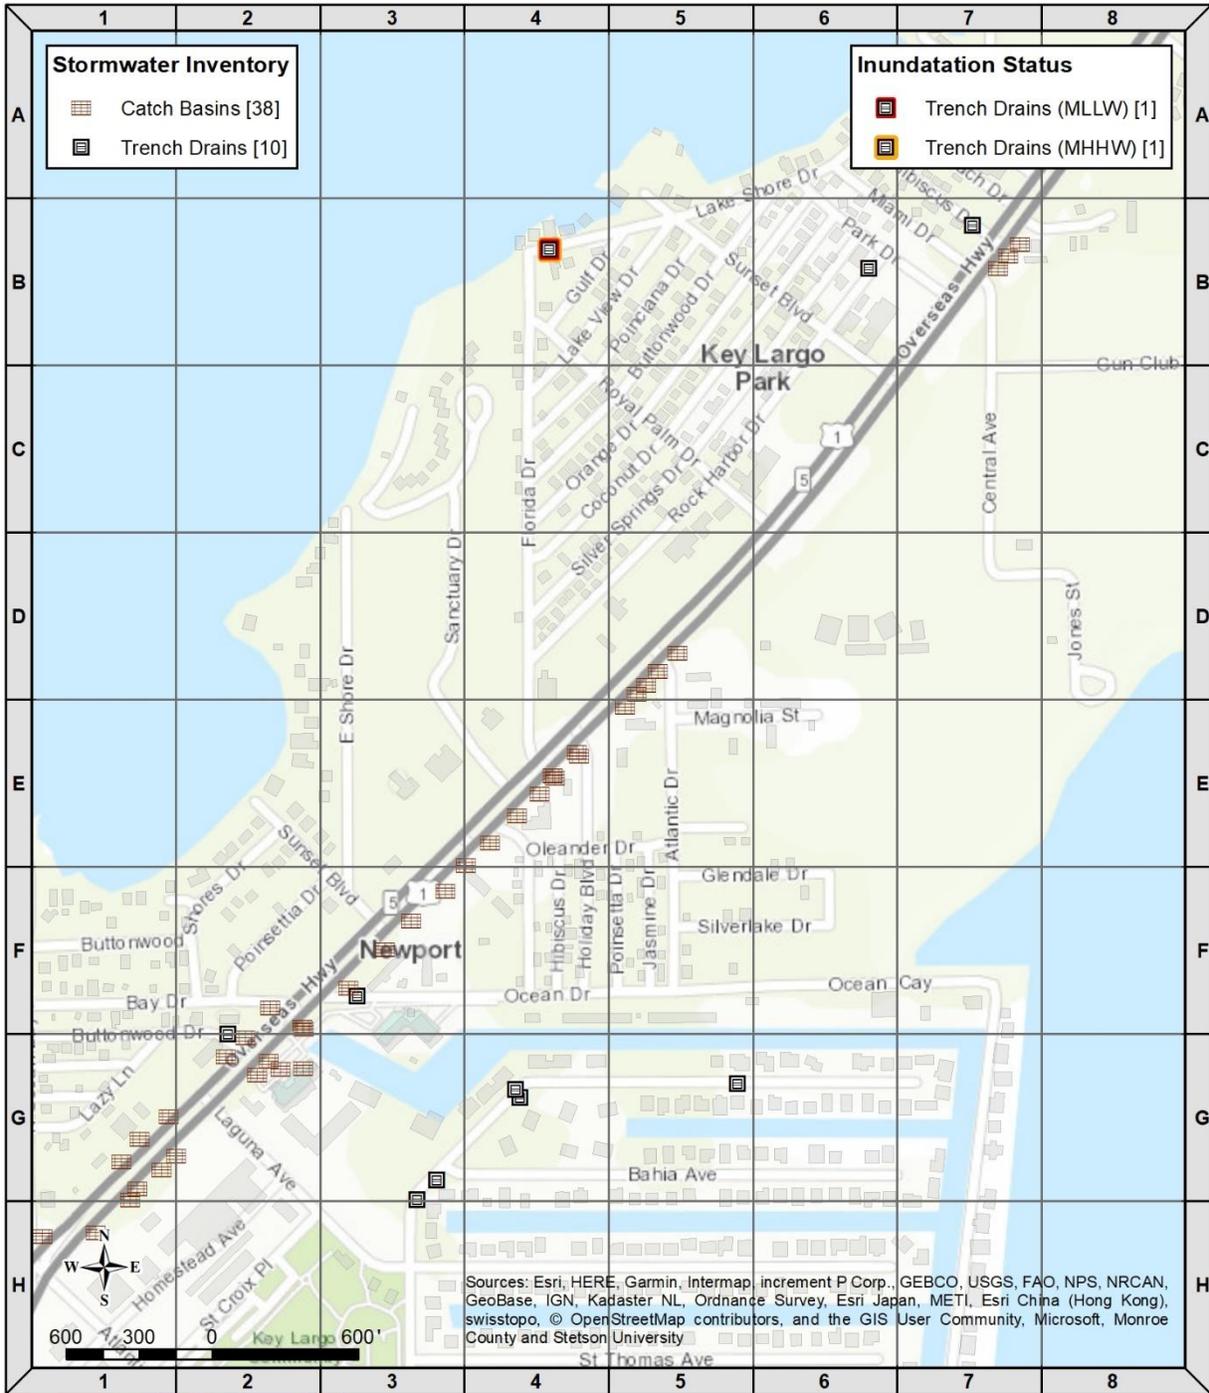
Map Series 4: Monroe County Stormwater Infrastructure Inventory with Potential Future Vulnerability to Tidal Flooding, 2100 Intermediate-High Sea-Level Rise

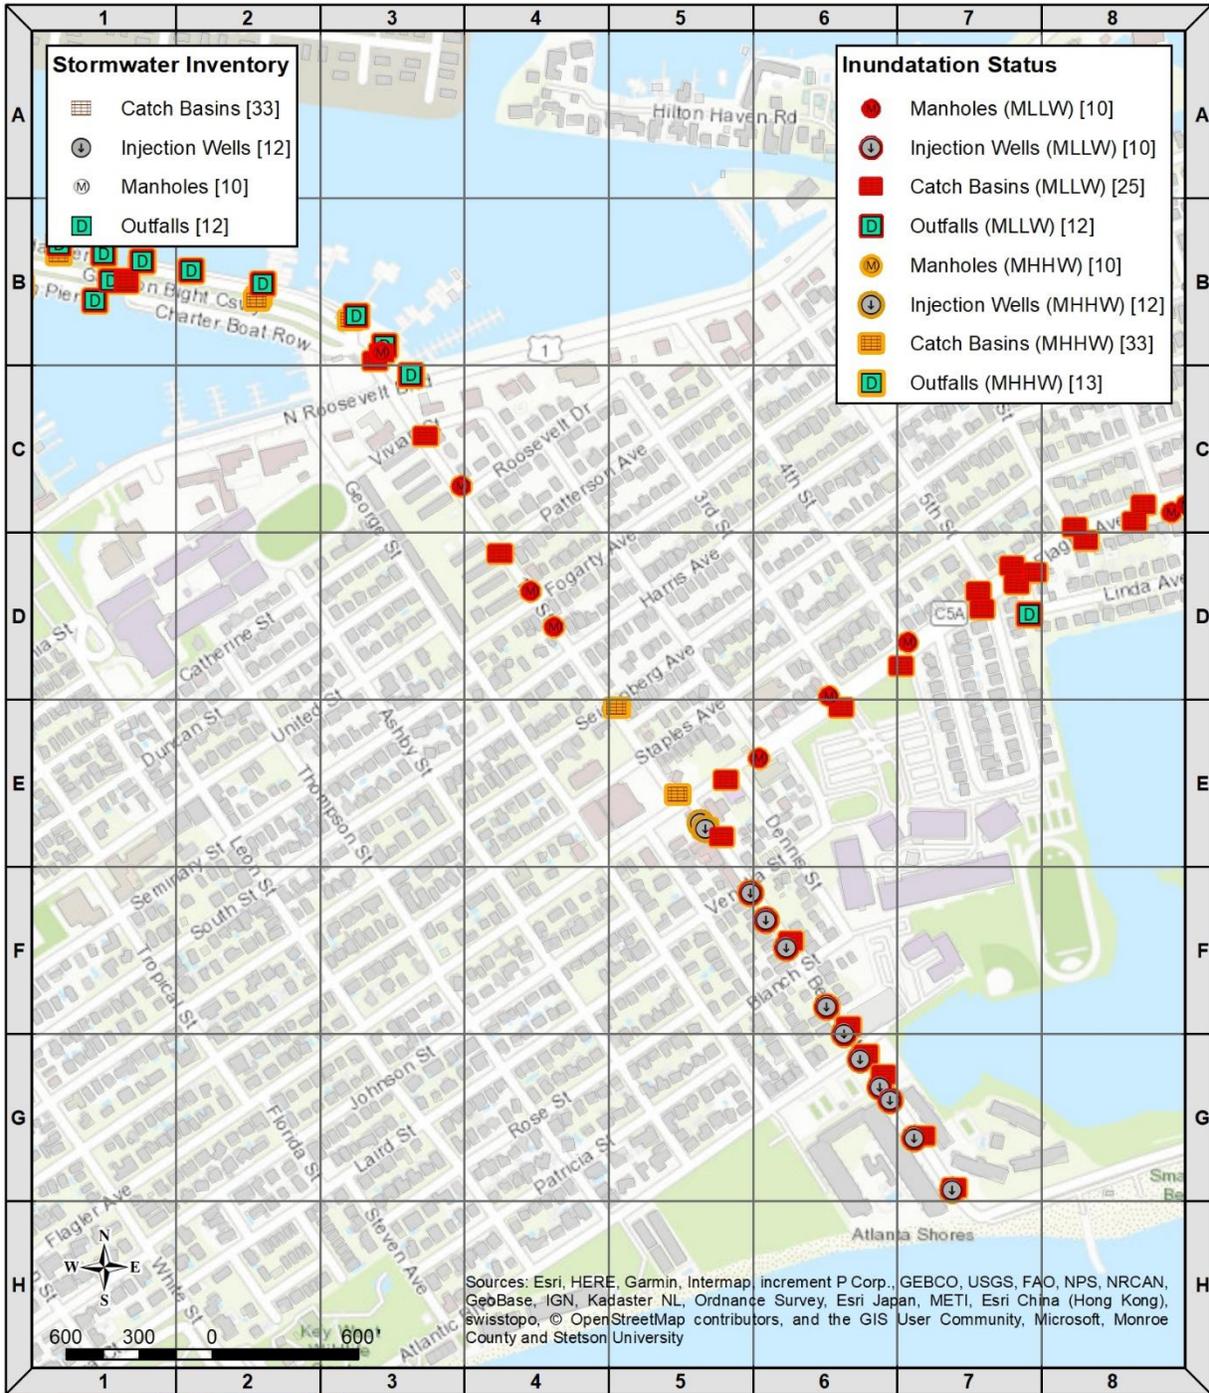
Map Series 4: Monroe County Stormwater Infrastructure Inventory with Potential Future Vulnerability to Tidal Flooding, 2100 Intermediate-High Sea-Level Rise

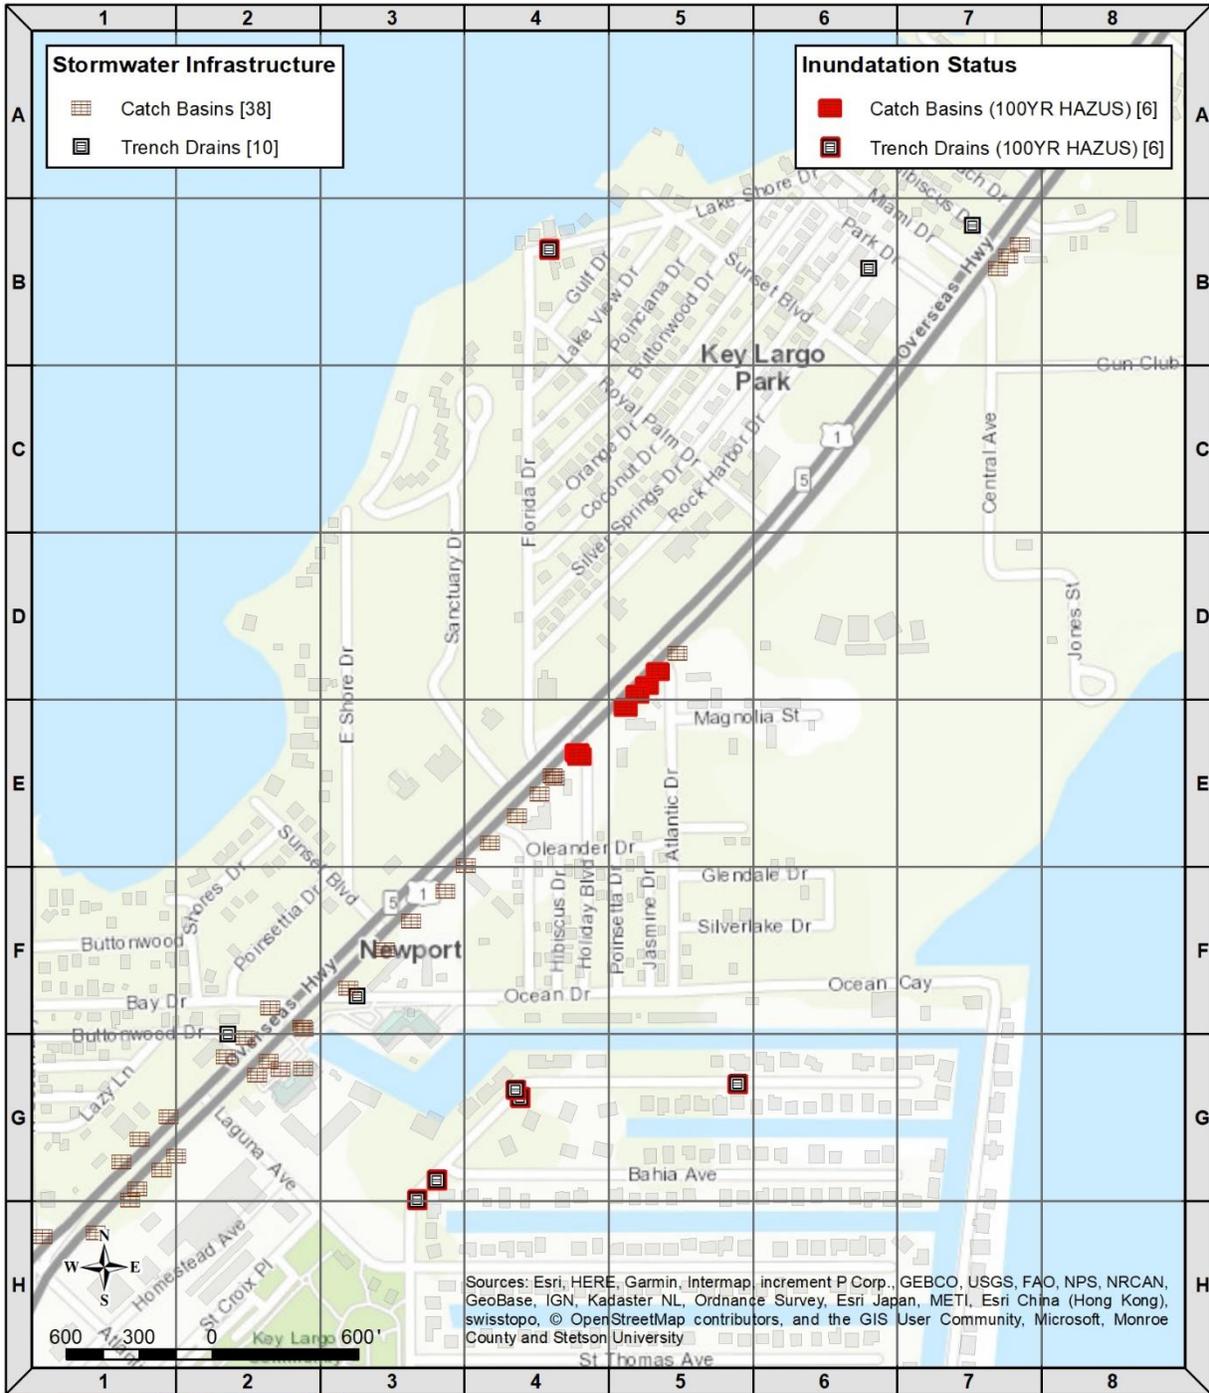
Map Series 5: Monroe County Stormwater Infrastructure Inventory with Vulnerability to Hazus-MH 100-Year Coastal Flood, Baseline Condition (1992 Sea Level)

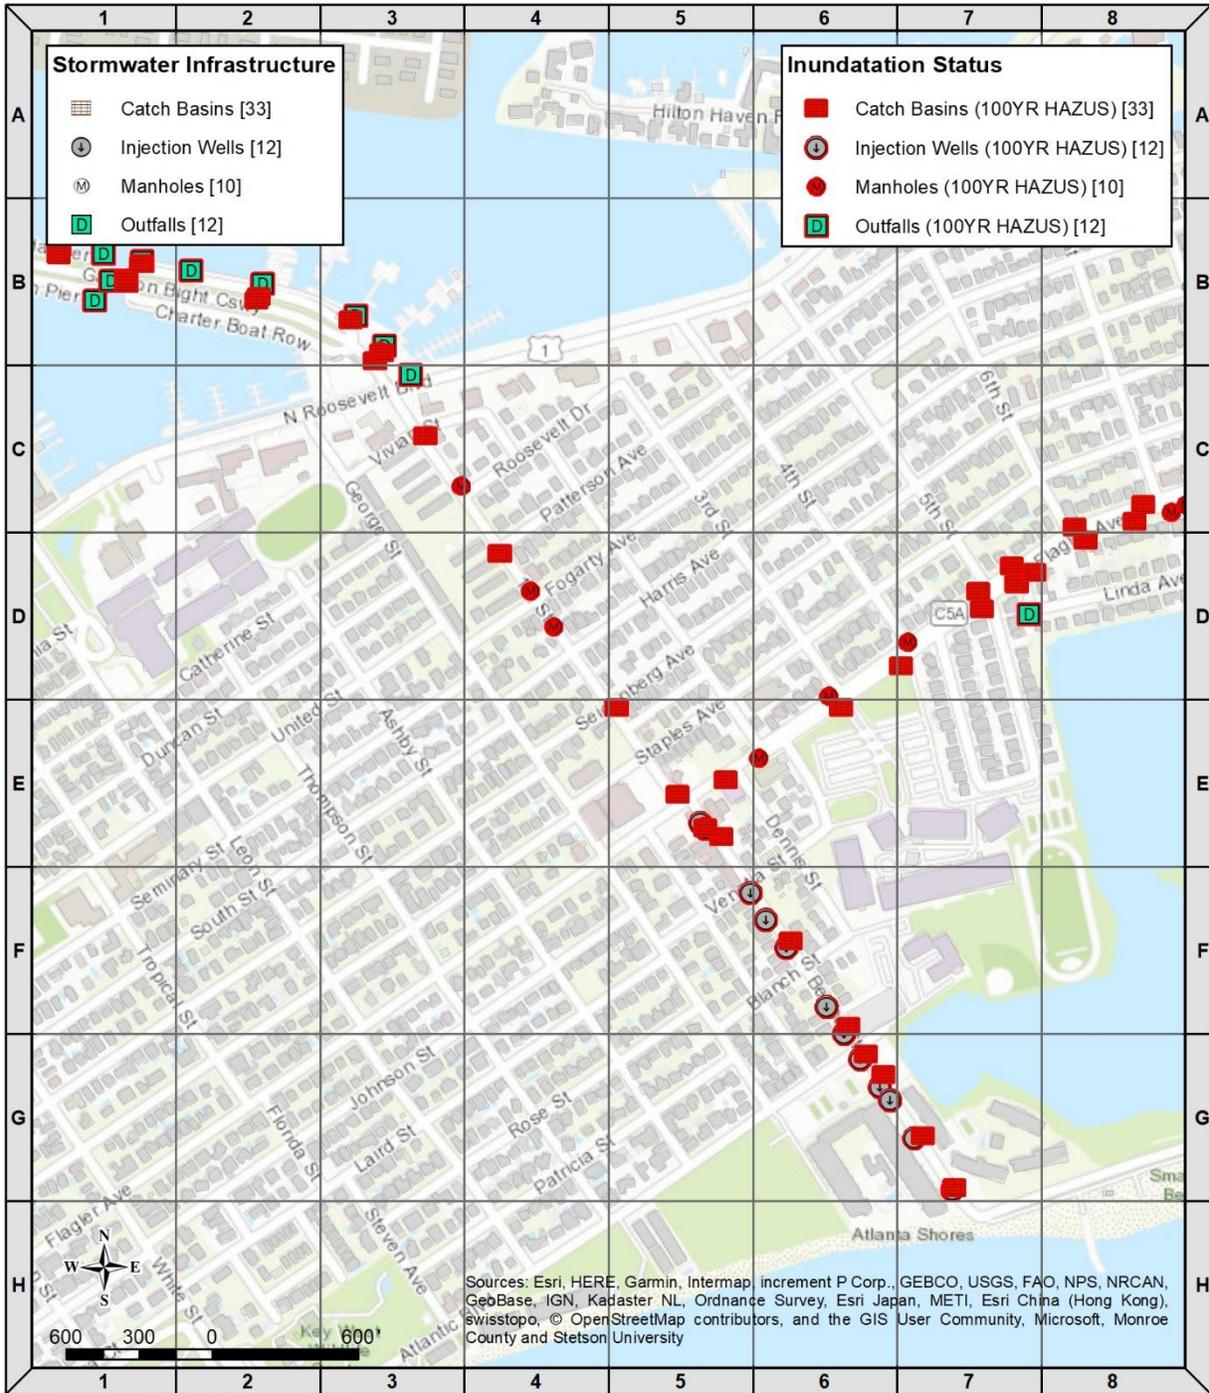
Map Series 5: Monroe County Stormwater Infrastructure Inventory with Vulnerability to Hazus-MH 100-Year Coastal Flood, Baseline Condition (1992 Sea Level)

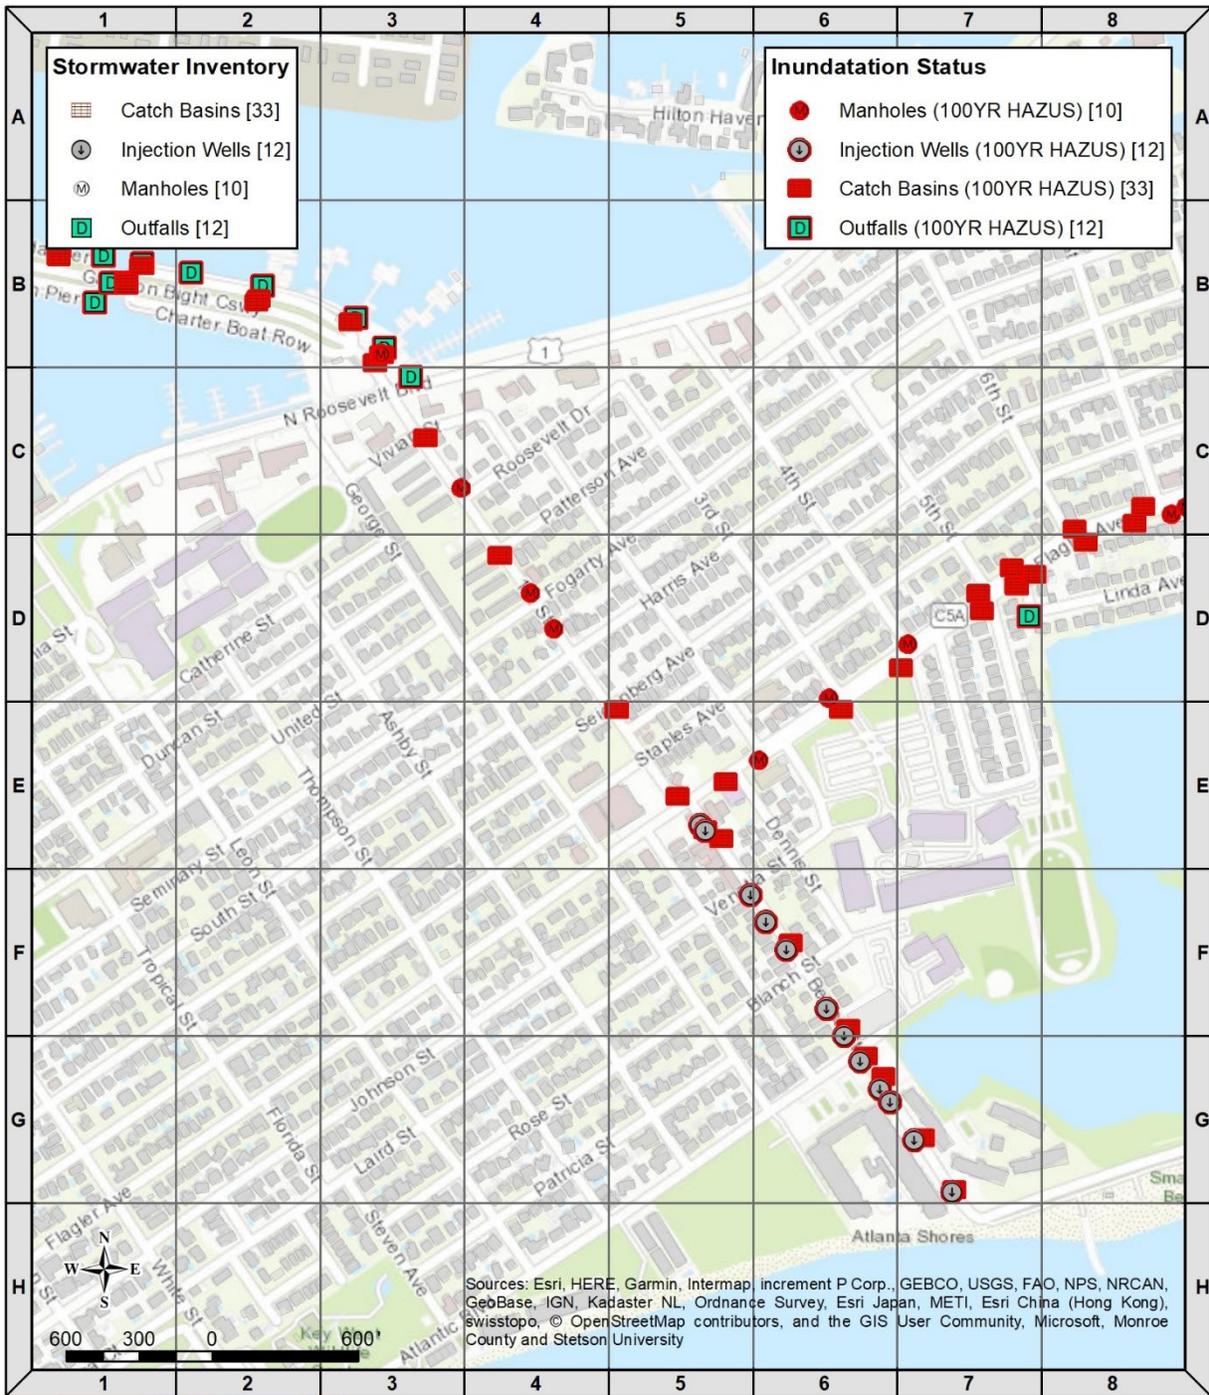
Map Series 6: Monroe County Stormwater Infrastructure Inventory with Potential Future Vulnerability to Hazus-MH 100-Year Coastal Flood, 2100 Intermediate-High (4.13') Sea-Level Rise

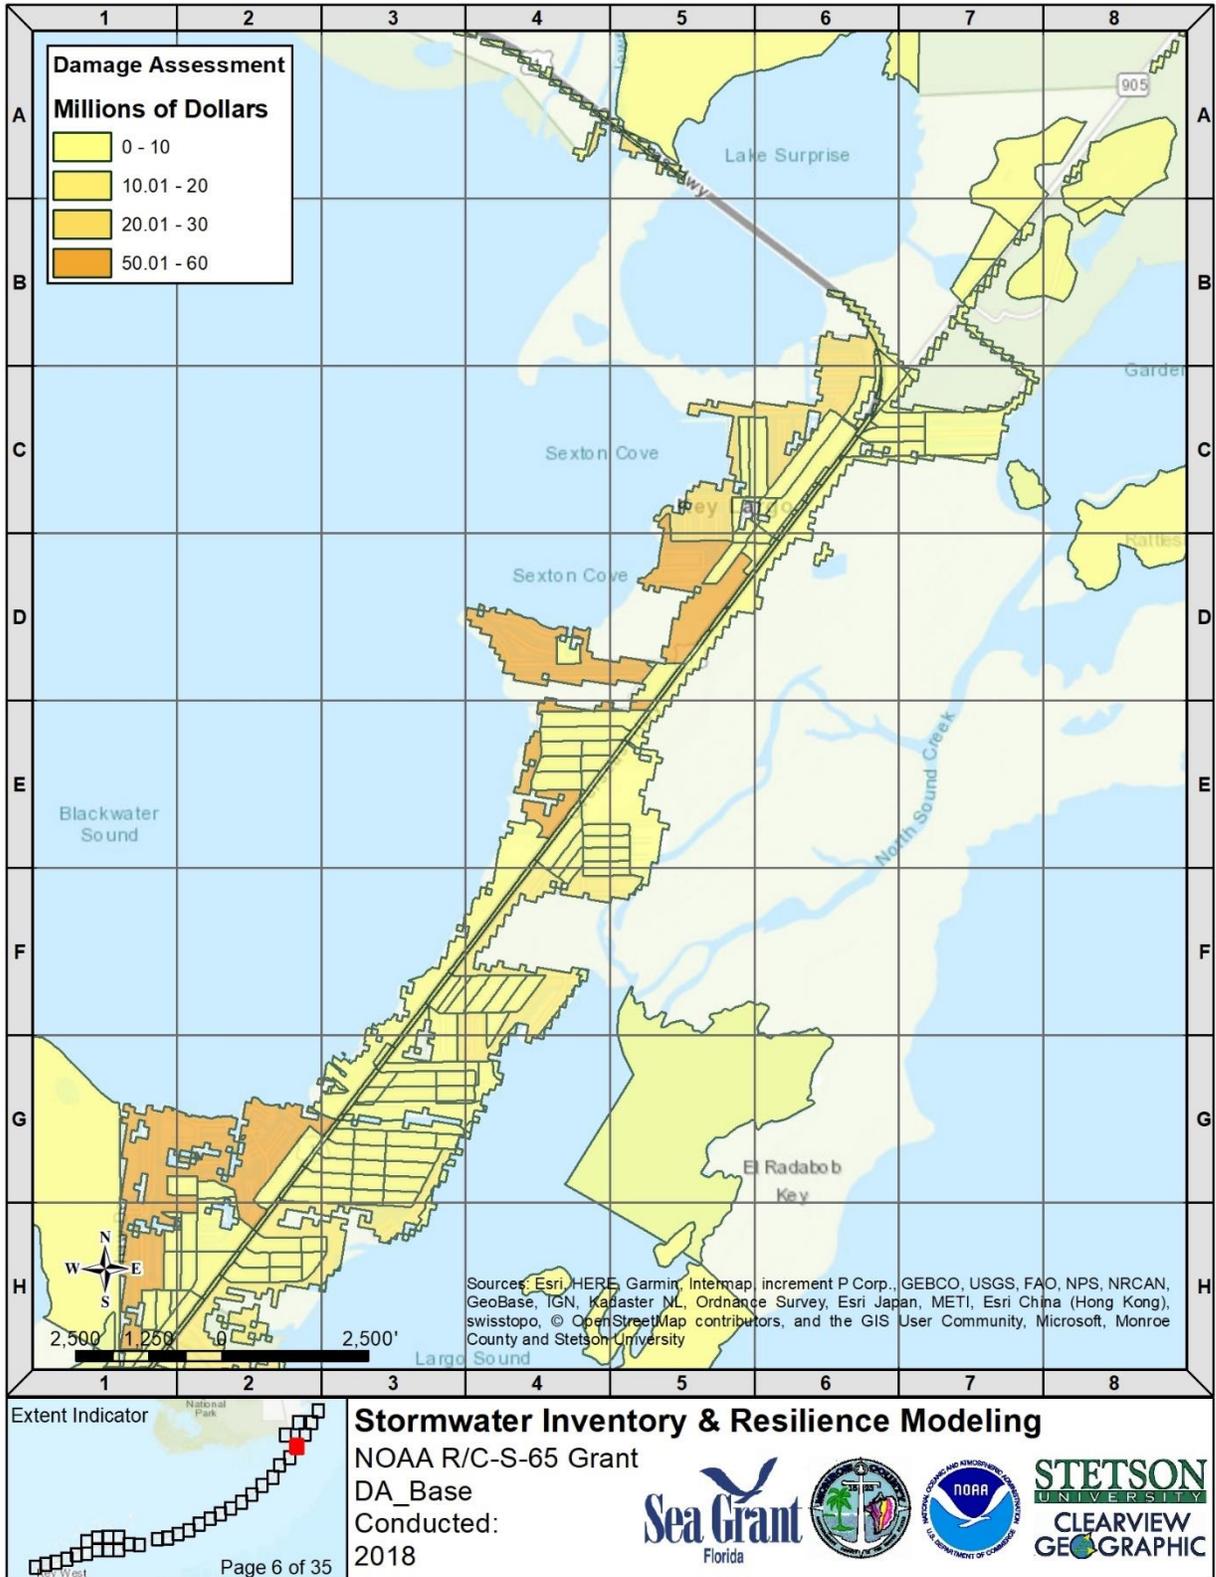
Map Series 7: Hazus-MH 100-Year Coastal Flood Model Damage Assessment for Monroe County, Baseline Scenario (1992 Sea-Level)

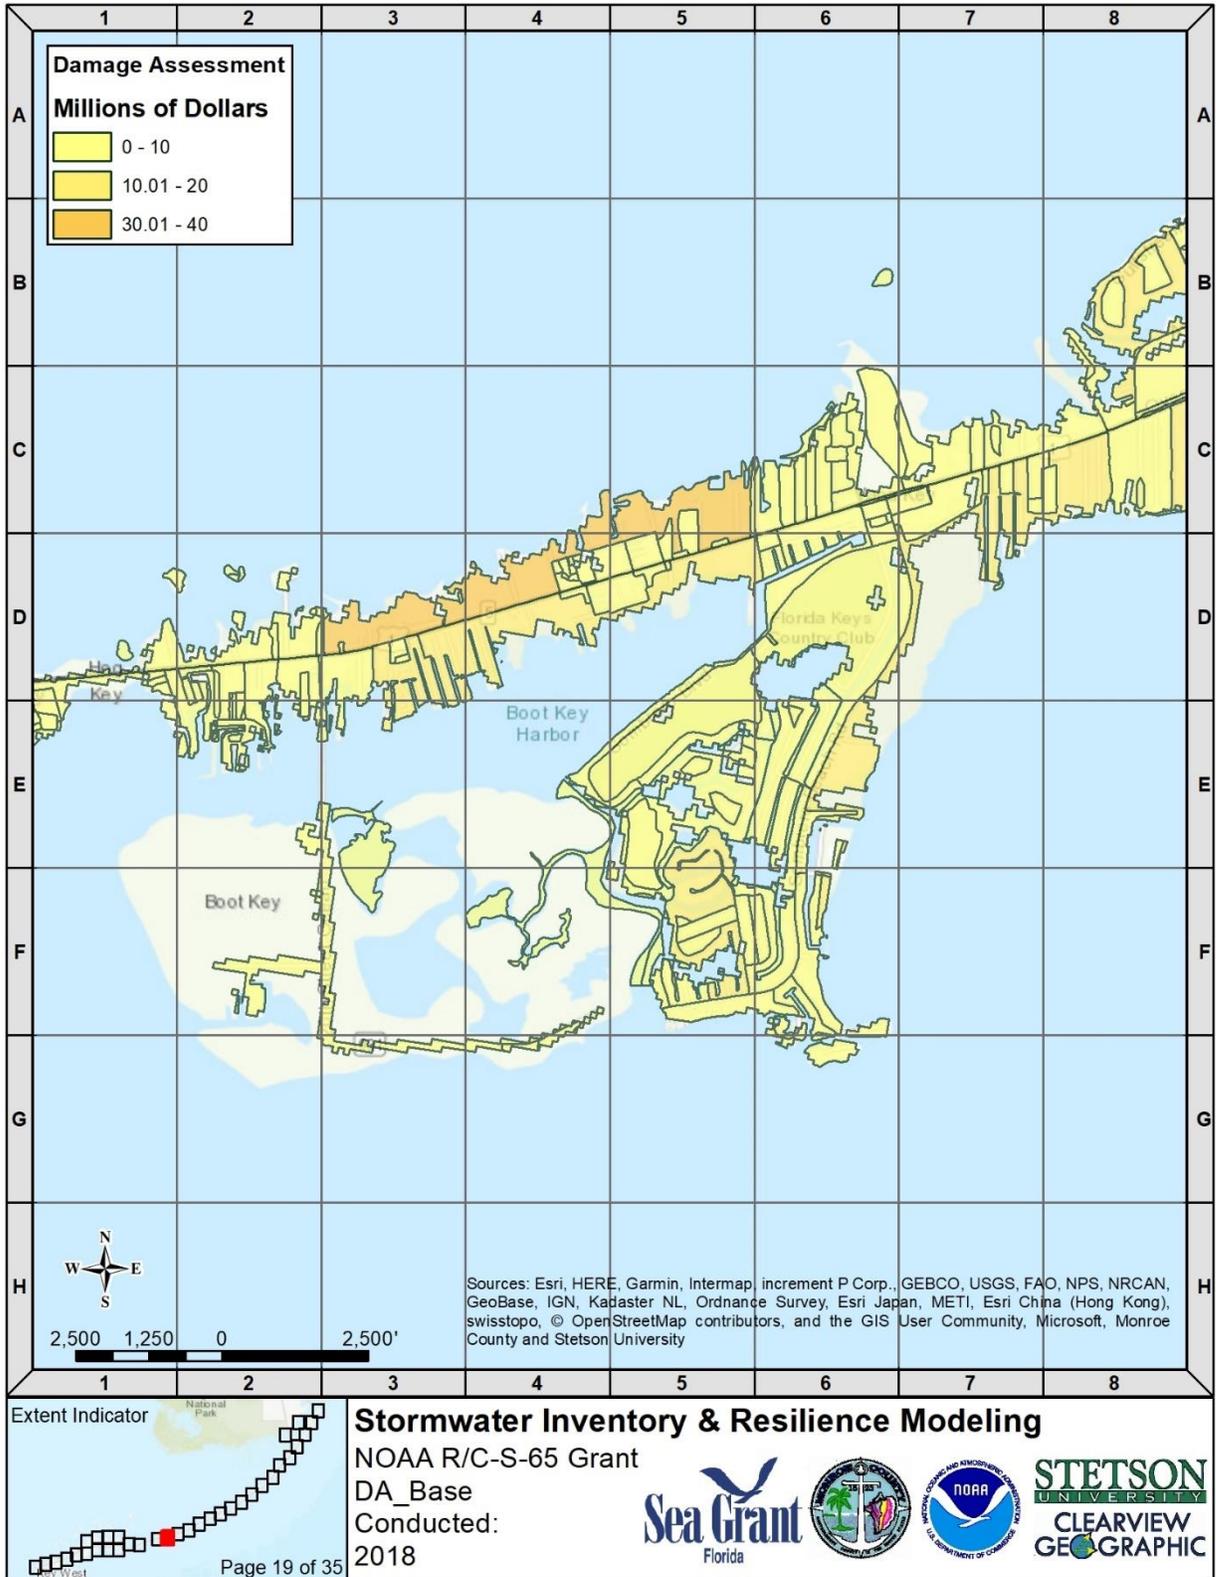
Map Series 7: Hazus-MH 100-Year Coastal Flood Model Damage Assessment for Monroe County, Baseline Scenario (1992 Sea-Level)

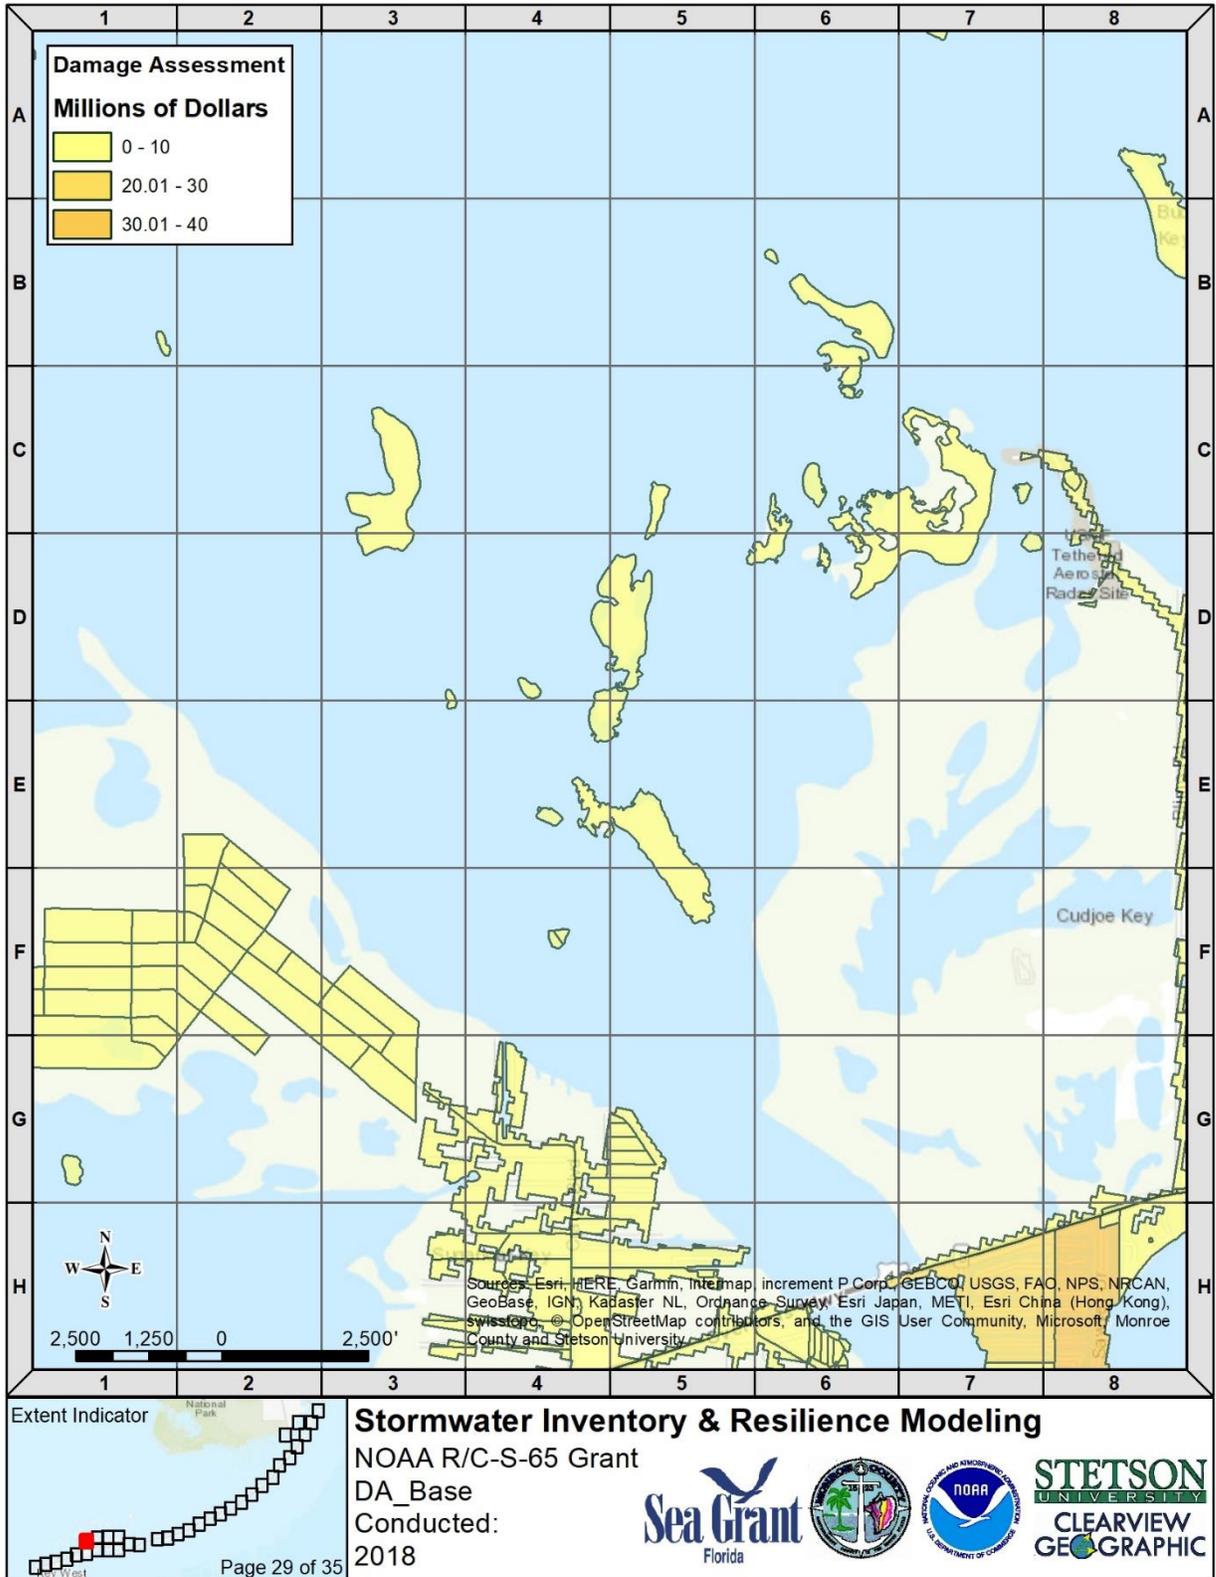
Map Series 7: Hazus-MH 100-Year Coastal Flood Model Damage Assessment for Monroe County, Baseline Scenario (1992 Sea-Level)
