Monroe County Watershed Management Plan

Draft report by:

August 2019

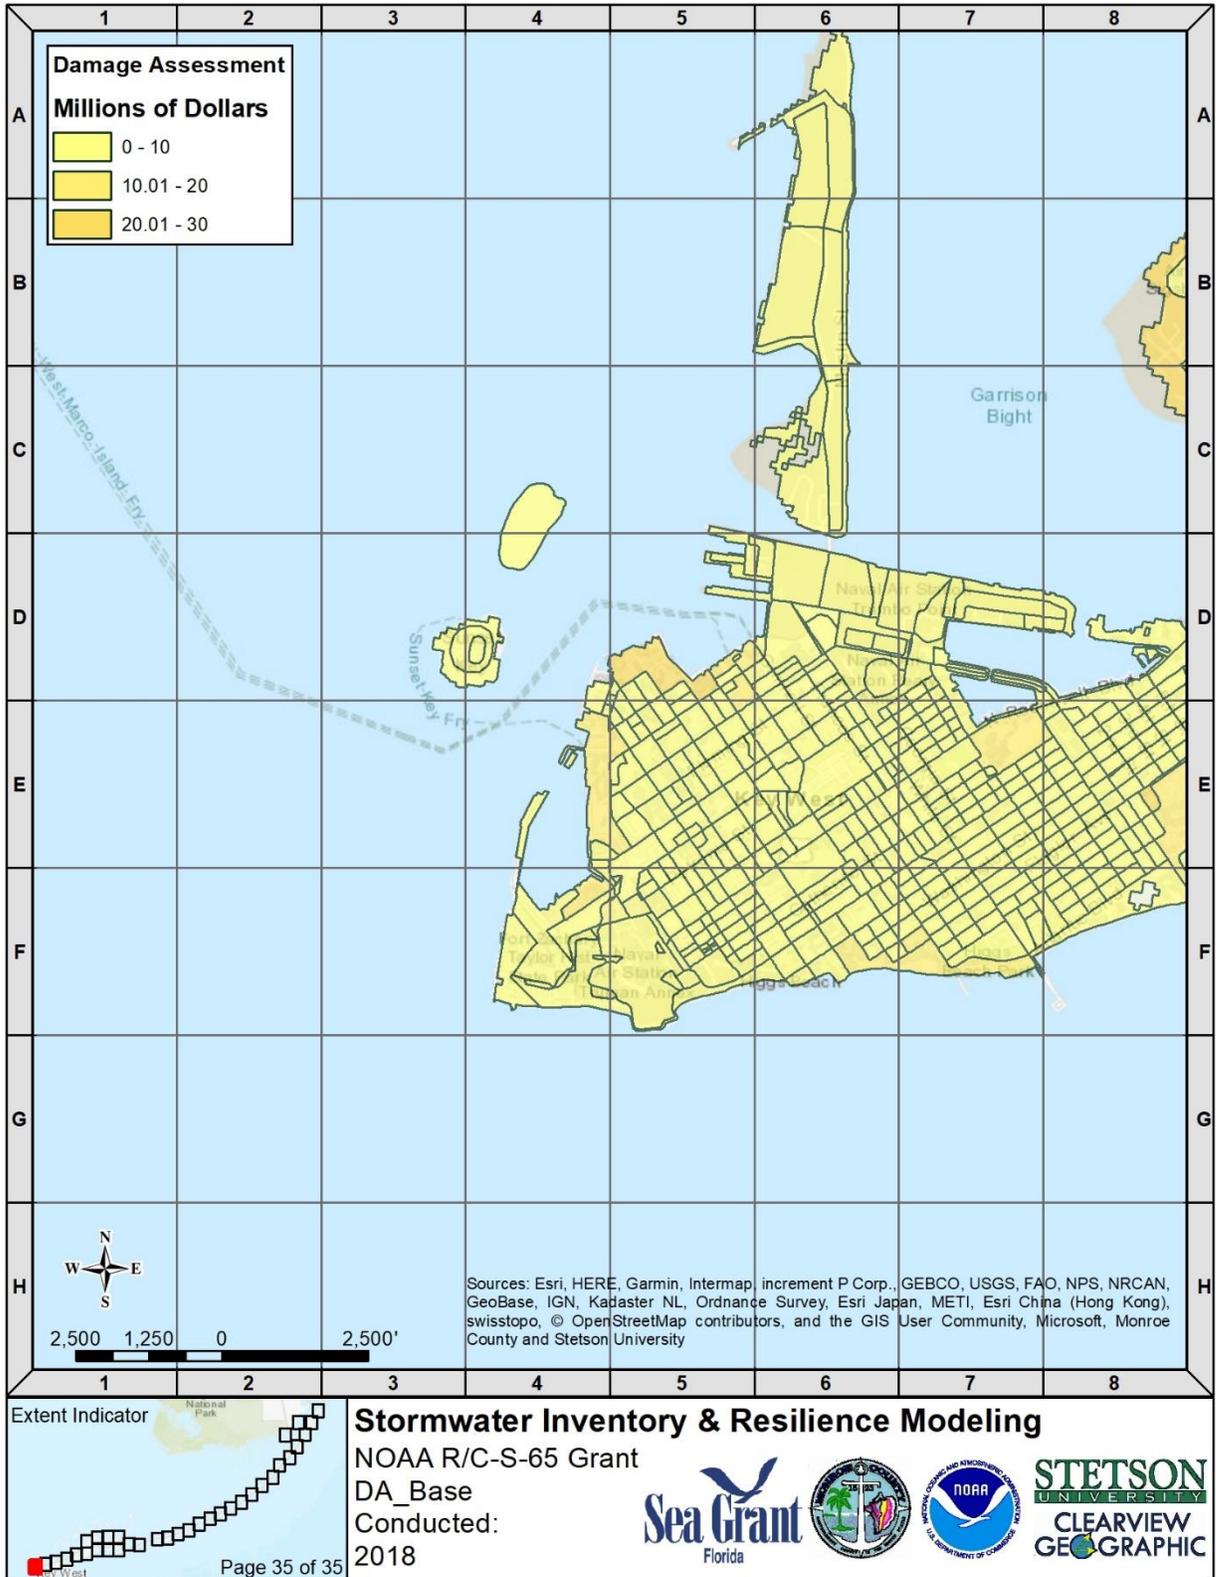
Map Series 7: Hazus-MH 100-Year Coastal Flood Model Damage Assessment for Monroe County, Baseline Scenario (1992 Sea-Level)

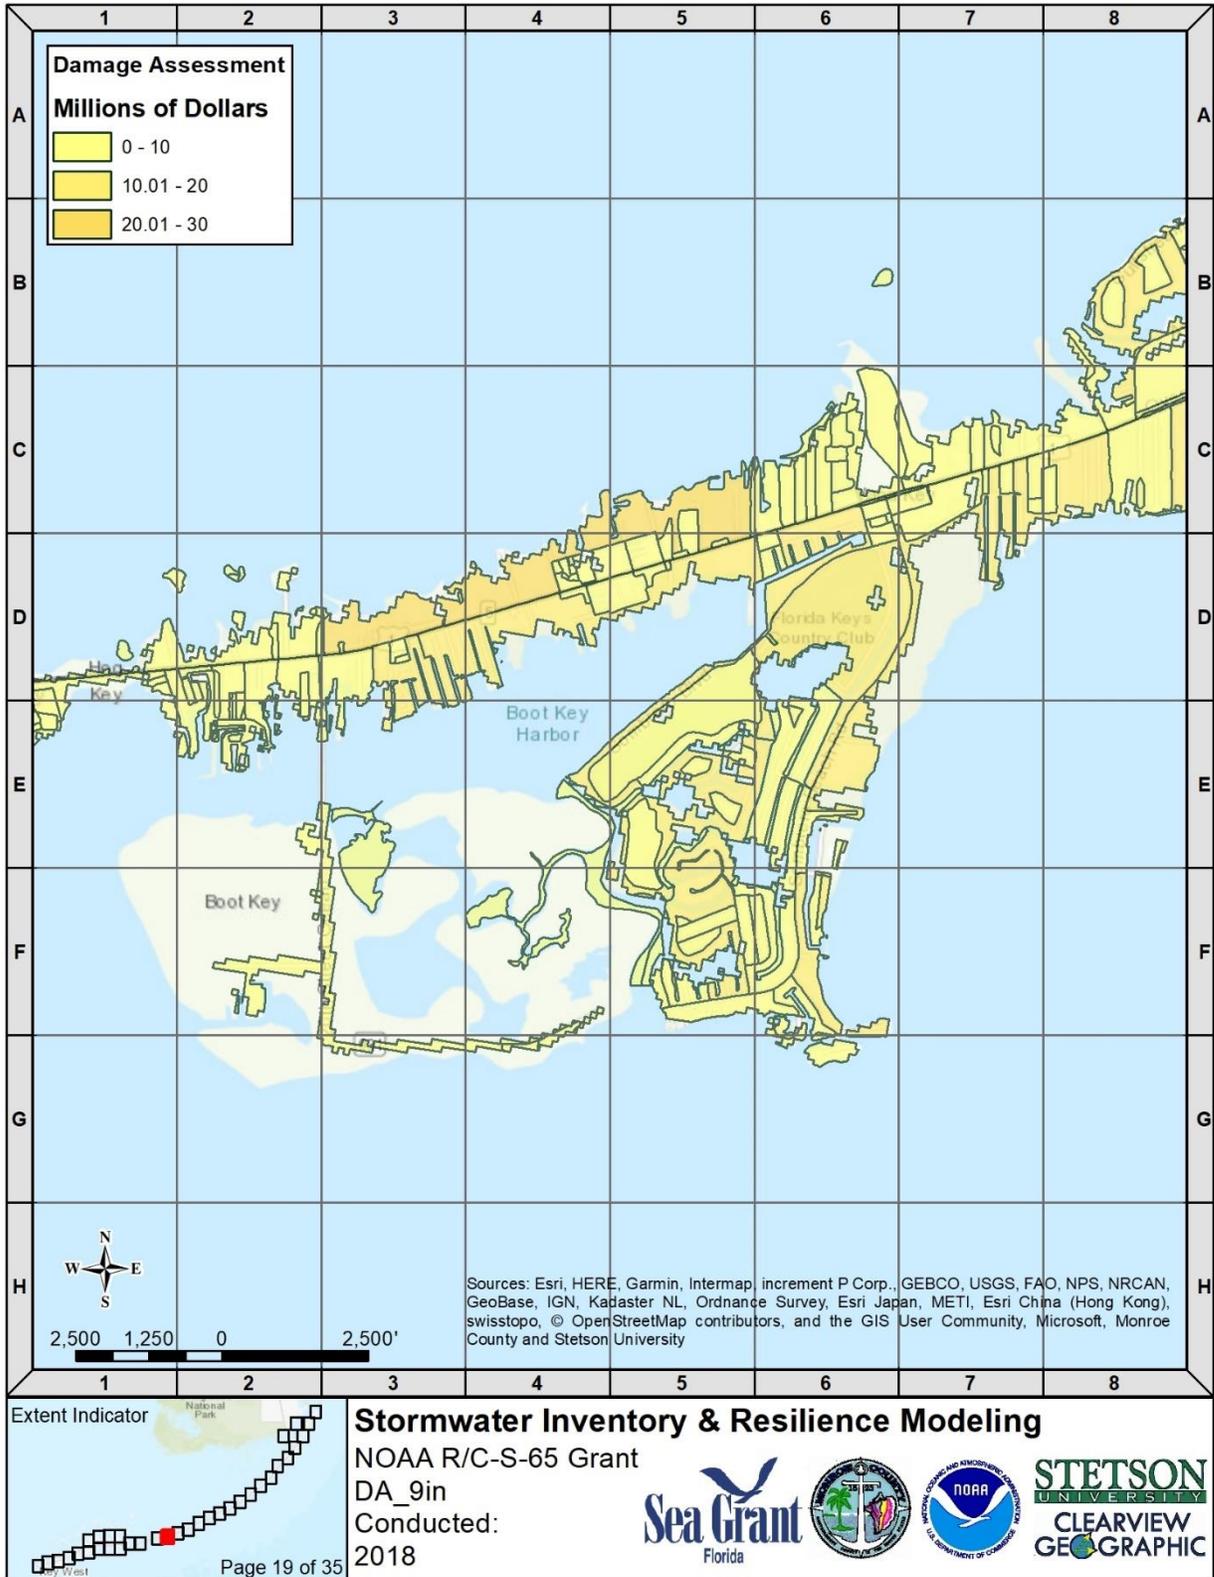
Map Series 8: Hazus-MH 100-Year Coastal Flood Model Damage Assessment for Monroe County
 2060 Low Sea-Level Rise (14") & 2014 Assessed Valuations

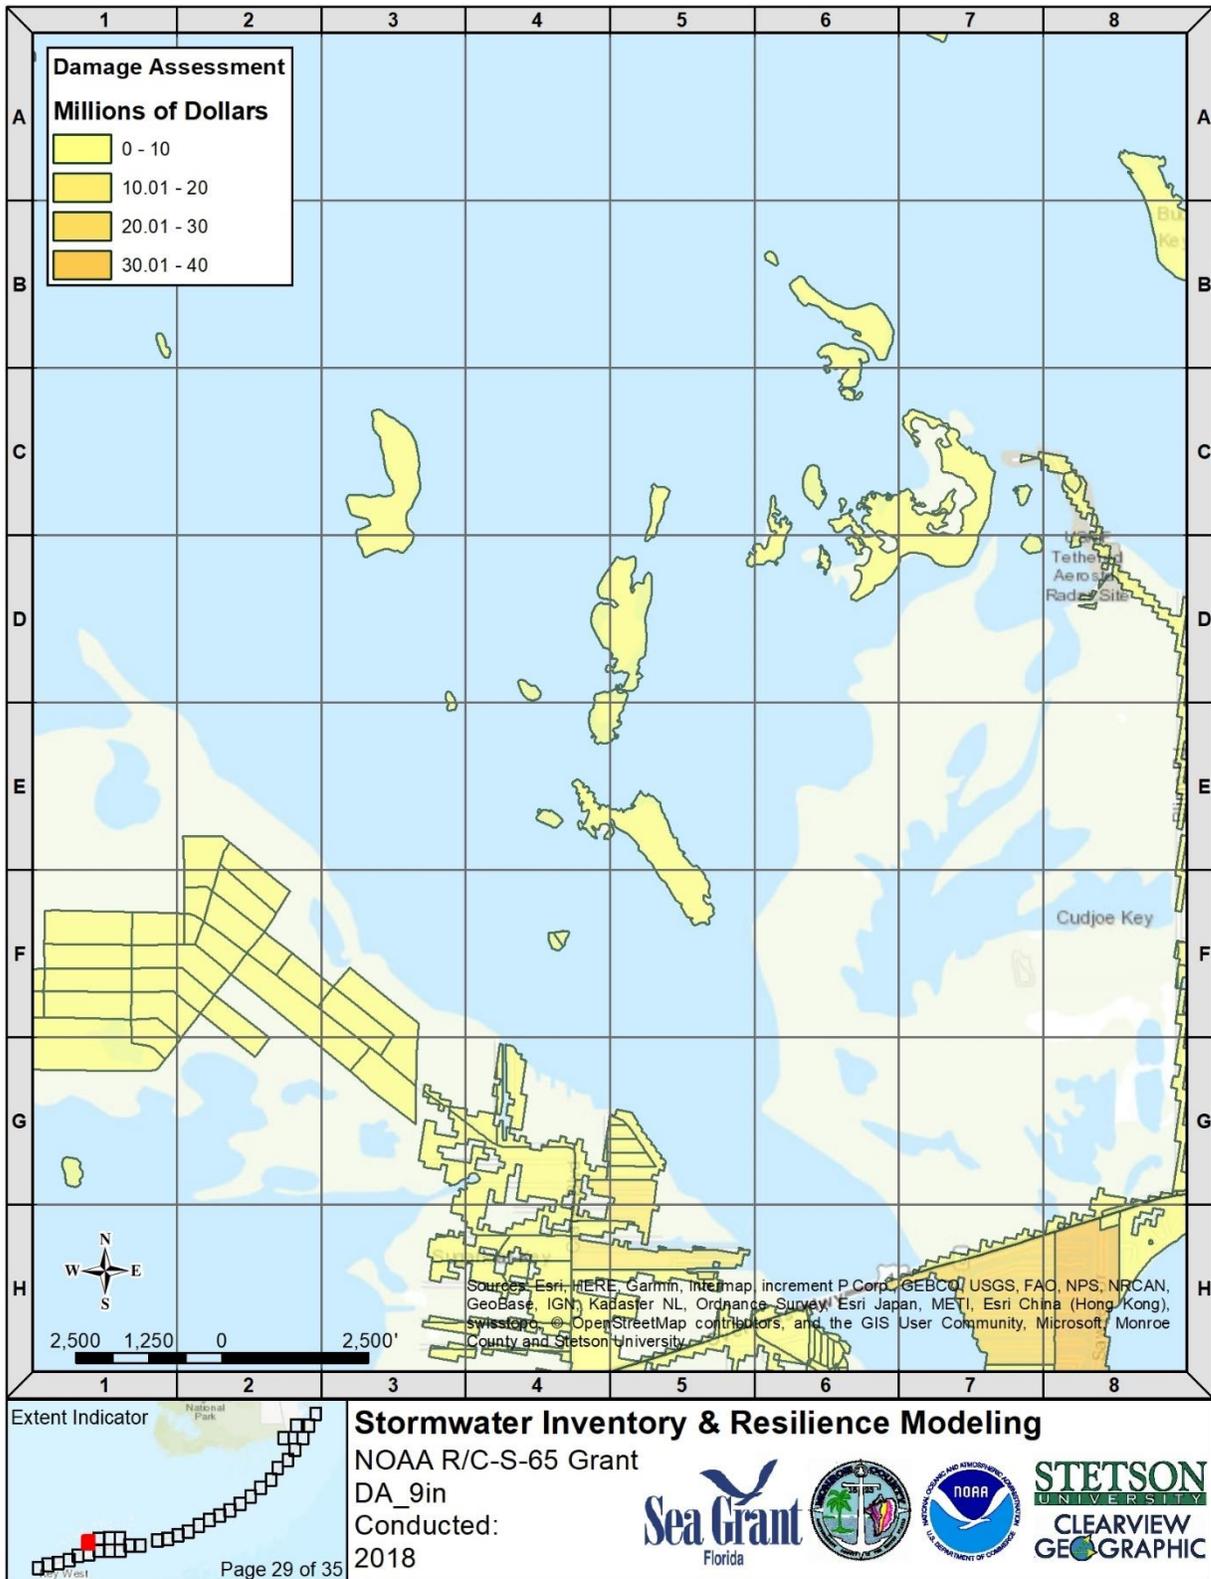
Map Series 8: Hazus-MH 100-Year Coastal Flood Model Damage Assessment for Monroe County
 2060 Low Sea-Level Rise (14") & 2014 Assessed Valuations

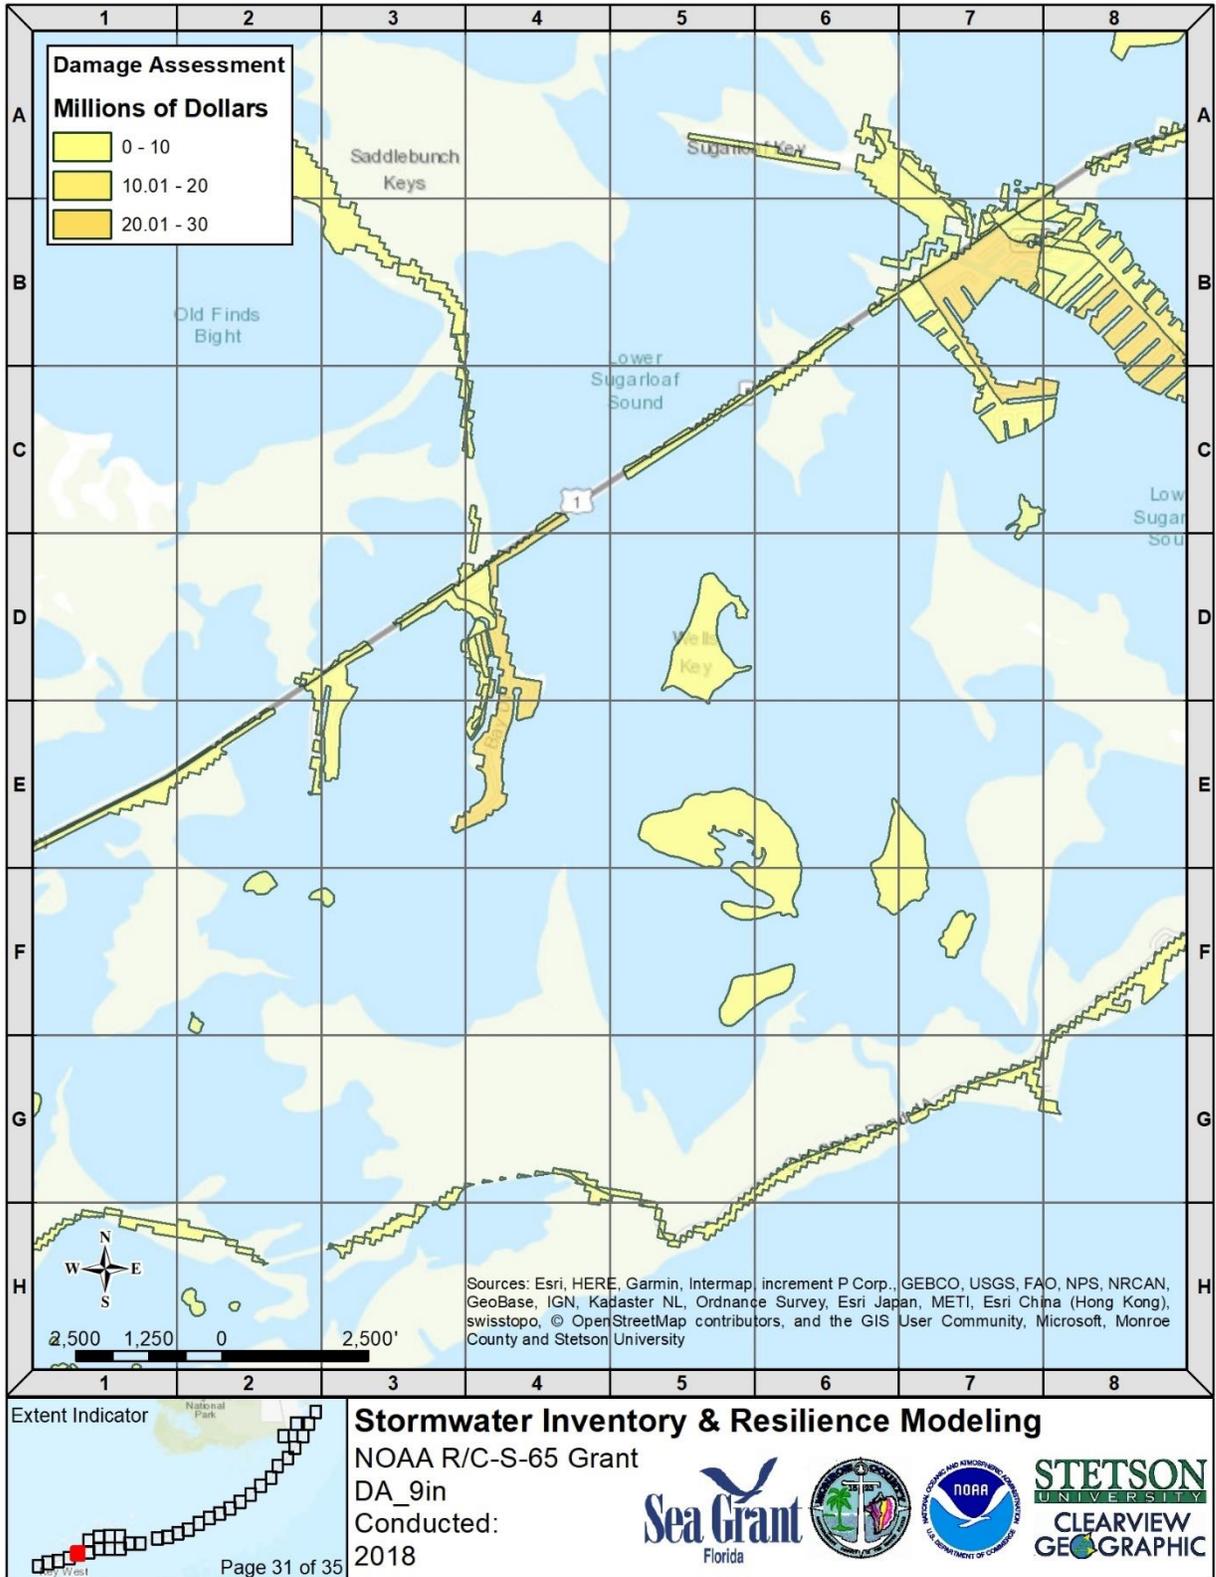
Map Series 8: Hazus-MH 100-Year Coastal Flood Model Damage Assessment for Monroe County
 2060 Low Sea-Level Rise (14") & 2014 Assessed Valuations

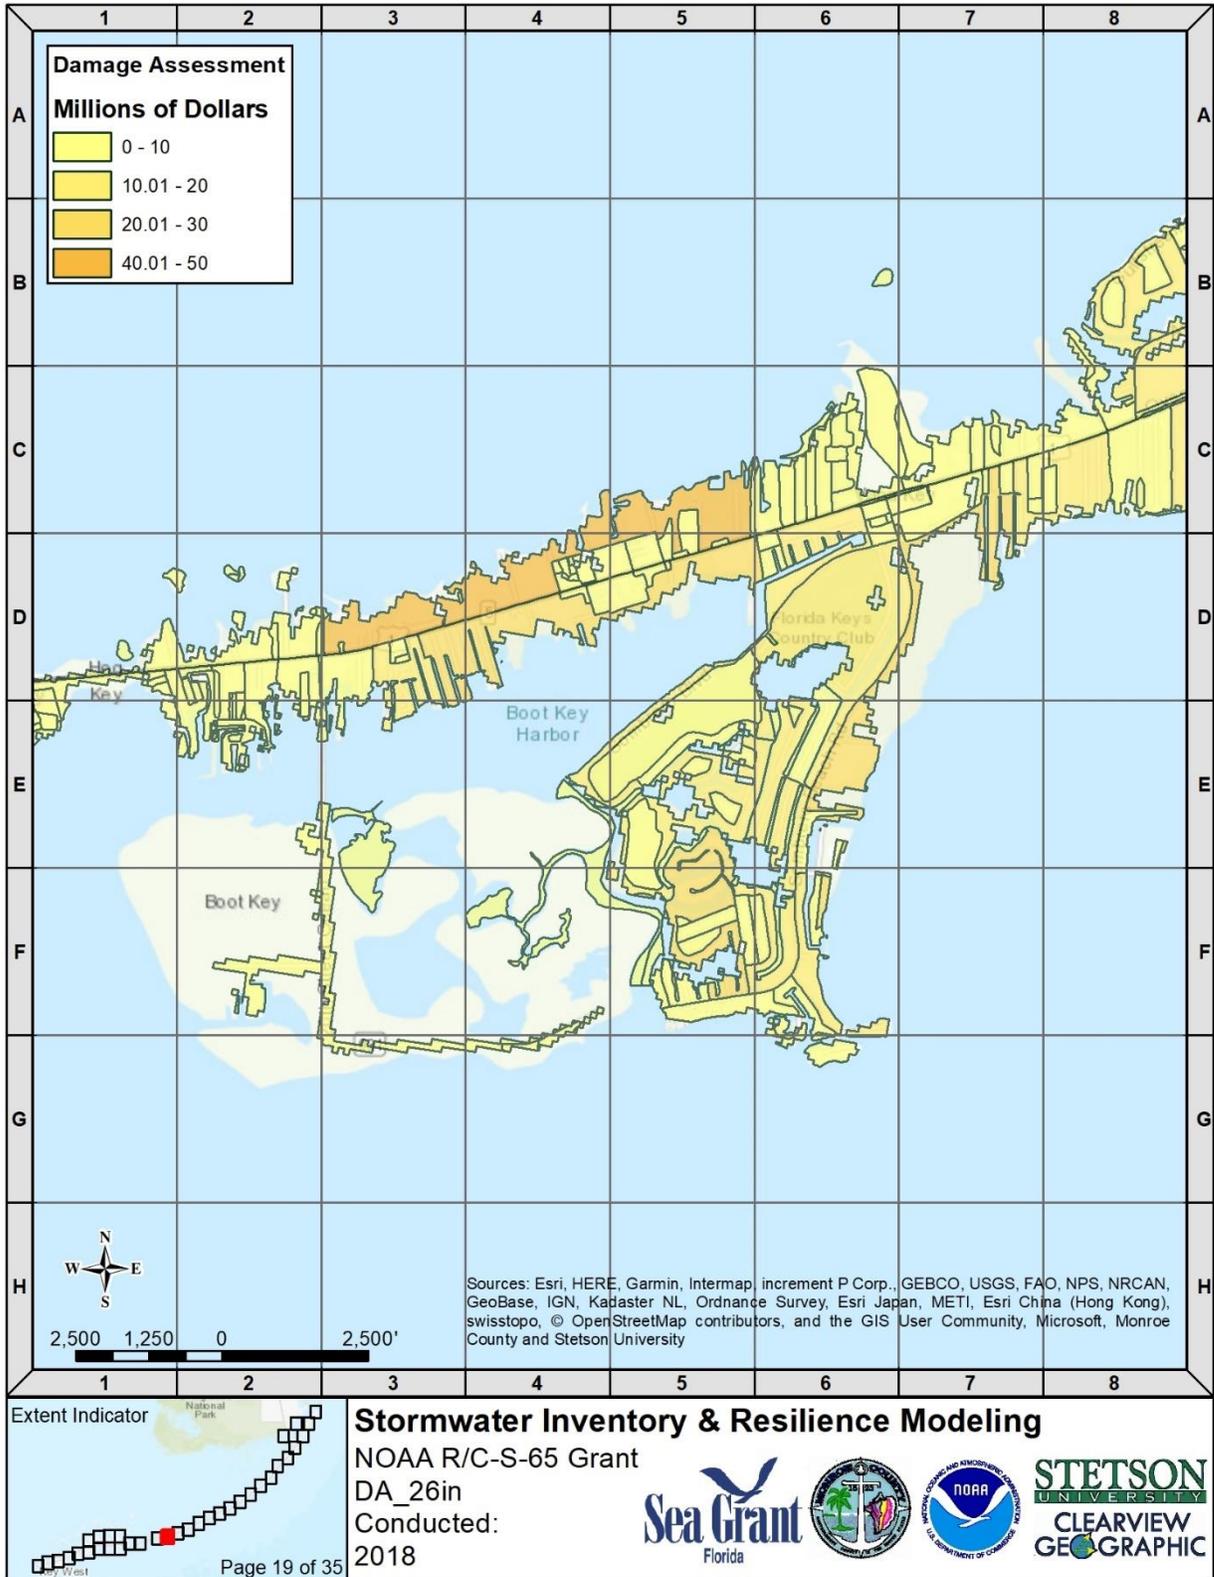
Map Series 9: Hazus-MH 100-Year Coastal Flood Model Damage Assessment for Monroe County
 2060 High Sea-Level Rise (26") & 2014 Assessed Valuations

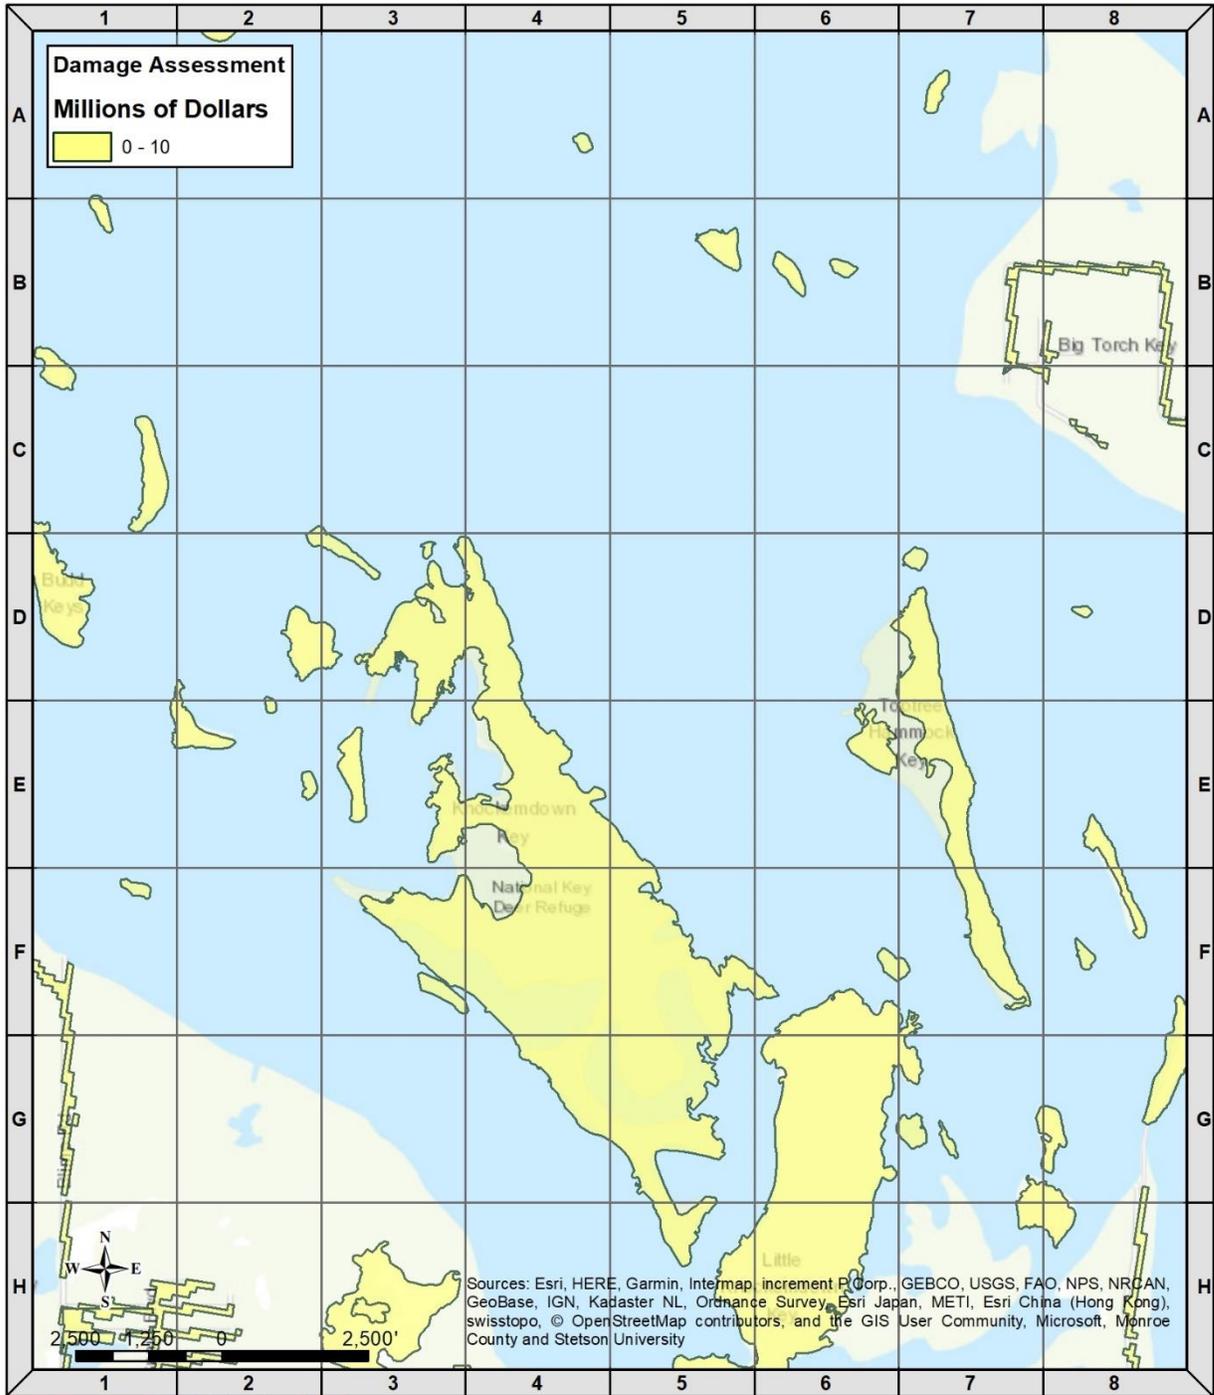
Map Series 9: Hazus-MH 100-Year Coastal Flood Model Damage Assessment for Monroe County
 2060 High Sea-Level Rise (26") & 2014 Assessed Valuations

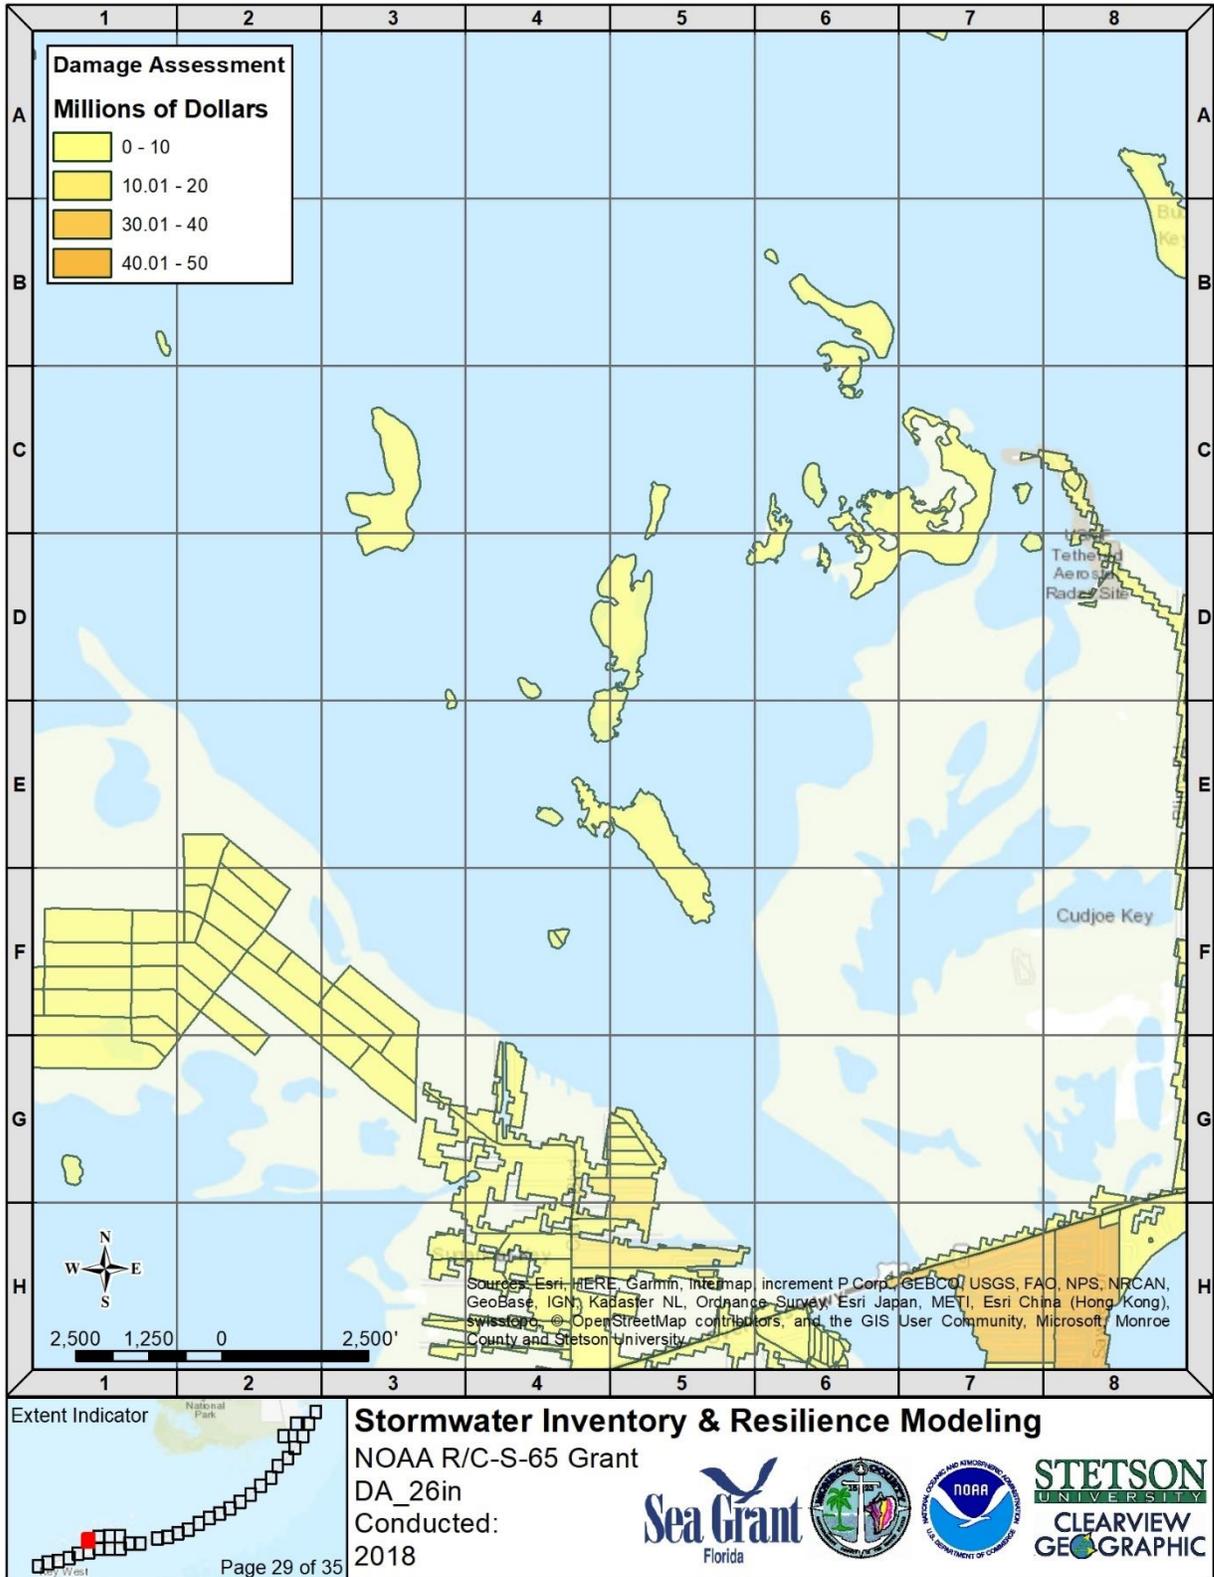
Map Series 9: Hazus-MH 100-Year Coastal Flood Model Damage Assessment for Monroe County
 2060 High Sea-Level Rise (26") & 2014 Assessed Valuations

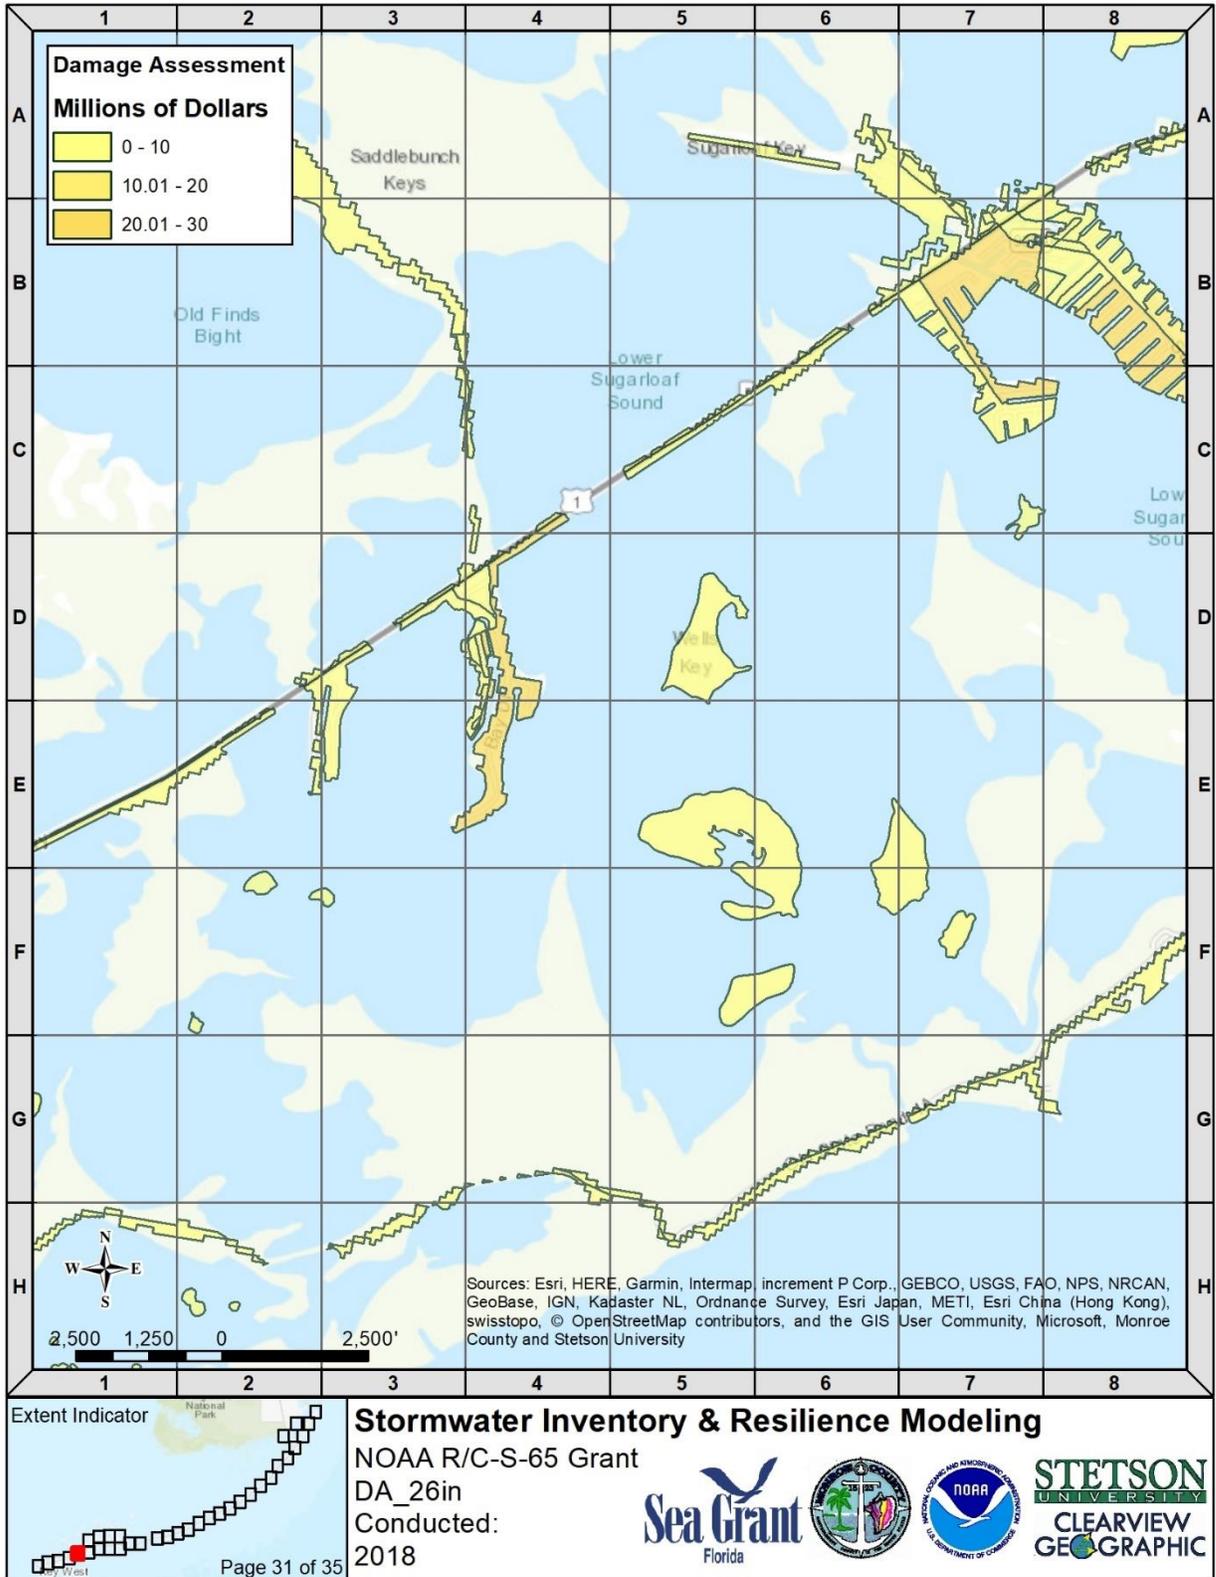
Map Series 9: Hazus-MH 100-Year Coastal Flood Model Damage Assessment for Monroe County
 2060 High Sea-Level Rise (26") & 2014 Assessed Valuations
