Americans with Disabilities Act Transition Plan Lower Keys - Part 2

Volume 4 of 4

Monroe County

October 29, 2010

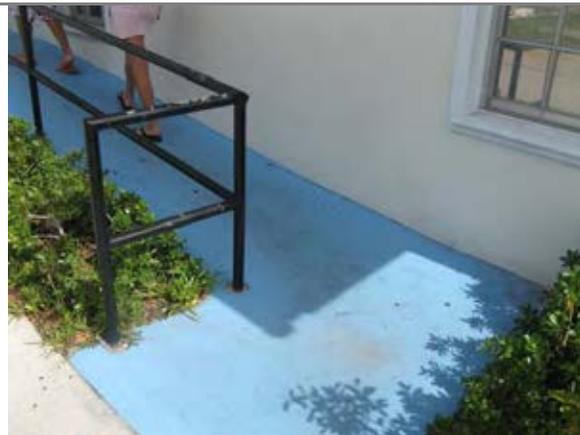
Inspection Area: 3.3 STEPS	
Observation	Recommendations
Front Steps lead to the landing at the front door. Side steps lead to the landing and the side door. In each case, ⊗ There are no handrails.	A\$ - Install handrails in accordance with FACBC 11-4.9.

Front Ramp

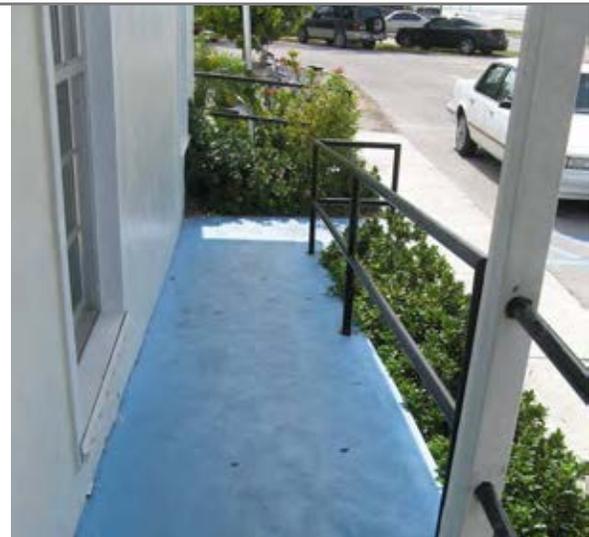
Front Ramp

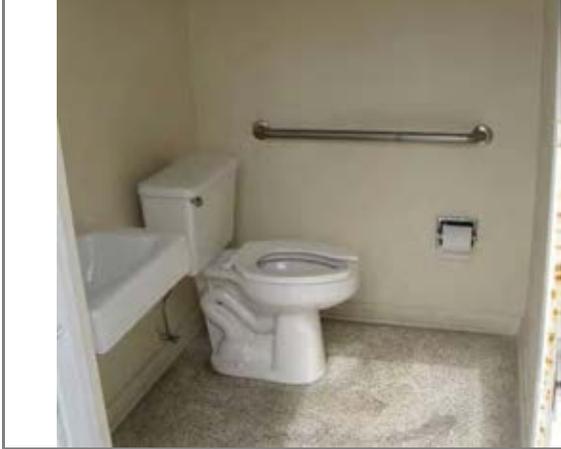
Typical Inaccessible Restroom

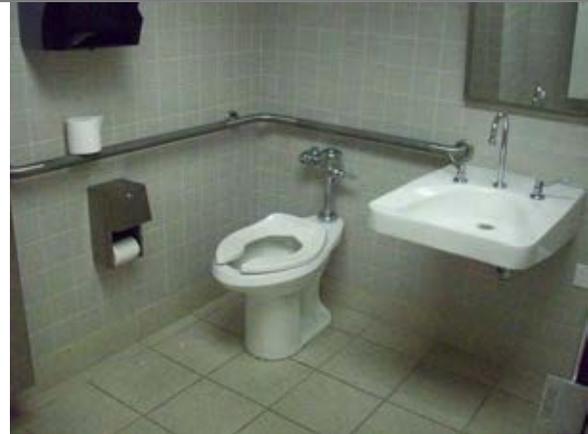
Typical Accessible Stall (non-compliant)

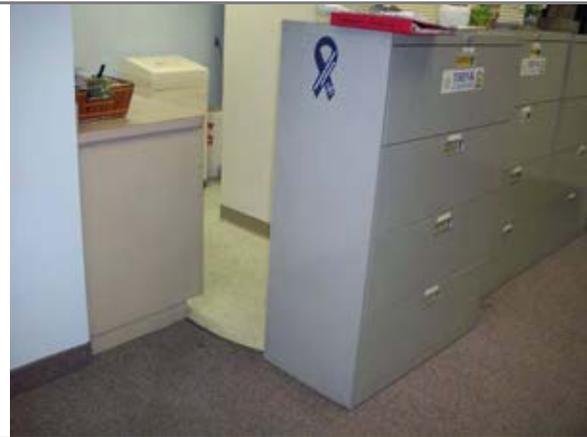
Filing Cabinet Blocking Accessible Route

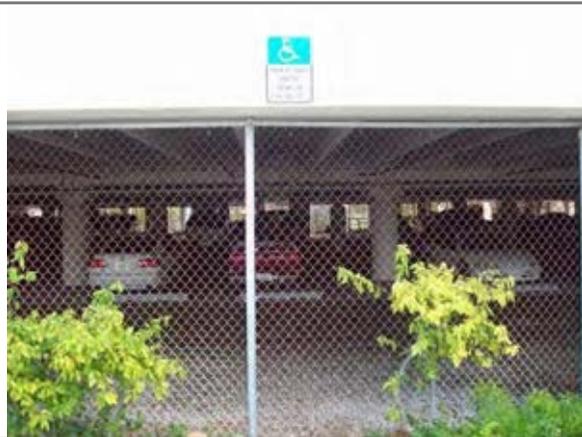
Signage at Incorrect Height

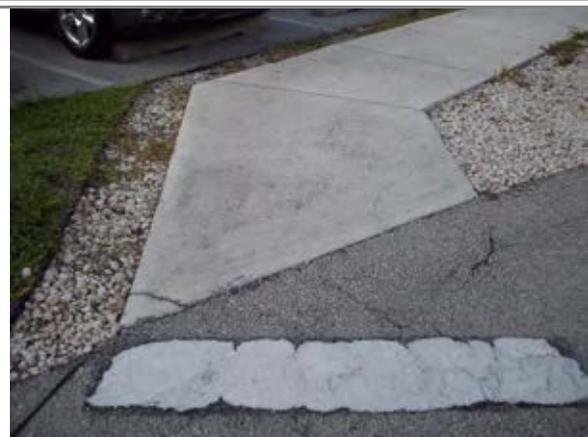
No Detectable Warnings

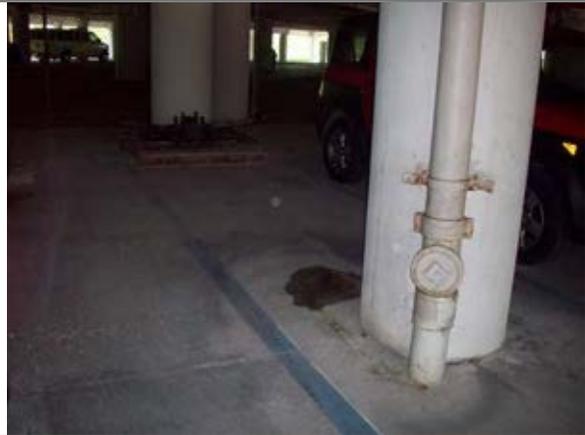
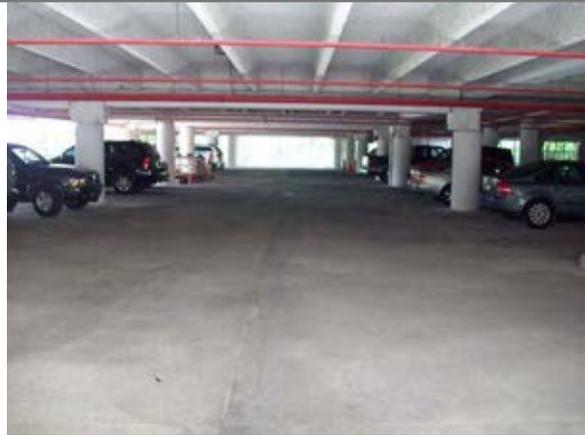
Obstructions at Access Aisle	Parking Area

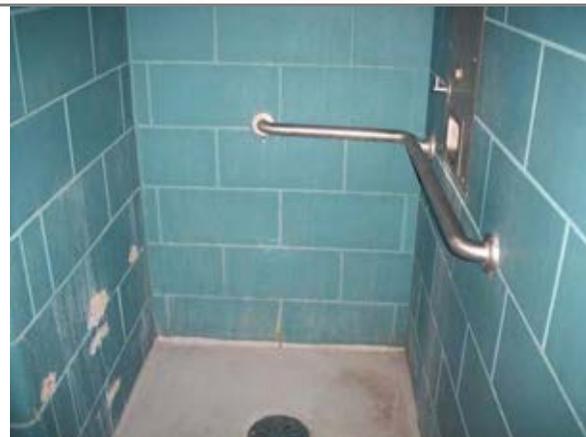
Missing Seat at Shower

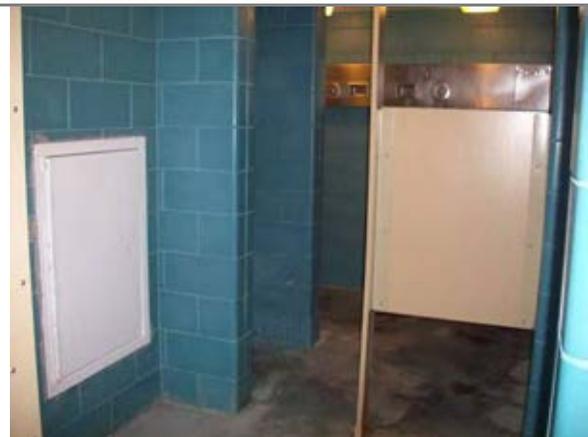
Partition Obstructing Travel Path

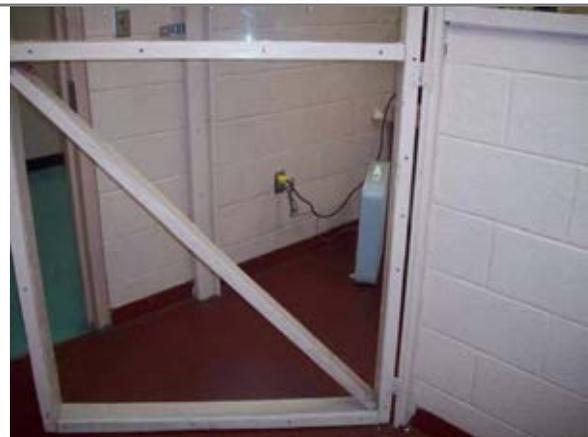
Sewing Area(Non-compliant door)

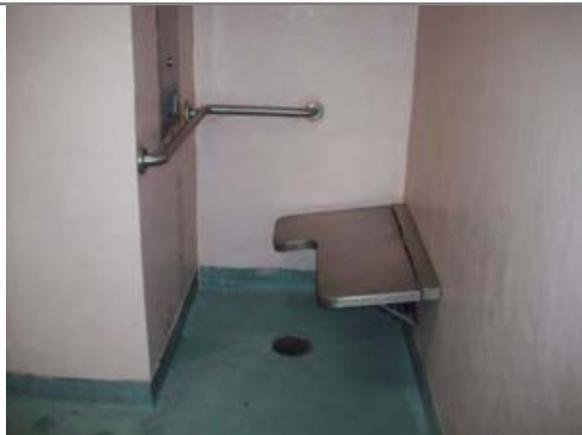
Broken Seat at Intake Shower

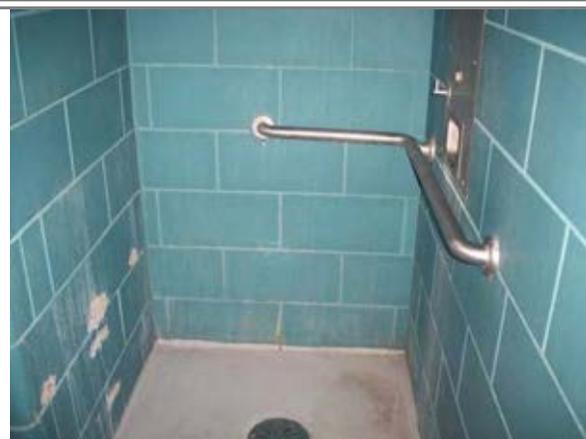
Typical Shower with Missing Seat

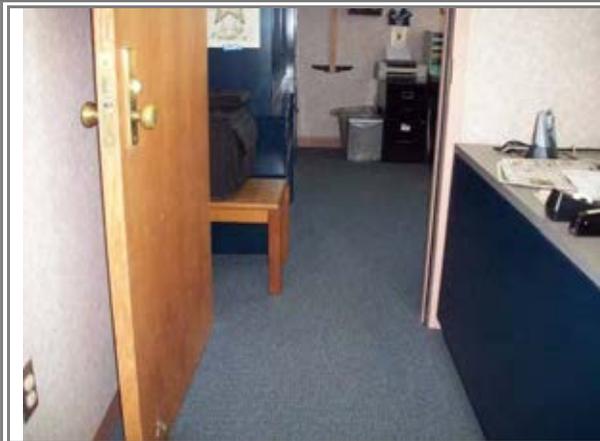
Office 7338 (Furniture Obstruction)

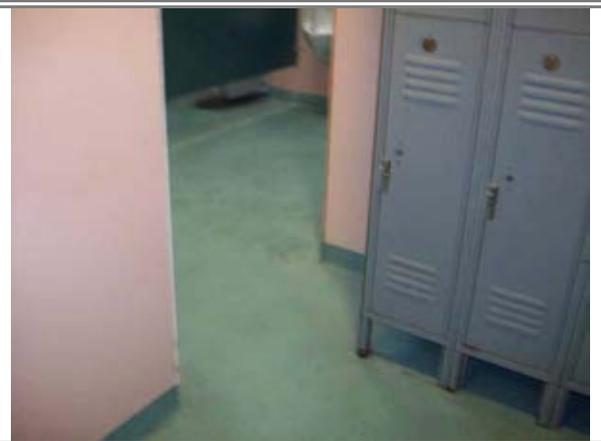
Locker Room (Furniture Obstruction)

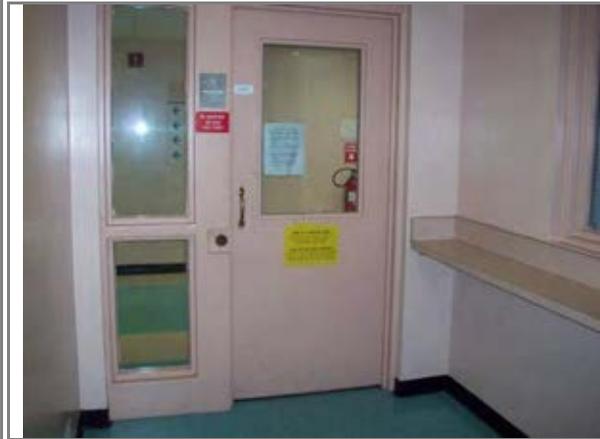
Typical Secure Door (Intercom 60" high)

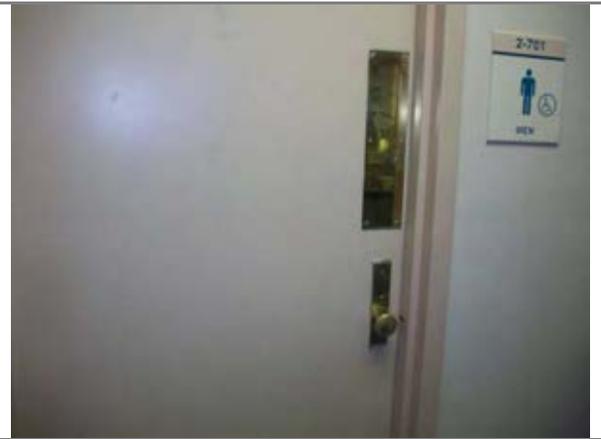
Non-Compliant Door Hardware

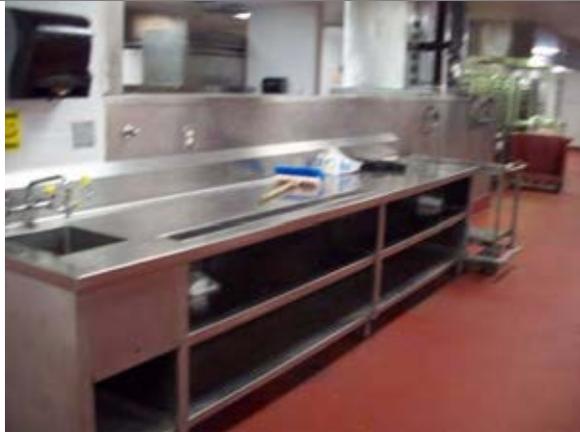
Kitchen

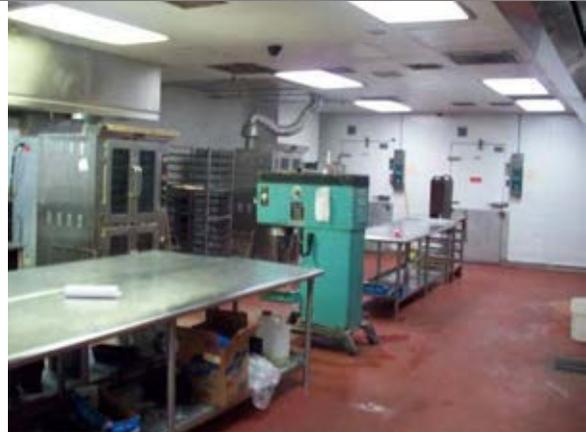
Kitchen

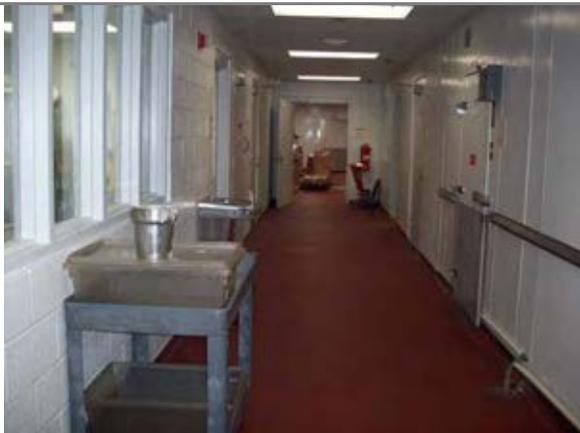
Kitchen Corridor

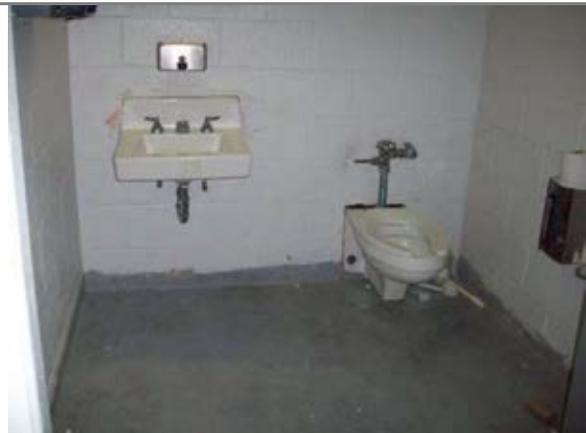
Restroom (Kitchen Area)

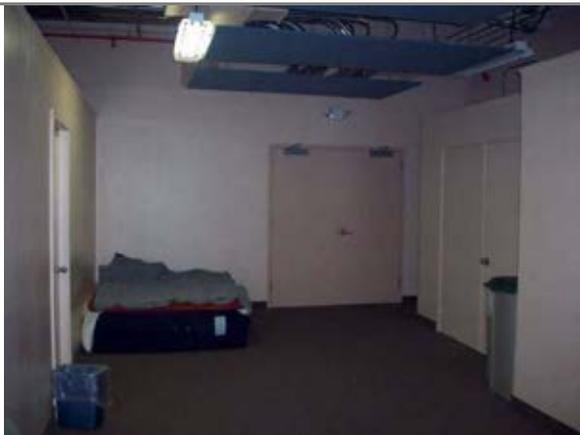
Officer Bunk Room Area

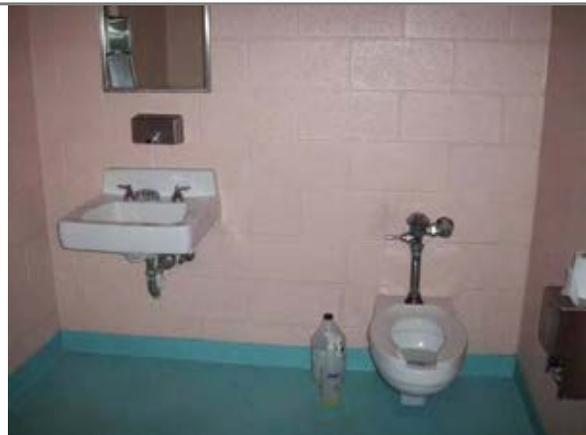
Officer Bunk Room Restroom

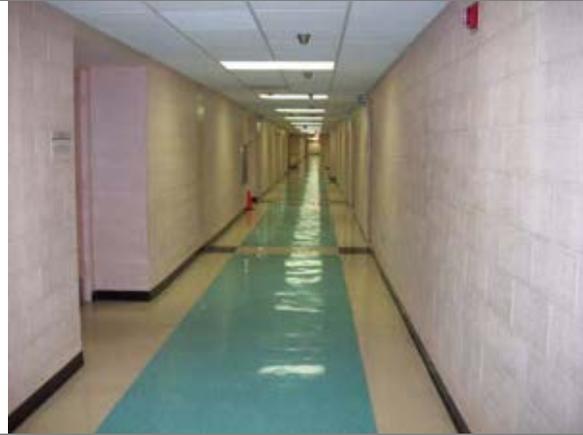
Corridor

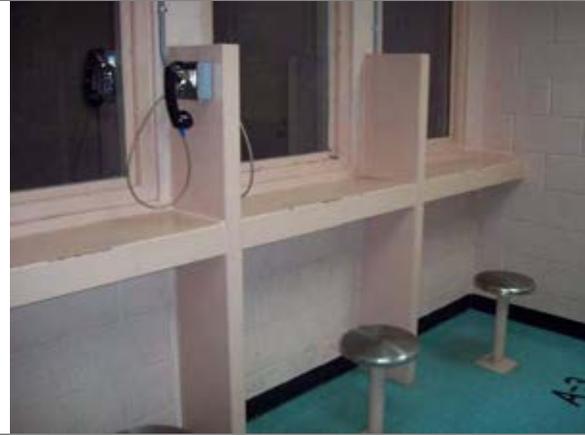
Visitation Room

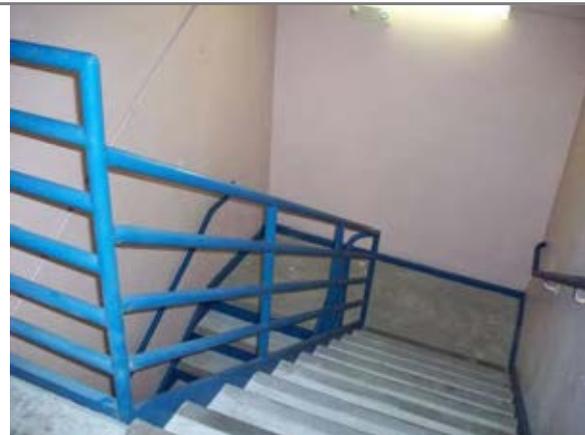
Stairwell Zone “E”

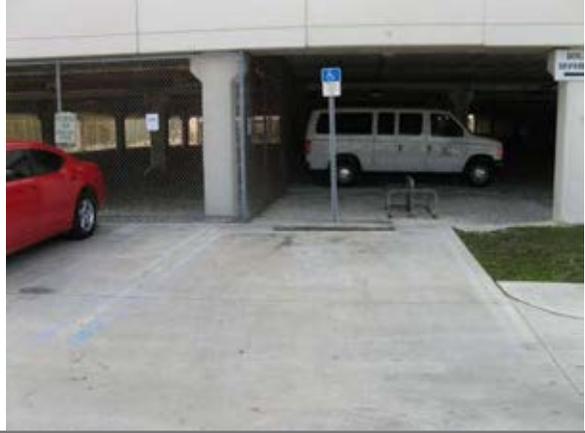
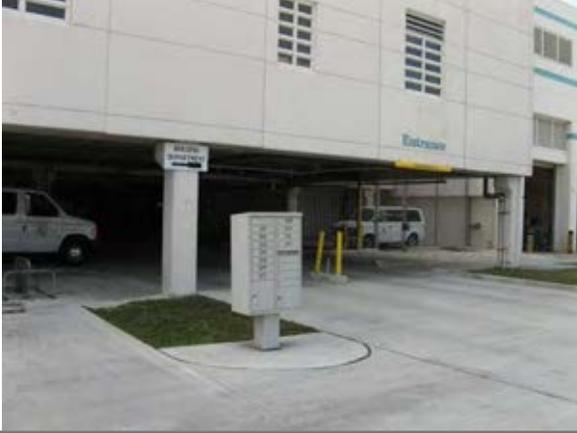
<p>There are 7 parking spaces Under the building, including 2 accessible spaces. They are on the shortest route to the entrance.</p> <ul style="list-style-type: none"> ⊗ The Accessible Parking spaces are 11'-0" x 16'-6", less than the 12' width and 18' length required. ✓ The parking space slope is less than 1:50. ✓ The markings are correct for accessible spaces. ✓ The Access Aisle to between the spaces is 66" wide. ✓ The Signage is correct. 	<p>A\$ - Reconfigure one parking space to the proper dimensions in accordance with FACBC 11-4.6.3.</p>
<p>The Access Route from the parking area to the front elevator is 60" wide.</p> <ul style="list-style-type: none"> ✓ The curb cut is correctly marked. ✓ It has a slope of 1:12. It is approximately 60" x 44" with flared edges. ⊗ The surface is etched with a non-slip pattern but is not the new style. ⊗ At the bottom of the cut, there is a gap > ½". The curb near by is 6" high. 	<p>A\$ - Install detectable warnings in accordance with FACBC 11-4.29.5. A\$ - Grout the crack to ensure the gap is smooth or < ½".</p>

<p>Accessible Parking</p>	<p>Route to Main Entrance</p>

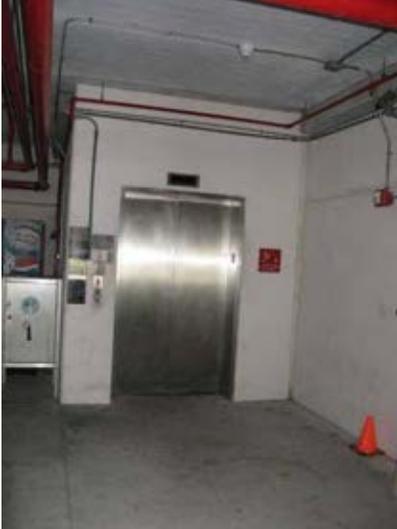
Inspection Area: 4.2 ELEVATORS	
Observation	Recommendations
The Elevator is the only public access to the floors above. <input checked="" type="checkbox"/> The car is 69" x 94". <input checked="" type="checkbox"/> The elevator is completely compliant. However, <input checked="" type="checkbox"/> The call button on the second floor does not light up.	RA\$ - Repair call button.
A second elevator operates from the Sally Port area to the controlled holding area on the first floor. It is locked out at the second floor. It opens on the ground floor to a fenced in area. <input checked="" type="checkbox"/> This elevator is compliant.

Elevator at Main Entrance

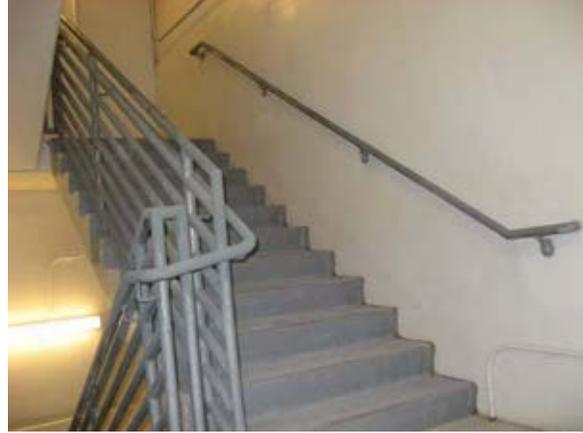
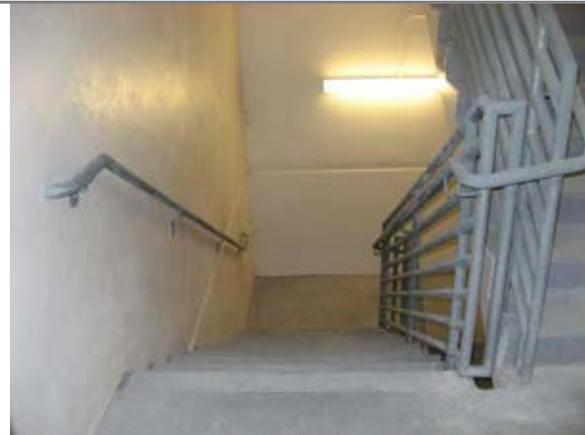
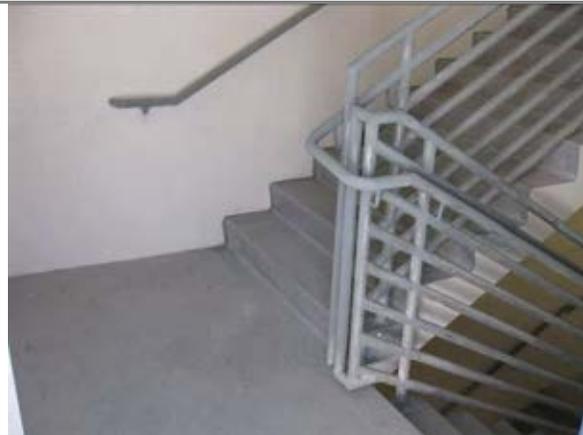
Typical Stairs

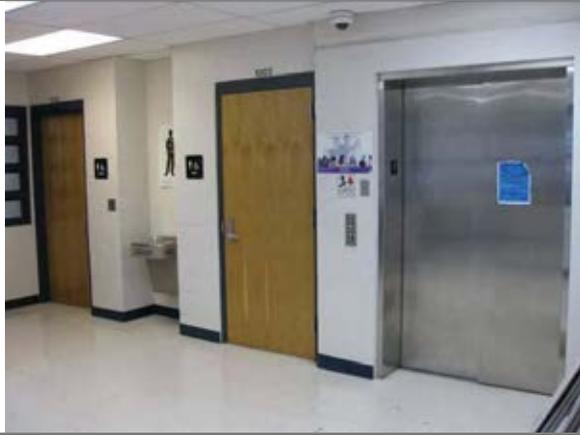
Lobby Area

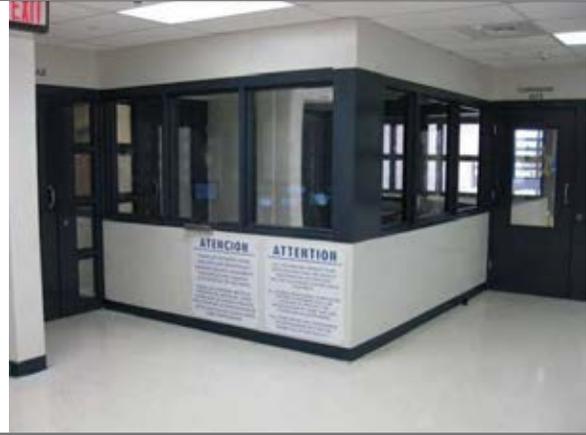
Security Control

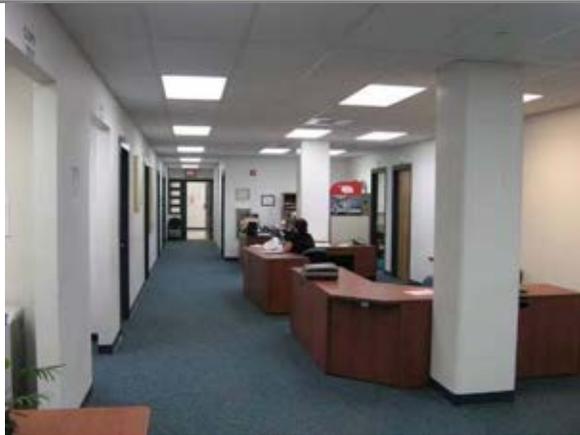
Common Area

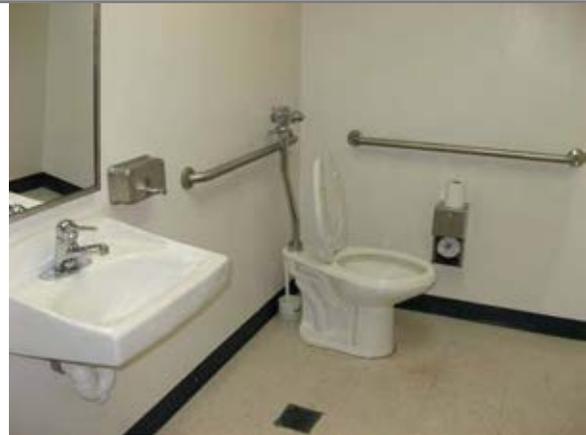
Typical Accessible Restroom

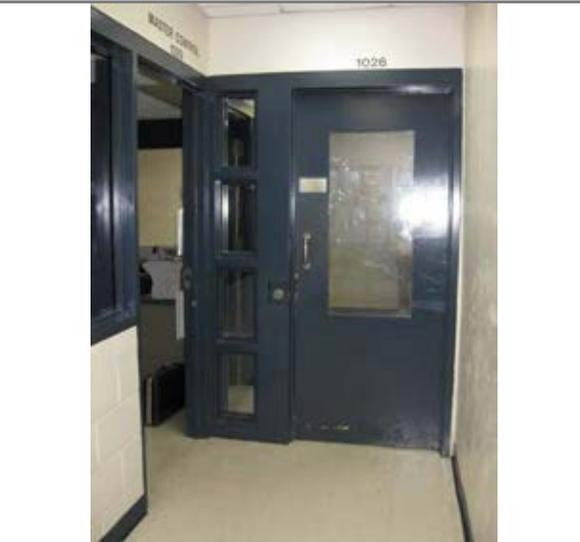
Door to Detention Area

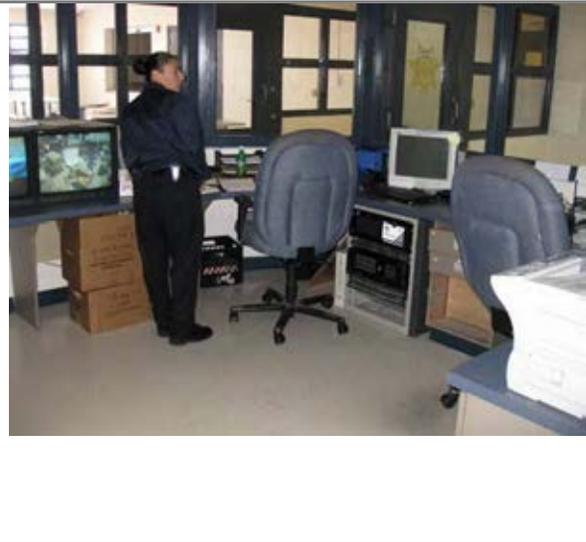
Control Room

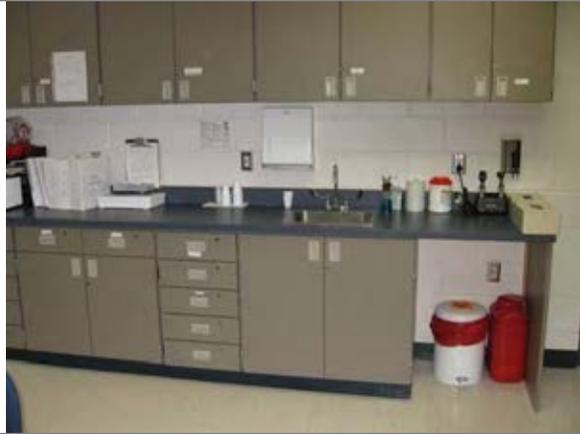
Nurses Area

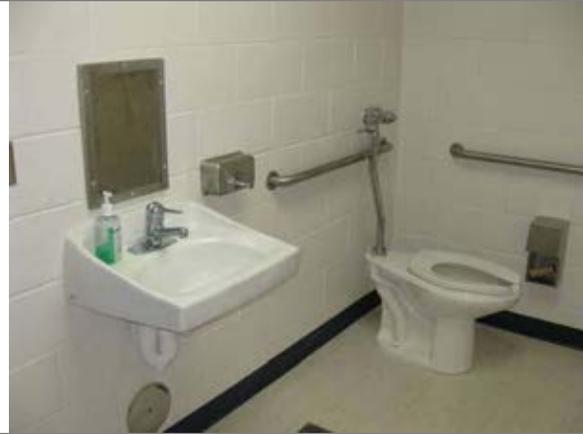
Nurse's Area Restroom

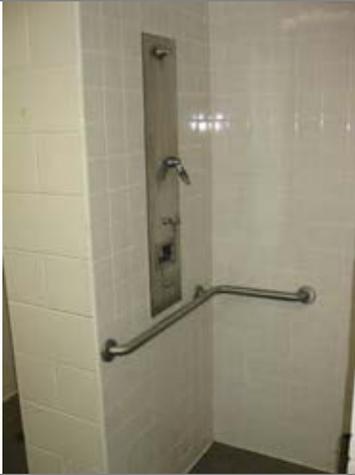
Accessible Shower in Girl's Area

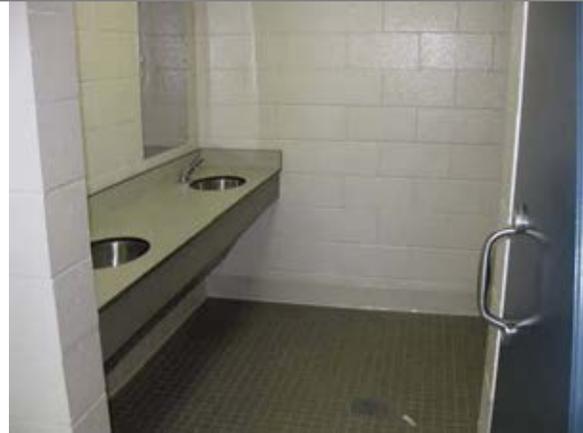
Girl's Shower Room

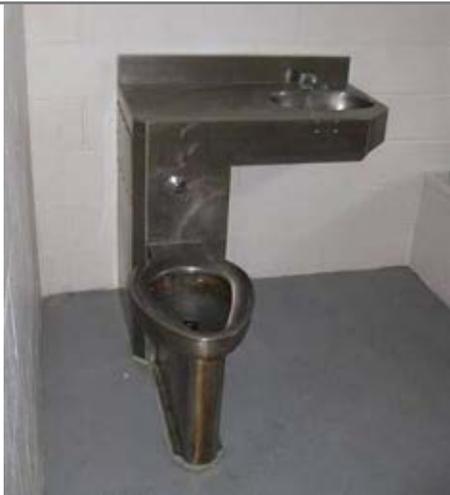
Accessible Toilet/Sink

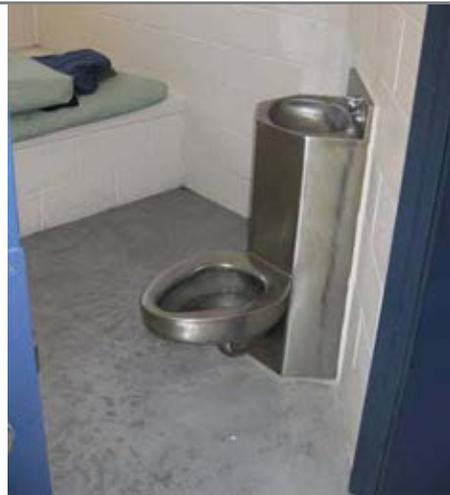
Typical Standard Toilet/Sink

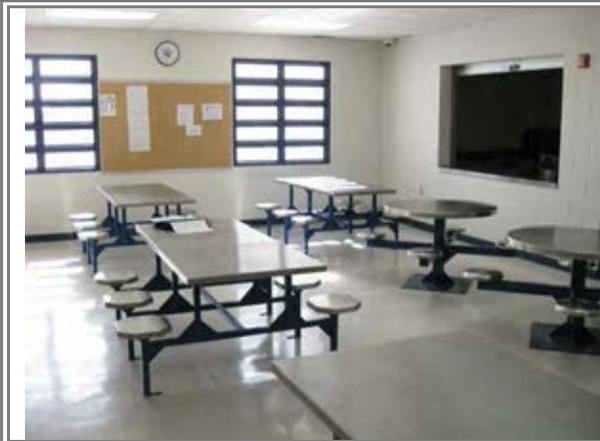
Juvenile Dining Area

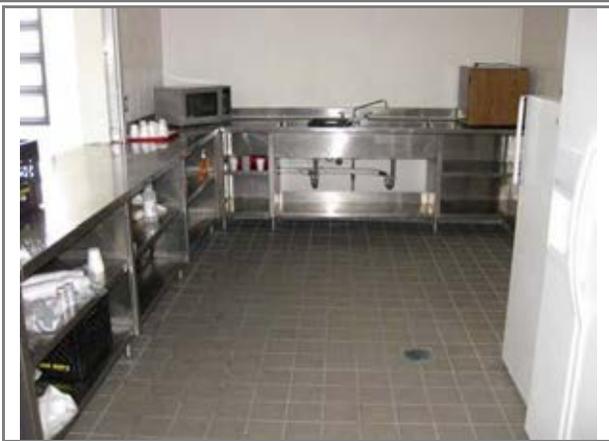
Kitchen Area

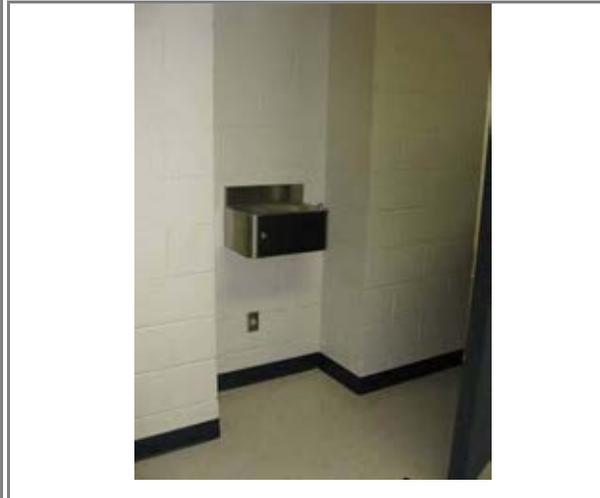
Typical High Fountain

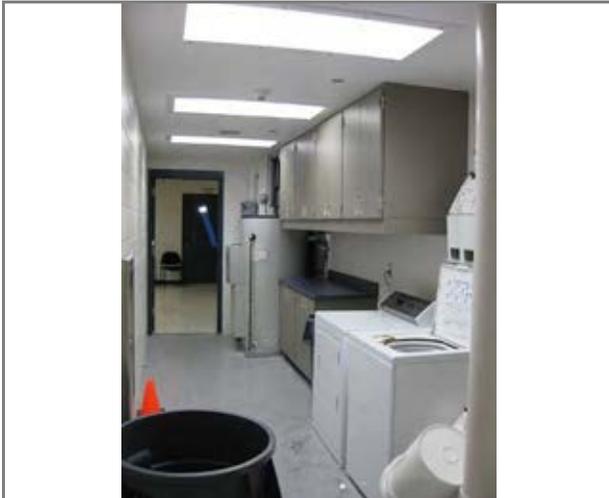
Adult Detention Area Laundry

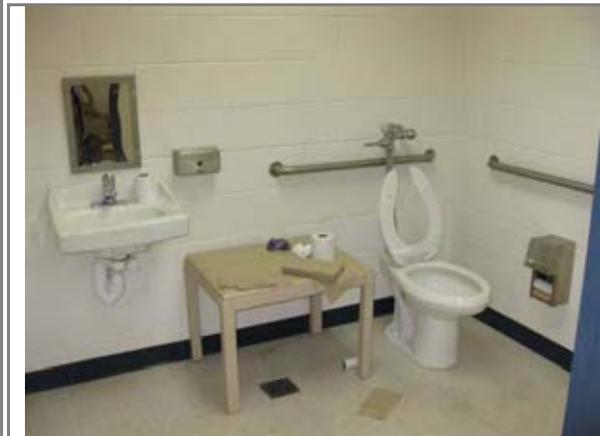
Training Room B Restroom

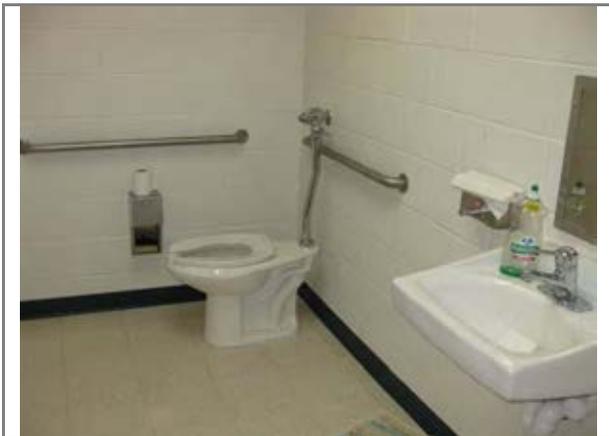
Training Room A Restroom

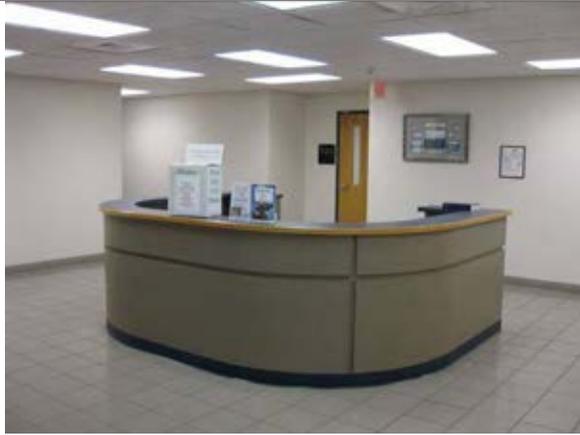
Lobby Counter

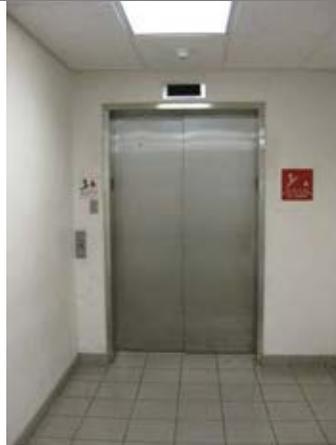
Lobby Elevator

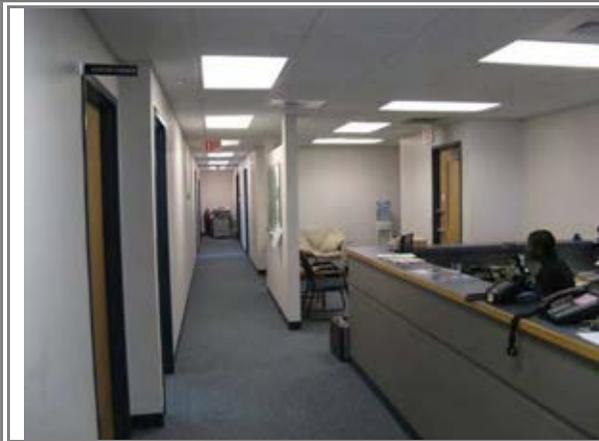
Typical Office Area

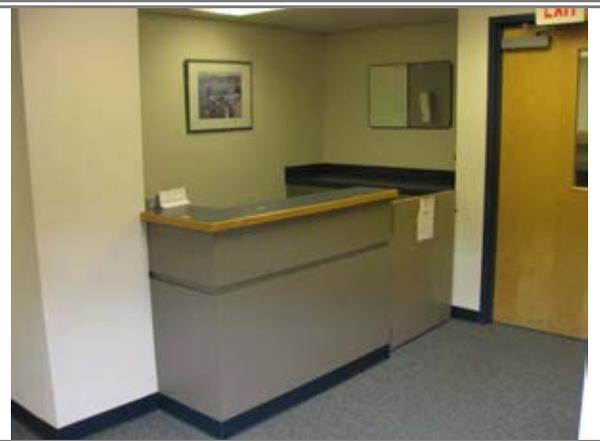
Typical Reception Desk

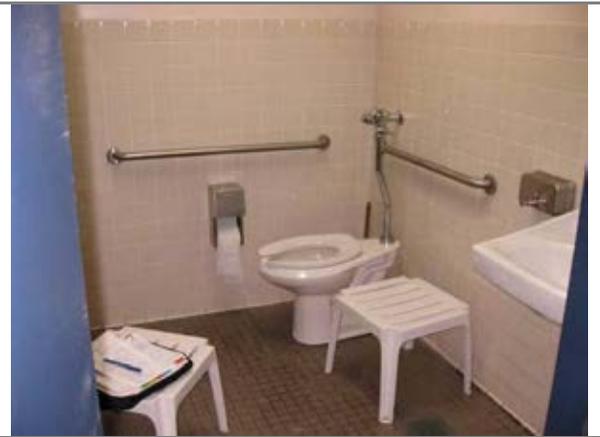
Men's Restroom, Gym

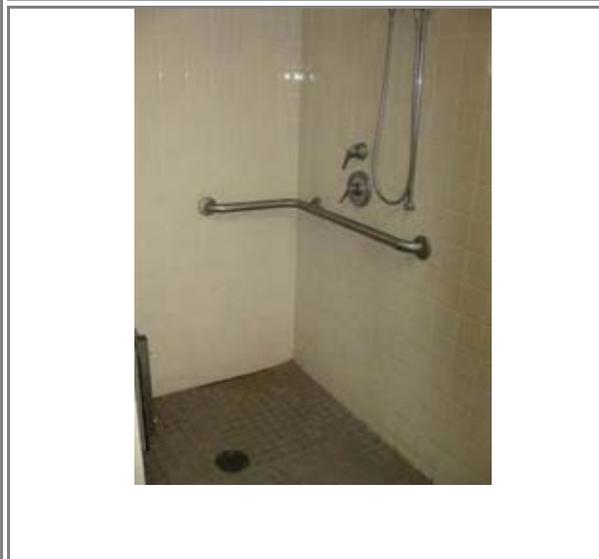
Men's Shower, Gym

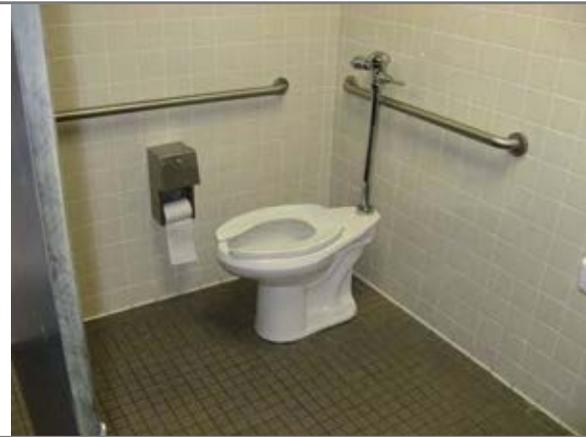
Women's Stall, South Corner

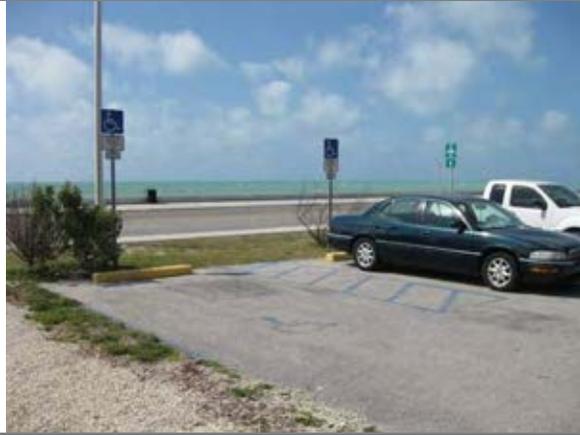
Public Works Accessible Parking

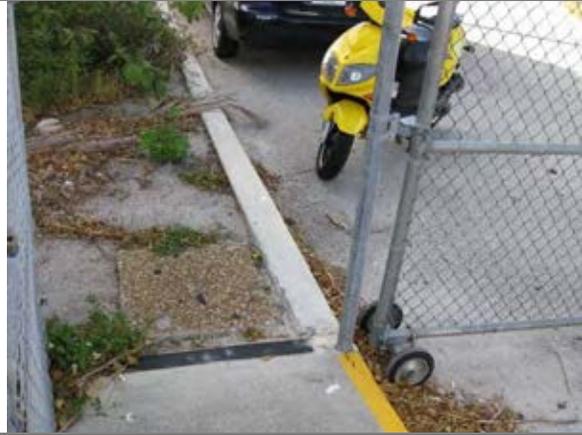
Bottom of Ramp

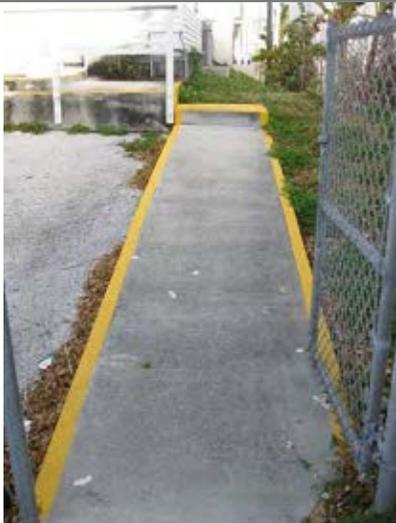
Ramp and Steps

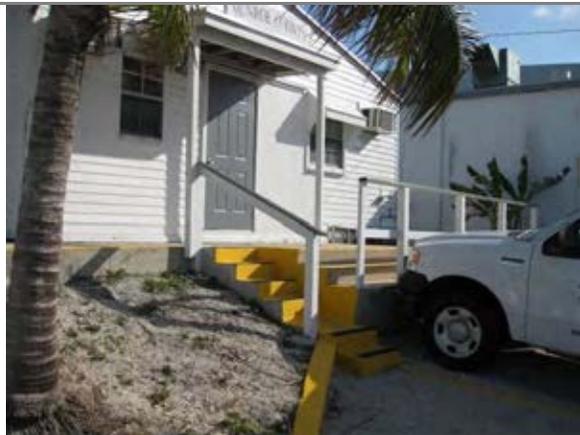
Rear Entrance Steps

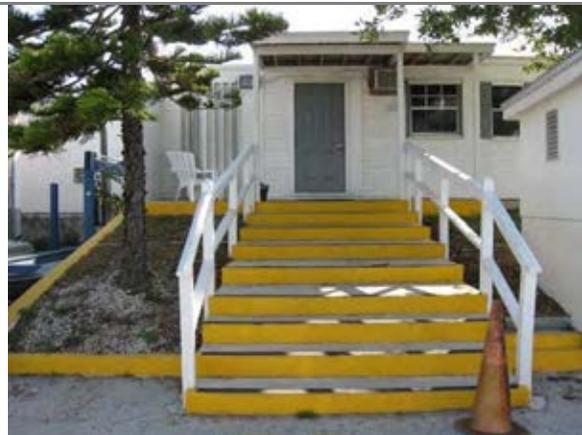
Main Entrance Steps

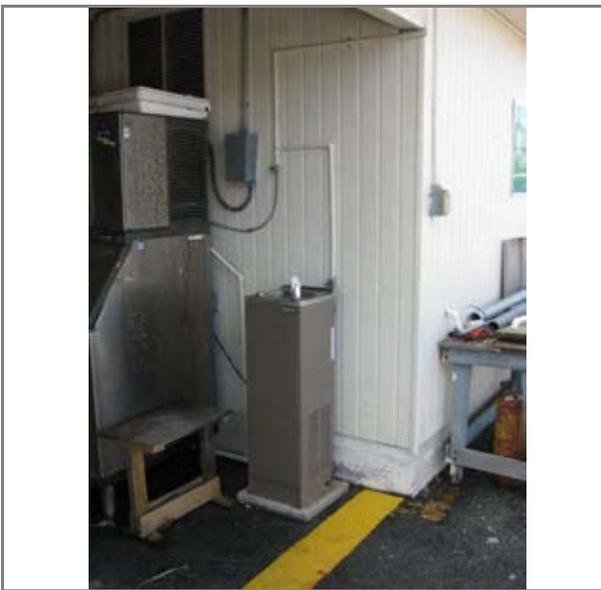
Carpenter Shop Fountain

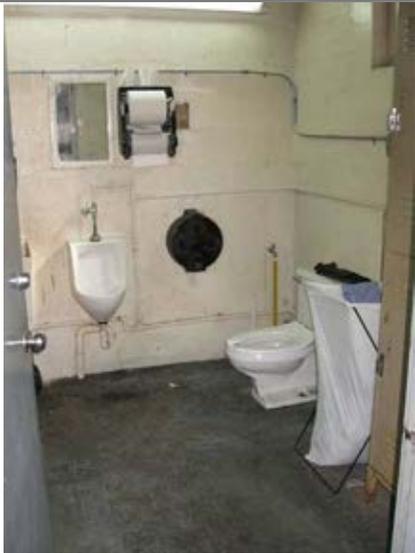
Restroom in Garage

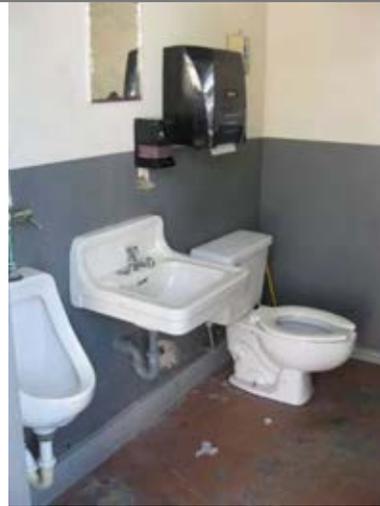
Men's Restroom

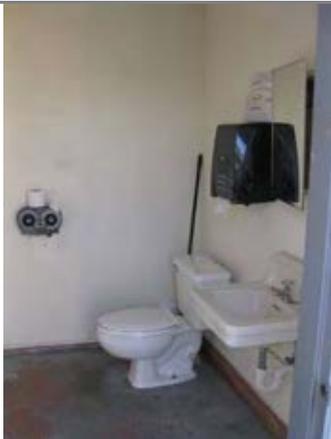
Women's Restroom

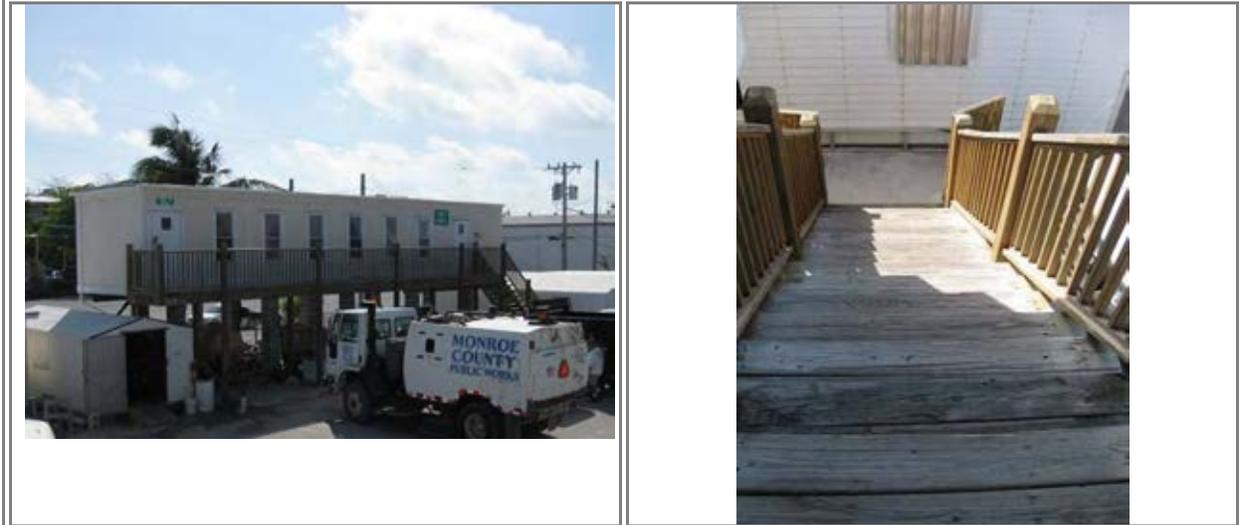
Entrance and Parking	Stairs up to Office
----------------------	---------------------

AS - Reverse the swing of the door to provide clear egress to the deck in accordance with the FBC.
RAS - Provide proper signage in accordance with FACBC 11-4.30.6.

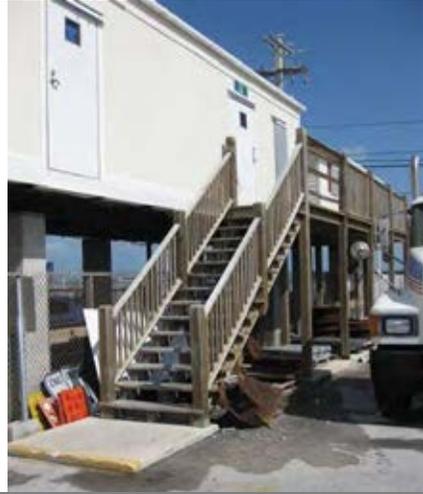
Sign Trailer

Stairs to Sign office

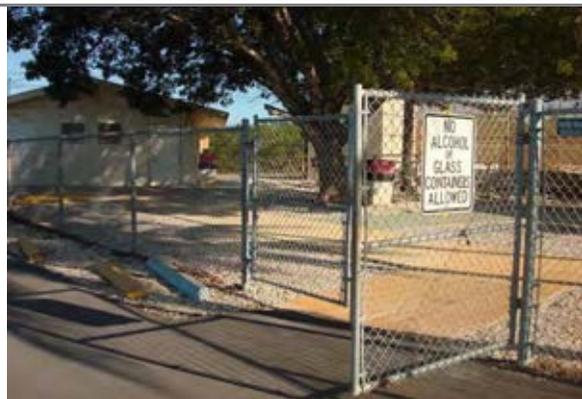
Compliant Access to Ball Field

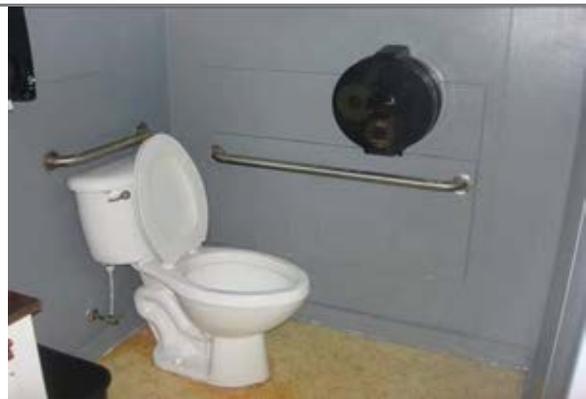
Non-compliant Restroom

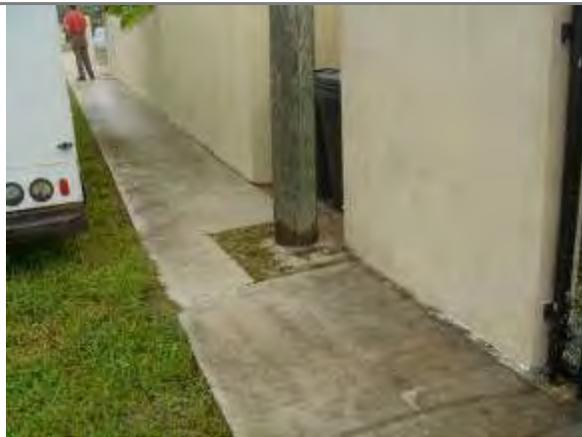
Typical Photo 01: Utility pole reduces clear width

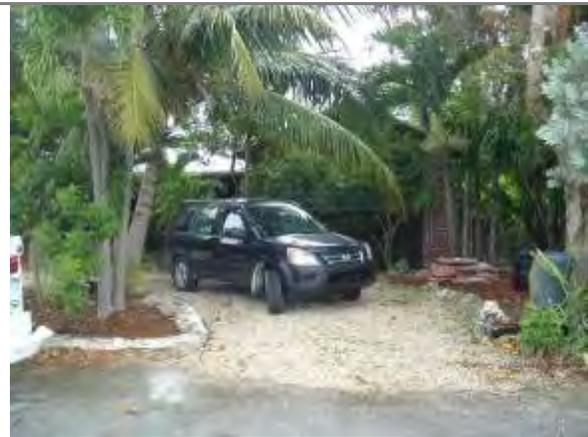
Typical Photo 02: Gravel driveway extends into sidewalk

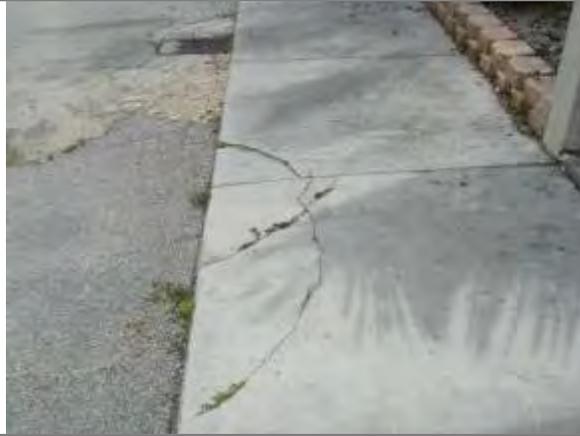
Typical Photo 03: Cracks greater than 1/2" in surface

Observation	Recommendations
<p>⊗ Cracks greater than ½" in surface. (Typical Photo 03) EAST SIDEWALK NORTHEAST ON BOUGAINVILLEA AVENUE</p> <ul style="list-style-type: none"> Survey Point 0'-100' <p>⊗ Cross Slope exceeds 2%. ⊗ Cracks greater than ½" in surface. (Typical Photo 03) NORTH SIDEWALK NORTHEAST ON BOUGAINVILLEA AVENUE</p> <ul style="list-style-type: none"> Survey Point 0'-100' <p>⊗ Cross Slope exceeds 2%. ⊗ Cracks greater than ½" in surface. (Typical Photo 03) ⊗ Driveway approaches non-compliant. (Typical Photo 04) NORTH SIDEWALK SOUTHWEST ON BOUGAINVILLEA AVENUE</p> <ul style="list-style-type: none"> Survey Point 0'-100' <p>⊗ Cross Slope exceeds 2%. ⊗ Cracks greater than ½" in surface. (Typical Photo 03)</p> <ul style="list-style-type: none"> Survey Point 100'-200' <p>⊗ Cross Slope exceeds 2%.</p>

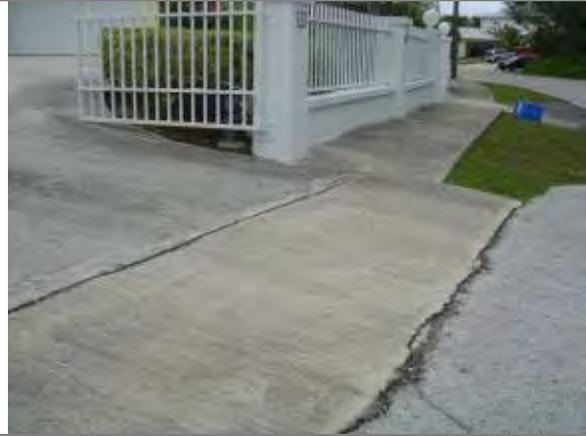
Typical Photo 04: Non-compliant driveway approach across sidewalk

Observation	Recommendations
<p>SOUTHEAST SIDEWALK SOUTH ON DRIFTWOOD DRIVE</p> <ul style="list-style-type: none"> • Survey Point 0'-100' <ul style="list-style-type: none"> ⊗ Sidewalks do not exist in this area. • Survey Point 100'-200' <ul style="list-style-type: none"> ⊗ Driveway approaches non-compliant. (Typical Photo 04) ⊗ Sidewalk elevated +/- 9" above road surface. ⊗ Cross Slope exceeds 2%. ⊗ Running Slope exceeds 5%. <p>EAST SIDEWALK NORTHEAST ON DRIFTWOOD DRIVE</p> <ul style="list-style-type: none"> • Survey Point 0'-700' <ul style="list-style-type: none"> ⊗ Sidewalks do not exist in this area. • Survey Point 700'-800' <ul style="list-style-type: none"> ✓ ADA Compliant • Survey Point 800'-1100' <ul style="list-style-type: none"> ⊗ Sidewalks do not exist in this area. <p>NORTH SIDEWALK NORTHEAST ON DRIFTWOOD DRIVE</p> <ul style="list-style-type: none"> • Survey Point 0'-100' <ul style="list-style-type: none"> ⊗ Cross Slope exceeds 2%. ⊗ Cracks greater than ½" in surface. (Typical Photo 03) ⊗ Utility guy wire reduces clear width. (Typical Photo 07) • Survey Point 100'-200' <ul style="list-style-type: none"> ⊗ Cross Slope exceeds 2%. • Survey Point 200'-300' <ul style="list-style-type: none"> ⊗ Sidewalk exists partially in this area. (Typical Photo 05) ⊗ Cross Slope exceeds 2%. • Survey Point 300'-400' <ul style="list-style-type: none"> ⊗ Sidewalk exists partially in this area. (Typical Photo 05) ⊗ Cross Slope exceeds 2%. ⊗ Existing water meter recessed below sidewalk surface. • Survey Point 400'-500' <ul style="list-style-type: none"> ⊗ Sidewalk exists partially in this area. (Typical Photo 05) 	<p>A\$ - F\$\$ - Depending on the specific situation at each location, install accessible sidewalks and intersections in compliance with ADAAG and PROWAAC guidance and FDOT Design Standards. This should include, but not be limited to, detectable warnings, driveway crossings, street crossing markings, signs, and pedestrian crossing signals as required.</p>

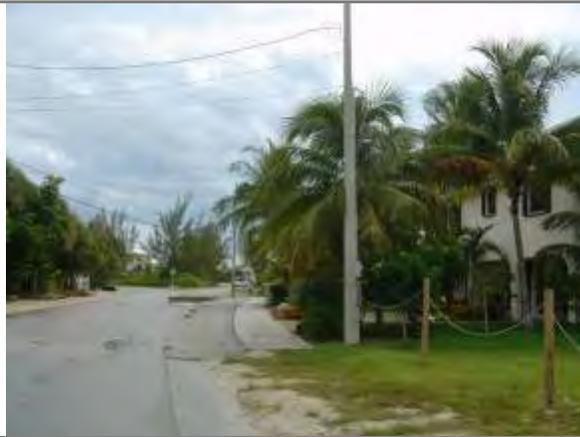
Typical Photo 05: Sidewalk exists partially in this area
