Americans with Disabilities Act Transition Plan Lower Keys - Part 2

Volume 4 of 4

Monroe County

October 29, 2010

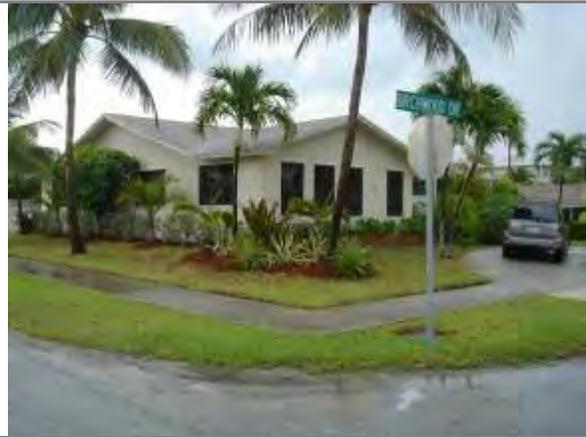
Typical Photo 06: Existing sidewalk does not provide accessible connection to street

Observation	Recommendations
<p>NORTH CORNER</p> <ul style="list-style-type: none"> ⊗ Existing sidewalk does not provide accessible connection to street. (Typical Photo 06) ⊗ Detectable warnings are not provided. ⊗ Cross Slope exceeds 2%. ⊗ Running Slope exceeds 5%. <p>NORTH SIDEWALK EAST ON ALLAMANDA AVENUE</p> <ul style="list-style-type: none"> • Survey Points 0'-200' ⊗ Intermittent breaks / cracks in surface. <p>NORTH SIDEWALK NORTH ON KEY HAVEN ROAD</p> <ul style="list-style-type: none"> • Survey Points 0'-900' ⊗ Intermittent breaks / cracks in surface. ⊗ Cross Slope exceeds 2%. <p>EAST CORNER</p> <ul style="list-style-type: none"> ⊗ Sidewalks do not exist in this area. <p>EAST SIDEWALK EAST ON ALLAMANDA AVENUE</p> <ul style="list-style-type: none"> • Survey Points 0'-100' ⊗ Sidewalk exists partially in this area. (Typical Photo 05) ⊗ Intermittent breaks / cracks in surface. ⊗ Cross Slope exceeds 2%. <p>EAST SIDEWALK SOUTH ON KEY HAVEN ROAD</p> <ul style="list-style-type: none"> • Survey Points 0'-400' ⊗ Sidewalks do not exist in this area. <p>WEST SIDEWALK NORTH ON KEY HAVEN ROAD</p> <ul style="list-style-type: none"> • Survey Points 0'-900' ⊗ Sidewalks do not exist in this area. <p>WEST SIDEWALK SOUTH ON KEY HAVEN ROAD</p> <ul style="list-style-type: none"> • Survey Points 0'-400' ⊗ Sidewalks do not exist in this area. 	<p>A\$ - F\$\$ - Depending on the specific situation at each location, install accessible sidewalks and intersections in compliance with ADAAG and PROWAAC guidance and FDOT Design Standards. This should include, but not be limited to, detectable warnings, driveway crossings, street crossing markings, signs, and pedestrian crossing signals as required.</p>

Observation	Recommendations
<p>WEST CORNER</p> <ul style="list-style-type: none"> ⊗ Detectable warnings are not provided. ⊗ Cross Slope exceeds 2%. ⊗ Existing sidewalk does not provide accessible connection to street. (Typical Photo 06) <p>WEST SIDEWALK SOUTHWEST ON ALLAMANDA AVENUE</p> <ul style="list-style-type: none"> • Survey Point 0'-100' <ul style="list-style-type: none"> ⊗ Cross Slope exceeds 2%. ⊗ Running Slope exceeds 5%. <p>WEST SIDEWALK NORTHWEST ON AMARYLLIS DRIVE</p> <ul style="list-style-type: none"> • Survey Point 0'-100' <ul style="list-style-type: none"> ⊗ Cross Slope exceeds 2%. ⊗ Intermittent breaks / cracks in surface / uneven. • Survey Points 100'-300' <ul style="list-style-type: none"> ⊗ Cross Slope exceeds 2%. ⊗ Running Slope exceeds 5%. 	<p>A\$ - F\$\$ - Depending on the specific situation at each location, install accessible sidewalks and intersections in compliance with ADAAG and PROWAAC guidance and FDOT Design Standards. This should include, but not be limited to, detectable warnings, driveway crossings, street crossing markings, signs, and pedestrian crossing signals as required.</p>

Observation	Recommendations
<p>WEST CORNER</p> <ul style="list-style-type: none"> ⊗ Detectable warnings are not provided. ⊗ Cross Slope exceeds 2%. ⊗ Existing sidewalk does not provide accessible connection to street. (Typical Photo 06) <p>WEST SIDEWALK SOUTHWEST ON ALLAMANDA AVENUE</p> <ul style="list-style-type: none"> • Survey Point 0'-100' ⊗ Cross Slope exceeds 2%. <p>WEST SIDEWALK NORTHWEST ON ARBUTUS DRIVE</p> <ul style="list-style-type: none"> • Survey Point 0'-800' ⊗ Cross Slope exceeds 2%. ⊗ Intermittent breaks / cracks in surface. <p>NORTH CORNER</p> <ul style="list-style-type: none"> ⊗ Detectable warnings are not provided. ⊗ Cross Slope exceeds 2%. <p>NORTH SIDEWALK NORTHEAST ON ALLAMANDA AVENUE</p> <ul style="list-style-type: none"> • Survey Point 0'-200' 	<p>A\$ - F\$\$ - Depending on the specific situation at each location, install accessible sidewalks and intersections in compliance with ADAAG and PROWAAC guidance and FDOT Design Standards. This should include, but not be limited to, detectable warnings, driveway crossings, street crossing markings, signs, and pedestrian crossing signals as required.</p>

Observation	Recommendations
<p>SOUTH CORNER</p> <ul style="list-style-type: none"> ⊗ Detectable warnings are not provided. ⊗ Cross Slope exceeds 2%. ⊗ Existing sidewalk does not provide accessible connection to street. (Typical Photo 06) <p>SOUTH SIDEWALK SOUTHWEST ON BOUGAINVILLEA AVENUE</p> <ul style="list-style-type: none"> • Survey Point 0'-100' <ul style="list-style-type: none"> ⊗ Cross Slope exceeds 2%. ⊗ Cracks greater than ½" in surface. (Typical Photo 03) • Survey Point 100'-200' <ul style="list-style-type: none"> ⊗ Cross Slope exceeds 2%. ⊗ Cracks greater than ½" in surface. (Typical Photo 03) ⊗ Sidewalk exists partially in this area. (Typical Photo 05) <p>SOUTH SIDEWALK SOUTHEAST ON BAMBOO TERRACE</p> <ul style="list-style-type: none"> • Survey Point 0'-200' <ul style="list-style-type: none"> ⊗ Cross Slope exceeds 2%. ⊗ Cracks greater than ½" in surface. (Typical Photo 03) <p>EAST CORNER</p> <ul style="list-style-type: none"> ⊗ Detectable warnings are not provided. ⊗ Cross Slope exceeds 2%. ⊗ Existing sidewalk does not provide accessible connection to street. (Typical Photo 06) <p>EAST SIDEWALK SOUTHEAST ON BAMBOO TERRACE</p> <ul style="list-style-type: none"> • Survey Point 0'-100' <ul style="list-style-type: none"> ⊗ Cross Slope exceeds 2%. ⊗ Cracks greater than ½" in surface. (Typical Photo 03) ⊗ Required clear width reduced at utility poles. (Typical Photo 01) • Survey Point 100'-200' <ul style="list-style-type: none"> ⊗ Cross Slope exceeds 2%. 	<p>A\$ - F\$\$ - Depending on the specific situation at each location, install accessible sidewalks and intersections in compliance with ADAAG and PROWAAC guidance and FDOT Design Standards. This should include, but not be limited to, detectable warnings, driveway crossings, street crossing markings, signs, and pedestrian crossing signals as required.</p>

Observation	Recommendations
<p>NORTH CORNER</p> <ul style="list-style-type: none"> ⊗ Detectable warnings are not provided. ⊗ Cross Slope exceeds 2%. ⊗ Existing sidewalk does not provide accessible connection to street. (Typical Photo 06) ⊗ Running Slope exceeds 5%. <p>NORTH SIDEWALK NORTHEAST ON BAMBOO TERRACE</p> <ul style="list-style-type: none"> • Survey Point 0'-100' ⊗ Cross Slope exceeds 2%. <p>NORTH SIDEWALK NORTHWEST ON BIRCHWOOD DRIVE</p> <ul style="list-style-type: none"> • Survey Point 0'-100' ⊗ Cross Slope exceeds 2%. • Survey Point 100'-200' ⊗ Cross Slope exceeds 2%. ⊗ Sidewalk exists partially in this area. (Typical Photo 05) • Survey Point 200'-400' ⊗ Sidewalks do not exist in this area. <p>WEST CORNER</p> <ul style="list-style-type: none"> ⊗ Detectable warnings are not provided. ⊗ Existing sidewalk does not provide accessible connection to street. (Typical Photo 06) <p>WEST SIDEWALK NORTHWEST ON BIRCHWOOD DRIVE</p> <ul style="list-style-type: none"> • Survey Point 0'-100' ⊗ Cross Slope exceeds 2%. ⊗ Sidewalk exists partially in this area. (Typical Photo 05) • Survey Point 100'-400' ⊗ Sidewalks do not exist in this area. <p>WEST SIDEWALK SOUTHWEST ON BAMBOO TERRACE</p> <ul style="list-style-type: none"> • Survey Point 0'-400' ⊗ Cross Slope exceeds 2%. ⊗ Driveway approaches non-compliant. (Typical Photo 04) 	<p>A\$ - F\$\$ - Depending on the specific situation at each location, install accessible sidewalks and intersections in compliance with ADAAG and PROWAAC guidance and FDOT Design Standards. This should include, but not be limited to, detectable warnings, driveway crossings, street crossing markings, signs, and pedestrian crossing signals as required.</p>

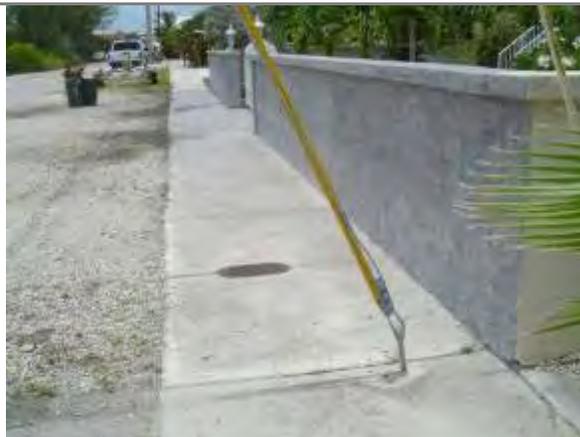
Typical Photo 07: Utility guy wire reduces clear width

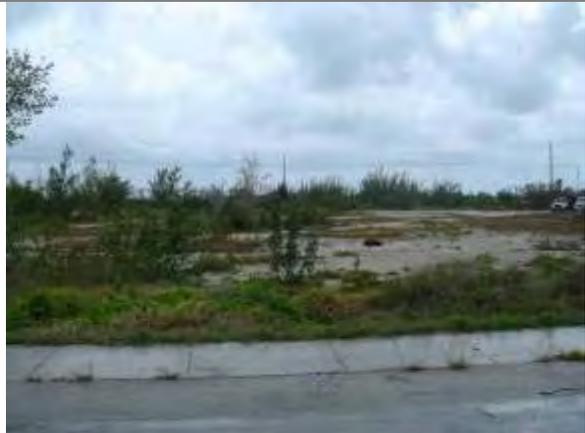
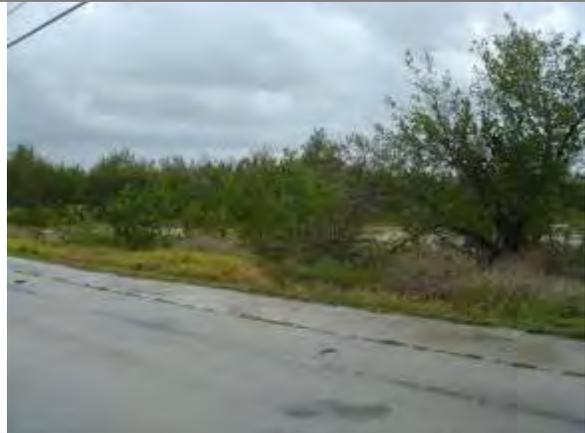
Southeast Across from Amaryllis Drive	East Corner

Observation	Recommendations
AVENUE <ul style="list-style-type: none"> • Survey Points 0'-200' ⊗ Intermittent breaks / uneven. SOUTHEAST SIDEWALK SOUTHWEST ON ALLAMANDA AVENUE AVENUE <ul style="list-style-type: none"> • Survey Point 0'-100' ⊗ Intermittent breaks / uneven.

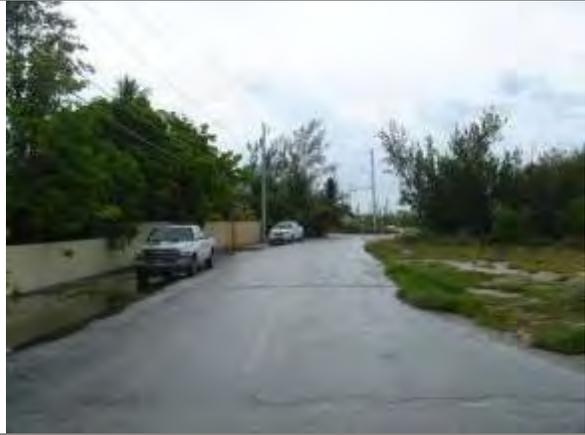
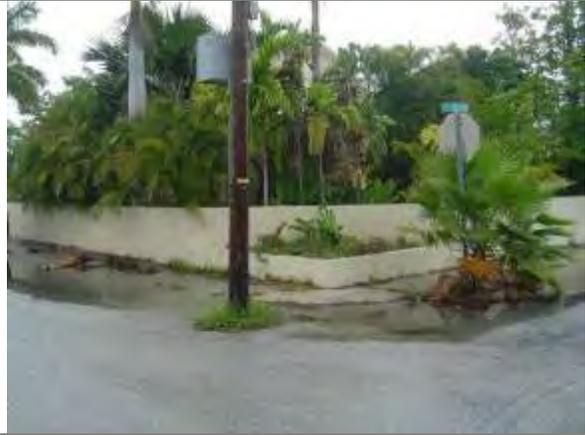
Southeast on Key Haven Boulevard	East Corner

Observation	Recommendations
<p>⊗ Cross Slope exceeds 2%.</p> <p>NORTH SIDEWALK NORTHWEST ON ARBUTUS DRIVE</p> <ul style="list-style-type: none"> Survey Point 0'-800' ⊗ Cross Slope exceeds 2%. ⊗ Intermittent breaks / cracks in surface. <p>EAST CORNER</p> <ul style="list-style-type: none"> ⊗ Detectable warnings are not provided. <p>EAST SIDEWALK NORTHEAST ON ALLAMANDA AVENUE</p> <ul style="list-style-type: none"> Survey Point 0'-200' ✓ ADA Compliant <p>EAST SIDEWALK SOUTHEAST ON KEY HAVEN BOULEVARD</p> <ul style="list-style-type: none"> Survey Point 0'-100' ✓ ADA Compliant <p>SOUTH CORNER</p> <ul style="list-style-type: none"> ⊗ Sidewalks do not exist in this area. <p>SOUTH SIDEWALK SOUTHWEST ON ALLAMANDA AVENUE</p> <ul style="list-style-type: none"> Survey Point 0'-100' ⊗ Sidewalk exists partially in this area. (Typical Photo 05) <p>SOUTH SIDEWALK SOUTHEAST ON KEY HAVEN BOULEVARD</p> <ul style="list-style-type: none"> ⊗ Sidewalks do not exist in this area.

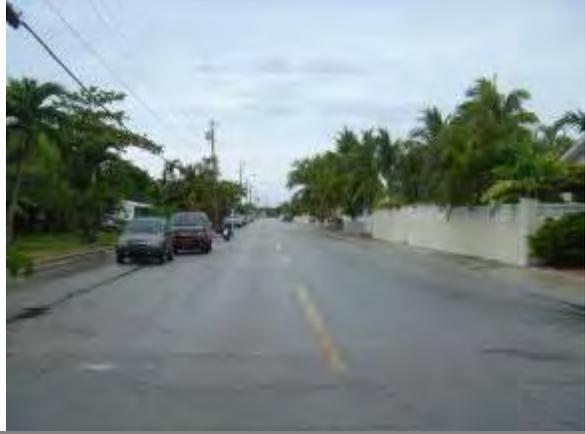
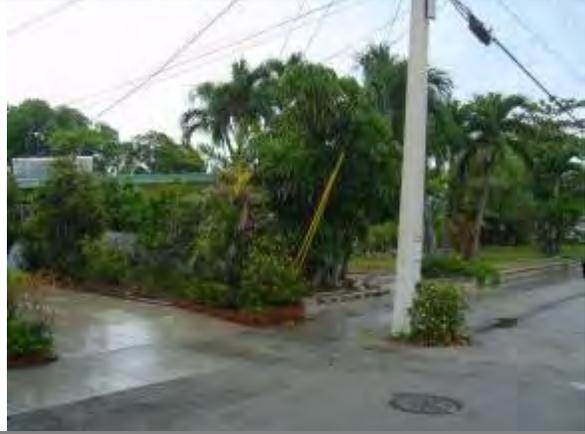
Southwest on Allamanda Avenue	South Corner

Observation	Recommendations
<p>WEST CORNER</p> <ul style="list-style-type: none"> ⊗ Detectable warnings are not provided. ⊗ Cross Slope exceeds 2%. <p>WEST SIDEWALK SOUTHWEST ON ALLAMANDA AVENUE</p> <ul style="list-style-type: none"> • Survey Point 0'-100' <ul style="list-style-type: none"> ⊗ Cross Slope exceeds 2%. <p>WEST SIDEWALK NORTHWEST ON ASTER TERRACE</p> <ul style="list-style-type: none"> • Survey Point 0'-100' <ul style="list-style-type: none"> ⊗ Cross Slope exceeds 2%. ⊗ Intermittent breaks / cracks in surface. • Survey Point 100'-200' <ul style="list-style-type: none"> ⊗ Cross Slope exceeds 2%. ⊗ Running Slope exceeds 5%. ⊗ Intermittent breaks / cracks in surface. • Survey Point 200'-800' <ul style="list-style-type: none"> ⊗ Cross Slope exceeds 2%. ⊗ Intermittent breaks / cracks in surface. <p>NORTH CORNER</p> <ul style="list-style-type: none"> ⊗ Detectable warnings are not provided. <p>NORTH SIDEWALK NORTHEAST ON ALLAMANDA AVENUE</p> <ul style="list-style-type: none"> • Survey Point 0'-200' <ul style="list-style-type: none"> ⊗ Cross Slope exceeds 2%. ⊗ Cracks greater than ½" in surface. (Typical Photo 03) <p>NORTH SIDEWALK NORTHWEST ON ASTER TERRACE</p> <ul style="list-style-type: none"> • Survey Point 0'-100' <ul style="list-style-type: none"> ⊗ Cross Slope exceeds 2%. ⊗ Intermittent breaks / cracks in surface. ⊗ Existing water meter protrudes above sidewalk surface. • Survey Point 100'-800' <ul style="list-style-type: none"> ⊗ Cross Slope exceeds 2%. ⊗ Intermittent breaks / cracks in surface. <p>EAST SIDEWALK NORTHEAST ON ALLAMANDA AVENUE</p>	<p>A\$ - F\$\$ - Depending on the specific situation at each location, install accessible sidewalks and intersections in compliance with ADAAG and PROWAAC guidance and FDOT Design Standards. This should include, but not be limited to, detectable warnings, driveway crossings, street crossing markings, signs, and pedestrian crossing signals as required.</p>

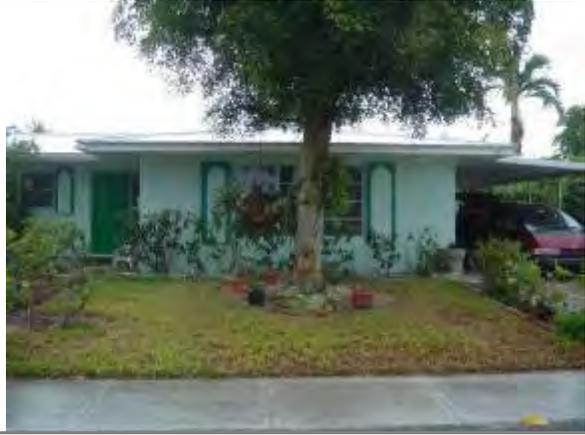
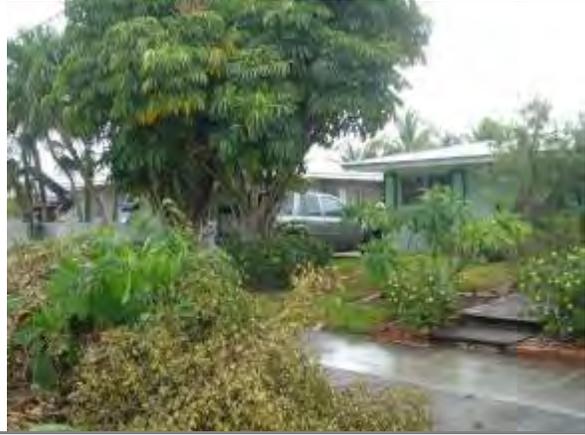
Southeast across from Aster Terrace	East Corner

Observation	Recommendations
<ul style="list-style-type: none"> • Survey Point 0'-200' ⊗ Cross Slope exceeds 2%. <p style="text-align: center;">EAST SIDEWALK SOUTHWEST ON ALLAMANDA AVENUE</p> <ul style="list-style-type: none"> • Survey Point 0'-100' ⊗ Cross Slope exceeds 2%.

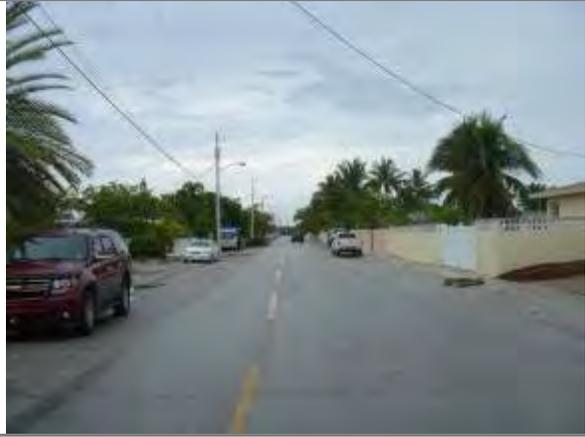
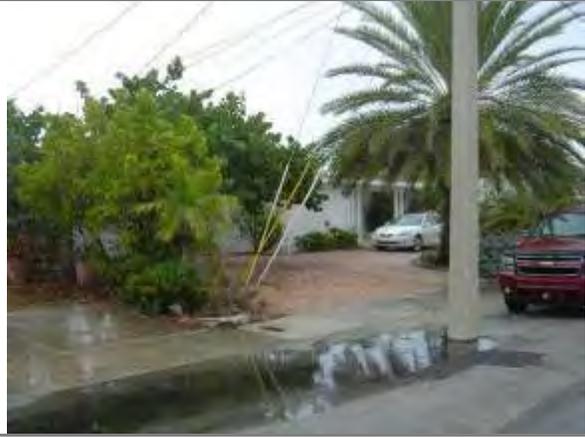
Southwest on Allamanda Avenue		South Corner

Observation	Recommendations
<p>WEST CORNER</p> <ul style="list-style-type: none"> ⊗ Detectable warnings are not provided. ⊗ Cross Slope exceeds 2%. <p>WEST SIDEWALK SOUTHWEST ON ALLAMANDA AVENUE</p> <ul style="list-style-type: none"> • Survey Point 0'-100' ⊗ Cross Slope exceeds 2%. ⊗ Intermittent breaks / cracks in surface. <p>WEST SIDEWALK NORTHWEST ON ALLAMANDA TERRACE</p> <ul style="list-style-type: none"> • Survey Point 0'-800' ⊗ Cross Slope exceeds 2%. <p>EAST CORNER</p> <ul style="list-style-type: none"> ⊗ Intermittent breaks / cracks in surface. ⊗ Utility pole cut flush to surface <p>EAST SIDEWALK NORTHWEST ON ALLAMANDA TERRACE</p> <ul style="list-style-type: none"> • Survey Point 0'-100' ✓ ADA Compliant • Survey Point 100'-300' 	<p>A\$ - F\$\$ - Depending on the specific situation at each location, install accessible sidewalks and intersections in compliance with ADAAG and PROWAAC guidance and FDOT Design Standards. This should include, but not be limited to, detectable warnings, driveway crossings, street crossing markings, signs, and pedestrian crossing signals as required.</p>

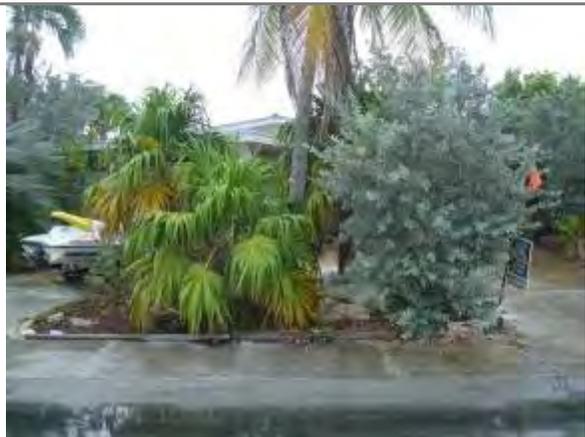
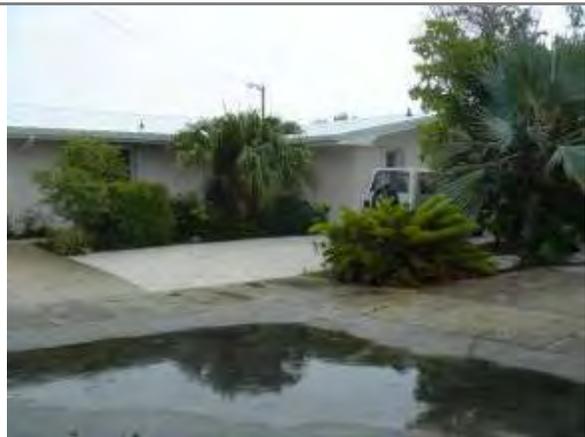
Southeast across from Allamanda Terrace		East Corner

Observation	Recommendations
<ul style="list-style-type: none"> ⊗ Intermittent breaks / cracks in surface. • Survey Point 300'-800' ✓ ADA Compliant <p>EAST SIDEWALK SOUTHWEST ON ALLAMANDA AVENUE</p> <ul style="list-style-type: none"> • Survey Point 0'-100' ⊗ Cross Slope exceeds 2%.

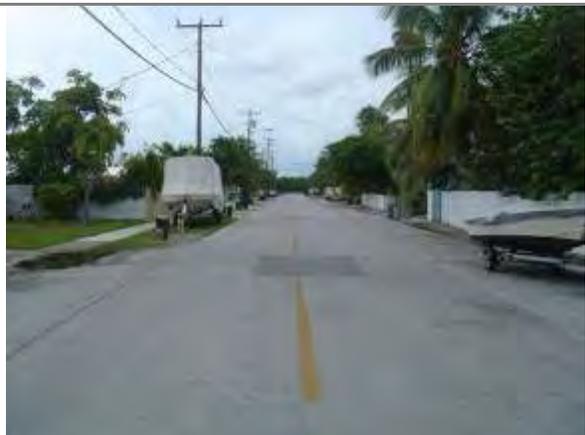
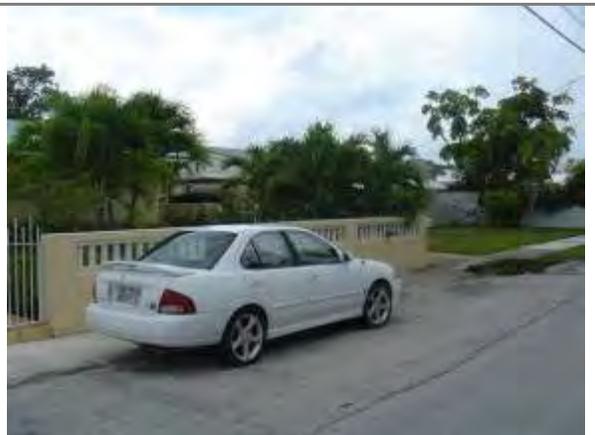
Northeast on Bougainvillea Avenue	North Corner

Observation	Recommendations
<p>⊗ Cracks greater than ½" in surface. (Typical Photo 03) EAST SIDEWALK NORTHEAST ON BOUGAINVILLEA AVENUE</p> <ul style="list-style-type: none"> Survey Point 0'-100' <p>⊗ Cross Slope exceeds 2%. ⊗ Cracks greater than ½" in surface. (Typical Photo 03) NORTH SIDEWALK NORTHEAST ON BOUGAINVILLEA AVENUE</p> <ul style="list-style-type: none"> Survey Point 0'-100' <p>⊗ Cross Slope exceeds 2%. ⊗ Cracks greater than ½" in surface. (Typical Photo 03) ⊗ Driveway approaches non-compliant. (Typical Photo 04) NORTH SIDEWALK SOUTHWEST ON BOUGAINVILLEA AVENUE</p> <ul style="list-style-type: none"> Survey Point 0'-100' <p>⊗ Cross Slope exceeds 2%. ⊗ Cracks greater than ½" in surface. (Typical Photo 03)</p> <ul style="list-style-type: none"> Survey Point 100'-200' <p>⊗ Cross Slope exceeds 2%.</p>

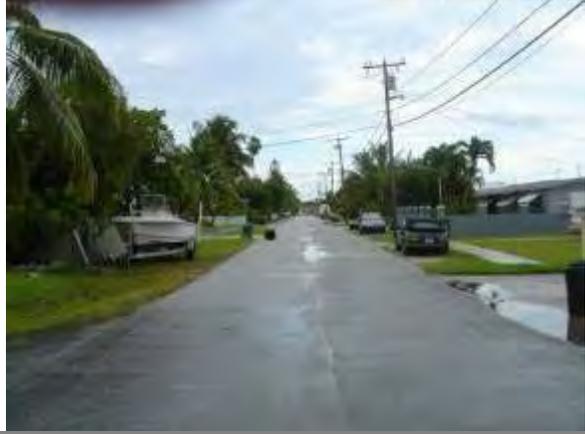
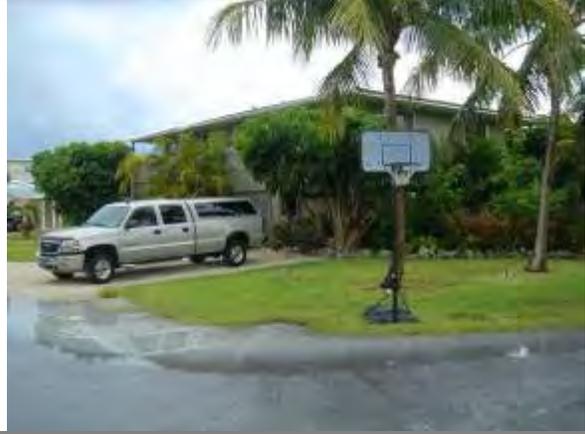
Southwest on Bougainvillea Avenue	South Corner

Observation	Recommendations
<p>SOUTH CORNER</p> <ul style="list-style-type: none"> ⊗ Sidewalks do not exist in this area. <p>SOUTH SIDEWALK SOUTHWEST ON BOUGAINVILLEA AVENUE</p> <ul style="list-style-type: none"> • Survey Point 0'-200' <ul style="list-style-type: none"> ⊗ Cross Slope exceeds 2%. ⊗ Cracks greater than ½" in surface. (Typical Photo 03) ⊗ Sidewalk exists partially in this area. (Typical Photo 05) <p>SOUTH SIDEWALK SOUTHEAST ON BEECHWOOD DRIVE</p> <ul style="list-style-type: none"> • Survey Point 0'-100' <ul style="list-style-type: none"> ⊗ Sidewalks exist partially in this area. (Typical Photo 05) • Survey Point 100'-200' <ul style="list-style-type: none"> ⊗ Cross Slope exceeds 2%. • Survey Point 200'-300' <ul style="list-style-type: none"> ⊗ Cross Slope exceeds 2%. ⊗ Sidewalk exists partially in this area. (Typical Photo 05) <p>EAST CORNER</p> <ul style="list-style-type: none"> ⊗ Sidewalks do not exist in this area. <p>EAST SIDEWALK SOUTHEAST ON BEECHWOOD DRIVE</p> <ul style="list-style-type: none"> • Survey Point 0'-100' <ul style="list-style-type: none"> ⊗ Cross Slope exceeds 2%. ⊗ Intermittent breaks / cracks in surface. • Survey Point 100'-200' <ul style="list-style-type: none"> ⊗ Cross Slope exceeds 2%. ⊗ Sidewalk exists partially in this area. (Typical Photo 05) ⊗ Intermittent breaks / cracks in surface. • Survey Point 200'-300' <ul style="list-style-type: none"> ⊗ Sidewalks do not exist in this area. <p>EAST SIDEWALK NORTHEAST ON BOUGAINVILLEA AVENUE</p> <ul style="list-style-type: none"> • Survey Point 0'-100' <ul style="list-style-type: none"> ⊗ Sidewalks do not exist in this area. 	<p>A\$ - F\$\$ - Depending on the specific situation at each location, install accessible sidewalks and intersections in compliance with ADAAG and PROWAAC guidance and FDOT Design Standards. This should include, but not be limited to, detectable warnings, driveway crossings, street crossing markings, signs, and pedestrian crossing signals as required.</p>

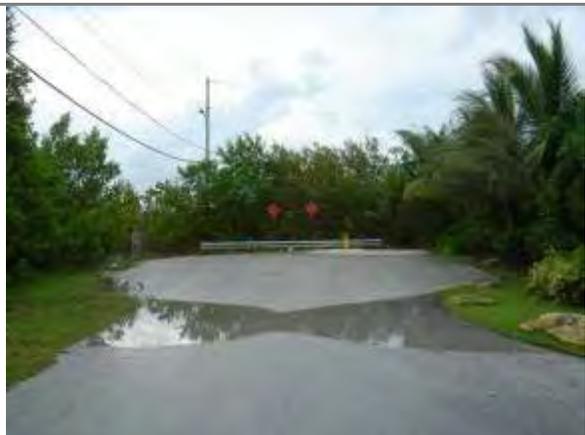
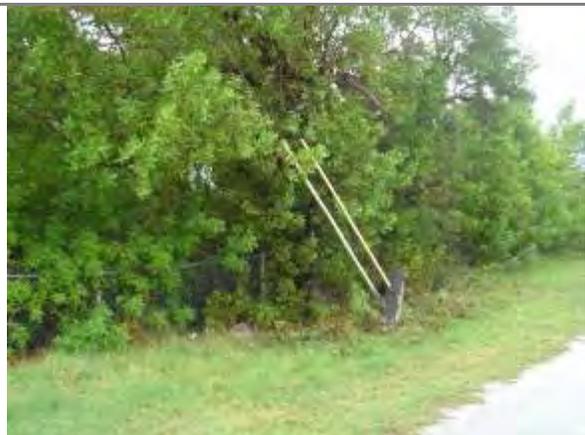
Northeast on Bougainvillea Avenue	North Corner

Observation	Recommendations
<p>NORTH SIDEWALK NORTHEAST ON BOUGAINVILLEA AVENUE</p> <ul style="list-style-type: none"> • Survey Point 0'-100' <ul style="list-style-type: none"> ⊗ Sidewalks do not exist in this area. <p>NORTH SIDEWALK SOUTHWEST ON BOUGAINVILLEA AVENUE</p> <ul style="list-style-type: none"> • Survey Point 0'-100' <ul style="list-style-type: none"> ⊗ Cross Slope exceeds 2%. ⊗ Sidewalk exists partially in this area. (Typical Photo 05) ⊗ Intermittent breaks / cracks in surface. • Survey Point 100'-200' <ul style="list-style-type: none"> ⊗ Cross Slope exceeds 2%. ⊗ Intermittent breaks / cracks in surface.

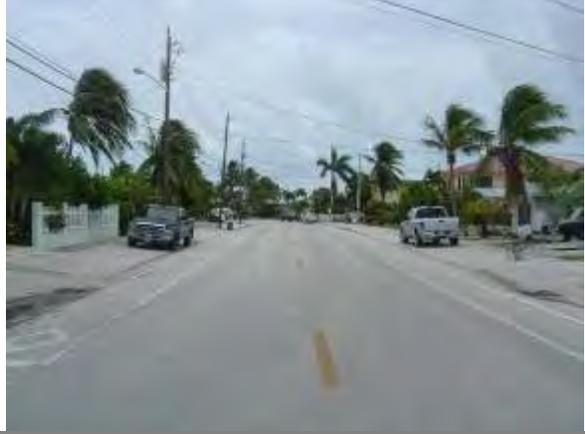
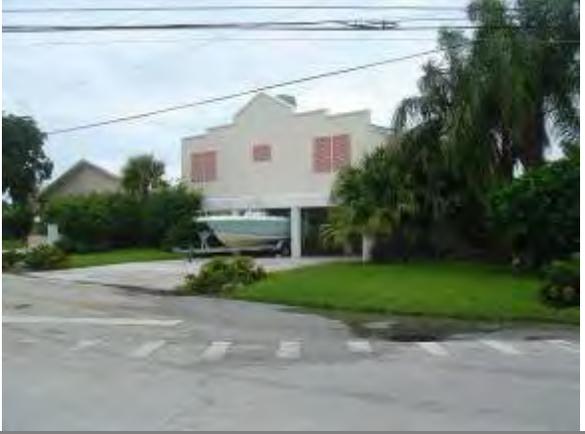
Southeast on Key Haven Road	East Corner

Observation	Recommendations
<p>WEST SIDEWALK SOUTH ON KEY HAVEN ROAD</p> <ul style="list-style-type: none"> • Survey Point 0'-300' <ul style="list-style-type: none"> ⊗ Cross Slope exceeds 2%. ⊗ Intermittent breaks / cracks in surface. <p>EAST CORNER</p> <ul style="list-style-type: none"> ⊗ Sidewalks do not exist in this area. <p>EAST SIDEWALK SOUTH ON KEY HAVEN ROAD</p> <ul style="list-style-type: none"> • Survey Point 0'-100' <ul style="list-style-type: none"> ⊗ Cross Slope exceeds 2%. ⊗ Intermittent breaks / cracks in surface. • Survey Point 100'-300' <ul style="list-style-type: none"> ⊗ Intermittent breaks / cracks in surface. <p>EAST SIDEWALK NORTHEAST ON CYPRESS AVENUE</p> <ul style="list-style-type: none"> • Survey Point 0'-100' <ul style="list-style-type: none"> ⊗ Sidewalk exists partially in this area. (Typical Photo 05)

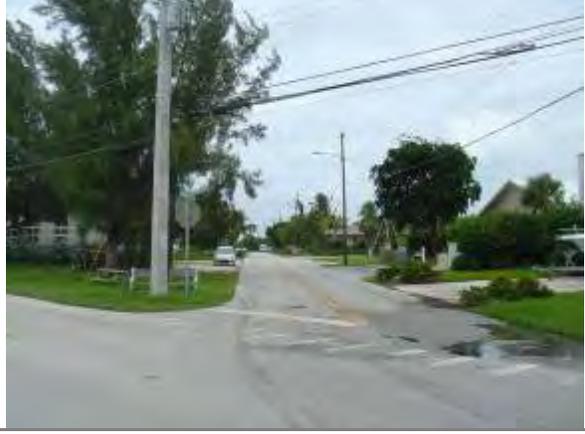
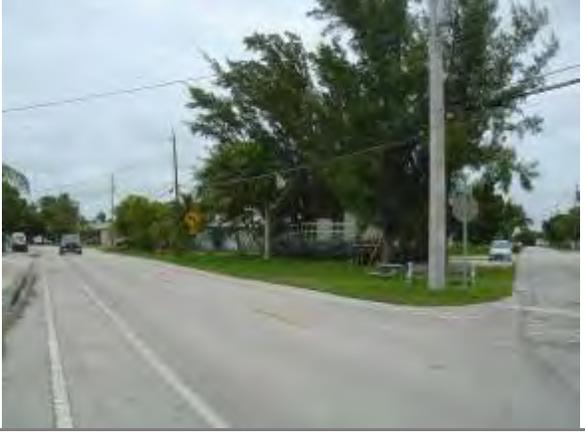
Northeast on Cypress Avenue	North Corner

Observation	Recommendations
<p>NORTH CORNER</p> <ul style="list-style-type: none"> ⊗ Sidewalks do not exist in this area. <p>NORTH SIDEWALK NORTHEAST ON CYPRESS AVENUE</p> <ul style="list-style-type: none"> • Survey Point 0'-100' ⊗ Sidewalks do not exist in this area. <p>NORTH SIDEWALK NORTHWEST ON KEY HAVEN ROAD</p> <ul style="list-style-type: none"> • Survey Point 0'-400' ⊗ Sidewalks do not exist in this area. • Survey Point 400'-600' ⊗ Cross Slope exceeds 2%. ⊗ Intermittent breaks / cracks in surface. ⊗ Driveway approaches non-compliant. (Typical Photo 04) ⊗ Running Slope exceeds 5%. • Survey Point 600'-700' ⊗ Sidewalks do not exist in this area. <p>WEST SIDEWALK NORTHWEST ON KEY HAVEN ROAD</p> <ul style="list-style-type: none"> • Survey Point 0'-200' ⊗ Cross Slope exceeds 2%. ⊗ Intermittent breaks / cracks in surface. • Survey Point 200'-300' ⊗ Cross Slope exceeds 2%. ⊗ Intermittent breaks / cracks in surface. ⊗ Sidewalk exists partially in this area. (Typical Photo 05) • Survey Point 300'-400' ⊗ Sidewalks do not exist in this area. • Survey Point 400'-600' ⊗ Cross Slope exceeds 2%. ⊗ Intermittent breaks / cracks in surface. ⊗ Sidewalk exists partially in this area. (Typical Photo 05) • Survey Point 600'-700' ⊗ Sidewalks do not exist in this area. 	<p>A\$ - F\$\$ - Depending on the specific situation at each location, install accessible sidewalks and intersections in compliance with ADAAG and PROWAAC guidance and FDOT Design Standards. This should include, but not be limited to, detectable warnings, driveway crossings, street crossing markings, signs, and pedestrian crossing signals as required.</p>

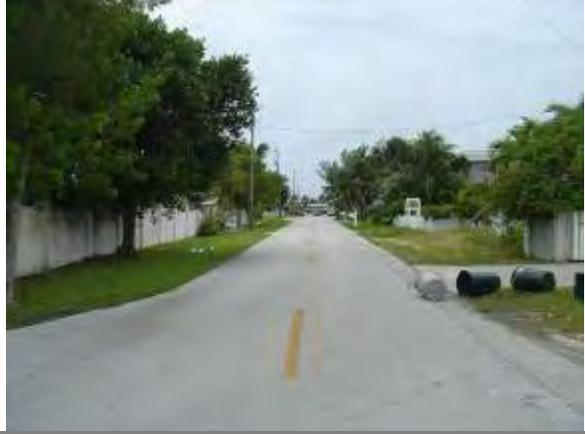
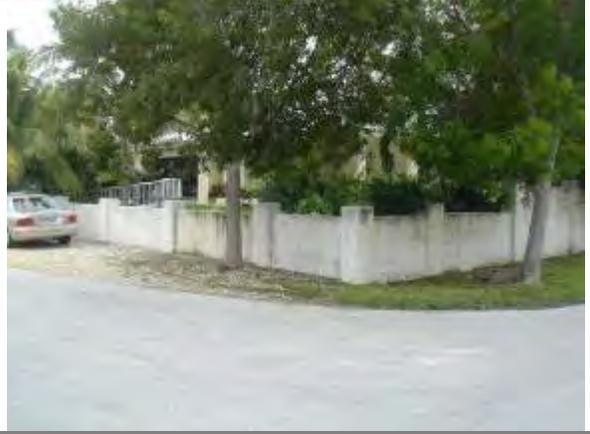
Southwest on Cypress Avenue	South Corner

Observation	Recommendations
<p>SOUTH CORNER</p> <ul style="list-style-type: none"> ⊗ Sidewalks do not exist in this area. <p>SOUTH SIDEWALK SOUTHWEST ON CYPRESS AVENUE</p> <ul style="list-style-type: none"> • Survey Point 0'-200' ⊗ Sidewalks do not exist in this area. <p>SOUTH SIDEWALK SOUTHEAST ON COCONUT DRIVE</p> <ul style="list-style-type: none"> • Survey Point 0'-400' ⊗ Sidewalks do not exist in this area. <p>EAST CORNER</p> <ul style="list-style-type: none"> ⊗ Sidewalks do not exist in this area. <p>EAST SIDEWALK SOUTHEAST ON COCONUT DRIVE</p> <ul style="list-style-type: none"> • Survey Point 0'-100' ⊗ Sidewalks do not exist in this area. • Survey Point 100'-300' ⊗ Sidewalk exists partially in this area. (Typical Photo 05) ⊗ Cross Slope exceeds 2%. ⊗ Running Slope exceeds 5%. • Survey Point 100'-400' ⊗ Sidewalks do not exist in this area. <p>EAST SIDEWALK NORTHEAST ON CYPRESS AVENUE</p> <ul style="list-style-type: none"> • Survey Point 0'-600' ⊗ Sidewalks do not exist in this area. <p>WEST SIDEWALK NORTHEAST ON CYPRESS AVENUE</p> <ul style="list-style-type: none"> • Survey Point 0'-100' ⊗ Sidewalks do not exist in this area. • Survey Point 100'-200' ⊗ Sidewalk exists partially in this area. (Typical Photo 05) ⊗ Driveway approaches non-compliant. (Typical Photo 04) ⊗ Cross Slope exceeds 2%. ⊗ Running Slope exceeds 5%. • Survey Point 200'-300' 	<p>A\$ - F\$\$ - Depending on the specific situation at each location, install accessible sidewalks and intersections in compliance with ADAAG and PROWAAC guidance and FDOT Design Standards. This should include, but not be limited to, detectable warnings, driveway crossings, street crossing markings, signs, and pedestrian crossing signals as required.</p>

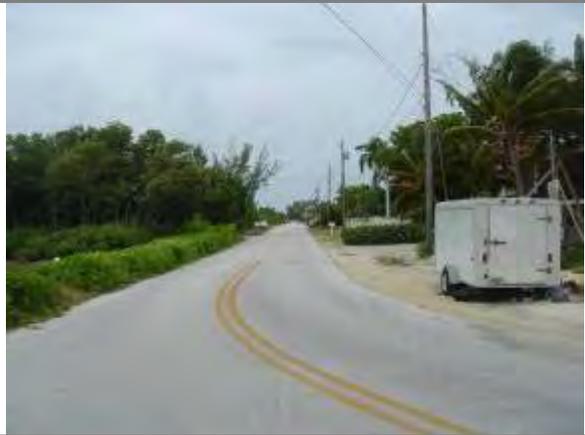
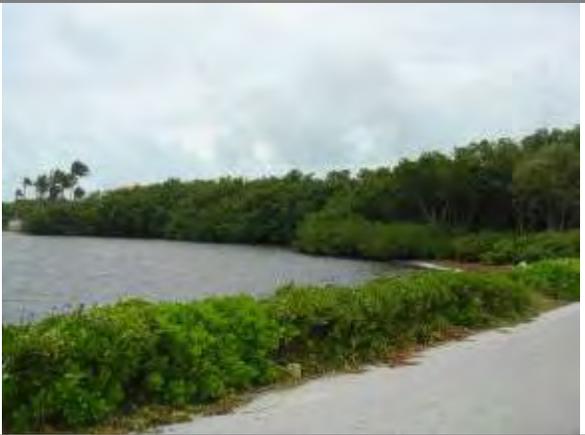
Southwest on Cypress Avenue	South Corner

Observation	Recommendations
<p>SOUTH SIDEWALK SOUTHWEST ON CYPRESS AVENUE</p> <ul style="list-style-type: none"> • Survey Point 0'-600' ⊗ Sidewalks do not exist in this area. <p>NORTH CORNER</p> <ul style="list-style-type: none"> ⊗ Sidewalks do not exist in this area. <p>NORTH SIDEWALK NORTHWEST ON CYPRESS TERRACE</p> <ul style="list-style-type: none"> • Survey Point 0'-200' ⊗ Sidewalks do not exist in this area. <p>SOUTHWEST CORNER</p> <ul style="list-style-type: none"> ⊗ Sidewalks do not exist in this area. <p>SOUTH SIDEWALK NORTHWEST ON CYPRESS TERRACE</p> <ul style="list-style-type: none"> • Survey Point 0'-200' ⊗ Sidewalks do not exist in this area. <p>SOUTH SIDEWALK SOUTHWEST ON CYPRESS AVENUE</p> <ul style="list-style-type: none"> • Survey Point 0'-200' ⊗ Sidewalks do not exist in this area. 	<p>A\$ - F\$\$ - Depending on the specific situation at each location, install accessible sidewalks and intersections in compliance with ADAAG and PROWAAC guidance and FDOT Design Standards. This should include, but not be limited to, detectable warnings, driveway crossings, street crossing markings, signs, and pedestrian crossing signals as required.</p>

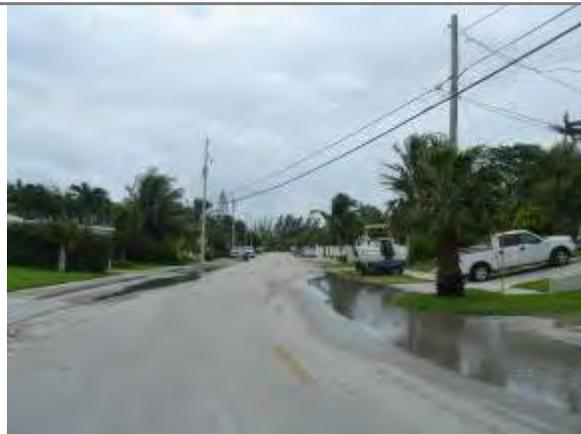
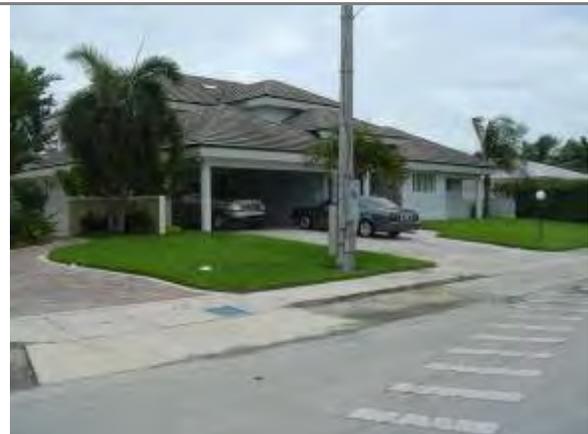
East Corner

Observation	Recommendations
<p>EAST CORNER</p> <ul style="list-style-type: none"> ⊗ Sidewalks do not exist in this area. <p>EAST SIDEWALK SOUTHEAST ON KEY HAVEN ROAD</p> <ul style="list-style-type: none"> • Survey Point 0'-100' ⊗ Sidewalks do not exist in this area. <p>EAST SIDEWALK NORTHEAST ON DRIFTWOOD TERRACE</p> <ul style="list-style-type: none"> • Survey Point 0'-100' ⊗ Sidewalks do not exist in this area. <p>NORTH CORNER</p> <ul style="list-style-type: none"> ⊗ Sidewalks do not exist in this area. <p>NORTH SIDEWALK NORTHEAST ON DRIFTWOOD TERRACE</p> <ul style="list-style-type: none"> • Survey Point 0'-100' ⊗ Sidewalks do not exist in this area. <p>NORTH SIDEWALK NORTHWEST ON KEY HAVEN ROAD</p> <ul style="list-style-type: none"> • Survey Point 0'-200' ⊗ Sidewalks do not exist in this area. <p>WEST SIDEWALK NORTHWEST ON KEY HAVEN ROAD</p> <ul style="list-style-type: none"> • Survey Point 0'-200' ⊗ Sidewalks do not exist in this area. <p>WEST SIDEWALK SOUTHEAST ON KEY HAVEN ROAD</p> <ul style="list-style-type: none"> • Survey Point 0'-100' ⊗ Sidewalks do not exist in this area. 	<p>A\$ - F\$\$ - Depending on the specific situation at each location, install accessible sidewalks and intersections in compliance with ADAAG and PROWAAC guidance and FDOT Design Standards. This should include, but not be limited to, detectable warnings, driveway crossings, street crossing markings, signs, and pedestrian crossing signals as required.</p>

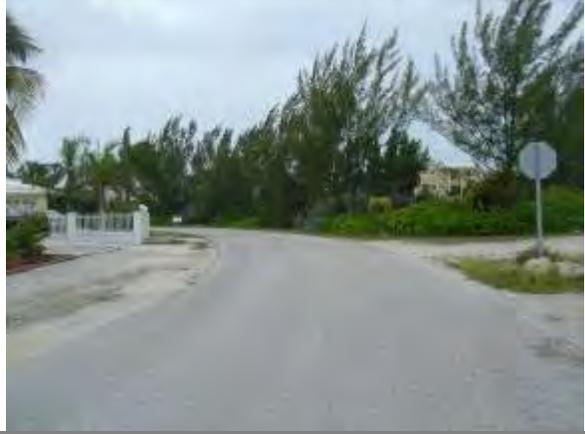
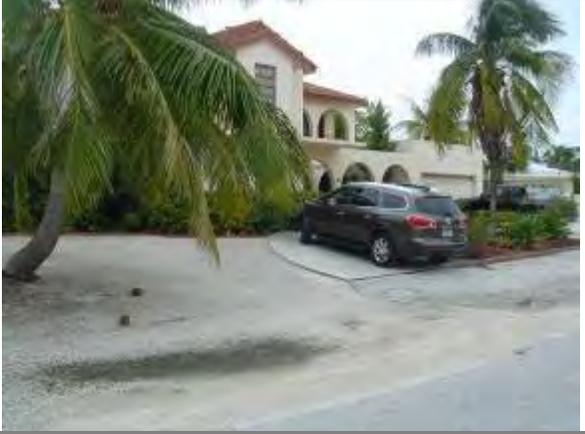
South on Driftwood Drive	Southeast Corner

Observation	Recommendations
<p>SOUTHEAST SIDEWALK SOUTH ON DRIFTWOOD DRIVE</p> <ul style="list-style-type: none"> • Survey Point 0'-100' <ul style="list-style-type: none"> ⊗ Sidewalks do not exist in this area. • Survey Point 100'-200' <ul style="list-style-type: none"> ⊗ Driveway approaches non-compliant. (Typical Photo 04) ⊗ Sidewalk elevated +/- 9" above road surface. ⊗ Cross Slope exceeds 2%. ⊗ Running Slope exceeds 5%. <p>EAST SIDEWALK NORTHEAST ON DRIFTWOOD DRIVE</p> <ul style="list-style-type: none"> • Survey Point 0'-700' <ul style="list-style-type: none"> ⊗ Sidewalks do not exist in this area. • Survey Point 700'-800' <ul style="list-style-type: none"> ✓ ADA Compliant • Survey Point 800'-1100' <ul style="list-style-type: none"> ⊗ Sidewalks do not exist in this area. <p>NORTH SIDEWALK NORTHEAST ON DRIFTWOOD DRIVE</p> <ul style="list-style-type: none"> • Survey Point 0'-100' <ul style="list-style-type: none"> ⊗ Cross Slope exceeds 2%. ⊗ Cracks greater than ½" in surface. (Typical Photo 03) ⊗ Utility guy wire reduces clear width. (Typical Photo 07) • Survey Point 100'-200' <ul style="list-style-type: none"> ⊗ Cross Slope exceeds 2%. • Survey Point 200'-300' <ul style="list-style-type: none"> ⊗ Sidewalk exists partially in this area. (Typical Photo 05) ⊗ Cross Slope exceeds 2%. • Survey Point 300'-400' <ul style="list-style-type: none"> ⊗ Sidewalk exists partially in this area. (Typical Photo 05) ⊗ Cross Slope exceeds 2%. ⊗ Existing water meter recessed below sidewalk surface. • Survey Point 400'-500' <ul style="list-style-type: none"> ⊗ Sidewalk exists partially in this area. (Typical Photo 05) 	<p>A\$ - F\$\$ - Depending on the specific situation at each location, install accessible sidewalks and intersections in compliance with ADAAG and PROWAAC guidance and FDOT Design Standards. This should include, but not be limited to, detectable warnings, driveway crossings, street crossing markings, signs, and pedestrian crossing signals as required.</p>

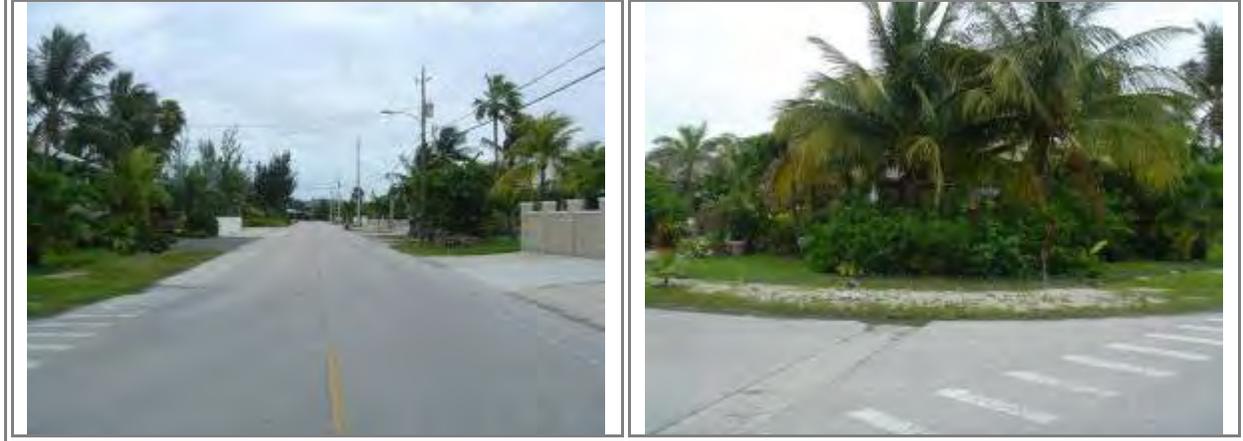
Southeast on Key Haven Road	East Corner
-----------------------------	-------------

Observation	Recommendations
<p>EAST CORNER</p> <ul style="list-style-type: none"> ⊗ Sidewalks do not exist in this area. <p>EAST SIDEWALK SOUTHEAST ON KEY HAVEN ROAD</p> <ul style="list-style-type: none"> • Survey Point 0'-100' ⊗ Sidewalks do not exist in this area. <p>EAST SIDEWALK NORTHEAST ON EVERGREEN AVENUE</p> <ul style="list-style-type: none"> • Survey Point 0'-100' ⊗ Sidewalks do not exist in this area. <p>NORTH CORNER</p> <ul style="list-style-type: none"> ⊗ Sidewalks do not exist in this area. <p>NORTH SIDEWALK NORTHEAST ON EVERGREEN AVENUE</p> <ul style="list-style-type: none"> • Survey Point 0'-100' ⊗ Sidewalks do not exist in this area. <p>NORTH SIDEWALK NORTHWEST ON KEY HAVEN ROAD</p> <ul style="list-style-type: none"> • Survey Point 0'-200' ⊗ Sidewalks do not exist in this area. <p>WEST SIDEWALK NORTHWEST ON KEY HAVEN ROAD</p> <ul style="list-style-type: none"> • Survey Point 0'-200' ⊗ Sidewalks do not exist in this area. <p>WEST SIDEWALK SOUTHEAST ON KEY HAVEN ROAD</p> <ul style="list-style-type: none"> • Survey Point 0'-100' ⊗ Sidewalks do not exist in this area. 	<p>A\$ - F\$\$ - Depending on the specific situation at each location, install accessible sidewalks and intersections in compliance with ADAAG and PROWAAC guidance and FDOT Design Standards. This should include, but not be limited to, detectable warnings, driveway crossings, street crossing markings, signs, and pedestrian crossing signals as required.</p>

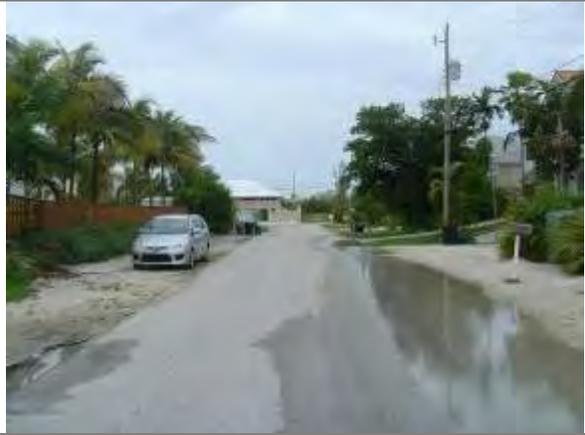
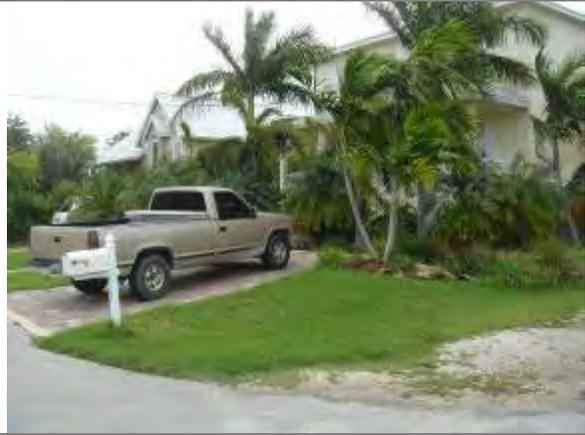
Southwest on Evergreen Avenue	South Corner

Observation	Recommendations
<p>SOUTH CORNER</p> <ul style="list-style-type: none"> ⊗ Sidewalks do not exist in this area. <p>SOUTH SIDEWALK SOUTHWEST ON EVERGREEN AVENUE</p> <ul style="list-style-type: none"> • Survey Point 0'-200' ⊗ Sidewalks do not exist in this area. <p>SOUTH SIDEWALK SOUTHEAST ON EVERGREEN COURT</p> <ul style="list-style-type: none"> • Survey Point 0'-100' ⊗ Sidewalks do not exist in this area. <p>EAST CORNER</p> <ul style="list-style-type: none"> ⊗ Sidewalks do not exist in this area. <p>EAST SIDEWALK SOUTHEAST ON EVERGREEN COURT</p> <ul style="list-style-type: none"> • Survey Point 0'-100' ⊗ Sidewalks do not exist in this area. <p>EAST SIDEWALK NORTHEAST ON EVERGREEN AVENUE</p> <ul style="list-style-type: none"> • Survey Point 0'-100' ⊗ Sidewalks do not exist in this area. <p>NORTH SIDEWALK NORTHEAST ON EVERGREEN AVENUE</p> <ul style="list-style-type: none"> • Survey Point 0'-100' ⊗ Sidewalks do not exist in this area. <p>NORTH SIDEWALK SOUTHWEST ON EVERGREEN AVENUE</p> <ul style="list-style-type: none"> • Survey Point 0'-200' ⊗ Sidewalks do not exist in this area. 	<p>A\$ - F\$\$ - Depending on the specific situation at each location, install accessible sidewalks and intersections in compliance with ADAAG and PROWAAC guidance and FDOT Design Standards. This should include, but not be limited to, detectable warnings, driveway crossings, street crossing markings, signs, and pedestrian crossing signals as required.</p>

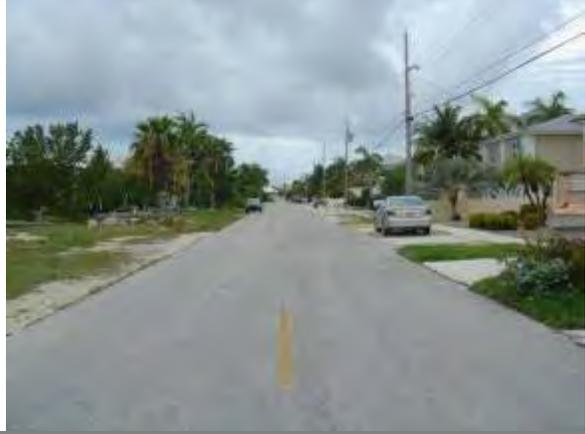
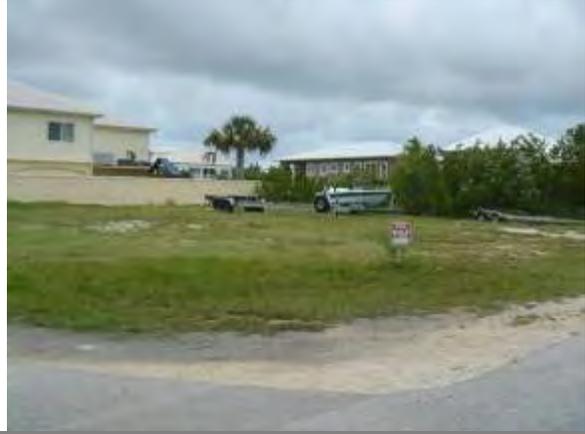
Southwest on Evergreen Avenue	South Corner

Observation	Recommendations
<p>SOUTH CORNER</p> <ul style="list-style-type: none"> ⊗ Sidewalks do not exist in this area. <p>SOUTH SIDEWALK SOUTHWEST ON EVERGREEN AVENUE</p> <ul style="list-style-type: none"> • Survey Point 0'-200' ⊗ Sidewalks do not exist in this area. <p>SOUTH SIDEWALK SOUTHEAST ON EVERGREEN TERRACE</p> <ul style="list-style-type: none"> • Survey Point 0'-100' ⊗ Sidewalks do not exist in this area. <p>EAST CORNER</p> <ul style="list-style-type: none"> ⊗ Sidewalks do not exist in this area. <p>EAST SIDEWALK SOUTHEAST ON EVERGREEN TERRACE</p> <ul style="list-style-type: none"> • Survey Point 0'-100' ⊗ Sidewalks do not exist in this area. <p>EAST SIDEWALK NORTHEAST ON EVERGREEN AVENUE</p> <ul style="list-style-type: none"> • Survey Point 0'-300' ⊗ Sidewalks do not exist in this area. <p>NORTH SIDEWALK NORTHEAST ON EVERGREEN AVENUE</p> <ul style="list-style-type: none"> • Survey Point 0'-300' ⊗ Sidewalks do not exist in this area. <p>NORTH SIDEWALK SOUTHWEST ON EVERGREEN AVENUE</p> <ul style="list-style-type: none"> • Survey Point 0'-200' ⊗ Driveway approaches non-compliant. (Typical Photo 04) ⊗ Utility pole reduces required clear width. (Typical Photo 01) ⊗ Cross Slope exceeds 2%. 	<p>A\$ - F\$\$ - Depending on the specific situation at each location, install accessible sidewalks and intersections in compliance with ADAAG and PROWAAC guidance and FDOT Design Standards. This should include, but not be limited to, detectable warnings, driveway crossings, street crossing markings, signs, and pedestrian crossing signals as required.</p>

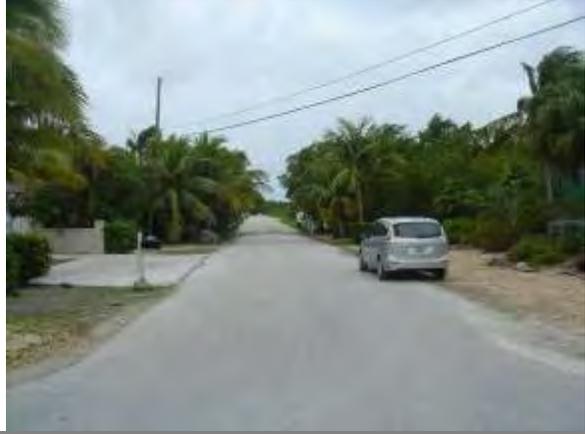
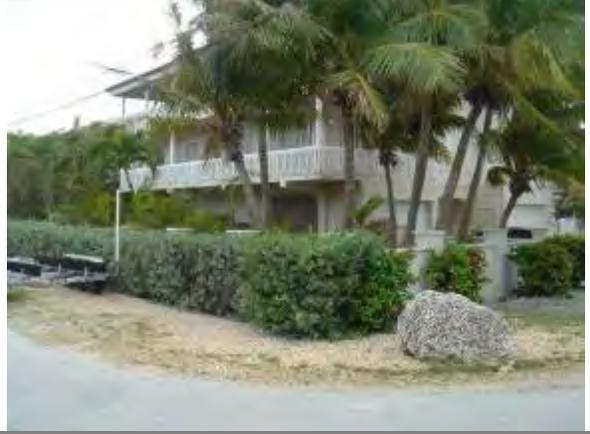
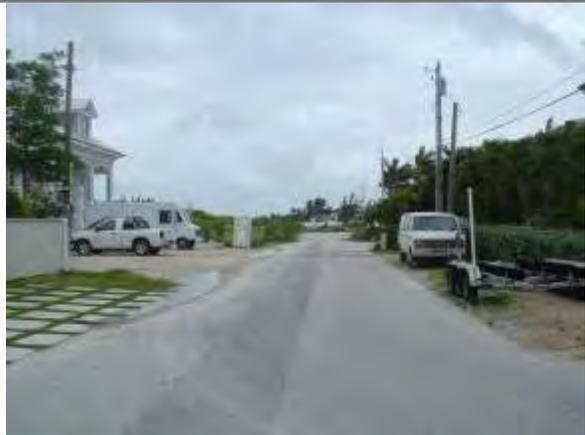
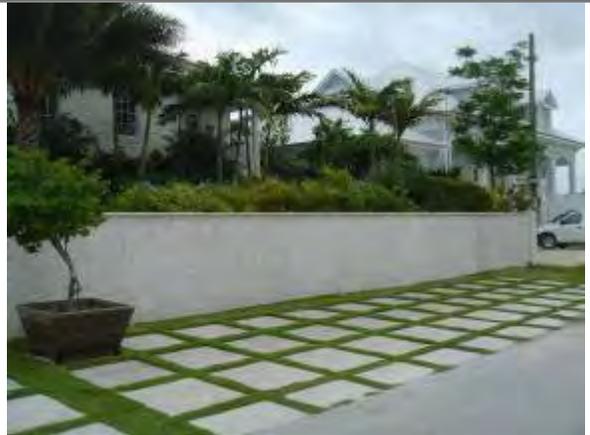
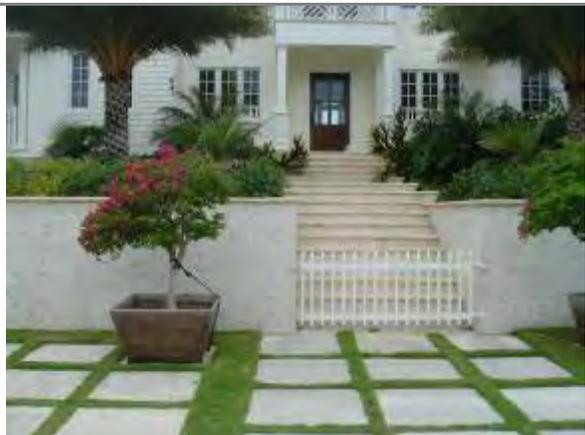
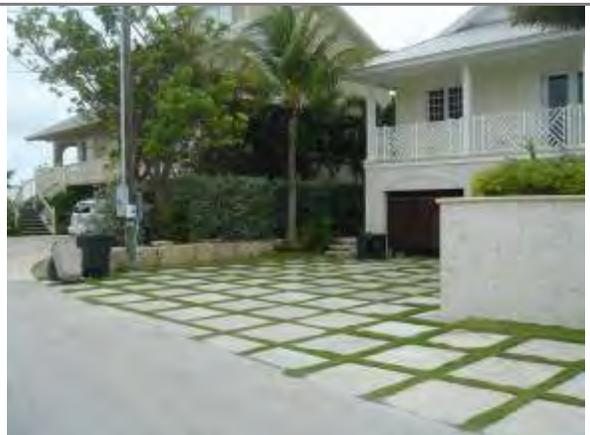
8.2 FLORAL AVENUE AND DRIFTWOOD DRIVE	
Road Atlas Identification:	R 21.1 R 15.1

Observation	Recommendations
<p>SOUTH CORNER</p> <ul style="list-style-type: none"> ⊗ Sidewalks do not exist in this area. <p>SOUTH SIDEWALK SOUTHWEST ON FLORAL ROAD</p> <ul style="list-style-type: none"> • Survey Point 0'-800' ⊗ Sidewalks do not exist in this area. <p>SOUTH SIDEWALK SOUTHEAST ON DRIFTWOOD DRIVE</p> <ul style="list-style-type: none"> • Survey Point 0'-300' ⊗ Sidewalks do not exist in this area. <p>EAST SIDEWALK SOUTHEAST ON DRIFTWOOD DRIVE</p> <ul style="list-style-type: none"> • Survey Point 0'-300' ⊗ Sidewalks do not exist in this area. <p>EAST SIDEWALK NORTHWEST ON DRIFTWOOD DRIVE</p> <ul style="list-style-type: none"> • Survey Point 0'-100' ⊗ Sidewalks do not exist in this area. <p>WEST CORNER</p> <ul style="list-style-type: none"> ⊗ Sidewalks do not exist in this area. <p>WEST SIDEWALK NORTHWEST ON DRIFTWOOD DRIVE</p> <ul style="list-style-type: none"> • Survey Point 0'-100' ⊗ Sidewalks do not exist in this area. <p>SOUTH SIDEWALK SOUTHWEST ON FLORAL AVENUE</p> <ul style="list-style-type: none"> • Survey Point 0'-800' ⊗ Sidewalks do not exist in this area. 	<p>A\$ - F\$\$ - Depending on the specific situation at each location, install accessible sidewalks and intersections in compliance with ADAAG and PROWAAC guidance and FDOT Design Standards. This should include, but not be limited to, detectable warnings, driveway crossings, street crossing markings, signs, and pedestrian crossing signals as required.</p>

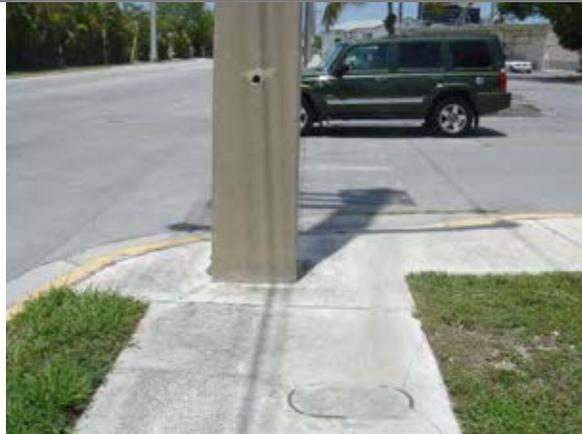
Typical Photo 01: Utility pole reduces clear width

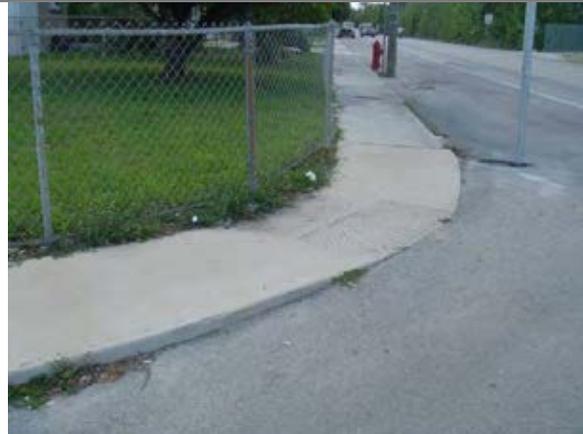
Typical Photo 02: Non-compliant detectable warning at corner.

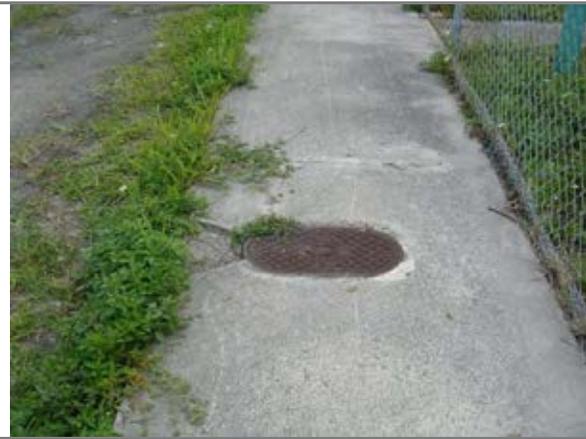
Typical Photo 03: Water meter recessed below surface

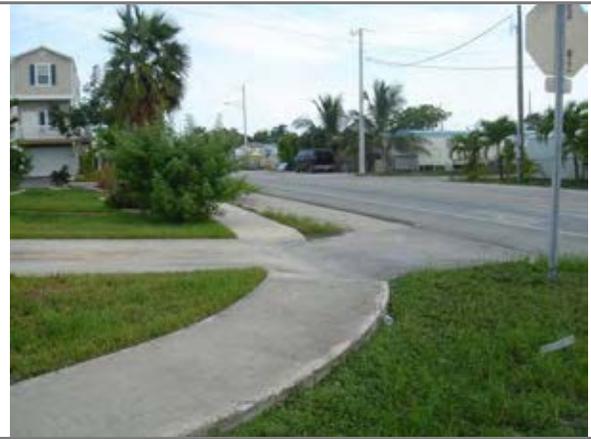
Typical Photo 04: Non-compliant driveway approach across sidewalk

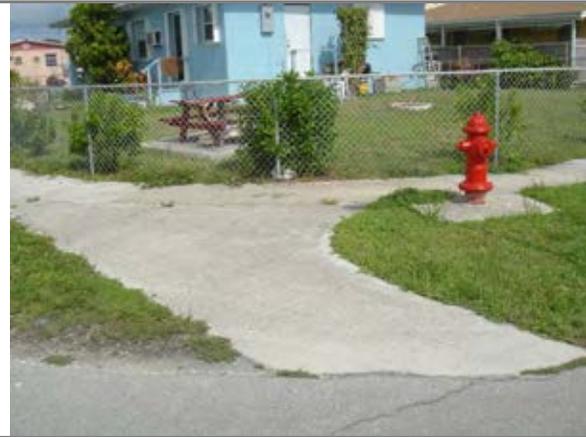
Typical Photo 05: Non-compliant street access

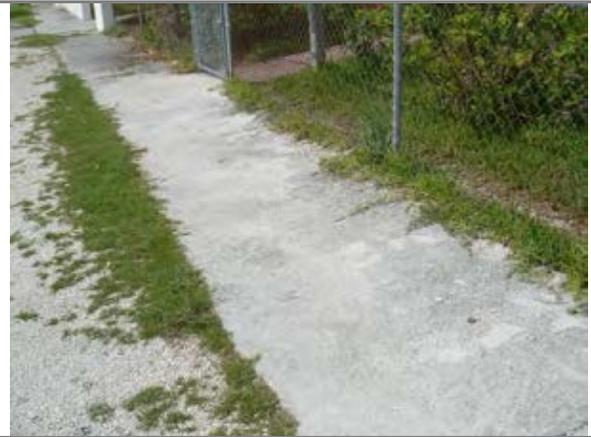
Typical Photo 06: Rough uneven surface

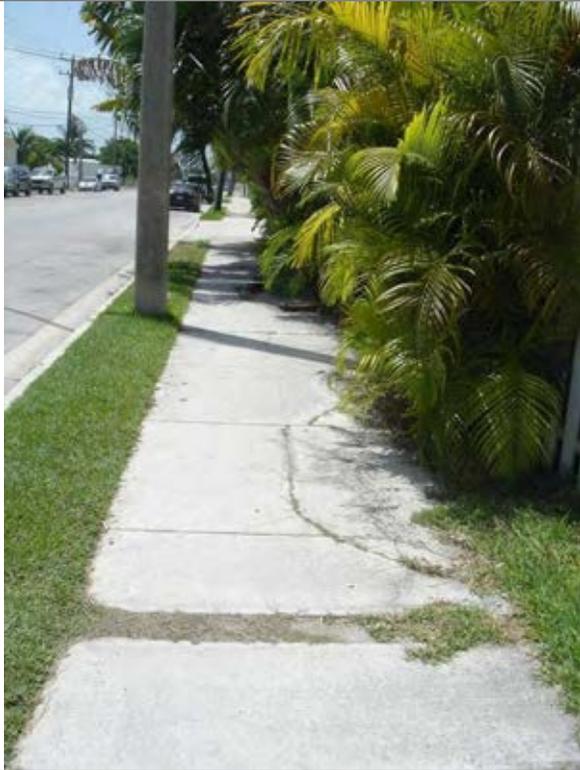
Typical Photo 07: Cracks / gaps greater than ½" in surface.
