Americans with Disabilities Act Transition Plan Lower Keys - Part 2

Volume 4 of 4

Monroe County

October 29, 2010

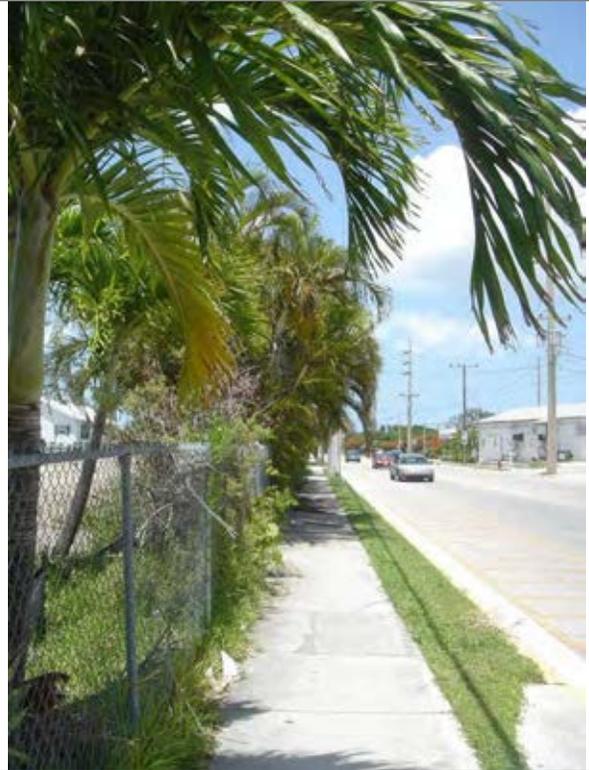
Typical Photo 08: Vegetation reduces required clear width.

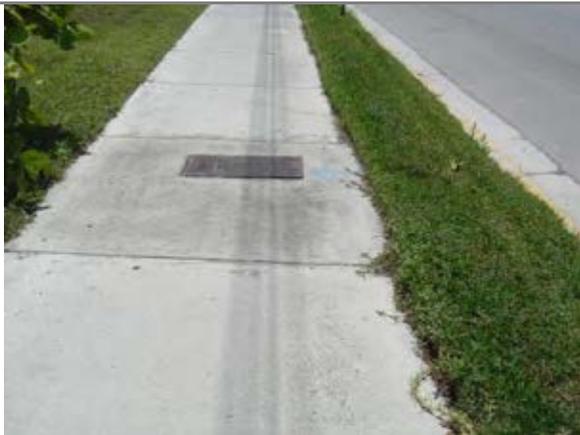
Typical Photo 09: Water meter protrudes above surface

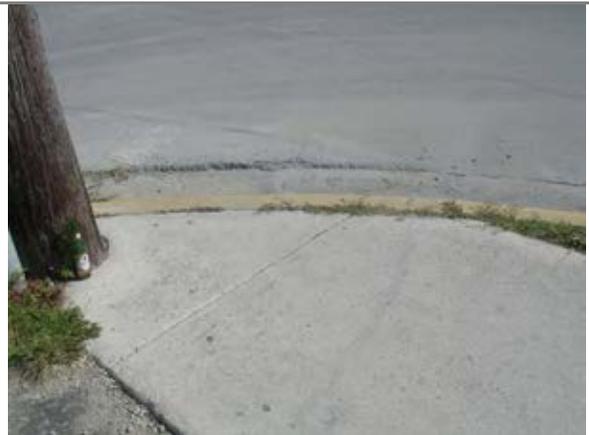
Typical Photo 10: Existing sidewalk does not provide accessible connection to street.

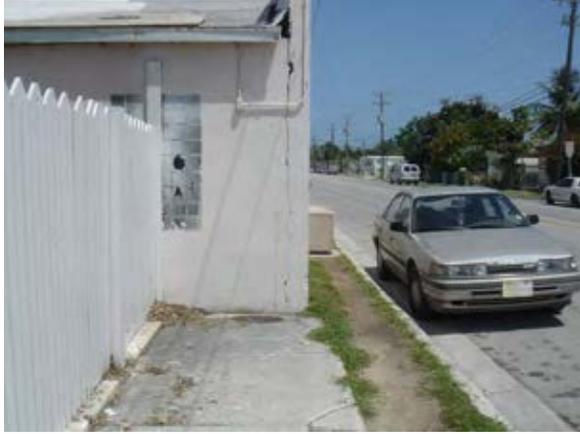
Typical Photo 11: Sidewalk terminates at building

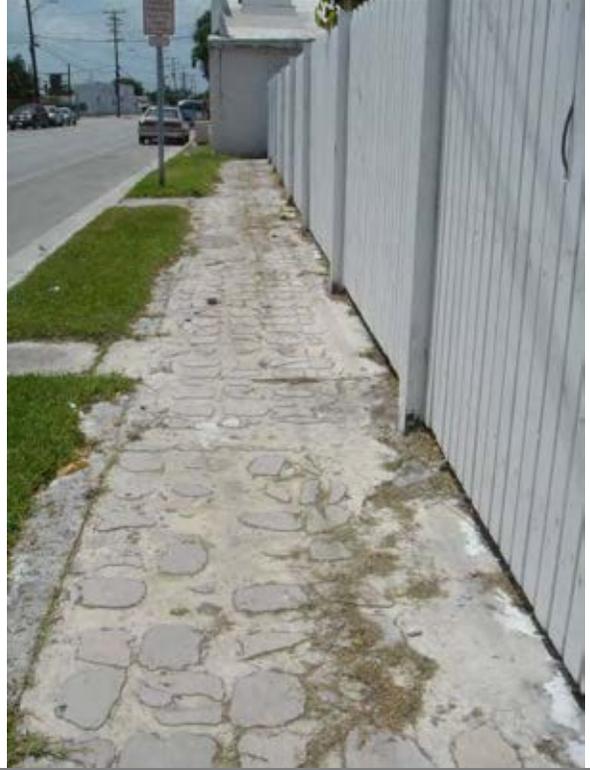
Typical Photo 12: Rough and uneven surface

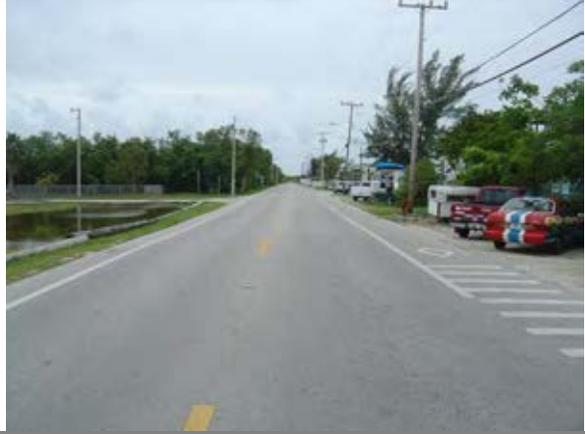
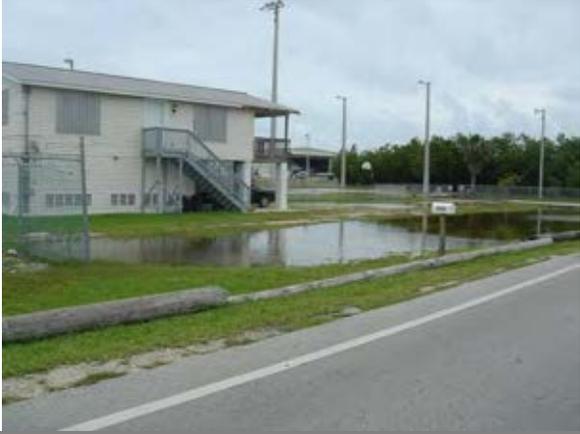
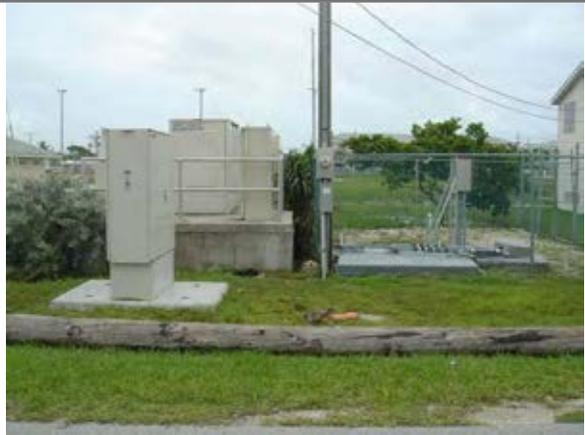
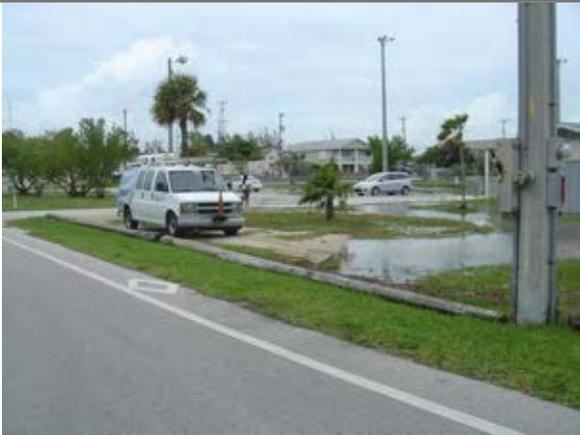
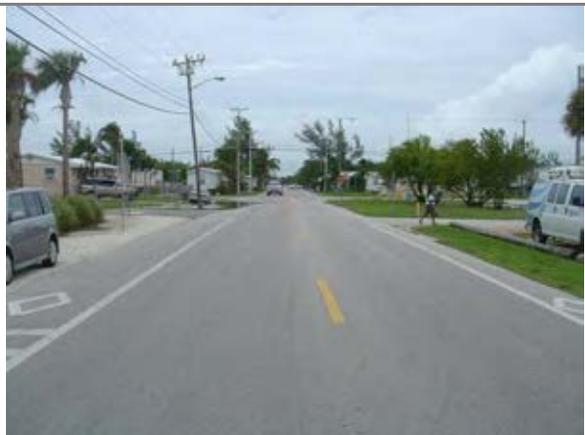
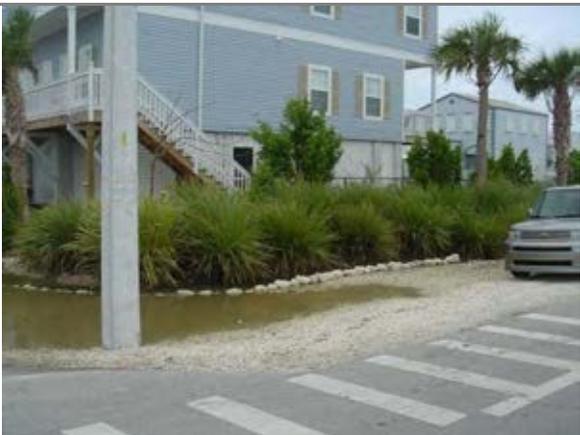
3.2 5 TH STREET AND 7 TH AVENUE		
Road Atlas Identification:	S 13.1	S 15.1

Observation	Recommendations
<p>SOUTHWEST CORNER ☒ Sidewalks do not exist in this area.</p> <p>SOUTHWEST SIDEWALK WEST ON 7th AVENUE • Survey Points 0'-500' ☒ Sidewalks do not exist in this area.</p> <p>SOUTHWEST SIDEWALK SOUTH ON 5th STREET • Survey Points 0'-100' ☒ Sidewalks do not exist in this area.</p> <p>EAST SIDEWALK SOUTH ON 5th STREET • Survey Points 0'-100' ☒ Sidewalks do not exist in this area.</p> <p>EAST SIDEWALK NORTH ON 5th STREET • Survey Points 0'-100' ☒ Sidewalks do not exist in this area.</p> <p>NORTHWEST CORNER ☒ Sidewalks do not exist in this area.</p> <p>NORTHWEST SIDEWALK NORTH ON 5th STREET • Survey Points 0'-100' ☒ Sidewalks do not exist in this area.</p> <p>NORTHWEST SIDEWALK WEST ON 7th AVENUE • Survey Points 0'-500' ☒ Sidewalks do not exist in this area.</p>	<p>AS - F\$\$ - Depending on the specific situation at each location, install accessible sidewalks and intersections in compliance with ADAAG and PROWAAC guidance and FDOT Design Standards. This should include, but not be limited to, detectable warnings, driveway crossings, street crossing markings, signs, and pedestrian crossing signals as required.</p>

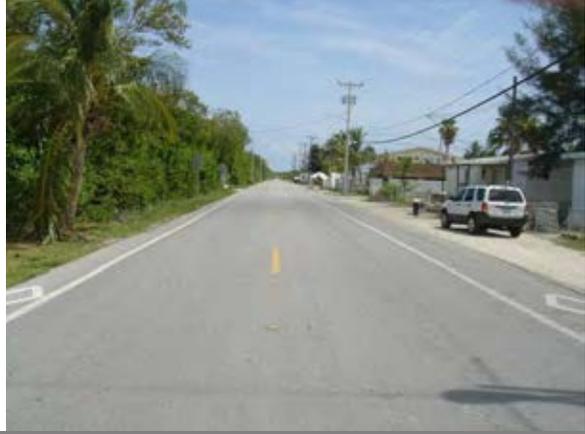
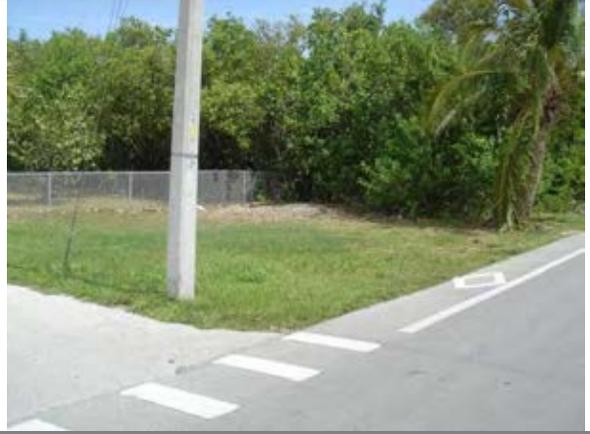
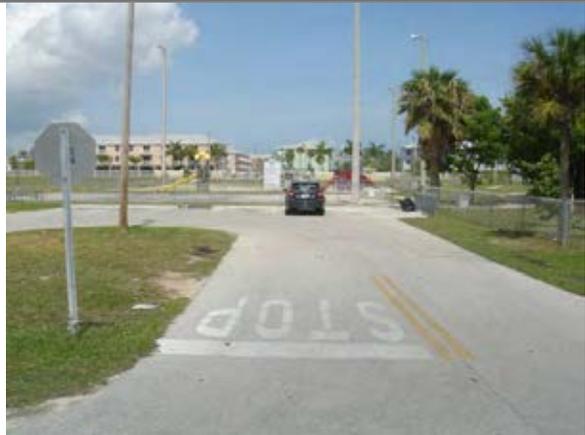
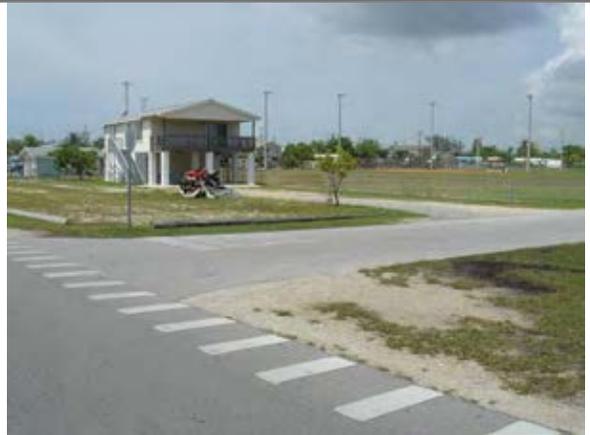
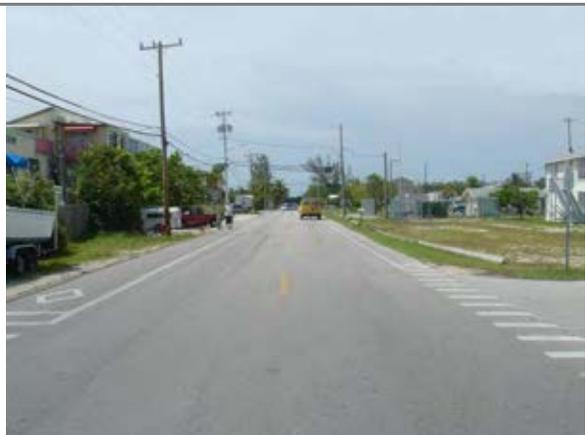
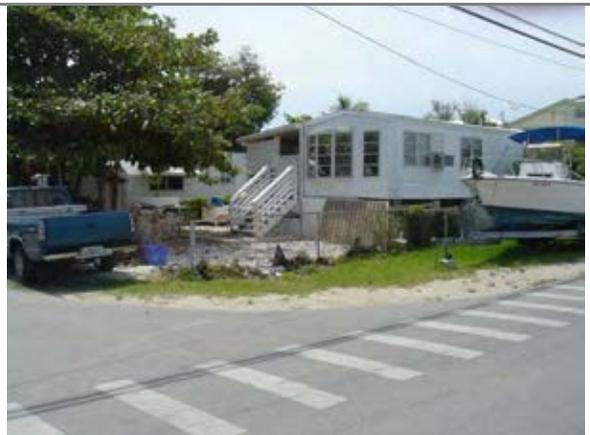
3.3 5 TH STREET AND 8 TH AVENUE		
Road Atlas Identification:	S 13.1	S16.1

Observation	Recommendations
<p>SOUTHWEST CORNER ☒ Sidewalks do not exist in this area.</p> <p>SOUTHWEST SIDEWALK WEST ON 8th AVENUE • Survey Points 0'-500' ☒ Sidewalks do not exist in this area.</p> <p>SOUTHWEST SIDEWALK SOUTH ON 5th STREET • Survey Points 0'-100' ☒ Sidewalks do not exist in this area.</p> <p>EAST SIDEWALK SOUTH ON 5th STREET • Survey Points 0'-100' ☒ Sidewalks do not exist in this area.</p> <p>EAST SIDEWALK NORTH ON 5th STREET • Survey Points 0'-100' ☒ Sidewalks do not exist in this area.</p> <p>NORTHWEST CORNER ☒ Sidewalks do not exist in this area.</p> <p>NORTHWEST SIDEWALK NORTH ON 5th STREET • Survey Points 0'-100' ☒ Sidewalks do not exist in this area.</p> <p>NORTHWEST SIDEWALK WEST ON 8th AVENUE • Survey Points 0'-500' ☒ Sidewalks do not exist in this area.</p>	<p>A\$ - F\$\$ - Depending on the specific situation at each location, install accessible sidewalks and intersections in compliance with ADAAG and PROWAAC guidance and FDOT Design Standards. This should include, but not be limited to, detectable warnings, driveway crossings, street crossing markings, signs, and pedestrian crossing signals as required.</p>

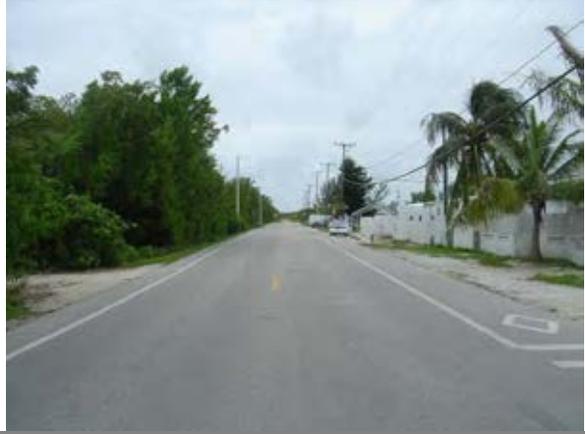
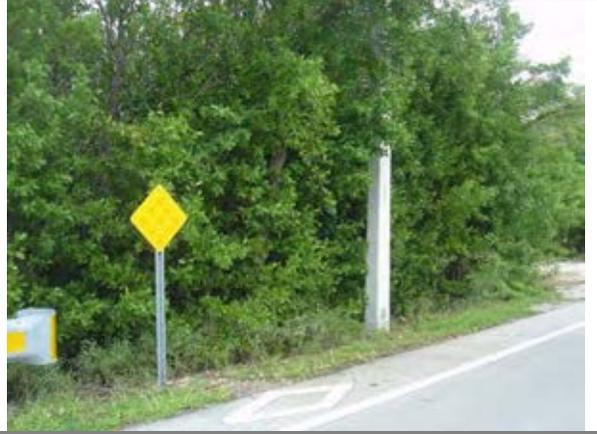
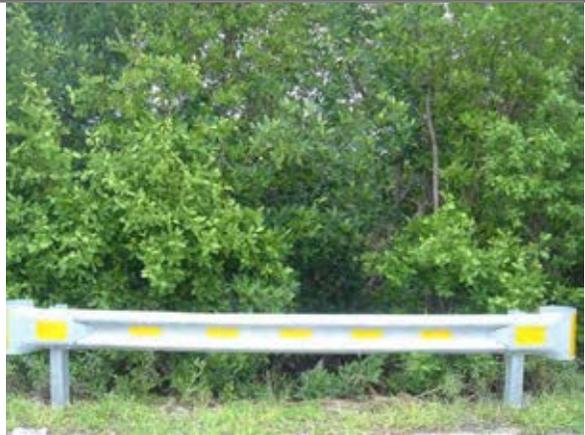
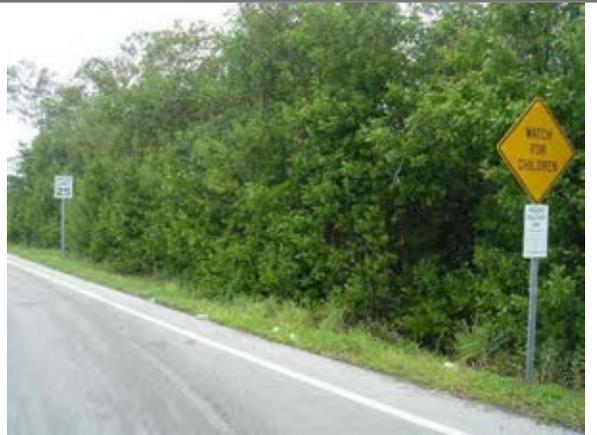
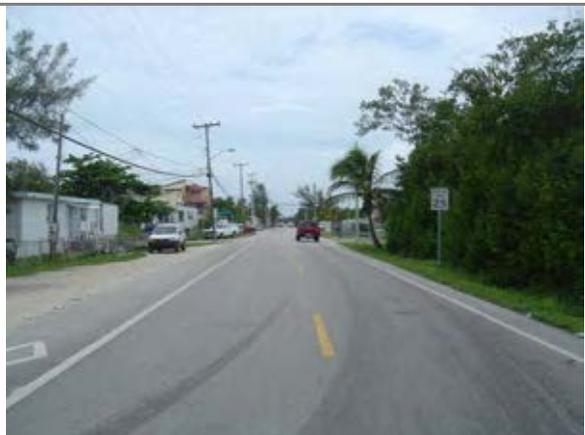
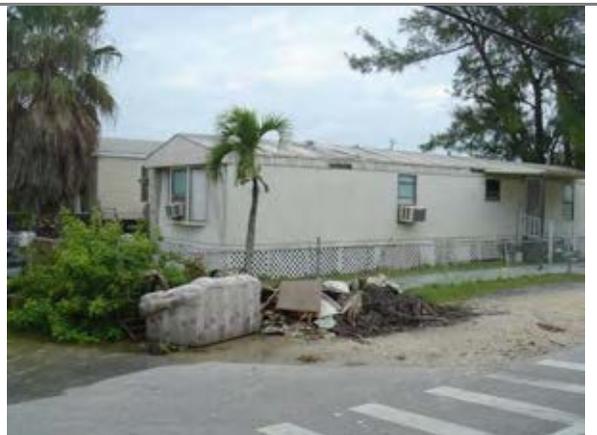
3.4 5 TH STREET AND 9 TH AVENUE		
Road Atlas Identification:	S 13.1	S 17.1

Observation	Recommendations
<p>SOUTHWEST CORNER ☒ Sidewalks do not exist in this area.</p> <p>SOUTHWEST SIDEWALK WEST ON 9th AVENUE • Survey Points 0'-500' ☒ Sidewalks do not exist in this area.</p> <p>SOUTHWEST SIDEWALK SOUTH ON 5th STREET • Survey Points 0'-100' ☒ Sidewalks do not exist in this area.</p> <p>EAST SIDEWALK SOUTH ON 5th STREET • Survey Points 0'-100' ☒ Sidewalks do not exist in this area.</p> <p>EAST SIDEWALK NORTH ON 5th STREET • Survey Points 0'-100' ☒ Sidewalks do not exist in this area.</p> <p>NORTHWEST CORNER ☒ Sidewalks do not exist in this area.</p> <p>NORTHWEST SIDEWALK NORTH ON 5th STREET • Survey Points 0'-100' ☒ Sidewalks do not exist in this area.</p> <p>NORTHWEST SIDEWALK WEST ON 9th AVENUE • Survey Points 0'-500' ☒ Sidewalks do not exist in this area.</p>	<p>AS - F\$\$ - Depending on the specific situation at each location, install accessible sidewalks and intersections in compliance with ADAAG and PROWAAAC guidance and FDOT Design Standards. This should include, but not be limited to, detectable warnings, driveway crossings, street crossing markings, signs, and pedestrian crossing signals as required.</p>

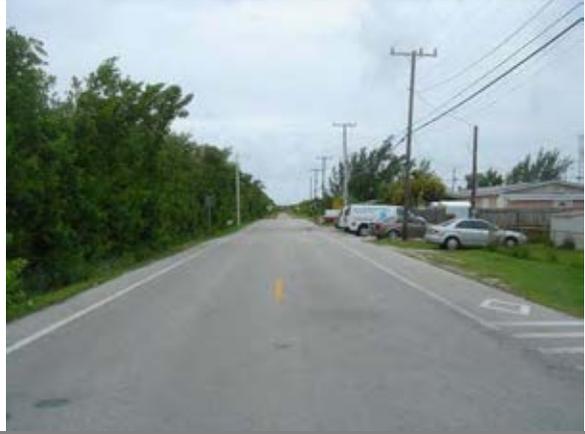
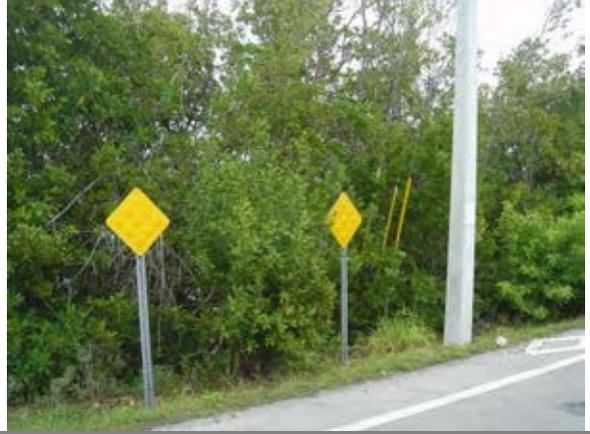
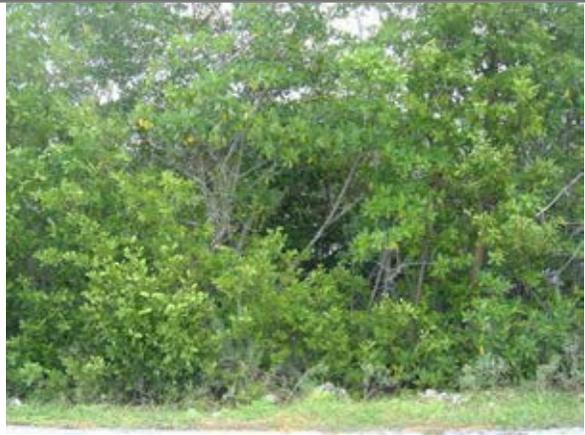
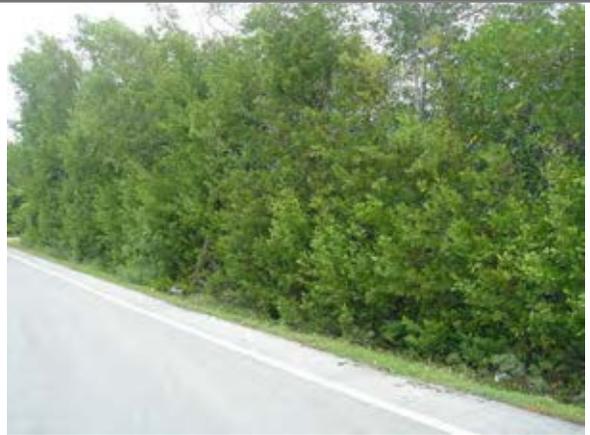
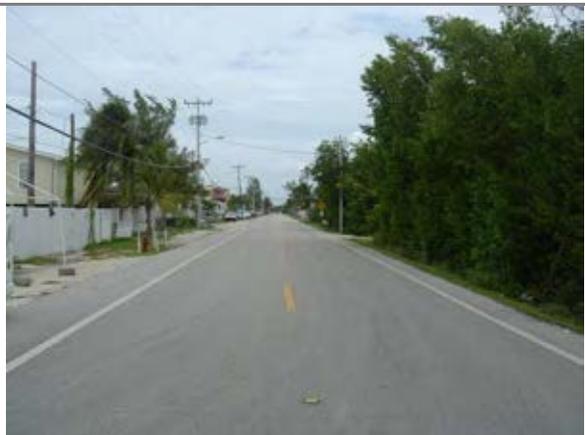
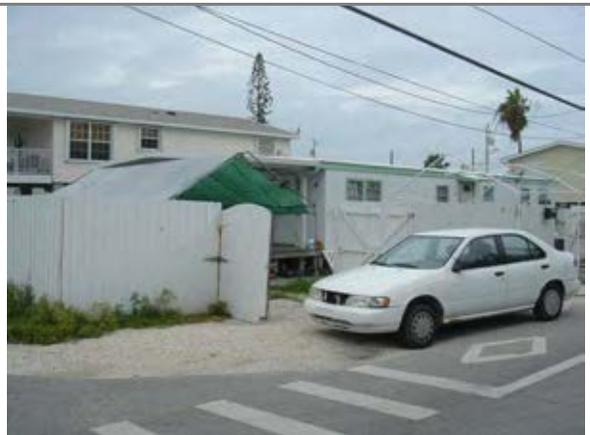
3.5 5 TH STREET AND 10 TH AVENUE	
Road Atlas Identification:	S 13.1 S 1.1

Observation	Recommendations
<p>SOUTHWEST CORNER ☒ Sidewalks do not exist in this area.</p> <p>SOUTHWEST SIDEWALK WEST ON 10th AVENUE • Survey Points 0'-500' ☒ Sidewalks do not exist in this area.</p> <p>SOUTHWEST SIDEWALK SOUTH ON 5th STREET • Survey Points 0'-100' ☒ Sidewalks do not exist in this area.</p> <p>EAST SIDEWALK SOUTH ON 5th STREET • Survey Points 0'-100' ☒ Sidewalks do not exist in this area.</p> <p>EAST SIDEWALK NORTH ON 5th STREET • Survey Points 0'-100' ☒ Sidewalks do not exist in this area.</p> <p>NORTHWEST CORNER ☒ Sidewalks do not exist in this area.</p> <p>NORTHWEST SIDEWALK NORTH ON 5th STREET • Survey Points 0'-100' ☒ Sidewalks do not exist in this area.</p> <p>NORTHWEST SIDEWALK WEST ON 10th AVENUE • Survey Points 0'-500' ☒ Sidewalks do not exist in this area.</p>	<p>A\$ - F\$\$ - Depending on the specific situation at each location, install accessible sidewalks and intersections in compliance with ADAAG and PROWAAC guidance and FDOT Design Standards. This should include, but not be limited to, detectable warnings, driveway crossings, street crossing markings, signs, and pedestrian crossing signals as required.</p>

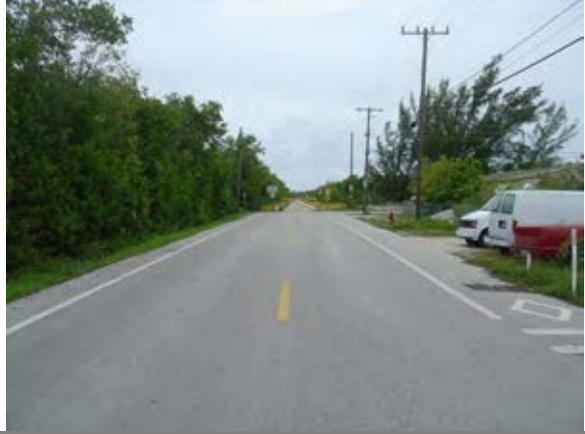
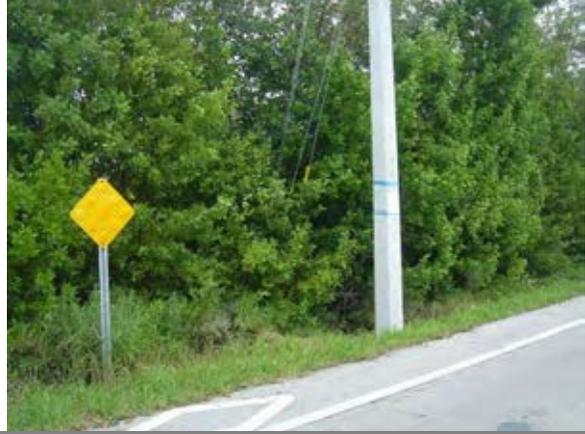
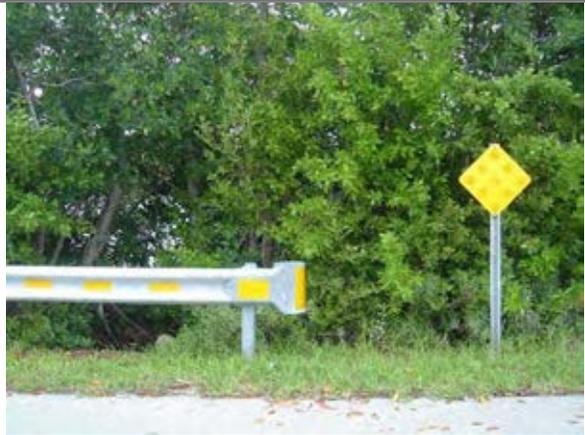
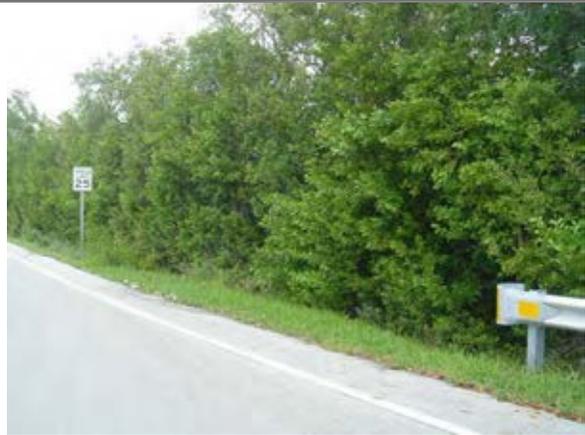
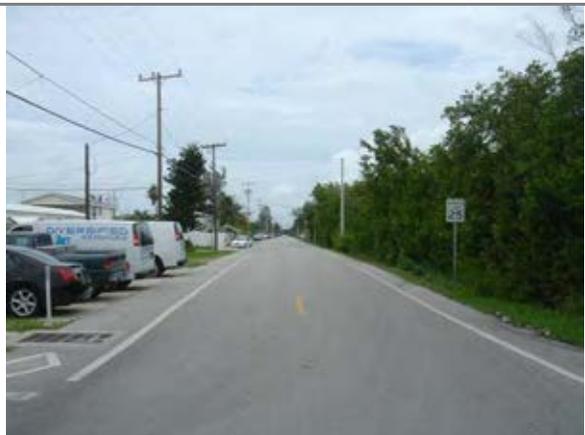
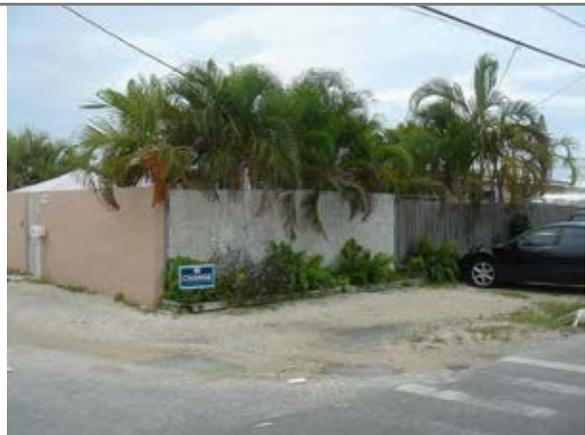
3.6 5 TH STREET AND 11 TH AVENUE	
Road Atlas Identification:	S 13.1 S 2.1

Observation	Recommendations
<p>SOUTHWEST CORNER ☒ Sidewalks do not exist in this area.</p> <p>SOUTHWEST SIDEWALK WEST ON 11th AVENUE • Survey Points 0'-500' ☒ Sidewalks do not exist in this area.</p> <p>SOUTHWEST SIDEWALK SOUTH ON 5th STREET • Survey Points 0'-100' ☒ Sidewalks do not exist in this area.</p> <p>EAST SIDEWALK SOUTH ON 5th STREET • Survey Points 0'-100' ☒ Sidewalks do not exist in this area.</p> <p>EAST SIDEWALK NORTH ON 5th STREET • Survey Points 0'-100' ☒ Sidewalks do not exist in this area.</p> <p>NORTHWEST CORNER ☒ Sidewalks do not exist in this area.</p> <p>NORTHWEST SIDEWALK NORTH ON 5th STREET • Survey Points 0'-100' ☒ Sidewalks do not exist in this area.</p> <p>NORTHWEST SIDEWALK WEST ON 11th AVENUE • Survey Points 0'-500' ☒ Sidewalks do not exist in this area.</p>	<p>AS - F\$\$ - Depending on the specific situation at each location, install accessible sidewalks and intersections in compliance with ADAAG and PROWAAC guidance and FDOT Design Standards. This should include, but not be limited to, detectable warnings, driveway crossings, street crossing markings, signs, and pedestrian crossing signals as required.</p>

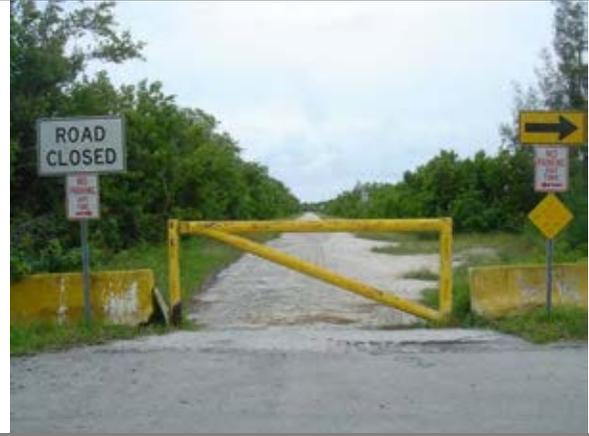
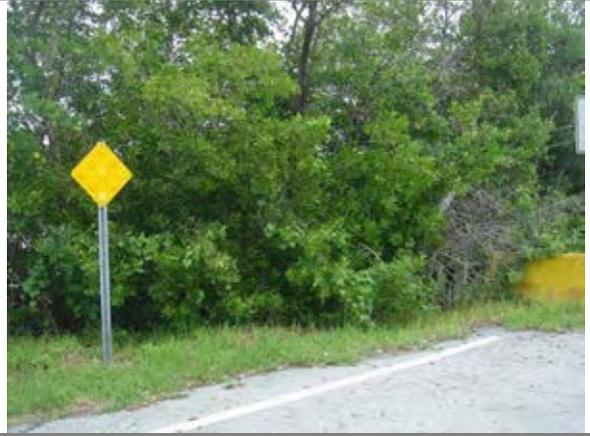
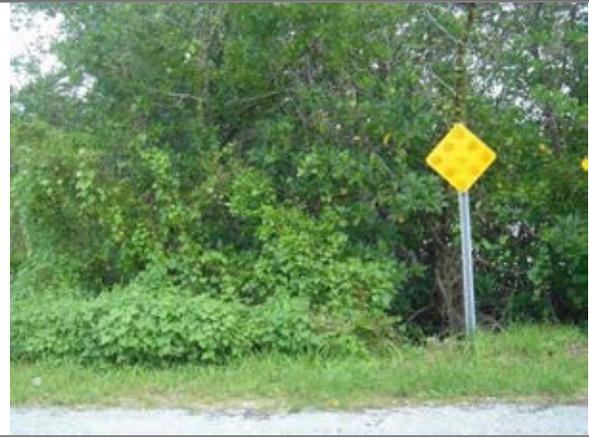
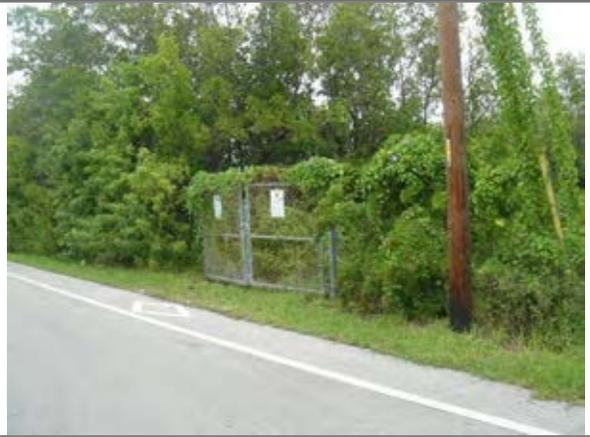
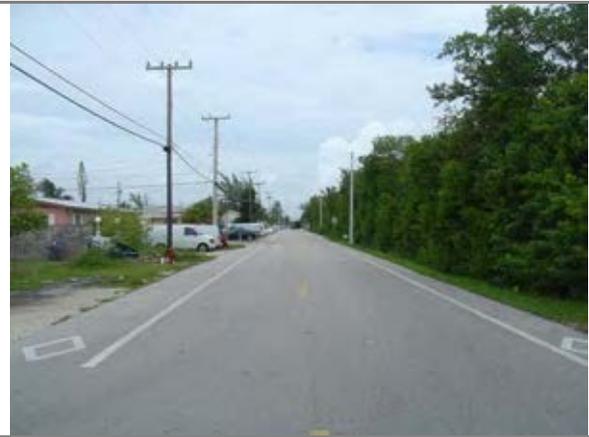
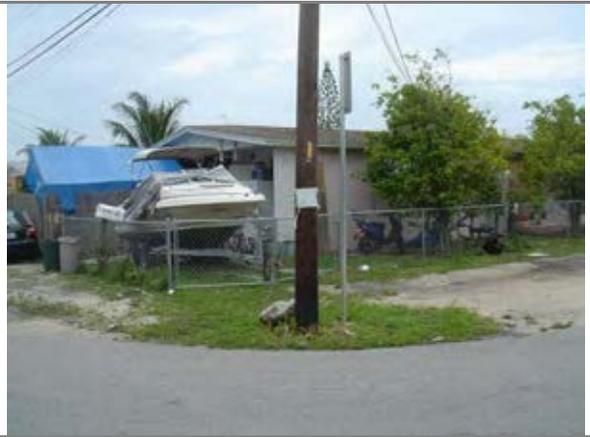
3.7 5 TH STREET AND 12 TH AVENUE	
Road Atlas Identification:	S 13.1

Observation	Recommendations
<p>SOUTHWEST CORNER</p> <ul style="list-style-type: none"> ⊗ Sidewalks do not exist in this area. <p>SOUTHWEST SIDEWALK WEST ON 12th AVENUE</p> <ul style="list-style-type: none"> • Survey Points 0'-500' ⊗ Sidewalks do not exist in this area. <p>SOUTHWEST SIDEWALK SOUTH ON 5th STREET</p> <ul style="list-style-type: none"> ⊗ Road closed. <p>EAST SIDEWALK SOUTH ON 5th STREET</p> <ul style="list-style-type: none"> ⊗ Road closed. <p>EAST SIDEWALK NORTH ON 5th STREET</p> <ul style="list-style-type: none"> • Survey Points 0'-100' ⊗ Sidewalks do not exist in this area. <p>NORTHWEST CORNER</p> <ul style="list-style-type: none"> ⊗ Sidewalks do not exist in this area. <p>NORTHWEST SIDEWALK NORTH ON 5th STREET</p> <ul style="list-style-type: none"> • Survey Points 0'-100' ⊗ Sidewalks do not exist in this area. <p>NORTHWEST SIDEWALK WEST ON 12th AVENUE</p> <ul style="list-style-type: none"> • Survey Points 0'-500' ⊗ Sidewalks do not exist in this area. 	<p>A\$ - F\$\$ - Depending on the specific situation at each location, install accessible sidewalks and intersections in compliance with ADAAG and PROWAAC guidance and FDOT Design Standards. This should include, but not be limited to, detectable warnings, driveway crossings, street crossing markings, signs, and pedestrian crossing signals as required.</p>

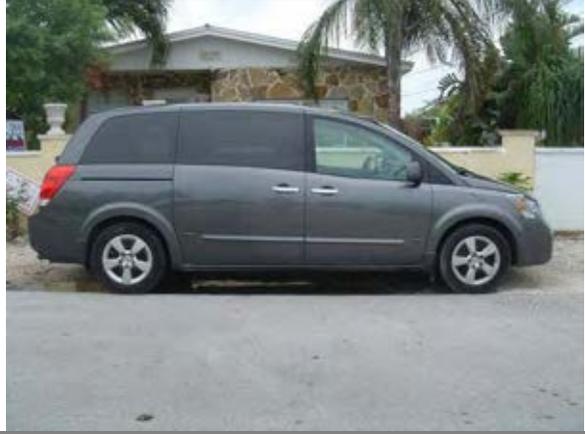
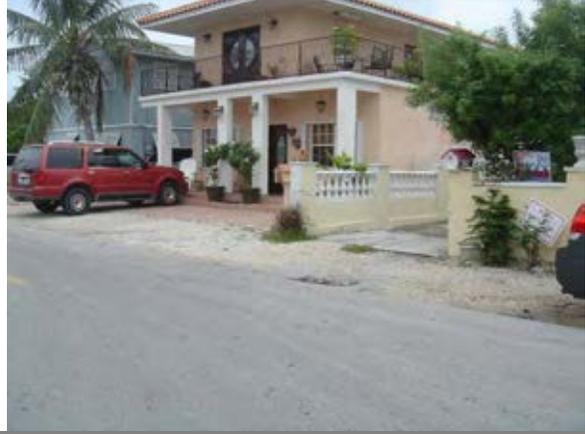
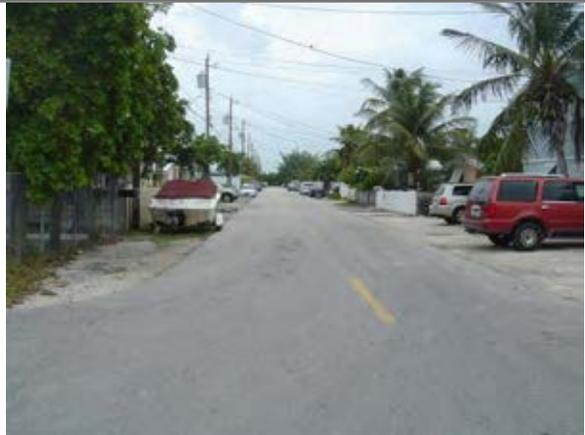
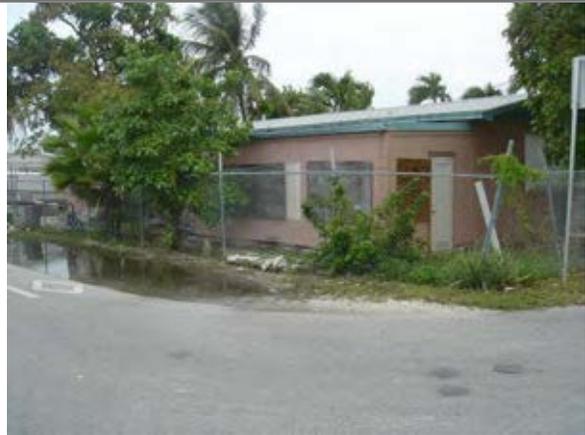
3.8 CROSS STREET AND 12 TH AVENUE	
Road Atlas Identification:	S 21.1
S 3.1

Observation	Recommendations
<p>SOUTH SIDEWALK WEST ON 12th AVENUE</p> <ul style="list-style-type: none"> • Survey Points 0'-100' ⊗ Sidewalks do not exist in this area. <p>SOUTH SIDEWALK EAST ON 12th AVENUE</p> <ul style="list-style-type: none"> • Survey Points 0'-500' ⊗ Sidewalks do not exist in this area. <p>NORTHEAST CORNER</p> <ul style="list-style-type: none"> ⊗ Sidewalks do not exist in this area. <p>NORTHEAST SIDEWALK EAST ON 12th AVENUE</p> <ul style="list-style-type: none"> • Survey Points 0'-500' ⊗ Sidewalks do not exist in this area. <p>NORTHEAST SIDEWALK NORTH ON CROSS STREET</p> <ul style="list-style-type: none"> • Survey Points 0'-100' ⊗ Sidewalks do not exist in this area. <p>NORTHWEST CORNER</p> <ul style="list-style-type: none"> ⊗ Sidewalks do not exist in this area. <p>NORTHWEST SIDEWALK NORTH ON CROSS STREET</p> <ul style="list-style-type: none"> • Survey Points 0'-100' ⊗ Sidewalks do not exist in this area. <p>NORTHWEST SIDEWALK WEST ON 12th AVENUE</p> <ul style="list-style-type: none"> • Survey Points 0'-100' ⊗ Sidewalks do not exist in this area. 	<p>A\$ - F\$\$ - Depending on the specific situation at each location, install accessible sidewalks and intersections in compliance with ADAAG and PROWAAC guidance and FDOT Design Standards. This should include, but not be limited to, detectable warnings, driveway crossings, street crossing markings, signs, and pedestrian crossing signals as required.</p>

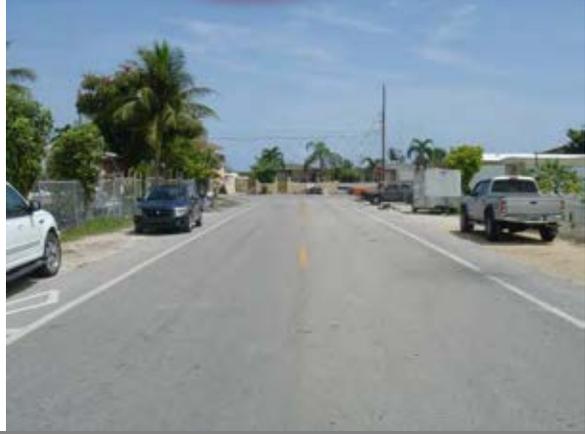
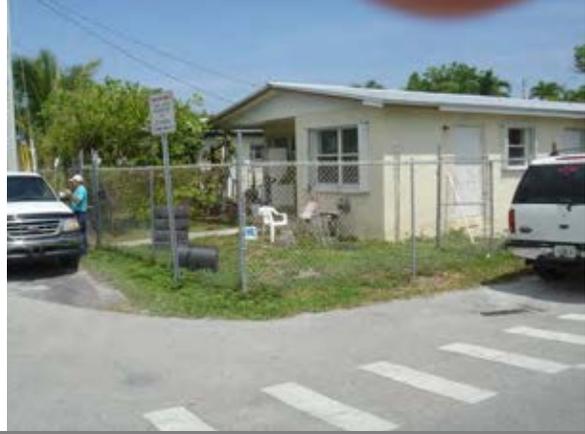
South on Cross Street	Southeast Corner

Observation	Recommendations
<p>SOUTHEAST CORNER</p> <ul style="list-style-type: none"> ⊗ Sidewalks do not exist in this area. <p>SOUTHEAST SIDEWALK SOUTH ON CROSS STREET</p> <ul style="list-style-type: none"> • Survey Points 0'-100' ⊗ Sidewalks do not exist in this area. <p>SOUTHEAST SIDEWALK EAST ON 11th Avenue</p> <ul style="list-style-type: none"> • Survey Points 0'-500' ⊗ Sidewalks do not exist in this area. <p>NORTHEAST CORNER</p> <ul style="list-style-type: none"> ⊗ Sidewalks do not exist in this area. <p>NORTHEAST SIDEWALK EAST ON 11th AVENUE</p> <ul style="list-style-type: none"> • Survey Points 0'-500' ⊗ Sidewalks do not exist in this area. <p>NORTHEAST SIDEWALK NORTH ON CROSS STREET</p> <ul style="list-style-type: none"> • Survey Points 0'-100' ⊗ Sidewalks do not exist in this area. <p>WEST SIDEWALK NORTH ON CROSS STREET</p> <ul style="list-style-type: none"> • Survey Points 0'-100' ⊗ Sidewalks do not exist in this area. <p>WEST SIDEWALK SOUTH ON CROSS STREET</p> <ul style="list-style-type: none"> • Survey Points 0'-100' ⊗ Sidewalks do not exist in this area. 	<p>A\$ - F\$\$ - Depending on the specific situation at each location, install accessible sidewalks and intersections in compliance with ADAAG and PROWAAC guidance and FDOT Design Standards. This should include, but not be limited to, detectable warnings, driveway crossings, street crossing markings, signs, and pedestrian crossing signals as required.</p>

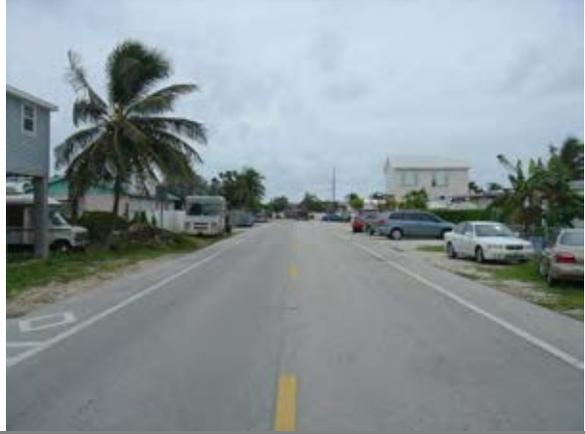
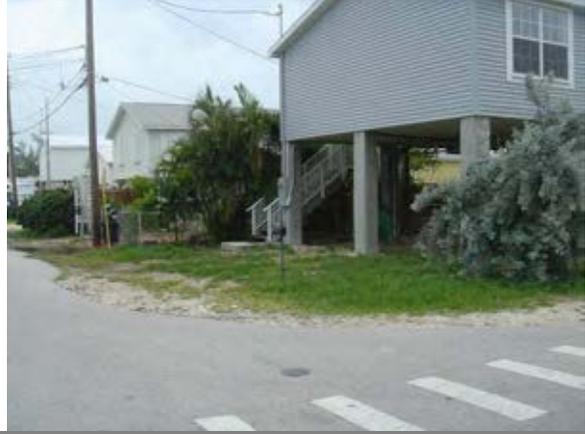
South on Cross Street	Southeast Corner

Observation	Recommendations
<p>SOUTHEAST CORNER</p> <ul style="list-style-type: none"> ⊗ Sidewalks do not exist in this area. <p>SOUTHEAST SIDEWALK SOUTH ON CROSS STREET</p> <ul style="list-style-type: none"> • Survey Points 0'-100' ⊗ Sidewalks do not exist in this area. <p>SOUTHEAST SIDEWALK EAST ON 10th Avenue</p> <ul style="list-style-type: none"> • Survey Points 0'-500' ⊗ Sidewalks do not exist in this area. <p>NORTHEAST CORNER</p> <ul style="list-style-type: none"> ⊗ Sidewalks do not exist in this area. <p>NORTHEAST SIDEWALK EAST ON 10th AVENUE</p> <ul style="list-style-type: none"> • Survey Points 0'-500' ⊗ Sidewalks do not exist in this area. <p>NORTHEAST SIDEWALK NORTH ON CROSS STREET</p> <ul style="list-style-type: none"> • Survey Points 0'-100' ⊗ Sidewalks do not exist in this area. <p>WEST SIDEWALK NORTH ON CROSS STREET</p> <ul style="list-style-type: none"> • Survey Points 0'-100' ⊗ Sidewalks do not exist in this area. <p>WEST SIDEWALK SOUTH ON CROSS STREET</p> <ul style="list-style-type: none"> • Survey Points 0'-100' ⊗ Sidewalks do not exist in this area. 	<p>A\$ - F\$\$ - Depending on the specific situation at each location, install accessible sidewalks and intersections in compliance with ADAAG and PROWAC guidance and FDOT Design Standards. This should include, but not be limited to, detectable warnings, driveway crossings, street crossing markings, signs, and pedestrian crossing signals as required.</p>

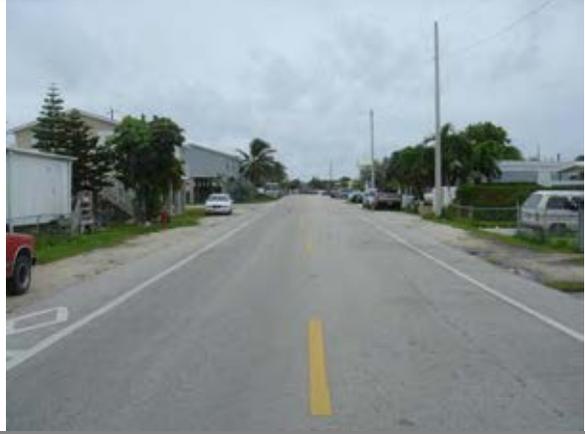
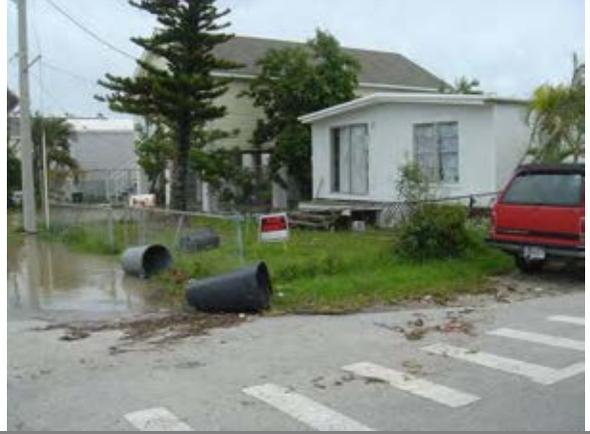
South on Cross Street	Southeast Corner

Observation	Recommendations
<p>SOUTHEAST CORNER</p> <ul style="list-style-type: none"> ⊗ Sidewalks do not exist in this area. <p>SOUTHEAST SIDEWALK SOUTH ON CROSS STREET</p> <ul style="list-style-type: none"> • Survey Points 0'-100' ⊗ Sidewalks do not exist in this area. <p>SOUTHEAST SIDEWALK EAST ON 9th Avenue</p> <ul style="list-style-type: none"> • Survey Points 0'-500' ⊗ Sidewalks do not exist in this area. <p>NORTHEAST CORNER</p> <ul style="list-style-type: none"> ⊗ Sidewalks do not exist in this area. <p>NORTHEAST SIDEWALK EAST ON 9th AVENUE</p> <ul style="list-style-type: none"> • Survey Points 0'-500' ⊗ Sidewalks do not exist in this area. <p>NORTHEAST SIDEWALK NORTH ON CROSS STREET</p> <ul style="list-style-type: none"> • Survey Points 0'-100' ⊗ Sidewalks do not exist in this area. <p>WEST SIDEWALK NORTH ON CROSS STREET</p> <ul style="list-style-type: none"> • Survey Points 0'-100' ⊗ Sidewalks do not exist in this area. <p>WEST SIDEWALK SOUTH ON CROSS STREET</p> <ul style="list-style-type: none"> • Survey Points 0'-100' ⊗ Sidewalks do not exist in this area. 	<p>A\$ - F\$\$ - Depending on the specific situation at each location, install accessible sidewalks and intersections in compliance with ADAAG and PROWAAC guidance and FDOT Design Standards. This should include, but not be limited to, detectable warnings, driveway crossings, street crossing markings, signs, and pedestrian crossing signals as required.</p>

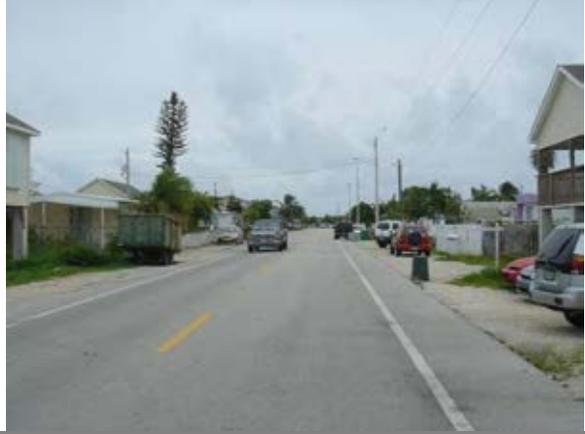
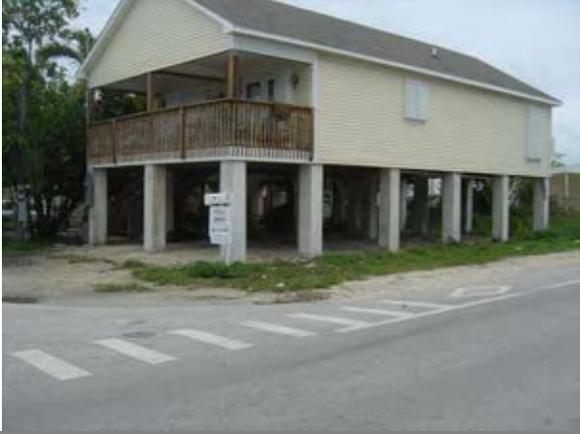
South on Cross Street	Southeast Corner

Observation	Recommendations
<p>SOUTHEAST CORNER</p> <ul style="list-style-type: none"> ⊗ Sidewalks do not exist in this area. <p>SOUTHEAST SIDEWALK SOUTH ON CROSS STREET</p> <ul style="list-style-type: none"> • Survey Points 0'-100' ⊗ Sidewalks do not exist in this area. <p>SOUTHEAST SIDEWALK EAST ON 8th Avenue</p> <ul style="list-style-type: none"> • Survey Points 0'-500' ⊗ Sidewalks do not exist in this area. <p>NORTHEAST CORNER</p> <ul style="list-style-type: none"> ⊗ Sidewalks do not exist in this area. <p>NORTHEAST SIDEWALK EAST ON 8th AVENUE</p> <ul style="list-style-type: none"> • Survey Points 0'-500' ⊗ Sidewalks do not exist in this area. <p>NORTHEAST SIDEWALK NORTH ON CROSS STREET</p> <ul style="list-style-type: none"> • Survey Points 0'-100' ⊗ Sidewalks do not exist in this area. <p>WEST SIDEWALK NORTH ON CROSS STREET</p> <ul style="list-style-type: none"> • Survey Points 0'-100' ⊗ Sidewalks do not exist in this area. <p>WEST SIDEWALK SOUTH ON CROSS STREET</p> <ul style="list-style-type: none"> • Survey Points 0'-100' ⊗ Sidewalks do not exist in this area. 	<p>A\$ - F\$\$ - Depending on the specific situation at each location, install accessible sidewalks and intersections in compliance with ADAAG and PROWAAC guidance and FDOT Design Standards. This should include, but not be limited to, detectable warnings, driveway crossings, street crossing markings, signs, and pedestrian crossing signals as required.</p>

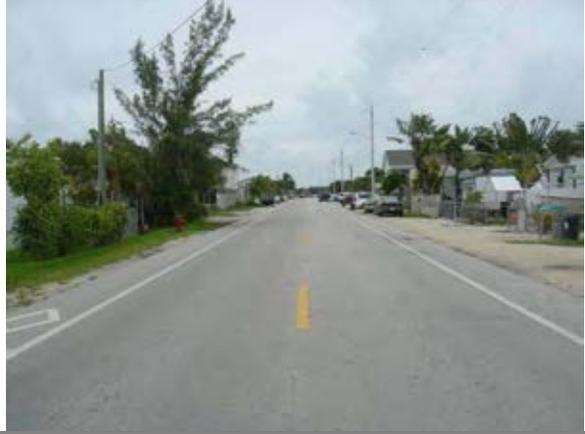
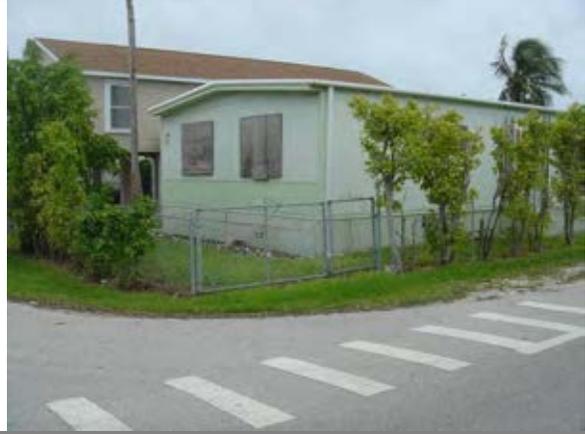
South on Cross Street	Southeast Corner

Observation	Recommendations
<p>SOUTHEAST CORNER</p> <ul style="list-style-type: none"> ⊗ Sidewalks do not exist in this area. <p>SOUTHEAST SIDEWALK SOUTH ON CROSS STREET</p> <ul style="list-style-type: none"> • Survey Points 0'-100' ⊗ Sidewalks do not exist in this area. <p>SOUTHEAST SIDEWALK EAST ON 7th Avenue</p> <ul style="list-style-type: none"> • Survey Points 0'-500' ⊗ Sidewalks do not exist in this area. <p>NORTHEAST CORNER</p> <ul style="list-style-type: none"> ⊗ Sidewalks do not exist in this area. <p>NORTHEAST SIDEWALK EAST ON 7th AVENUE</p> <ul style="list-style-type: none"> • Survey Points 0'-500' ⊗ Sidewalks do not exist in this area. <p>NORTHEAST SIDEWALK NORTH ON CROSS STREET</p> <ul style="list-style-type: none"> • Survey Points 0'-100' ⊗ Sidewalks do not exist in this area. <p>WEST SIDEWALK NORTH ON CROSS STREET</p> <ul style="list-style-type: none"> • Survey Points 0'-100' ⊗ Sidewalks do not exist in this area. <p>WEST SIDEWALK SOUTH ON CROSS STREET</p> <ul style="list-style-type: none"> • Survey Points 0'-100' ⊗ Sidewalks do not exist in this area. 	<p>A\$ - F\$\$ - Depending on the specific situation at each location, install accessible sidewalks and intersections in compliance with ADAAG and PROWAAC guidance and FDOT Design Standards. This should include, but not be limited to, detectable warnings, driveway crossings, street crossing markings, signs, and pedestrian crossing signals as required.</p>

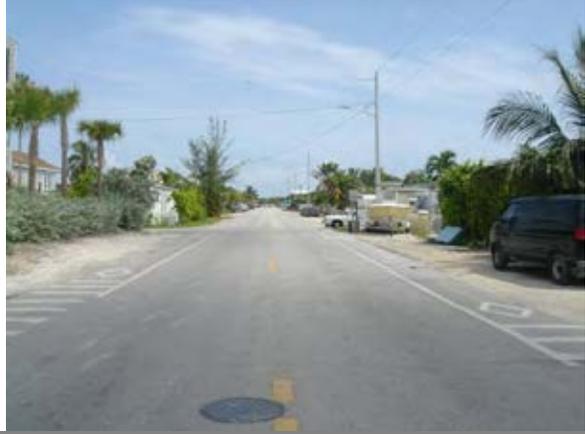
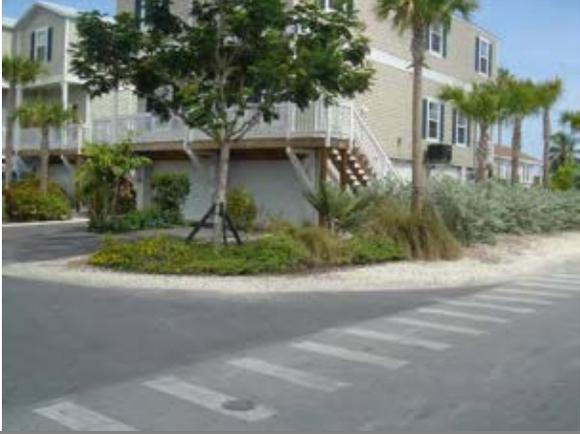
South on Cross Street	Southeast Corner

Observation	Recommendations
<p>SOUTHEAST CORNER</p> <ul style="list-style-type: none"> ⊗ Sidewalks do not exist in this area. <p>SOUTHEAST SIDEWALK SOUTH ON CROSS STREET</p> <ul style="list-style-type: none"> • Survey Points 0'-100' ⊗ Sidewalks do not exist in this area. <p>SOUTHEAST SIDEWALK EAST ON 6th Avenue</p> <ul style="list-style-type: none"> • Survey Points 0'-500' ⊗ Sidewalks do not exist in this area. <p>NORTHEAST CORNER</p> <ul style="list-style-type: none"> ⊗ Existing Sidewalks do not provide accessible connection to street. (Typical Photo 10) ⊗ Detectable warnings are not provided. ⊗ Utility pole reduces required clear width. (Typical Photo 01) <p>NORTHEAST SIDEWALK EAST ON 6th AVENUE</p> <ul style="list-style-type: none"> • Survey Points 0'-100' ⊗ Cross slope exceeds 2%. ⊗ Non-compliant driveway approach. (Typical Photo 04) ⊗ Intermittent breaks / cracks in surface. • Survey Points 100'-200' ⊗ Cross slope exceeds 2%. ⊗ Non-compliant driveway approach. (Typical Photo 04) ⊗ Intermittent breaks / cracks in surface. ⊗ Water meter recessed below surface. (Typical Photo 03) • Survey Points 200'-500' ⊗ Cross slope exceeds 2%. ⊗ Non-compliant driveway approach. (Typical Photo 04) ⊗ Intermittent breaks / cracks in surface. • Survey Points 500'-600' ⊗ Cross slope exceeds 2%. ⊗ Non-compliant driveway approach. (Typical Photo 04) 	<p>A\$ - F\$\$ - Depending on the specific situation at each location, install accessible sidewalks and intersections in compliance with ADAAG and PROWAAC guidance and FDOT Design Standards. This should include, but not be limited to, detectable warnings, driveway crossings, street crossing markings, signs, and pedestrian crossing signals as required.</p>

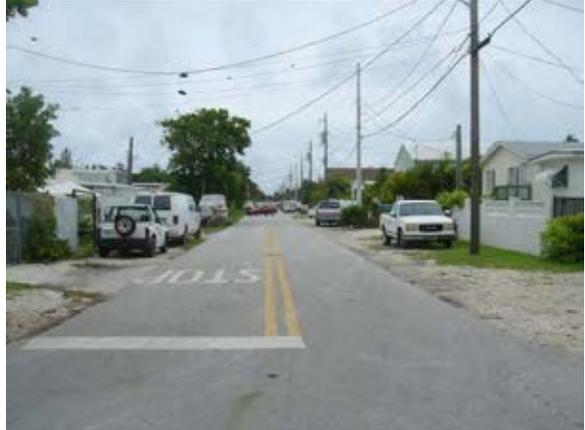
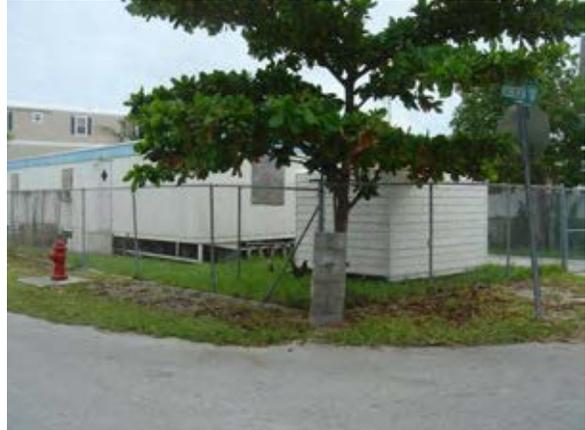
South on Roberta Street	Southeast Corner

Observation	Recommendations
<p>SOUTHEAST CORNER</p> <ul style="list-style-type: none"> ⊗ Sidewalks do not exist in this area. <p>SOUTHEAST SIDEWALK SOUTH ON ROBERTA STREET</p> <ul style="list-style-type: none"> • Survey Points 0'-600' ⊗ Sidewalks do not exist in this area. <p>SOUTHEAST SIDEWALK EAST ON ROBERTA STREET</p> <ul style="list-style-type: none"> • Survey Points 0'-100' ⊗ Sidewalks do not exist in this area. <p>NORTH SIDEWALK EAST ON ROBERTA STREET</p> <ul style="list-style-type: none"> • Survey Points 0'-100' ⊗ Sidewalks do not exist in this area. <p>NORTH SIDEWALK WEST ON MIRIAM STREET</p> <ul style="list-style-type: none"> • Survey Points 0'-700' ⊗ Sidewalks do not exist in this area. <p>SOUTHWEST CORNER</p> <ul style="list-style-type: none"> ⊗ Sidewalks do not exist in this area. <p>SOUTHWEST SIDEWALK WEST ON MIRIAM STREET</p> <ul style="list-style-type: none"> • Survey Points 0'-700' ⊗ Sidewalks do not exist in this area. <p>SOUTHWEST SIDEWALK SOUTH ON ROBERTA STREET</p> <ul style="list-style-type: none"> • Survey Points 0'-600' ⊗ Sidewalks do not exist in this area. 	<p>A\$ - F\$\$ - Depending on the specific situation at each location, install accessible sidewalks and intersections in compliance with ADAAG and PROWAAC guidance and FDOT Design Standards. This should include, but not be limited to, detectable warnings, driveway crossings, street crossing markings, signs, and pedestrian crossing signals as required.</p>

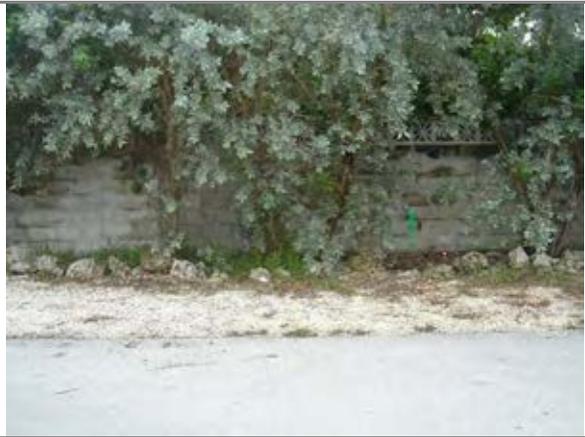
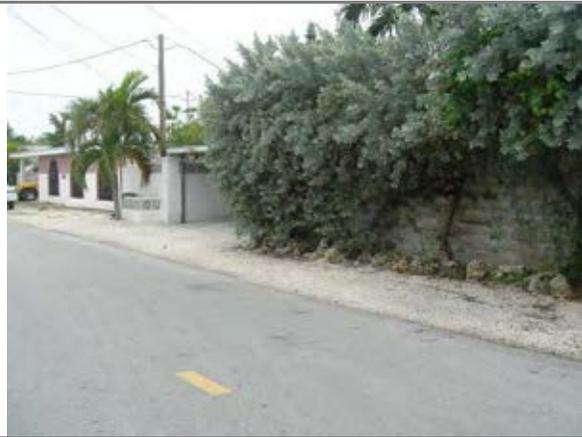
South across from Miriam Street	Southeast Corner

Observation	Recommendations
<p>SOUTHWEST CORNER ☒ Sidewalks do not exist in this area.</p> <p>SOUTHWEST SIDEWALK NORTH ON MIRIAM STREET • Survey Points 0'-600' ☒ Sidewalks do not exist in this area.</p> <p>SOUTHWEST SIDEWALK EAST ON 12th AVENUE • Survey Points 0'-100' ☒ Sidewalks do not exist in this area.</p> <p>NORTHEAST CORNER ☒ Sidewalks do not exist in this area.</p> <p>NORTHEAST SIDEWALK EAST ON 12th AVENUE • Survey Points 0'-100' ☒ Sidewalks do not exist in this area.</p> <p>NORTHEAST SIDEWALK NORTH ON MIRIAM STREET • Survey Points 0'-600' ☒ Sidewalks do not exist in this area.</p>	<p>A\$ - F\$\$ - Depending on the specific situation at each location, install accessible sidewalks and intersections in compliance with ADAAG and PROWAAC guidance and FDOT Design Standards. This should include, but not be limited to, detectable warnings, driveway crossings, street crossing markings, signs, and pedestrian crossing signals as required.</p>

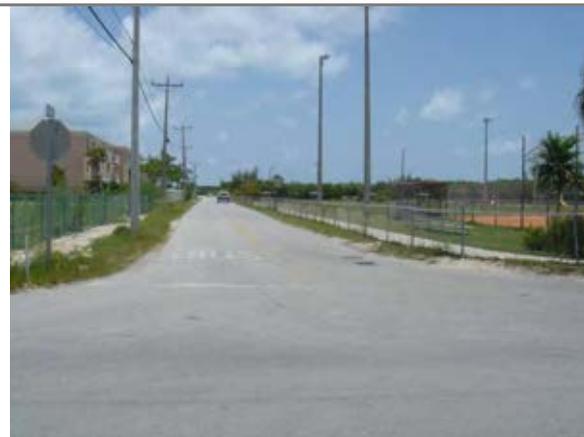
South on Shrimp Road

Observation	Recommendations
<p>SOUTHEAST CORNER</p> <ul style="list-style-type: none"> ⊗ Sidewalks do not exist in this area. <p>SOUTHEAST SIDEWALK SOUTH ON SHRIMP ROAD</p> <ul style="list-style-type: none"> • Survey Points 0'-3500' ⊗ Sidewalks do not exist in this area. <p>SOUTHEAST SIDEWALK EAST ON 5th AVENUE</p> <ul style="list-style-type: none"> • Survey Points 0'-100' ⊗ Sidewalks do not exist in this area. <p>NORTH SIDEWALK EAST ON 5th AVENUE</p> <ul style="list-style-type: none"> • Survey Points 0'-100' ⊗ Sidewalks do not exist in this area. <p>NORTH SIDEWALK WEST ON 5th AVENUE</p> <ul style="list-style-type: none"> • Survey Points 0'-300' ⊗ Sidewalks do not exist in this area. <p>SOUTHWEST CORNER</p> <ul style="list-style-type: none"> ⊗ Sidewalks do not exist in this area. <p>SOUTHWEST SIDEWALK WEST ON 5th AVENUE</p> <ul style="list-style-type: none"> • Survey Points 0'-300' ⊗ Sidewalks do not exist in this area. <p>SOUTHWEST SIDEWALK SOUTH ON SHRIMP ROAD</p> <ul style="list-style-type: none"> • Survey Points 0'-3500' ⊗ Sidewalks do not exist in this area. 	<p>A\$ - F\$\$ - Depending on the specific situation at each location, install accessible sidewalks and intersections in compliance with ADAAG and PROWAAC guidance and FDOT Design Standards. This should include, but not be limited to, detectable warnings, driveway crossings, street crossing markings, signs, and pedestrian crossing signals as required.</p>
