Americans with Disabilities Act Transition Plan Lower Keys - Part 2

Volume 4 of 4

Monroe County

October 29, 2010

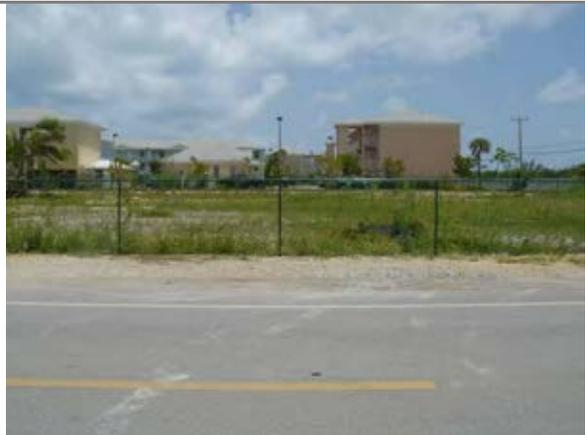
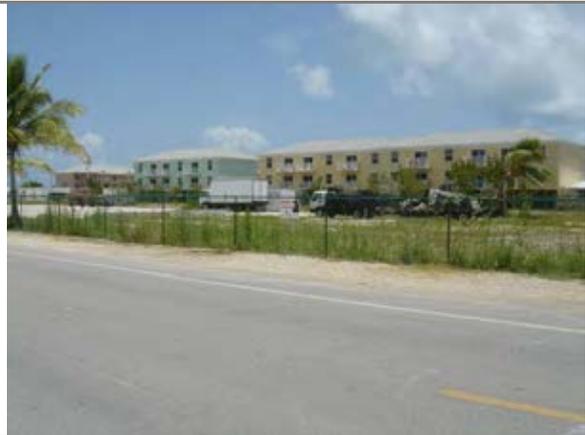
South across from 4 th Street	Southeast Corner

Observation	Recommendations
<p>SOUTH SIDEWALK WEST ON 5th AVENUE</p> <ul style="list-style-type: none"> Survey Points 0'-100' ⊗ Sidewalks do not exist in this area. <p>SOUTH SIDEWALK EAST ON 5th AVENUE</p> <ul style="list-style-type: none"> Survey Points 0'-300' ⊗ Sidewalks do not exist in this area. <p>NORTHEAST CORNER</p> <ul style="list-style-type: none"> ⊗ Sidewalks do not exist in this area. <p>NORTHEAST SIDEWALK EAST ON 5th AVENUE</p> <ul style="list-style-type: none"> Survey Points 0'-300' ⊗ Sidewalks do not exist in this area. <p>NORTHEAST SIDEWALK NORTH ON 4th STREET</p> <ul style="list-style-type: none"> Survey Points 0'-100' ⊗ Sidewalks do not exist in this area. <p>NORTHWEST CORNER</p> <ul style="list-style-type: none"> ⊗ Sidewalks do not exist in this area. <p>NORTHWEST SIDEWALK NORTH ON 4th STREET</p> <ul style="list-style-type: none"> Survey Points 0'-100' ⊗ Sidewalks do not exist in this area. <p>NORTHWEST SIDEWALK WEST ON 5th AVENUE</p> <ul style="list-style-type: none"> Survey Points 0'-100' ⊗ Sidewalks do not exist in this area. 	<p>A\$ - F\$\$ - Depending on the specific situation at each location, install accessible sidewalks and intersections in compliance with ADAAG and PROWAAC guidance and FDOT Design Standards. This should include, but not be limited to, detectable warnings, driveway crossings, street crossing markings, signs, and pedestrian crossing signals as required.</p>

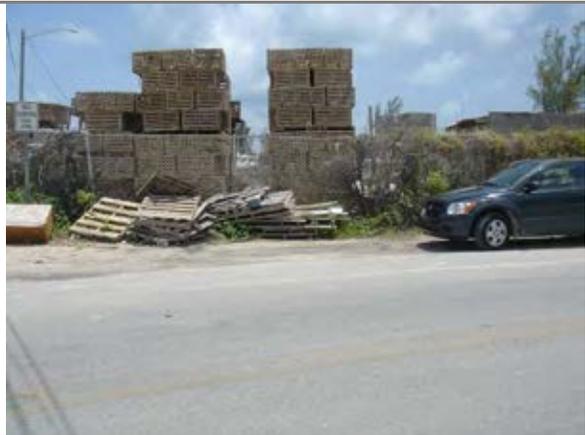
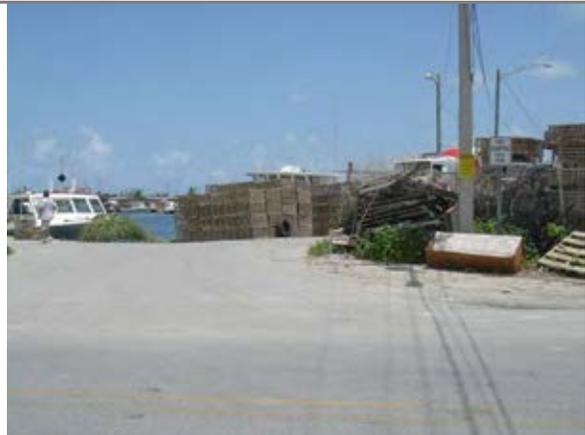
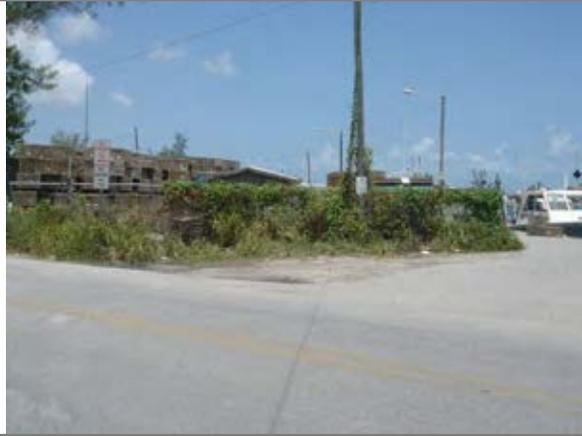
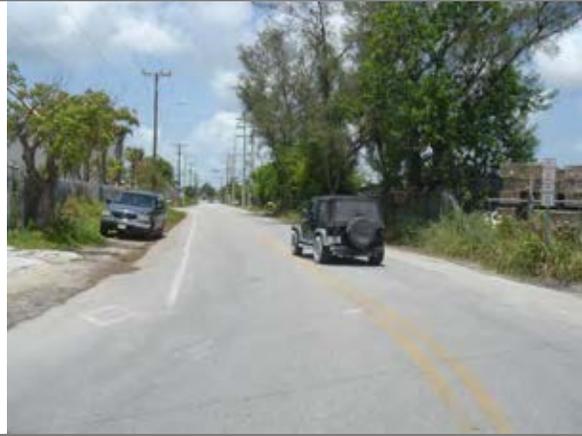
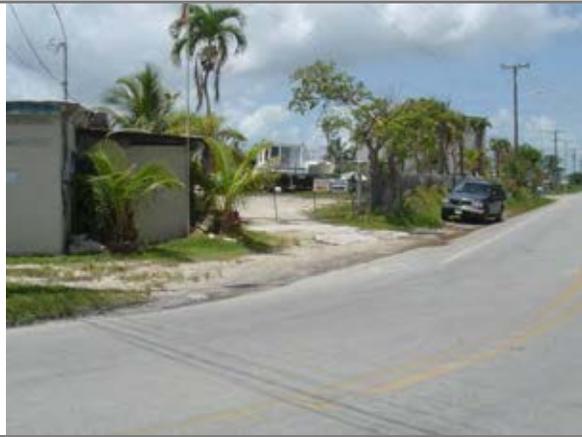
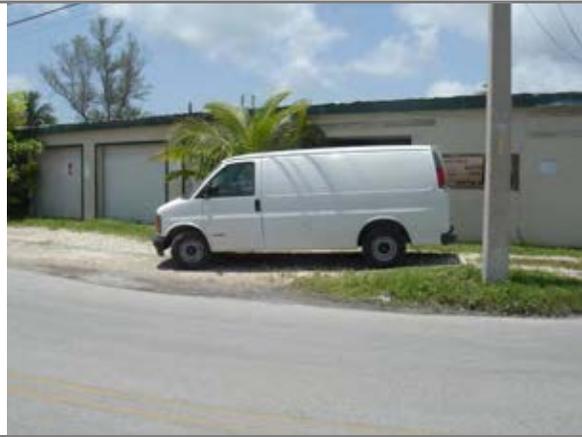
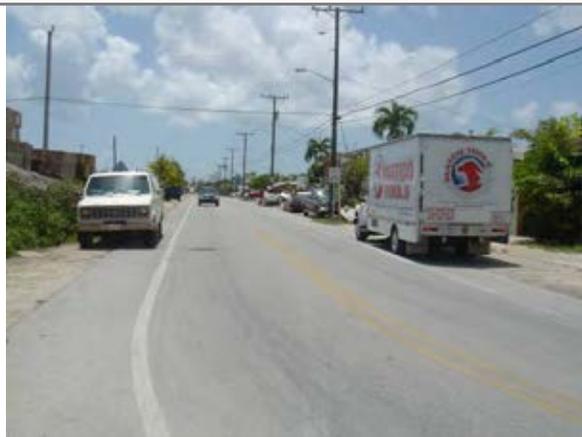
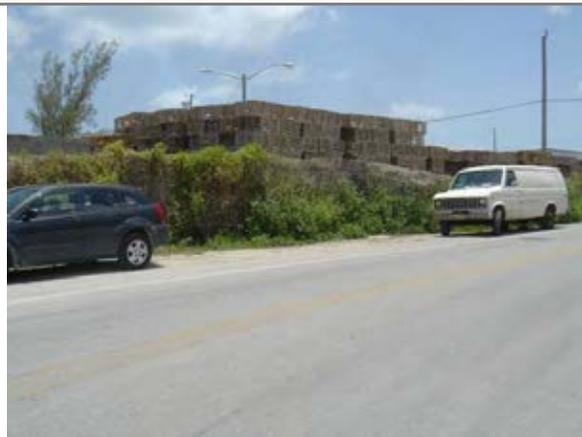
4.3 5 TH AVENUE AND 4 TH AVENUE		
Road Atlas Identification:	S 12.1	S 11.1

Observation	Recommendations
<p>SOUTHEAST SIDEWALK WEST ON 5th AVENUE</p> <ul style="list-style-type: none"> • Survey Points 0'-400' ⊗ Sidewalks do not exist in this area. <p>SOUTHEAST SIDEWALK NORTHEAST ON 4th STREET</p> <ul style="list-style-type: none"> • Survey Points 0'-200' ⊗ Sidewalks do not exist in this area. <p>NORTHWEST SIDEWALK NORTHEAST ON 4th STREET</p> <ul style="list-style-type: none"> • Survey Points 0'-200' ⊗ Sidewalks do not exist in this area. <p>NORTHWEST SIDEWALK WEST ON 5th AVENUE</p> <ul style="list-style-type: none"> • Survey Points 0'-400' ⊗ Sidewalks do not exist in this area. 	<p>A\$ - F\$\$ - Depending on the specific situation at each location, install accessible sidewalks and intersections in compliance with ADAAG and PROWAAC guidance and FDOT Design Standards. This should include, but not be limited to, detectable warnings, driveway crossings, street crossing markings, signs, and pedestrian crossing signals as required.</p>

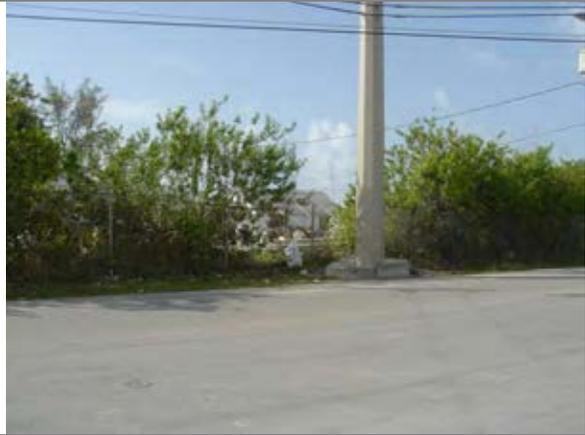
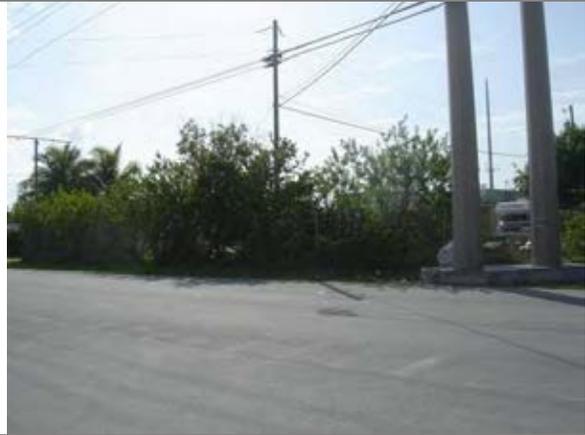
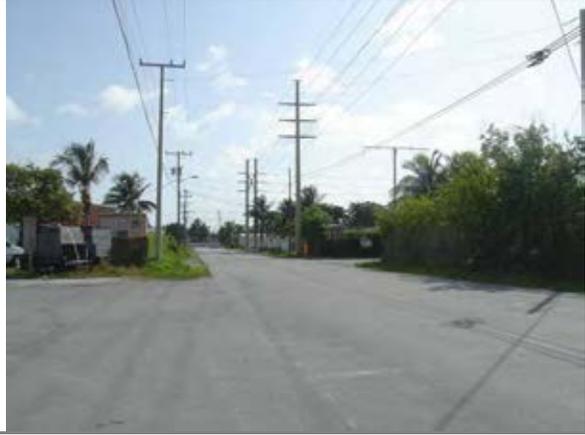
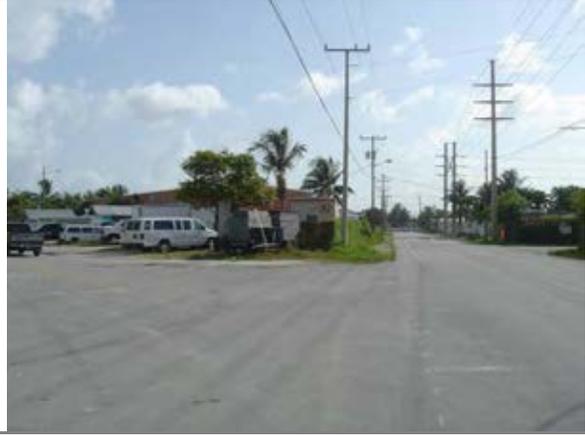
4.4 3 rd AVENUE AND 2 nd STREET AT 4 th AVENUE			
Road Atlas Identification:	S 9.1	S 7.1	S 11.1

Observation	Recommendations
<p>SOUTHEAST SIDEWALK SOUTHWEST ON 4th AVENUE</p> <ul style="list-style-type: none"> • Survey Points 0'-200' ⊗ Sidewalks do not exist in this area. <p>SOUTHEAST SIDEWALK NORTHEAST ON 4th AVENUE</p> <ul style="list-style-type: none"> • Survey Points 0'-200' ⊗ Sidewalks do not exist in this area. <p>NORTHEAST CORNER</p> <ul style="list-style-type: none"> ⊗ Sidewalks do not exist in this area. <p>NORTHEAST SIDEWALK NORTHEAST ON 4th AVENUE</p> <ul style="list-style-type: none"> • Survey Points 0'-200' ⊗ Sidewalks do not exist in this area. <p>NORTHEAST SIDEWALK NORTH ON 2nd STREET</p> <ul style="list-style-type: none"> • Survey Points 0'-400' ⊗ Sidewalks do not exist in this area. <p>NORTHWEST CORNER</p> <ul style="list-style-type: none"> ⊗ Sidewalks do not exist in this area. 	<p>AS - F\$\$ - Depending on the specific situation at each location, install accessible sidewalks and intersections in compliance with ADAAG and PROWAAC guidance and FDOT Design Standards. This should include, but not be limited to, detectable warnings, driveway crossings, street crossing markings, signs, and pedestrian crossing signals as required.</p>

Observation	Recommendations
NORTHWEST SIDEWALK NORTH ON 2 nd STREET <ul style="list-style-type: none"> • Survey Points 0'-400' ⊗ Sidewalks do not exist in this area. NORTHWEST SIDEWALK WEST ON 3 rd AVENUE <ul style="list-style-type: none"> • Survey Points 0'-200' ⊗ Sidewalks do not exist in this area. SOUTHWEST CORNER <ul style="list-style-type: none"> ⊗ Sidewalks do not exist in this area. SOUTHWEST SIDEWALK WEST ON 3 rd AVENUE <ul style="list-style-type: none"> • Survey Points 0'-200' ⊗ Sidewalks do not exist in this area. SOUTHWEST SIDEWALK SOUTHWEST ON 4 th AVENUE <ul style="list-style-type: none"> • Survey Points 0'-200' ⊗ Sidewalks do not exist in this area.

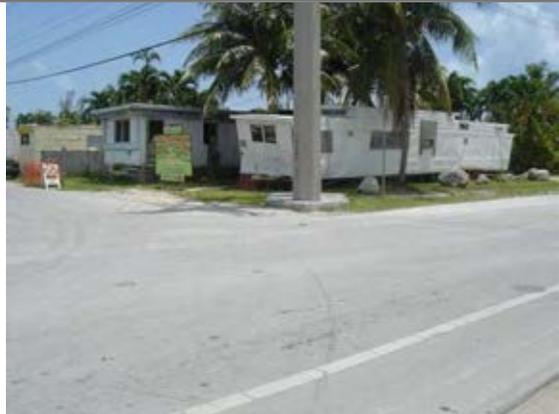
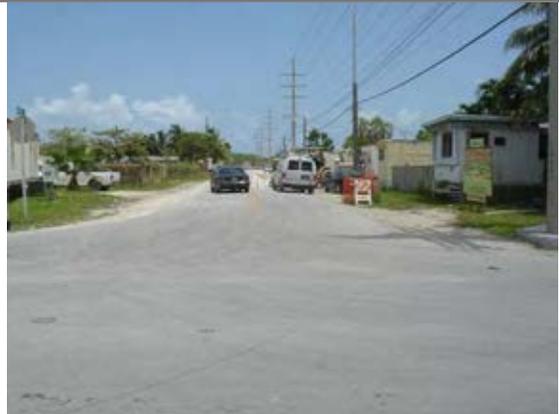
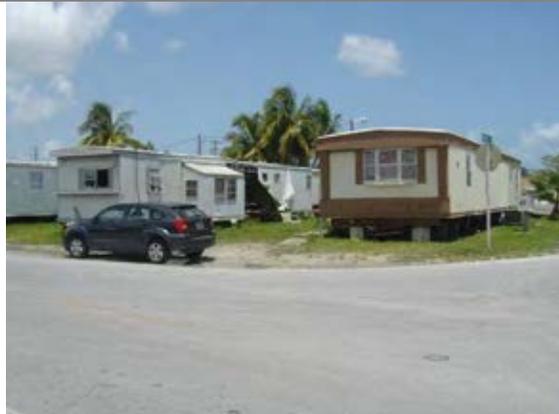
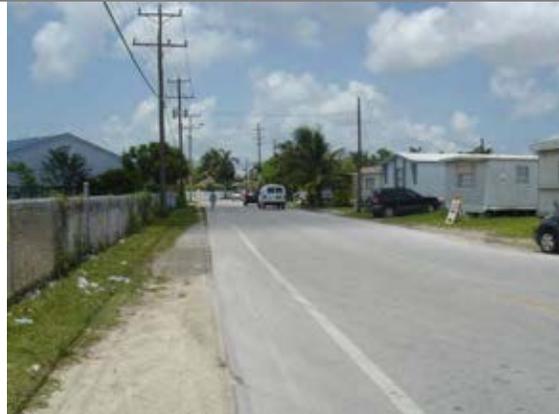
4.5 4 th AVENUE AND FRONT STREET			
Road Atlas Identification:		S 11.1	S 22.1

Observation	Recommendations
<p>SOUTH CORNER</p> <ul style="list-style-type: none"> ⊗ Sidewalks do not exist in this area. <p>SOUTH SIDEWALK SOUTHWEST ON 4th AVENUE</p> <ul style="list-style-type: none"> • Survey Points 0'-200' ⊗ Sidewalks do not exist in this area. <p>SOUTH SIDEWALK SOUTHEAST ON FRONT STREET</p> <ul style="list-style-type: none"> • Survey Points 0'-2300' ⊗ Sidewalks do not exist in this area. <p>EAST CORNER</p> <ul style="list-style-type: none"> ⊗ Sidewalk does not exist in this area. <p>EAST SIDEWALK SOUTHEAST ON FRONT STREET</p> <ul style="list-style-type: none"> • Survey Points 0'-2300' ⊗ Sidewalk does not exist in this area. <p>EAST SIDEWALK NORTHEAST ON 4th AVENUE</p> <ul style="list-style-type: none"> • Survey Points 0'-200' ⊗ Sidewalk does not exist in this area. 	<p>AS - FSS - Depending on the specific situation at each location, install accessible sidewalks and intersections in compliance with ADAAG and PROWAAC guidance and FDOT Design Standards. This should include, but not be limited to, detectable warnings, driveway crossings, street crossing markings, signs, and pedestrian crossing signals as required.</p>

Observation	Recommendations
WEST SIDEWALK NORTHEAST ON 4 th AVENUE <ul style="list-style-type: none"> • Survey Points 0'-200' ⊗ Sidewalk does not exist in this area. WEST SIDEWALK SOUTHWEST ON 4 th AVENUE <ul style="list-style-type: none"> • Survey Points 0'-200' ⊗ Sidewalk does not exist in this area.

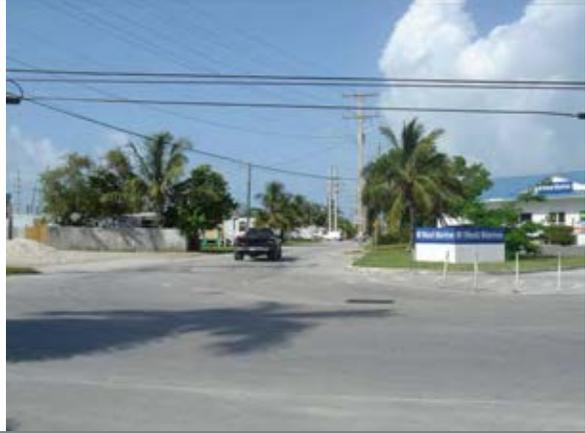
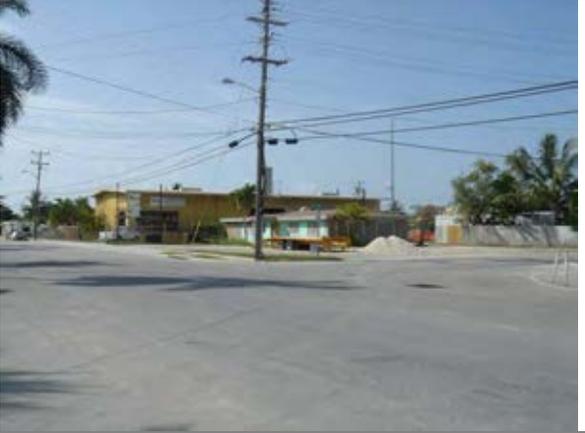
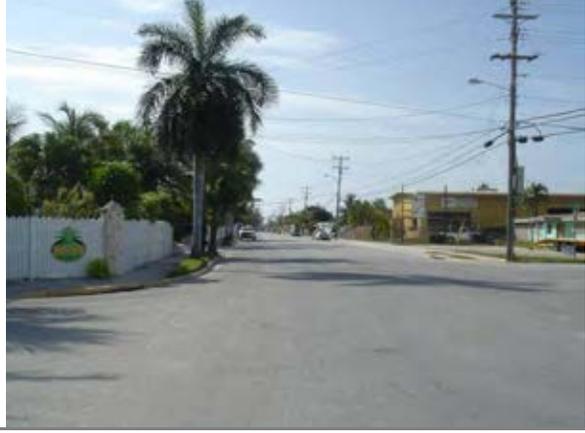
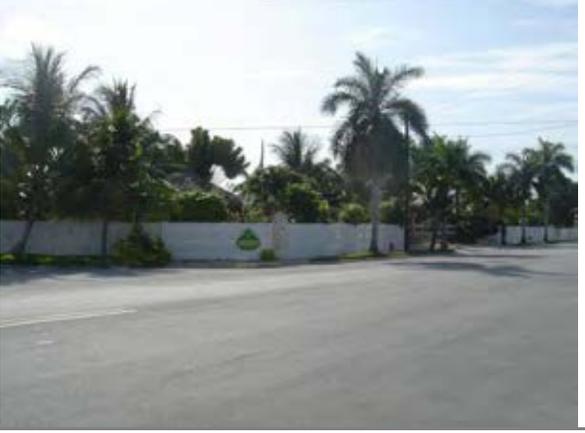
4.6 4 th AVE AND MALONEY AVE AT 2 nd AVE AND 1 st STREET				
Road Atlas Identification:	S 11.1	S 26.1	S 6.1	S 5.1

Observation	Recommendations
<p>SOUTH CORNER</p> <ul style="list-style-type: none"> ⊗ Existing sidewalk does not provide accessible connection to street. (Typical Photo 10) <p>SOUTH SIDEWALK SOUTHWEST ON 4th AVENUE</p> <ul style="list-style-type: none"> • Survey Points 0'-200' ⊗ Sidewalks do not exist in this area. <p>SOUTH SIDEWALK SOUTHEAST ON MALONEY AVENUE</p> <ul style="list-style-type: none"> • Survey Points 0'-300' ⊗ Non-compliant driveway approach. (Typical Photo 04) ⊗ Cracks / gaps greater than ½" in surface. (Typical Photo 07) • Survey Points 300'-400' ⊗ Non-compliant driveway approach. (Typical Photo 04) • Survey Points 400'-600' ✓ ADA Compliant • Survey Points 600'-700' 	<p>A\$ - F\$\$ - Depending on the specific situation at each location, install accessible sidewalks and intersections in compliance with ADAAG and PROWAAC guidance and FDOT Design Standards. This should include, but not be limited to, detectable warnings, driveway crossings, street crossing markings, signs, and pedestrian crossing signals as required.</p>

Observation	Recommendations
SOUTHWEST SIDEWALK SOUTHWEST ON 4 th AVENUE <ul style="list-style-type: none"> • Survey Points 0'-200' ⊗ Sidewalks do not exist in this area.

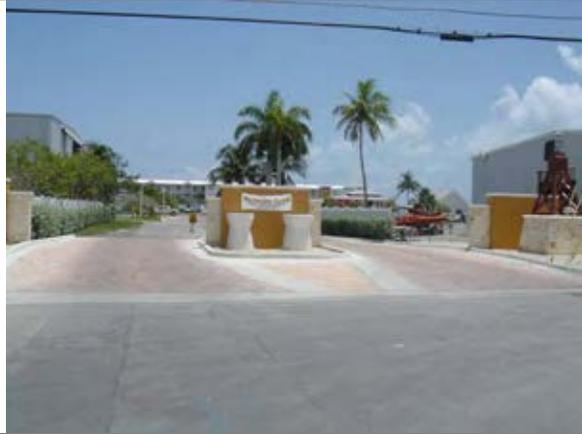
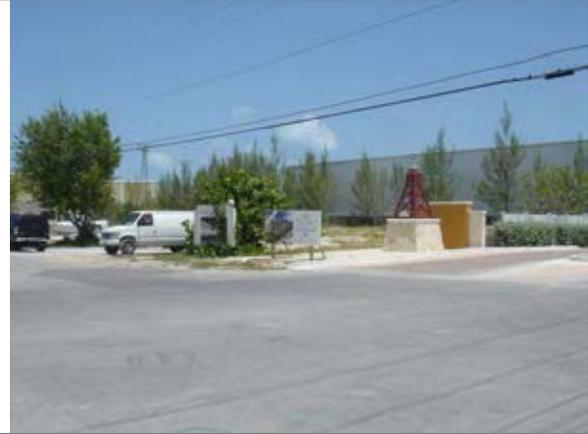
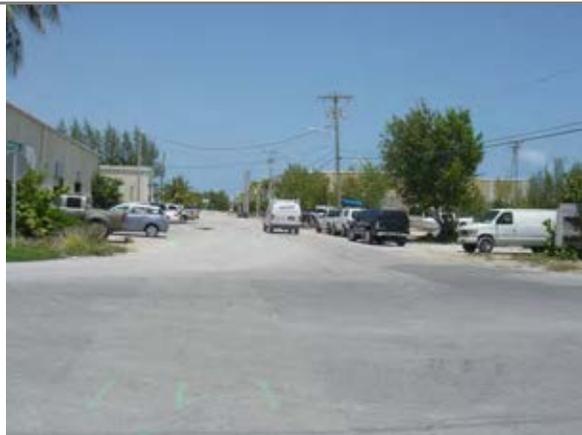
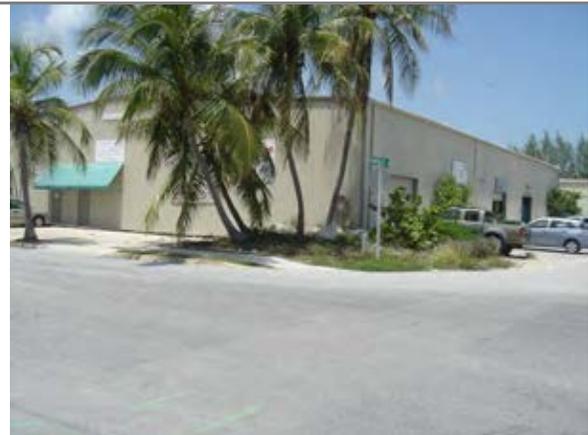
4.7 MALONEY AVENUE AND PENINSULAR AVENUE

Observation	Recommendations
<p>SOUTH SIDEWALK WEST ON PENINSULAR AVENUE</p> <ul style="list-style-type: none"> Survey Points 0'-200' ⊗ Sidewalks do not exist in this area. <p>SOUTH SIDEWALK EAST ON PENINSULAR AVENUE</p> <ul style="list-style-type: none"> Survey Points 0'-800' ⊗ Sidewalks do not exist in this area. <p>NORTHEAST CORNER</p> <ul style="list-style-type: none"> ⊗ Detectable warnings are non-compliant. ⊗ Running Slope exceeds 5%. <p>NORTHEAST SIDEWALK EAST ON PENINSULAR AVENUE</p> <ul style="list-style-type: none"> Survey Points 0'-800' ⊗ Sidewalks do not exist in this area. <p>NORTHEAST SIDEWALK NORTH ON MALONEY AVENUE</p> <ul style="list-style-type: none"> Survey Points 0'-100' ⊗ Non-compliant driveway approach. (Typical Photo 04) ⊗ Cross slope exceeds 2%. 	<p>A\$ - F\$\$ - Depending on the specific situation at each location, install accessible sidewalks and intersections in compliance with ADAAG and PROWAC guidance and FDOT Design Standards. This should include, but not be limited to, detectable warnings, driveway crossings, street crossing markings, signs, and pedestrian crossing signals as required.</p>

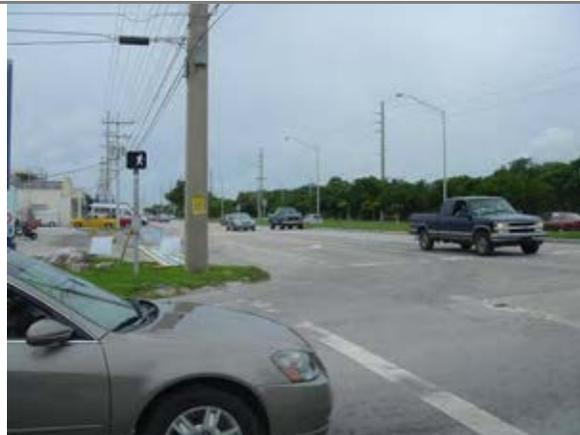
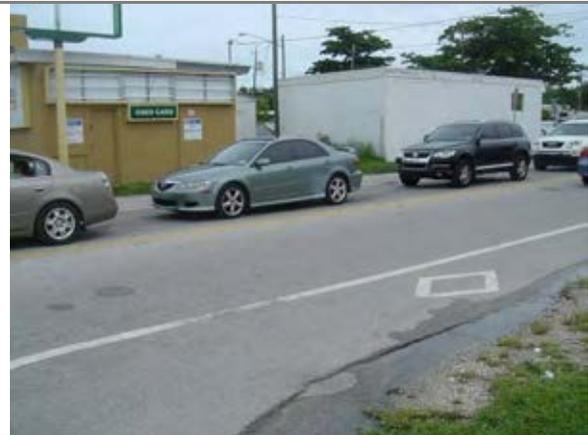
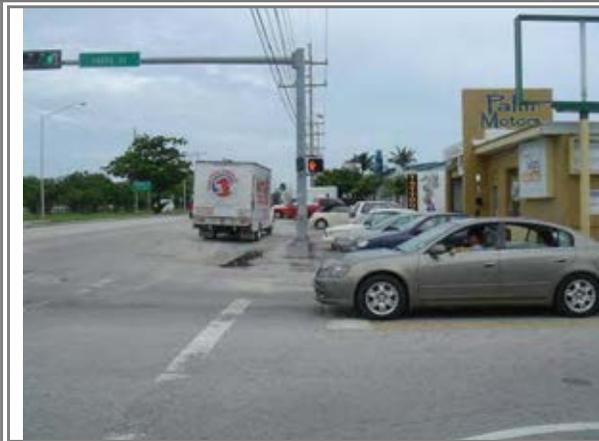
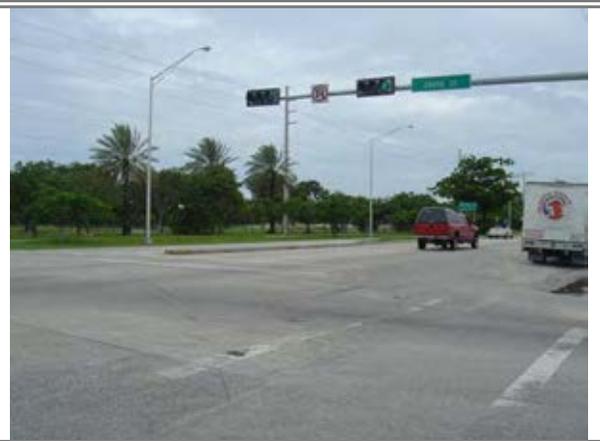
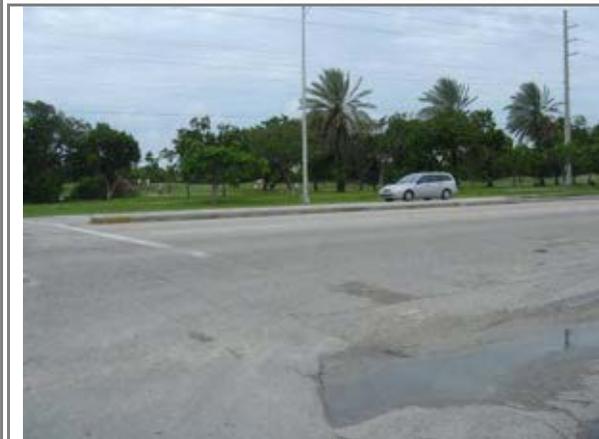
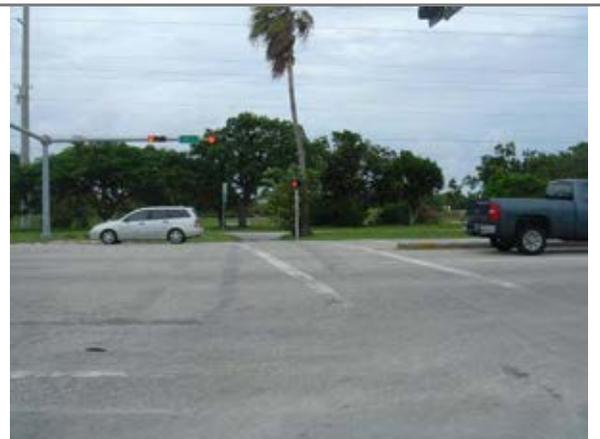
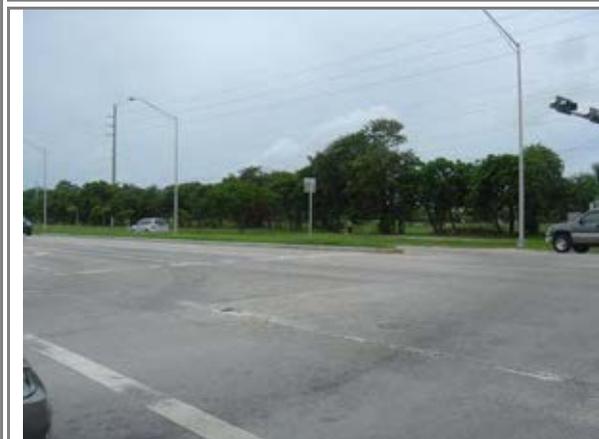
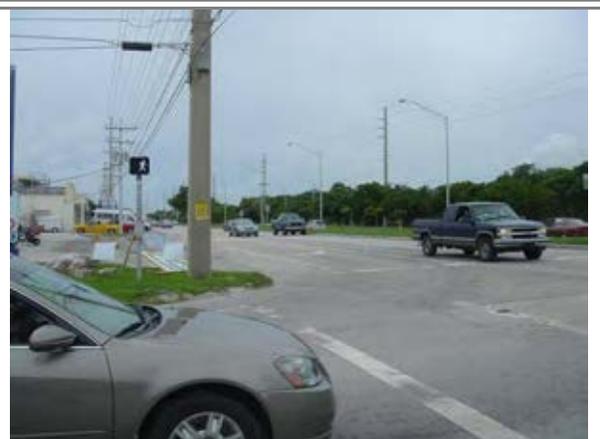
5.1 US 1 AND CROSS STREET

Observation	Recommendations
<p>SOUTH CORNER</p> <ul style="list-style-type: none"> ⊗ Sidewalks do not exist in this area. <p>SOUTH SIDEWALK SOUTHEAST ON CROSS STREET</p> <ul style="list-style-type: none"> • Survey Points 0'-100' ⊗ Sidewalks do not exist in this area. <p>EAST CORNER</p> <ul style="list-style-type: none"> ⊗ Sidewalk does not exist in this area. <p>EAST SIDEWALK SOUTHEAST ON CROSS STREET</p> <ul style="list-style-type: none"> • Survey Points 0'-100' ⊗ Sidewalk does not exist in this area. 	<p>A\$ - F\$\$ - Depending on the specific situation at each location, install accessible sidewalks and intersections in compliance with ADAAG and PROWAAC guidance and FDOT Design Standards. This should include, but not be limited to, detectable warnings, driveway crossings, street crossing markings, signs, and pedestrian crossing signals as required.</p>

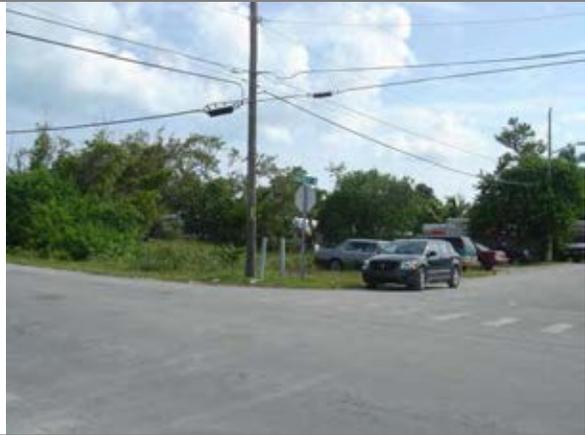
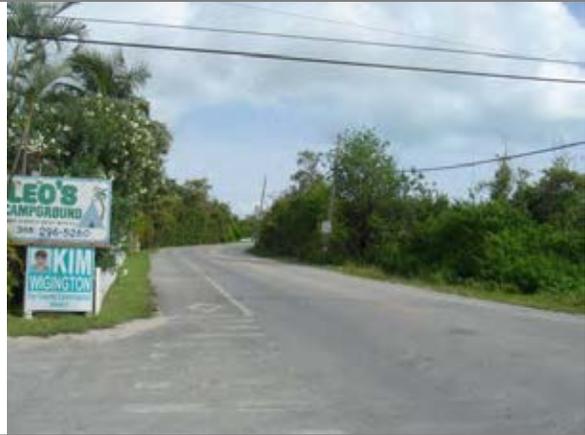
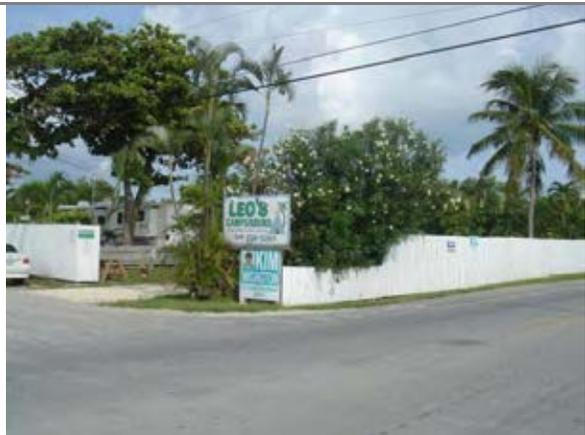
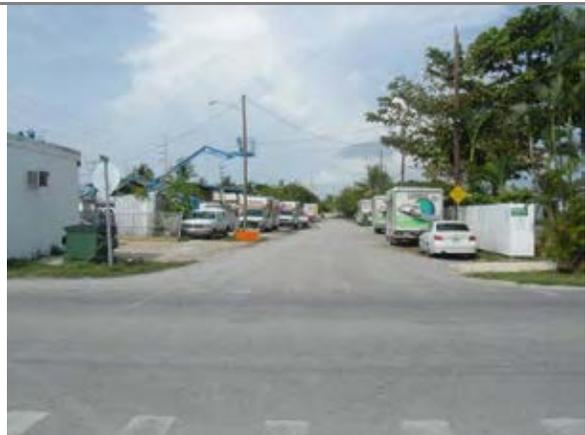
5.2 CROSS STREET AND SUNCREST ROAD		
Road Atlas Identification:	S 21.1	S 32.1

Observation	Recommendations
<p>SOUTH CORNER</p> <ul style="list-style-type: none"> ⊗ Sidewalks do not exist in this area. <p>SOUTH SIDEWALK SOUTHWEST ON SUNCREST ROAD</p> <ul style="list-style-type: none"> • Survey Points 0'-400' ⊗ Sidewalks do not exist in this area. <p>SOUTH SIDEWALK SOUTHEAST ON CROSS STREET</p> <ul style="list-style-type: none"> • Survey Points 0'-300' ⊗ Sidewalks do not exist in this area. <p>EAST CORNER</p> <ul style="list-style-type: none"> ⊗ Sidewalk does not exist in this area. <p>EAST SIDEWALK SOUTHEAST ON CROSS STREET</p> <ul style="list-style-type: none"> • Survey Points 0'-300' ⊗ Sidewalk does not exist in this area. <p>EAST SIDEWALK NORTHEAST ON SUNCREST ROAD</p> <ul style="list-style-type: none"> • Survey Points 0'-500' ⊗ Sidewalk does not exist in this area. 	<p>A\$ - F\$\$ - Depending on the specific situation at each location, install accessible sidewalks and intersections in compliance with ADAAG and PROWAAC guidance and FDOT Design Standards. This should include, but not be limited to, detectable warnings, driveway crossings, street crossing markings, signs, and pedestrian crossing signals as required.</p>

Observation	Recommendations
<p>NORTH CORNER</p> <ul style="list-style-type: none"> ⊗ Sidewalks do not exist in this area. <p>NORTH SIDEWALK NORTHWEST ON SUNCREST ROAD</p> <ul style="list-style-type: none"> • Survey Points 0'-500' ⊗ Sidewalks do not exist in this area. <p>NORTH SIDEWALK NORTHWEST ON CROSS STREET</p> <ul style="list-style-type: none"> • Survey Points 0'-100' ⊗ Sidewalks do not exist in this area. <p>WEST CORNER</p> <ul style="list-style-type: none"> ⊗ Sidewalks do not exist in this area. <p>WEST SIDEWALK NORTHWEST ON CROSS STREET</p> <ul style="list-style-type: none"> • Survey Points 0'-100' ⊗ Sidewalks do not exist in this area. <p>WEST SIDEWALK SOUTHWEST ON SUNCREST ROAD</p> <ul style="list-style-type: none"> • Survey Points 0'-400' ⊗ Sidewalks do not exist in this area.

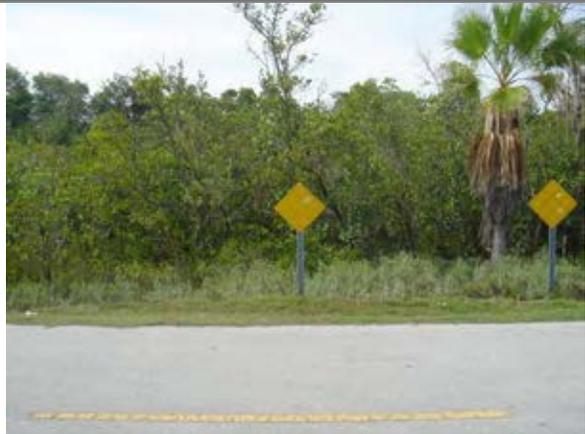
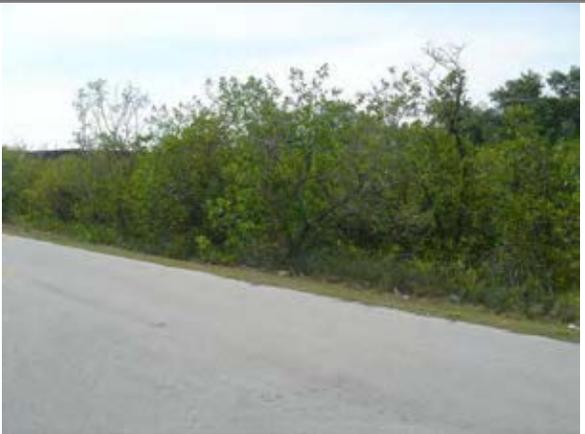
North across from Balido Street	Northwest Corner

Observation	Recommendations
<p>SOUTHWEST CORNER</p> <ul style="list-style-type: none"> ⊗ Detectable warnings are not provided. ⊗ Cross slope exceeds 2%. ⊗ Running Slope exceeds 5%. ⊗ Existing sidewalk does not provide accessible connection to street. (Typical Photo 10) ✓ Crosswalk markings indicated to Southeast Corner. <p>SOUTHWEST SIDEWALK WEST ON COUNTY ROAD</p> <ul style="list-style-type: none"> • Survey Points 0'-200' ⊗ Cross slope exceeds 2%. ⊗ Non-compliant driveway approach. (Typical Photo 04) ⊗ Cracks / gaps greater than ½" in surface. (Typical Photo 07) <p>SOUTHWEST SIDEWALK SOUTH ON BALIDO STREET</p> <ul style="list-style-type: none"> • Survey Points 0'-200' ⊗ Cross slope exceeds 2%. ⊗ Non-compliant driveway approach. (Typical Photo 04) ⊗ Cracks / gaps greater than ½" in surface. (Typical Photo 07) <p>SOUTHEAST CORNER</p> <ul style="list-style-type: none"> ⊗ Detectable warnings are not provided. ⊗ Cross slope exceeds 2%. ⊗ Running Slope exceeds 5%. ⊗ Existing sidewalk does not provide accessible connection to street. (Typical Photo 10) ✓ Crosswalk markings indicated to Southwest Corner. <p>SOUTHEAST SIDEWALK SOUTH ON BALIDO STREET</p> <ul style="list-style-type: none"> • Survey Points 0'-200' ⊗ Cross slope exceeds 2%. ⊗ Non-compliant driveway approach. (Typical Photo 04) ⊗ Cracks / gaps greater than ½" in surface. (Typical Photo 07) 	<p>A\$ - F\$\$ - Depending on the specific situation at each location, install accessible sidewalks and intersections in compliance with ADAAG and PROWAAC guidance and FDOT Design Standards. This should include, but not be limited to, detectable warnings, driveway crossings, street crossing markings, signs, and pedestrian crossing signals as required.</p>

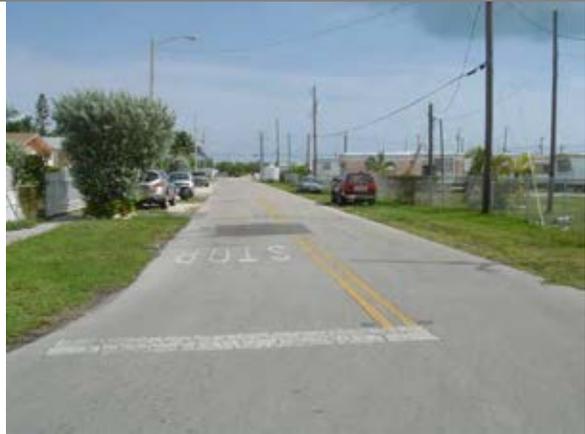
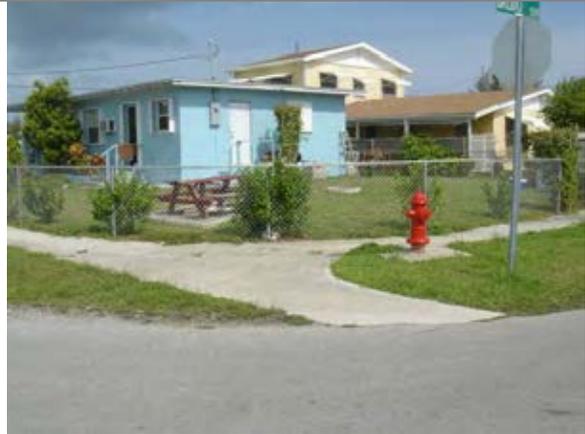
South on Balido Terrace	Southeast Corner

Observation	Recommendations
<p>SOUTHEAST CORNER</p> <ul style="list-style-type: none"> ⊗ Detectable warnings are not provided. ⊗ Cross slope exceeds 2%. ⊗ Running Slope exceeds 5%. ⊗ Existing sidewalk does not provide accessible connection to street. (Typical Photo 10) <p>SOUTHEAST SIDEWALK SOUTH ON BALIDO TERRACE</p> <ul style="list-style-type: none"> • Survey Points 0'-200' ⊗ Cross slope exceeds 2%. ⊗ Running Slope exceeds 5%. ⊗ Rough uneven surface. (Typical Photo 06) ⊗ Cracks / gaps greater than 1/2" in surface. (Typical Photo 07) <p>SOUTHEAST SIDEWALK EAST ON COUNTY ROAD</p> <ul style="list-style-type: none"> • Survey Points 0'-100' ⊗ Cross slope exceeds 2%. 	<p>AS - FSS - Depending on the specific situation at each location, install accessible sidewalks and intersections in compliance with ADAAG and PROWAAC guidance and FDOT Design Standards. This should include, but not be limited to, detectable warnings, driveway crossings, street crossing markings, signs, and pedestrian crossing signals as required.</p>

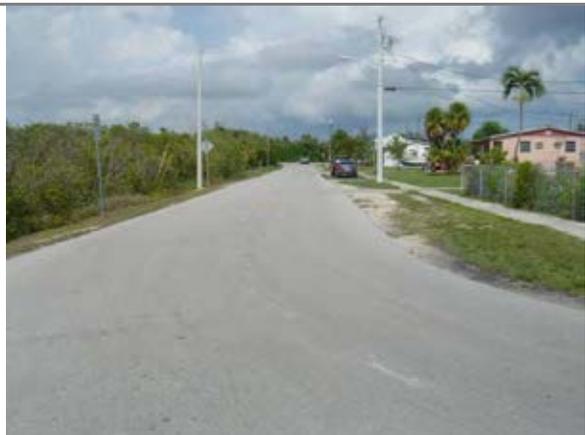
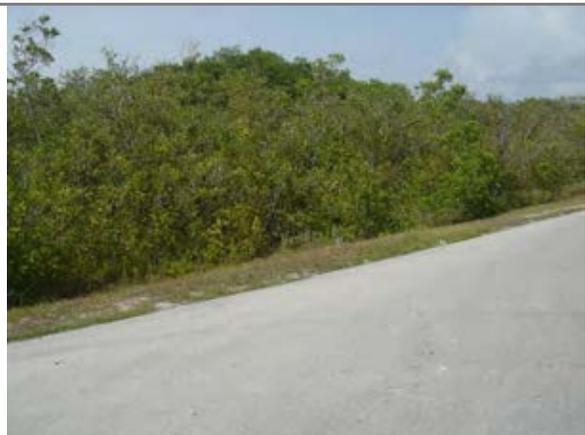
East on County Road	Northeast Corner

Observation	Recommendations
<ul style="list-style-type: none"> ⊗ Running Slope exceeds 5%. ⊗ Non-compliant driveway approach. (Typical Photo 04) ⊗ Cracks / gaps greater than ½" in surface. (Typical Photo 07) <p>NORTHWEST CORNER</p> <ul style="list-style-type: none"> ⊗ Sidewalks do not exist in this area. <p>NORTHWEST SIDEWALK EAST ON COUNTY ROAD</p> <ul style="list-style-type: none"> • Survey Points 0'-100' ⊗ Sidewalks do not exist in this area. <p>NORTHWEST SIDEWALK SOUTH ON BALIDO TERRACE</p> <ul style="list-style-type: none"> • Survey Points 0'-200' ⊗ Sidewalks do not exist in this area.

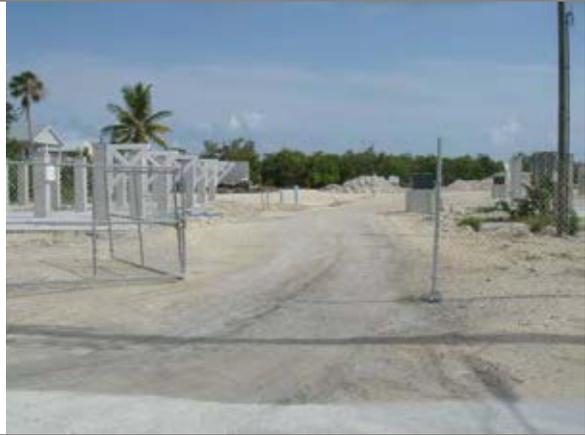
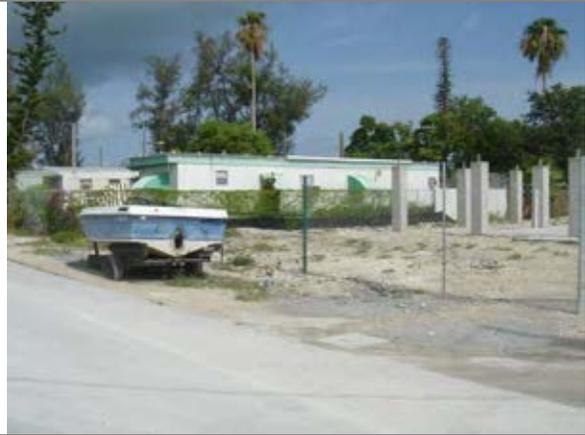
South across from Balido Terrace	Southeast Corner

Observation	Recommendations
<p>SOUTH SIDEWALK WEST ON 5TH AVENUE</p> <ul style="list-style-type: none"> Survey Points 0'-800' ⊗ Sidewalks do not exist in this area. <p>SOUTH SIDEWALK EAST ON 5TH AVENUE</p> <ul style="list-style-type: none"> Survey Points 0'-100' ⊗ Sidewalks do not exist in this area. <p>NORTHEAST CORNER</p> <ul style="list-style-type: none"> ⊗ Sidewalks do not exist in this area. <p>NORTHEAST SIDEWALK EAST ON 5TH AVENUE</p> <ul style="list-style-type: none"> Survey Points 0'-100' ⊗ Sidewalks do not exist in this area. <p>NORTHEAST SIDEWALK NORTH ON BALIDO TERRACE</p> <ul style="list-style-type: none"> Survey Points 0'-200' ⊗ Sidewalks do not exist in this area. Survey Points 200'-300' ⊗ Sidewalks exist partially in this area. 	<p>A\$ - F\$\$ - Depending on the specific situation at each location, install accessible sidewalks and intersections in compliance with ADAAG and PROWAAC guidance and FDOT Design Standards. This should include, but not be limited to, detectable warnings, driveway crossings, street crossing markings, signs, and pedestrian crossing signals as required.</p>

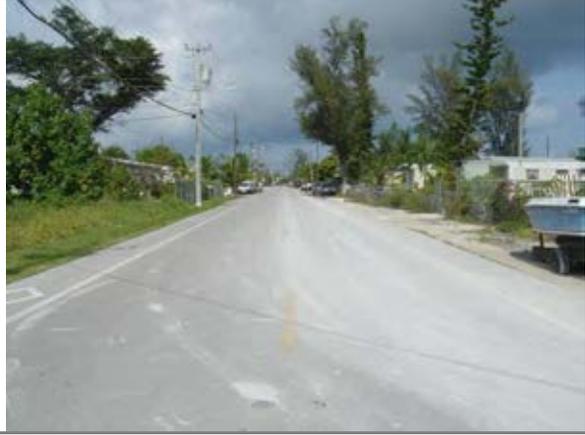
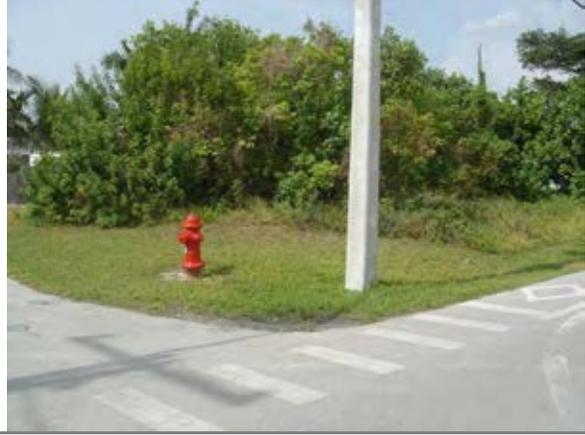
East on 5 th Avenue	Northeast Corner

Observation	Recommendations
<ul style="list-style-type: none"> ⊗ Cross slope exceeds 2%. ⊗ Running Slope exceeds 5%. ⊗ Rough uneven surface. (Typical Photo 06) ⊗ Cracks / gaps greater than ½" in surface. (Typical Photo 07) <p>NORTHWEST CORNER</p> <ul style="list-style-type: none"> ⊗ Sidewalks do not exist in this area. <p>NORTHWEST SIDEWALK NORTH ON BALIDO TERRACE</p> <ul style="list-style-type: none"> • Survey Points 0'-300' ⊗ Sidewalks do not exist in this area. <p>NORTHWEST SIDEWALK WEST ON 5th AVENUE</p> <ul style="list-style-type: none"> • Survey Points 0'-800' ⊗ Sidewalks do not exist in this area.

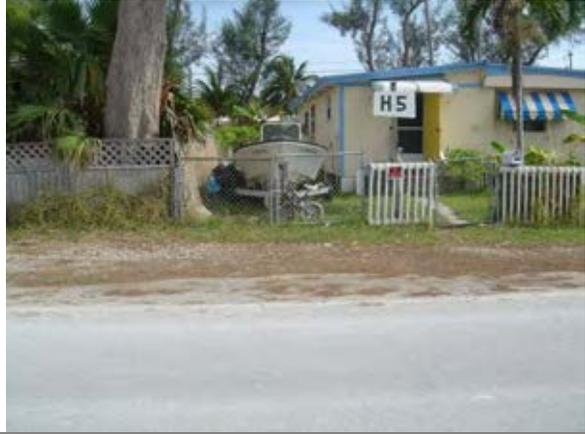
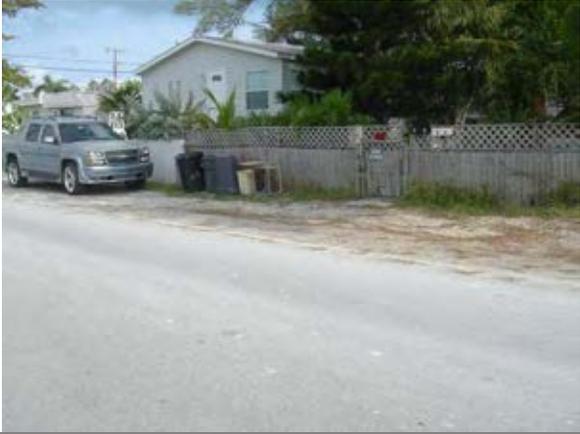
South across from Balido Street	Southeast Corner

Observation	Recommendations
<p>SOUTH SIDEWALK WEST ON 5th AVENUE</p> <ul style="list-style-type: none"> Survey Points 0'-200' ⊗ Sidewalks do not exist in this area. <p>SOUTH SIDEWALK EAST ON 5th AVENUE</p> <ul style="list-style-type: none"> Survey Points 0'-100' ⊗ Sidewalks do not exist in this area. <p>NORTHEAST CORNER</p> <ul style="list-style-type: none"> ⊗ Detectable warnings are not provided. ⊗ Cross slope exceeds 2%. ⊗ Running Slope exceeds 5%. ⊗ Existing sidewalk does not provide accessible connection to street. (Typical Photo 10) ⊗ Cracks / gaps greater than ½" in surface. (Typical Photo 07) <p>NORTHEAST SIDEWALK EAST ON 5th AVENUE</p> <ul style="list-style-type: none"> Survey Points 0'-100' 	<p>AS - F\$\$ - Depending on the specific situation at each location, install accessible sidewalks and intersections in compliance with ADAAG and PROWAAC guidance and FDOT Design Standards. This should include, but not be limited to, detectable warnings, driveway crossings, street crossing markings, signs, and pedestrian crossing signals as required.</p>

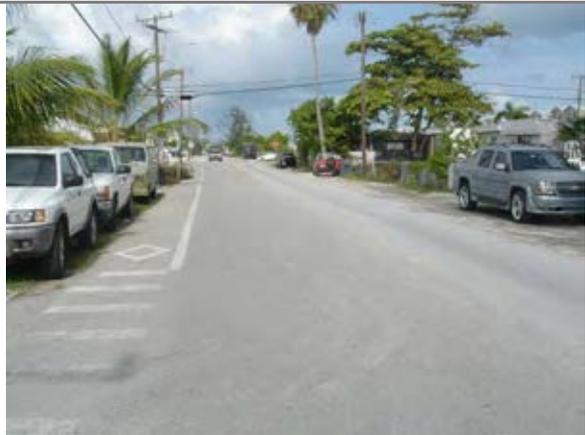
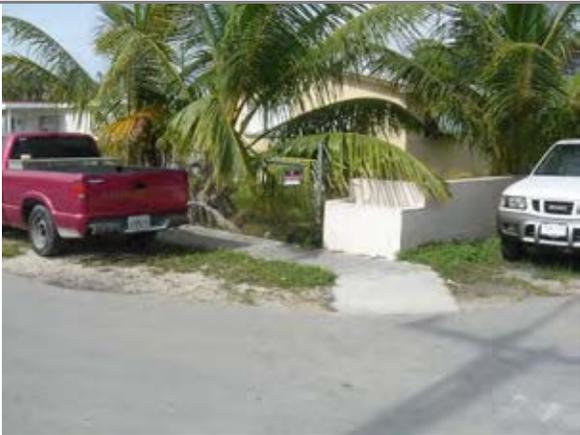
East on 5 th Avenue	Northeast Corner

Observation	Recommendations
<p>⊗ Sidewalks do not exist in this area.</p> <p>NORTHEAST SIDEWALK NORTH ON BALIDO STREET</p> <ul style="list-style-type: none"> • Survey Points 0'-300' ⊗ Cross slope exceeds 2%. ⊗ Non-compliant driveway approach. (Typical Photo 04) ⊗ Cracks / gaps greater than ½" in surface. (Typical Photo 07) ⊗ Running Slope exceeds 5%. <p>NORTHWEST CORNER</p> <ul style="list-style-type: none"> ⊗ Detectable warnings are not provided. ⊗ Cross slope exceeds 2%. ⊗ Running Slope exceeds 5%. ⊗ Existing sidewalk does not provide accessible connection to street. (Typical Photo 10) ⊗ Cracks / gaps greater than ½" in surface. (Typical Photo 07) <p>NORTHWEST SIDEWALK NORTH ON BALIDO STREET</p> <ul style="list-style-type: none"> • Survey Points 0'-300' ⊗ Cross slope exceeds 2%. ⊗ Non-compliant driveway approach. (Typical Photo 04) ⊗ Cracks / gaps greater than ½" in surface. (Typical Photo 07) ⊗ Running Slope exceeds 5%. <p>NORTHWEST SIDEWALK WEST ON 5th AVENUE</p> <ul style="list-style-type: none"> • Survey Points 0'-200' ⊗ Sidewalks do not exist in this area.

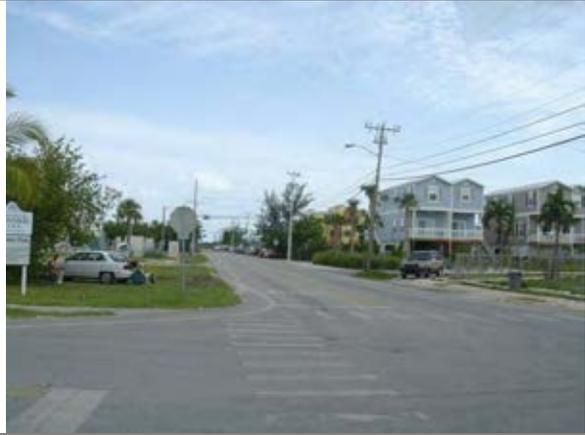
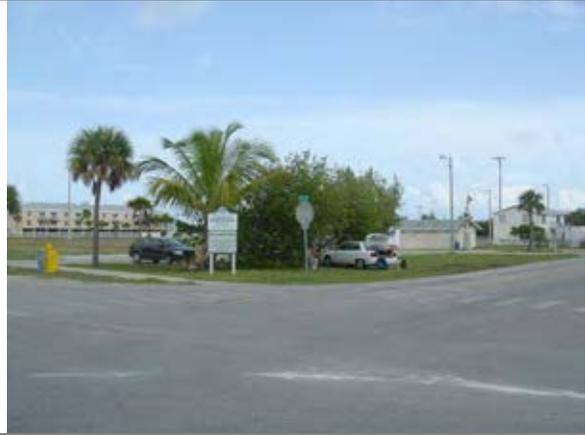
South on 5th Street	Southeast Corner

Observation	Recommendations
<p>SOUTHEAST CORNER</p> <ul style="list-style-type: none"> ⊗ Detectable warnings are not provided. ⊗ Cross slope exceeds 2%. ⊗ Running Slope exceeds 5%. ⊗ Surface is asphalt and enters into fenced in park. <p>SOUTHEAST SIDEWALK SOUTH ON 5th STREET</p> <ul style="list-style-type: none"> • Survey Points 0'-100' ⊗ Sidewalks do not exist in this area. <p>SOUTHEAST SIDEWALK EAST ON 5th AVENUE</p> <ul style="list-style-type: none"> • Survey Points 0'-300' ⊗ Asphalt path entering into fence in park; no connection to adjacent properties. <p>NORTHEAST CORNER</p> <ul style="list-style-type: none"> ⊗ Sidewalks do not exist in this area. <p>NORTHEAST SIDEWALK EAST ON 5th AVENUE</p> <ul style="list-style-type: none"> • Survey Points 0'-300' ⊗ Sidewalks do not exist in this area. <p>NORTHEAST SIDEWALK NORTH ON 5th STREET</p> <ul style="list-style-type: none"> • Survey Points 0'-100' ⊗ Sidewalks do not exist in this area. <p>NORTHWEST CORNER</p> <ul style="list-style-type: none"> ⊗ Sidewalks do not exist in this area. <p>NORTHWEST SIDEWALK NORTH ON 5th STREET</p> <ul style="list-style-type: none"> • Survey Points 0'-100' ⊗ Sidewalks do not exist in this area. <p>NORTHWEST SIDEWALK WEST ON 5th AVENUE</p> <ul style="list-style-type: none"> • Survey Points 0'-500' ⊗ Sidewalks do not exist in this area. <p>SOUTHWEST CORNER</p> <ul style="list-style-type: none"> ⊗ Detectable warnings are not provided. ⊗ Cross slope exceeds 2%. 	<p>A\$ - F\$\$ - Depending on the specific situation at each location, install accessible sidewalks and intersections in compliance with ADAAG and PROWAAC guidance and FDOT Design Standards. This should include, but not be limited to, detectable warnings, driveway crossings, street crossing markings, signs, and pedestrian crossing signals as required.</p>

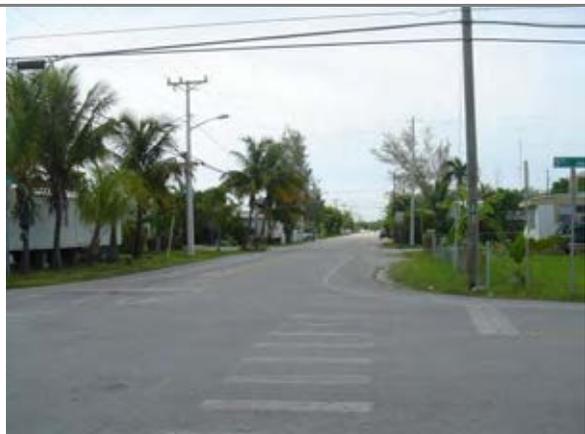
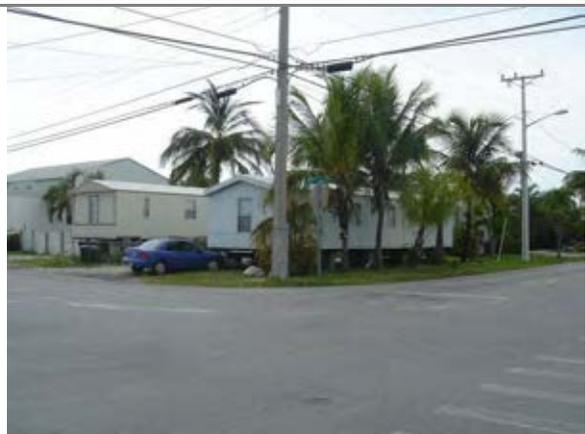
North on 5th Street	Northwest Corner

Observation	Recommendations
<ul style="list-style-type: none"> ⊗ Running Slope exceeds 5%. ⊗ Cracks / gaps greater than ½" in surface. (Typical Photo 07) ⊗ Existing sidewalk does not provide accessible connection to street. (Typical Photo 10) <p>SOUTHWEST SIDEWALK WEST ON 5th AVENUE</p> <ul style="list-style-type: none"> • Survey Points 0'-500' ⊗ Sidewalks do not exist in this area. <p>SOUTHWEST SIDEWALK SOUTH ON 5th STREET</p> <ul style="list-style-type: none"> • Survey Points 0'-100' ⊗ Non-compliant driveway approach. (Typical Photo 04) ⊗ Cross slope exceeds 2%. ⊗ Running Slope exceeds 5%. ⊗ Cracks / gaps greater than ½" in surface. (Typical Photo 07)

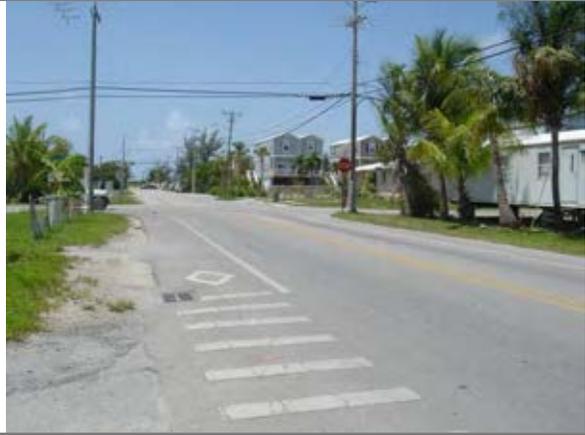
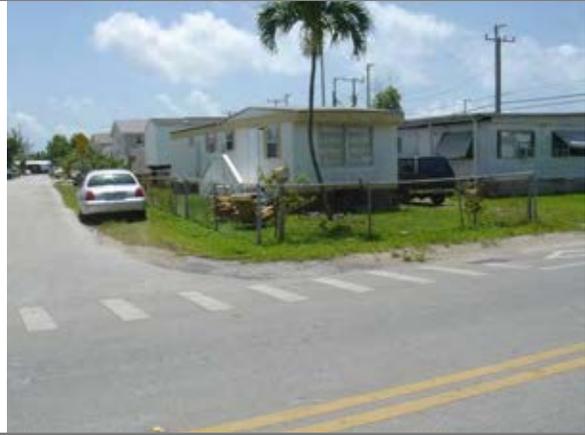
South on 5th Street	Southeast Corner

Observation	Recommendations
<p>SOUTHEAST CORNER</p> <ul style="list-style-type: none"> ⊗ Sidewalks do not exist in this area. <p>SOUTHEAST SIDEWALK SOUTH ON 5th STREET</p> <ul style="list-style-type: none"> • Survey Points 0'-100' ⊗ Sidewalks do not exist in this area. <p>SOUTHEAST SIDEWALK EAST ON ROBYN LANE</p> <ul style="list-style-type: none"> • Survey Points 0'-300' ⊗ Sidewalks do not exist in this area. <p>NORTHEAST CORNER</p> <ul style="list-style-type: none"> ⊗ Sidewalks do not exist in this area. <p>NORTHEAST SIDEWALK EAST ROBYN LANE</p> <ul style="list-style-type: none"> • Survey Points 0'-300' ⊗ Sidewalks do not exist in this area. <p>NORTHEAST SIDEWALK NORTH ON 5th STREET</p> <ul style="list-style-type: none"> • Survey Points 0'-100' ⊗ Sidewalks do not exist in this area. <p>WEST SIDEWALK NORTH ON 5th STREET</p> <ul style="list-style-type: none"> • Survey Points 0'-100' ⊗ Sidewalks do not exist in this area. <p>WEST SIDEWALK SOUTH ON 5th STREET</p> <ul style="list-style-type: none"> • Survey Points 0'-100' ⊗ Sidewalks do not exist in this area. 	<p>A\$ - F\$\$ - Depending on the specific situation at each location, install accessible sidewalks and intersections in compliance with ADAAG and PROWAAAC guidance and FDOT Design Standards. This should include, but not be limited to, detectable warnings, driveway crossings, street crossing markings, signs, and pedestrian crossing signals as required.</p>

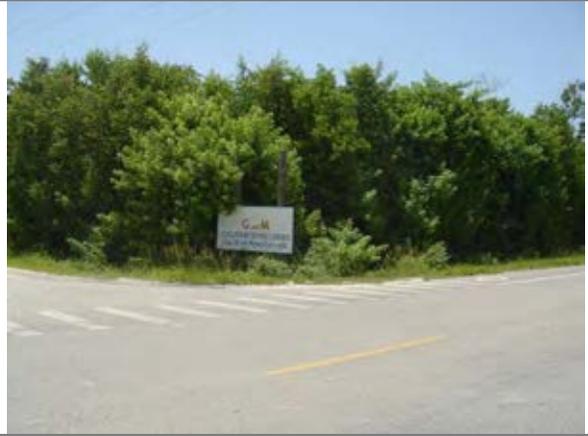
Southeast Corner

Observation	Recommendations
<p>SOUTHEAST CORNER</p> <ul style="list-style-type: none"> ⊗ Sidewalks do not exist in this area. <p>SOUTHEAST SIDEWALK SOUTH ON 5th STREET</p> <ul style="list-style-type: none"> • Survey Points 0'-200' ⊗ Sidewalks do not exist in this area. <p>SOUTHEAST SIDEWALK EAST ON 2nd AVENUE</p> <ul style="list-style-type: none"> • Survey Points 0'-500' ⊗ Sidewalks do not exist in this area. <p>NORTHEAST CORNER</p> <ul style="list-style-type: none"> ⊗ Sidewalks do not exist in this area. <p>NORTHEAST SIDEWALK EAST ON 2nd AVENUE</p> <ul style="list-style-type: none"> • Survey Points 0'-500' ⊗ Sidewalks do not exist in this area. <p>NORTHEAST SIDEWALK NORTH ON SUNSHINE STREET</p> <ul style="list-style-type: none"> • Survey Points 0'-300' ⊗ Sidewalks do not exist in this area. <p>NORTHWEST CORNER</p> <ul style="list-style-type: none"> ⊗ Sidewalks do not exist in this area. <p>NORTHWEST SIDEWALK NORTH ON 5th STREET</p> <ul style="list-style-type: none"> • Survey Points 0'-300' ⊗ Sidewalks do not exist in this area. <p>NORTHWEST SIDEWALK WEST ON 2nd AVENUE</p> <ul style="list-style-type: none"> • Survey Points 0'-200' ⊗ Sidewalks do not exist in this area. <p>SOUTHWEST CORNER</p> <ul style="list-style-type: none"> ⊗ Sidewalks do not exist in this area. <p>SOUTHWEST SIDEWALK WEST ON 2nd AVENUE</p> <ul style="list-style-type: none"> • Survey Points 0'-200' ⊗ Sidewalks do not exist in this area. <p>SOUTHWEST SIDEWALK SOUTH ON 5th STREET</p> <ul style="list-style-type: none"> • Survey Points 0'-200' 	<p>A\$ - F\$\$ - Depending on the specific situation at each location, install accessible sidewalks and intersections in compliance with ADAAG and PROWAAC guidance and FDOT Design Standards. This should include, but not be limited to, detectable warnings, driveway crossings, street crossing markings, signs, and pedestrian crossing signals as required.</p>

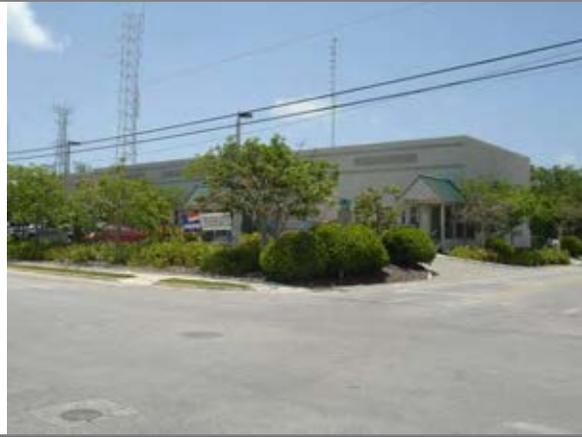
Southeast Corner

Observation	Recommendations
<p>SOUTHEAST CORNER</p> <ul style="list-style-type: none"> ⊗ Detectable warnings are not provided. ⊗ Running Slope exceeds 5%. ⊗ Existing sidewalk does not provide accessible connection to street. (Typical Photo 10) ✓ Crosswalk markings indicated to Southwest corner. ✓ Crosswalk markings indicated to Northeast corner. <p>SOUTHEAST SIDEWALK SOUTH ON 5th STREET</p> <ul style="list-style-type: none"> • Survey Points 0'-300' ⊗ Sidewalks do not exist in this area. <p>SOUTHEAST SIDEWALK EAST ON MacDONALD AVENUE</p> <ul style="list-style-type: none"> • Survey Points 0'-300' ⊗ Non-compliant driveway approach. (Typical Photo 04) <p>NORTHEAST CORNER</p> <ul style="list-style-type: none"> ⊗ Detectable warnings are not provided. ⊗ Existing sidewalk does not provide accessible 	<p>A\$ - F\$\$ - Depending on the specific situation at each location, install accessible sidewalks and intersections in compliance with ADAAG and PROWAAC guidance and FDOT Design Standards. This should include, but not be limited to, detectable warnings, driveway crossings, street crossing markings, signs, and pedestrian crossing signals as required.</p>
