Americans with Disabilities Act Transition Plan Lower Keys - Part 2

Volume 4 of 4

Monroe County

October 29, 2010

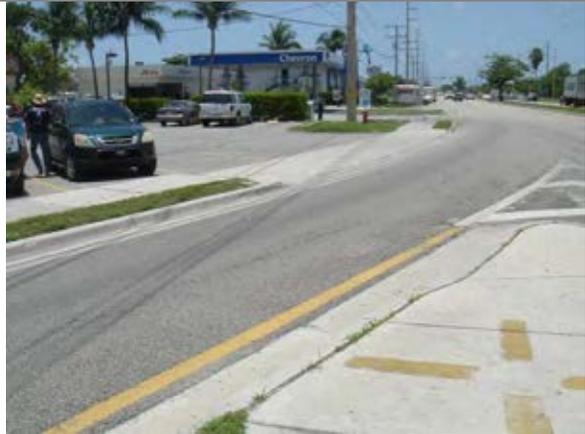
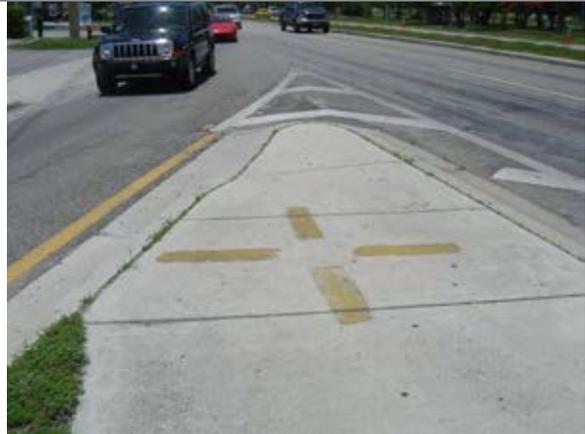
South Corner	Median West

Observation	Recommendations
<p>SOUTH CORNER</p> <ul style="list-style-type: none"> ⊗ Detectable warnings are not provided. ⊗ Existing sidewalk does not provide accessible connection to street. (Typical Photo 10) <p>SOUTH SIDEWALK EAST ON MacDONALD AVENUE</p> <ul style="list-style-type: none"> • Survey Points 0'-300' ⊗ Vegetation reduces required clear width. (Typical Photo 08) <p>MEDIAN WEST</p> <ul style="list-style-type: none"> ⊗ Detectable warnings are not provided. ⊗ Existing sidewalk does not provide accessible connection to street. (Typical Photo 10) <p>MEDIAN EAST</p> <ul style="list-style-type: none"> ⊗ Detectable warnings are not provided. ✓ Crosswalk markings indicated to East corner. <p>EAST CORNER</p>	<p>A\$ - F\$\$ - Depending on the specific situation at each location, install accessible sidewalks and intersections in compliance with ADAAG and PROWAAC guidance and FDOT Design Standards. This should include, but not be limited to, detectable warnings, driveway crossings, street crossing markings, signs, and pedestrian crossing signals as required.</p>

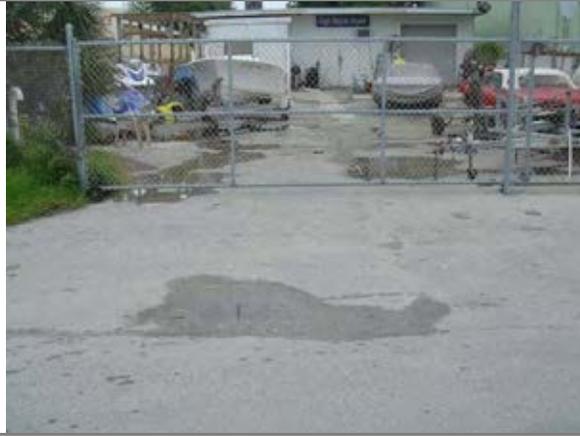
South across from 3rd Street

Observation	Recommendations
<p>SOUTH SIDEWALK WEST ON 3rd AVENUE</p> <ul style="list-style-type: none"> Survey Points 0'-600' ⊗ Sidewalks do not exist in this area. <p>SOUTH SIDEWALK EAST ON 3rd AVENUE</p> <ul style="list-style-type: none"> Survey Points 0'-100' ⊗ Sidewalks do not exist in this area. <p>NORTHEAST CORNER</p> <ul style="list-style-type: none"> ⊗ Sidewalk does not exist in this area. <p>NORTHEAST SIDEWALK EAST ON 3rd AVENUE</p> <ul style="list-style-type: none"> Survey Points 0'-100' ⊗ Sidewalk does not exist in this area. <p>NORTHEAST SIDEWALK NORTH ON 3rd STREET</p> <ul style="list-style-type: none"> Survey Points 0'-300' ⊗ Sidewalk does not exist in this area. <p>NORTHWEST CORNER</p> <ul style="list-style-type: none"> ⊗ Sidewalk does not exist in this area. <p>NORTHWEST SIDEWALK NORTH ON 3rd STREET</p> <ul style="list-style-type: none"> Survey Points 0'-300' ⊗ Sidewalk does not exist in this area. <p>NORTHEAST SIDEWALK WEST ON 3rd AVENUE</p> <ul style="list-style-type: none"> Survey Points 0'-600' ⊗ Sidewalk does not exist in this area. 	<p>A\$ - F\$\$ - Depending on the specific situation at each location, install accessible sidewalks and intersections in compliance with ADAAG and PROWAAC guidance and FDOT Design Standards. This should include, but not be limited to, detectable warnings, driveway crossings, street crossing markings, signs, and pedestrian crossing signals as required.</p>

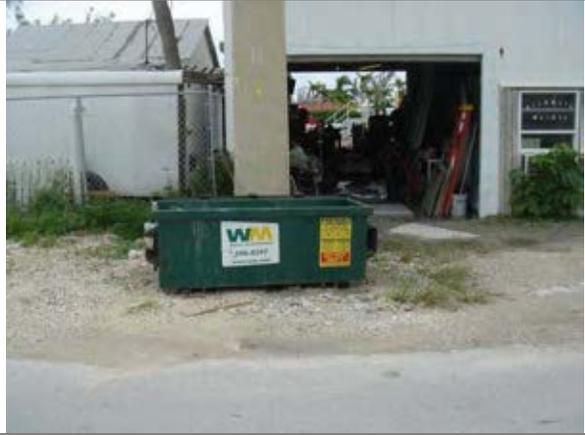
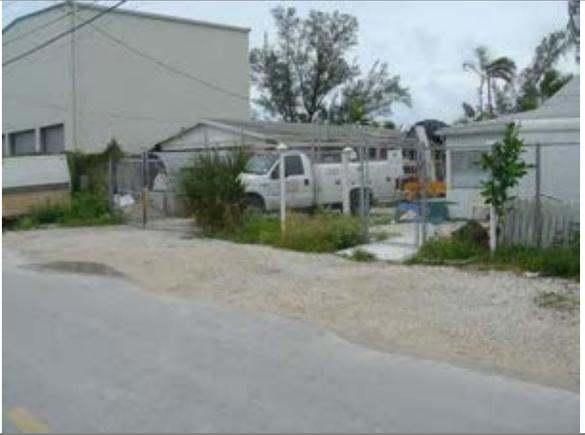
South across from 2 nd Terrace	Southeast Corner

Observation	Recommendations
<p>SOUTH SIDEWALK WEST ON 3rd AVENUE</p> <ul style="list-style-type: none"> • Survey Points 0'-200' ⊗ Sidewalks do not exist in this area. <p>SOUTH SIDEWALK EAST ON 3rd AVENUE</p> <ul style="list-style-type: none"> • Survey Points 0'-100' ⊗ Sidewalks do not exist in this area. <p>NORTHEAST CORNER</p> <ul style="list-style-type: none"> ⊗ Sidewalk does not exist in this area. <p>NORTHEAST SIDEWALK EAST ON 3rd AVENUE</p> <ul style="list-style-type: none"> • Survey Points 0'-100' ⊗ Sidewalk does not exist in this area. <p>NORTHEAST SIDEWALK NORTH ON 2nd TERRACE</p> <ul style="list-style-type: none"> • Survey Points 0'-300' ⊗ Sidewalk does not exist in this area. <p>NORTHWEST CORNER</p> <ul style="list-style-type: none"> ⊗ Sidewalk does not exist in this area. <p>NORTHWEST SIDEWALK NORTH ON 2nd TERRACE</p> <ul style="list-style-type: none"> • Survey Points 0'-300' ⊗ Sidewalk does not exist in this area. <p>NORTHEAST SIDEWALK WEST ON 3rd AVENUE</p> <ul style="list-style-type: none"> • Survey Points 0'-200' ⊗ Sidewalk does not exist in this area. 	<p>A\$ - F\$\$ - Depending on the specific situation at each location, install accessible sidewalks and intersections in compliance with ADAAG and PROWAAC guidance and FDOT Design Standards. This should include, but not be limited to, detectable warnings, driveway crossings, street crossing markings, signs, and pedestrian crossing signals as required.</p>

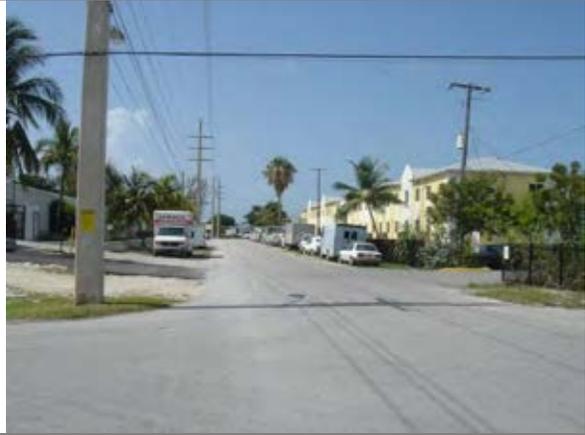
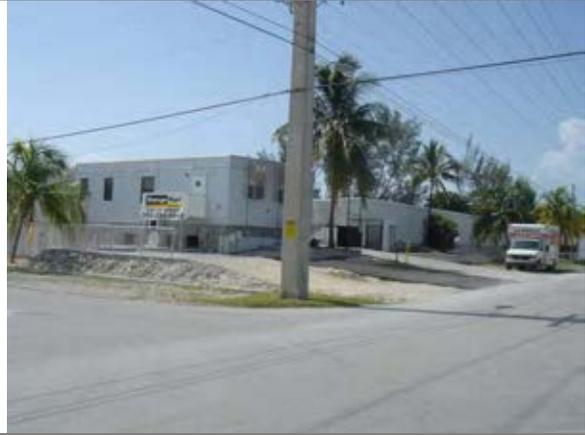
South on 3 rd Street	Southeast Corner

Observation	Recommendations
<p>SOUTHEAST CORNER</p> <ul style="list-style-type: none"> ⊗ Sidewalk does not exist in this area. <p>SOUTHEAST SIDEWALK SOUTH ON 3rd STREET</p> <ul style="list-style-type: none"> • Survey Points 0'-300' ⊗ Sidewalk does not exist in this area. <p>SOUTHEAST SIDEWALK EAST ON 2nd AVENUE</p> <ul style="list-style-type: none"> • Survey Points 0'-100' ⊗ Sidewalk does not exist in this area. <p>NORTHEAST CORNER</p> <ul style="list-style-type: none"> ⊗ Sidewalk does not exist in this area. <p>NORTHEAST SIDEWALK EAST ON 2nd AVENUE</p> <ul style="list-style-type: none"> • Survey Points 0'-100' ⊗ Sidewalk does not exist in this area. <p>NORTHEAST SIDEWALK NORTH ON 3rd STREET</p> <ul style="list-style-type: none"> • Survey Points 0'-200' ⊗ Sidewalk does not exist in this area. <p>NORTHWEST CORNER</p> <ul style="list-style-type: none"> ⊗ Sidewalk does not exist in this area. <p>NORTHWEST SIDEWALK NORTH ON 3rd STREET</p> <ul style="list-style-type: none"> • Survey Points 0'-200' ⊗ Sidewalk does not exist in this area. <p>NORTHEAST SIDEWALK WEST ON 2nd AVENUE</p> <ul style="list-style-type: none"> • Survey Points 0'-600' ⊗ Sidewalk does not exist in this area. <p>SOUTHWEST CORNER</p> <ul style="list-style-type: none"> ⊗ Sidewalk does not exist in this area. <p>SOUTHWEST SIDEWALK WEST ON 2nd AVENUE</p> <ul style="list-style-type: none"> • Survey Points 0'-600' ⊗ Sidewalk does not exist in this area. <p>SOUTHEAST SIDEWALK SOUTH ON 3rd STREET</p> <ul style="list-style-type: none"> • Survey Points 0'-300' 	<p>A\$ - F\$\$ - Depending on the specific situation at each location, install accessible sidewalks and intersections in compliance with ADAAG and PROWAAAC guidance and FDOT Design Standards. This should include, but not be limited to, detectable warnings, driveway crossings, street crossing markings, signs, and pedestrian crossing signals as required.</p>

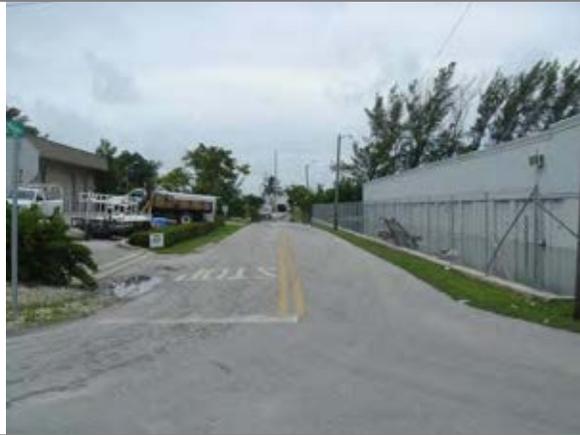
South on 2nd Terrace

Observation	Recommendations
<p>SOUTHEAST CORNER ☒ Sidewalk does not exist in this area.</p> <p>SOUTHEAST SIDEWALK SOUTH ON 2nd TERRACE</p> <ul style="list-style-type: none"> • Survey Points 0'-200' ☒ Sidewalk does not exist in this area. <p>SOUTHEAST SIDEWALK EAST ON 2nd AVENUE</p> <ul style="list-style-type: none"> • Survey Points 0'-100' ☒ Sidewalk does not exist in this area. <p>NORTH SIDEWALK EAST ON 2nd AVENUE</p> <ul style="list-style-type: none"> • Survey Points 0'-100' ☒ Sidewalks do not exist in this area. <p>NORTH SIDEWALK WEST ON 2nd AVENUE</p> <ul style="list-style-type: none"> • Survey Points 0'-200' ☒ Sidewalks do not exist in this area. <p>SOUTHWEST CORNER ☒ Sidewalk does not exist in this area.</p>	<p>A\$ - F\$\$ - Depending on the specific situation at each location, install accessible sidewalks and intersections in compliance with ADAAG and PROWAAC guidance and FDOT Design Standards. This should include, but not be limited to, detectable warnings, driveway crossings, street crossing markings, signs, and pedestrian crossing signals as required.</p>

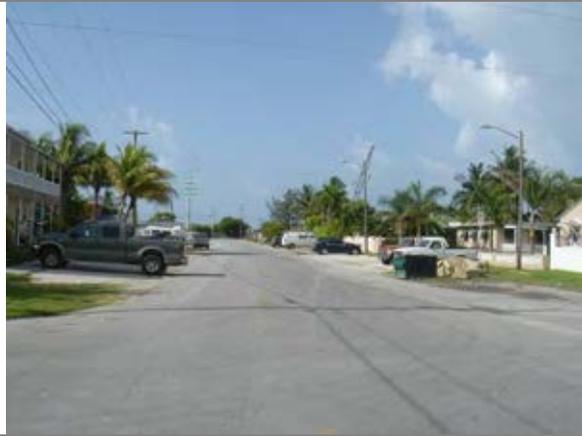
South on 2nd Street

Observation	Recommendations
<p>SOUTHEAST CORNER</p> <ul style="list-style-type: none"> ⊗ Sidewalk does not exist in this area. <p>SOUTHEAST SIDEWALK SOUTH ON 2nd STREET</p> <ul style="list-style-type: none"> • Survey Points 0'-300' ⊗ Sidewalk does not exist in this area. <p>SOUTHEAST SIDEWALK EAST ON 2nd AVENUE</p> <ul style="list-style-type: none"> • Survey Points 0'-200' ⊗ Sidewalk does not exist in this area. <p>NORTHEAST CORNER</p> <ul style="list-style-type: none"> ⊗ Sidewalk does not exist in this area. <p>NORTHEAST SIDEWALK EAST ON 2nd AVENUE</p> <ul style="list-style-type: none"> • Survey Points 0'-200' ⊗ Sidewalk does not exist in this area. <p>NORTHEAST SIDEWALK NORTH ON 2nd STREET</p> <ul style="list-style-type: none"> • Survey Points 0'-200' ⊗ Sidewalk does not exist in this area. 	<p>A\$ - F\$\$ - Depending on the specific situation at each location, install accessible sidewalks and intersections in compliance with ADAAG and PROWAAC guidance and FDOT Design Standards. This should include, but not be limited to, detectable warnings, driveway crossings, street crossing markings, signs, and pedestrian crossing signals as required.</p>

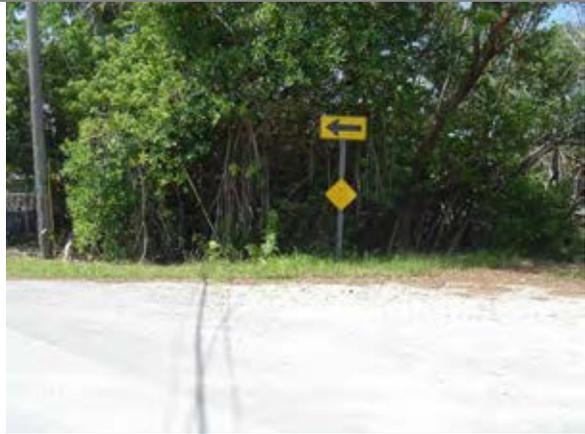
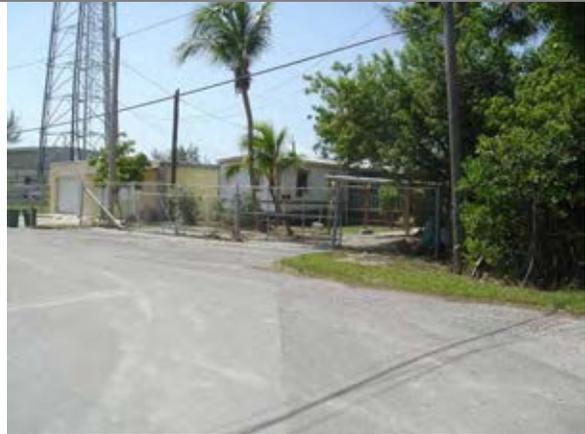
South across from 4 th Street	Southeast Corner

Observation	Recommendations
<p>NORTHEAST CORNER</p> <ul style="list-style-type: none"> ⊗ Sidewalk does not exist in this area. <p>NORTHEAST SIDEWALK EAST ON 1st AVENUE</p> <ul style="list-style-type: none"> • Survey Points 0'-300' ⊗ Sidewalk does not exist in this area. <p>NORTHEAST SIDEWALK NORTH ON 4th STREET</p> <ul style="list-style-type: none"> • Survey Points 0'-200' ⊗ Sidewalk does not exist in this area. <p>SOUTHWEST CORNER</p> <ul style="list-style-type: none"> ⊗ Sidewalk does not exist in this area. <p>SOUTHWEST SIDEWALK NORTH ON 4th STREET</p> <ul style="list-style-type: none"> • Survey Points 0'-200' ⊗ Sidewalk does not exist in this area. <p>SOUTHWEST SIDEWALK EAST ON 1st AVENUE</p> <ul style="list-style-type: none"> • Survey Points 0'-300' ⊗ Sidewalk does not exist in this area. 	<p>A\$ - F\$\$ - Depending on the specific situation at each location, install accessible sidewalks and intersections in compliance with ADAAG and PROWAAC guidance and FDOT Design Standards. This should include, but not be limited to, detectable warnings, driveway crossings, street crossing markings, signs, and pedestrian crossing signals as required.</p>

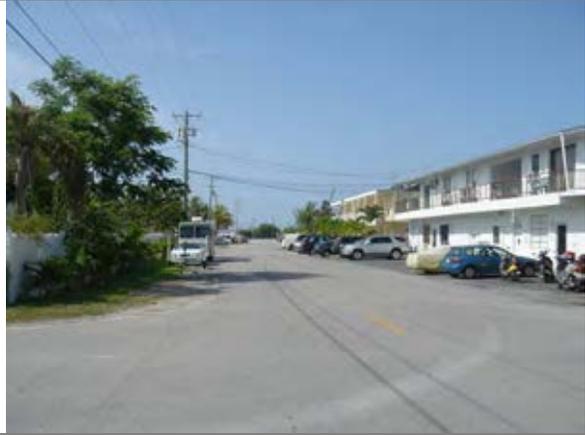
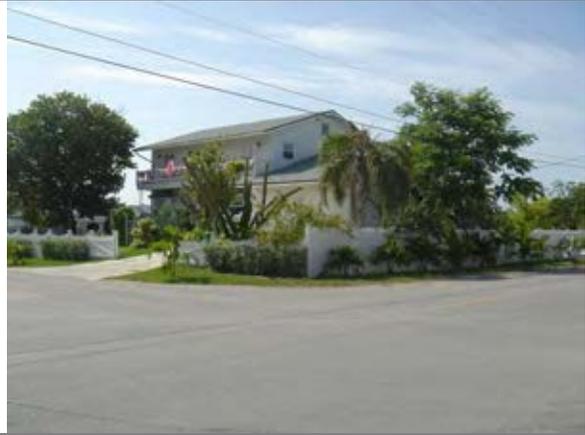
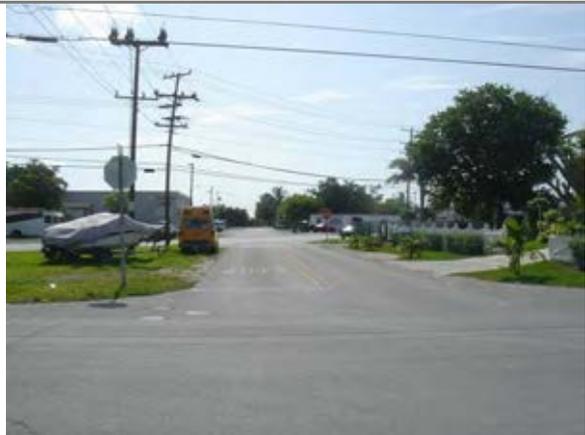
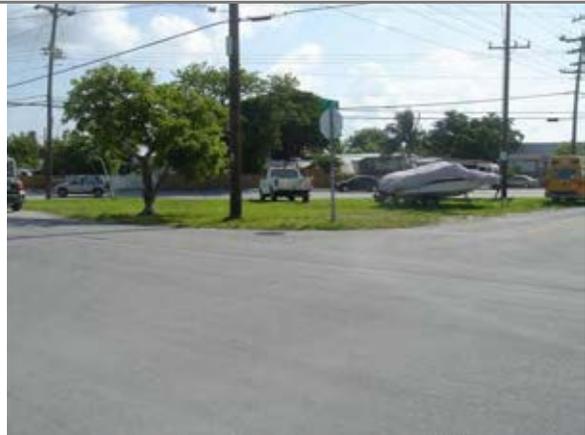
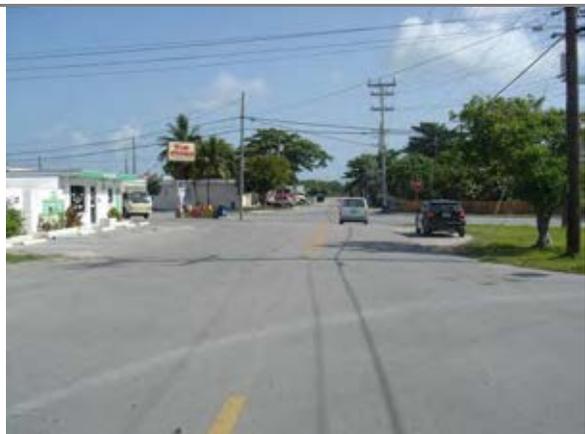
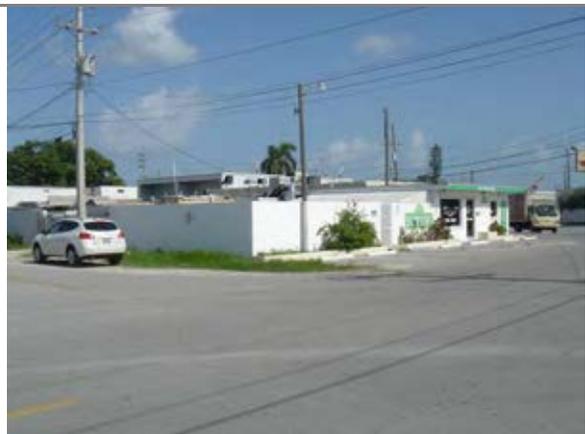
6.8 2 nd STREET AND 1 st AVENUE		
Road Atlas Identification:	S 7.1	S 4.1

Observation	Recommendations
<p>SOUTHEAST CORNER</p> <ul style="list-style-type: none"> ⊗ Sidewalk does not exist in this area. <p>SOUTHEAST SIDEWALK SOUTH ON 2nd STREET</p> <ul style="list-style-type: none"> • Survey Points 0'-100' ⊗ Sidewalk does not exist in this area. <p>SOUTHWEST SIDEWALK EAST ON 1st AVENUE</p> <ul style="list-style-type: none"> • Survey Points 0'-100' ⊗ Sidewalk does not exist in this area. <p>NORTHEAST CORNER</p> <ul style="list-style-type: none"> ⊗ Sidewalk does not exist in this area. <p>NORTHEAST SIDEWALK EAST ON 1st AVENUE</p> <ul style="list-style-type: none"> • Survey Points 0'-100' ⊗ Sidewalk does not exist in this area. <p>NORTHEAST SIDEWALK NORTH ON 2nd STREET</p> <ul style="list-style-type: none"> • Survey Points 0'-100' ⊗ Sidewalk does not exist in this area. <p>NORTHWEST CORNER</p> <ul style="list-style-type: none"> ⊗ Sidewalk does not exist in this area. <p>NORTHWEST SIDEWALK NORTH ON 2nd STREET</p> <ul style="list-style-type: none"> • Survey Points 0'-100' ⊗ Sidewalk does not exist in this area. <p>NORTHWEST SIDEWALK WEST ON 1st AVENUE</p> <ul style="list-style-type: none"> • Survey Points 0'-300' ⊗ Sidewalk does not exist in this area. <p>SOUTHWEST CORNER</p> <ul style="list-style-type: none"> ⊗ Sidewalk does not exist in this area. <p>SOUTHWEST SIDEWALK WEST ON 1st AVENUE</p> <ul style="list-style-type: none"> • Survey Points 0'-300' ⊗ Sidewalk does not exist in this area. <p>SOUTHWEST SIDEWALK SOUTH ON 2nd STREET</p> <ul style="list-style-type: none"> • Survey Points 0'-100' 	<p>A\$ - F\$\$ - Depending on the specific situation at each location, install accessible sidewalks and intersections in compliance with ADAAG and PROWAAC guidance and FDOT Design Standards. This should include, but not be limited to, detectable warnings, driveway crossings, street crossing markings, signs, and pedestrian crossing signals as required.</p>

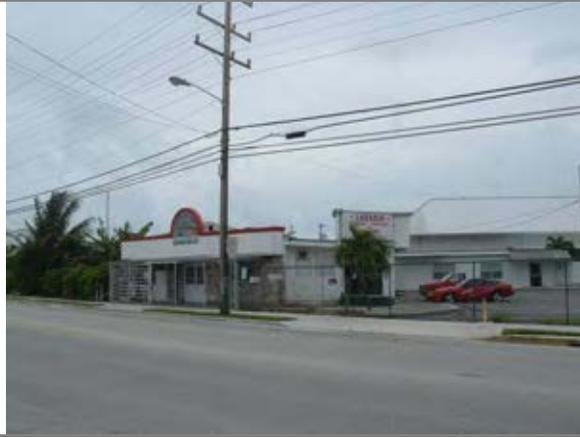
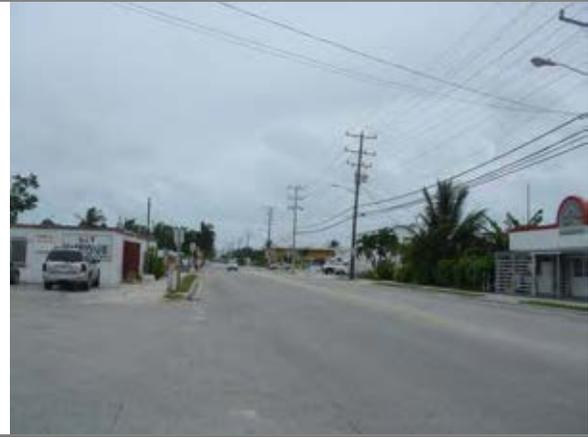
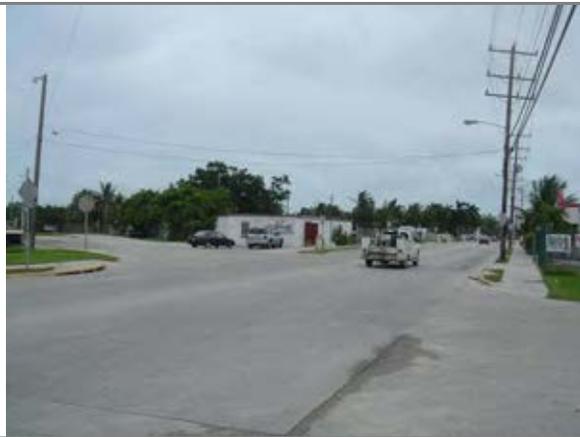
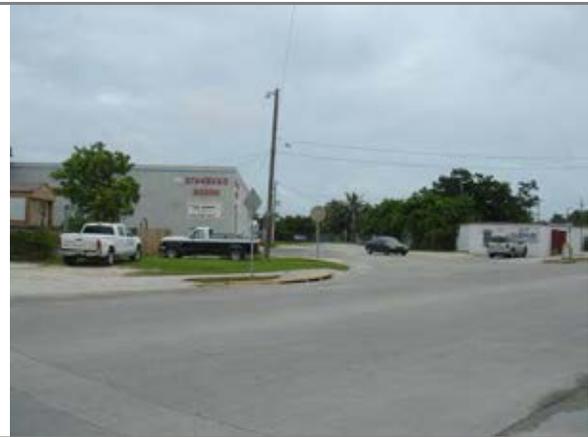
6.9	MALONEY AVENUE AND 1 st AVENUE
-----	---

Observation	Recommendations
<p>SOUTH CORNER</p> <ul style="list-style-type: none"> ⊗ Cracks / gaps greater than ½" in surface. (Typical Photo 07) ⊗ Detectable warnings are not provided. ⊗ Running Slope exceeds 5%. <p>SOUTH SIDEWALK WEST ON 1st AVENUE</p> <ul style="list-style-type: none"> • Survey Points 0'-100' ⊗ Sidewalks do not exist in this area. <p>SOUTH SIDEWALK SOUTHEAST ON MALONEY AVENUE</p> <ul style="list-style-type: none"> • Survey Points 0'-200' ⊗ Non-compliant driveway approach. (Typical Photo 04) <p>EAST CORNER</p> <ul style="list-style-type: none"> ⊗ Detectable warnings are not provided. ⊗ Running Slope exceeds 5%. ⊗ Cross slope exceeds 2%. <p>EAST SIDEWALK SOUTHEAST ON MALONEY AVENUE</p>	<p>A\$ - F\$\$ - Depending on the specific situation at each location, install accessible sidewalks and intersections in compliance with ADAAG and PROWAAC guidance and FDOT Design Standards. This should include, but not be limited to, detectable warnings, driveway crossings, street crossing markings, signs, and pedestrian crossing signals as required.</p>

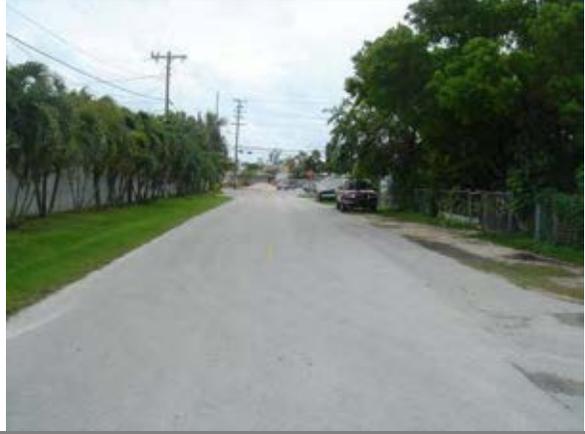
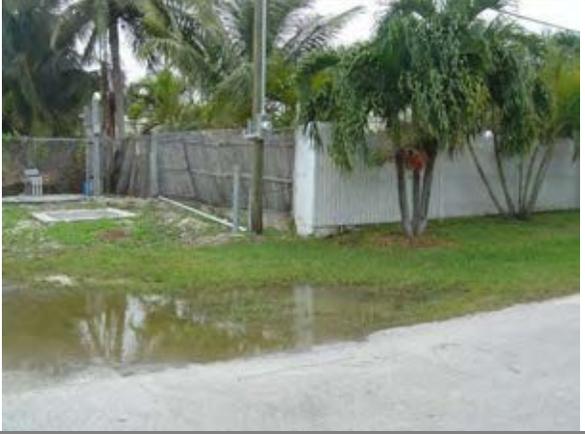
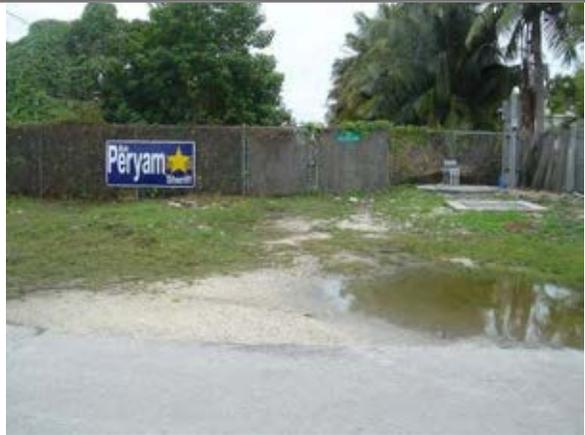
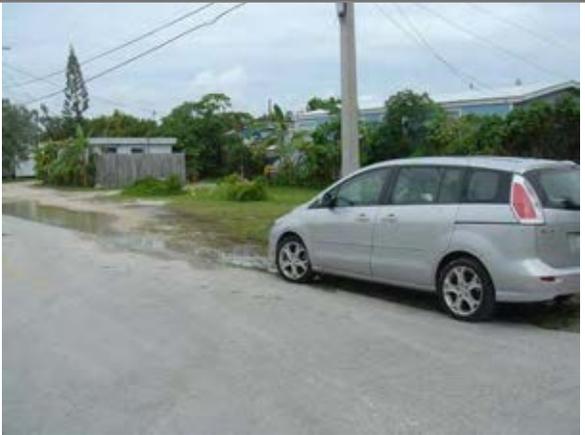
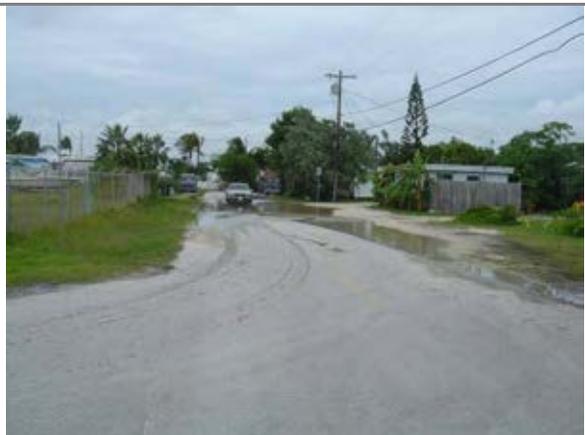
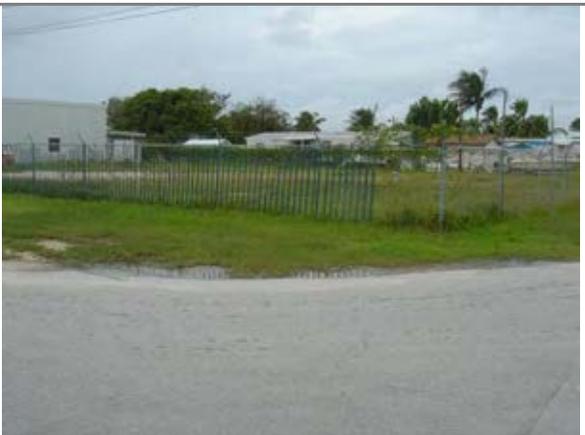
6.10 1 st STREET AND 1 st AVENUE		
Road Atlas Identification:	S 5.1	S 4.1

Observation	Recommendations
<p>EAST SIDEWALK SOUTH ON 1st STREET</p> <ul style="list-style-type: none"> • Survey Points 0'-100' ⊗ Sidewalk does not exist in this area. <p>EAST SIDEWALK NORTH ON 1st STREET</p> <ul style="list-style-type: none"> • Survey Points 0'-200' ⊗ Sidewalk does not exist in this area. <p>NORTHWEST CORNER</p> <ul style="list-style-type: none"> ⊗ Sidewalk does not exist in this area. <p>NORTHWEST SIDEWALK NORTH ON 1st STREET</p> <ul style="list-style-type: none"> • Survey Points 0'-200' ⊗ Sidewalk does not exist in this area. <p>NORTHWEST SIDEWALK WEST ON 1st AVENUE</p> <ul style="list-style-type: none"> • Survey Points 0'-200' ⊗ Sidewalk does not exist in this area. <p>SOUTHWEST CORNER</p> <ul style="list-style-type: none"> ⊗ Sidewalk does not exist in this area. <p>SOUTHWEST SIDEWALK WEST ON 1st AVENUE</p> <ul style="list-style-type: none"> • Survey Points 0'-200' ⊗ Sidewalk does not exist in this area. <p>SOUTHWEST SIDEWALK SOUTH ON 1st STREET</p> <ul style="list-style-type: none"> • Survey Points 0'-100' ⊗ Sidewalk does not exist in this area. 	<p>AS - F\$\$ - Depending on the specific situation at each location, install accessible sidewalks and intersections in compliance with ADAAG and PROWAAC guidance and FDOT Design Standards. This should include, but not be limited to, detectable warnings, driveway crossings, street crossing markings, signs, and pedestrian crossing signals as required.</p>

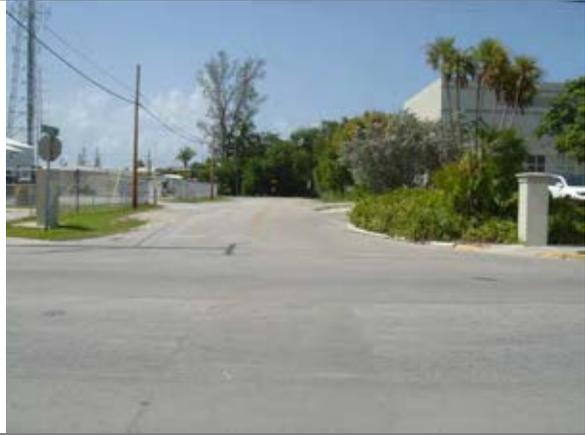
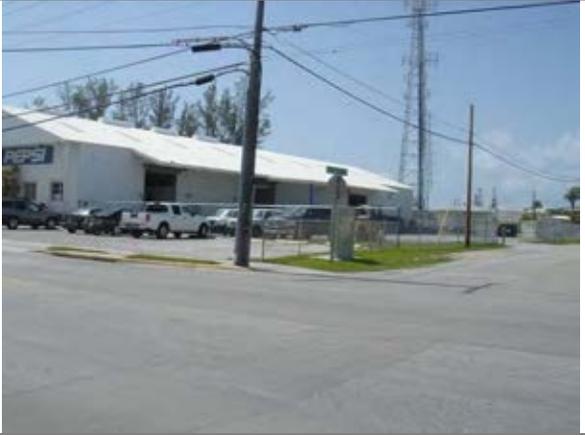
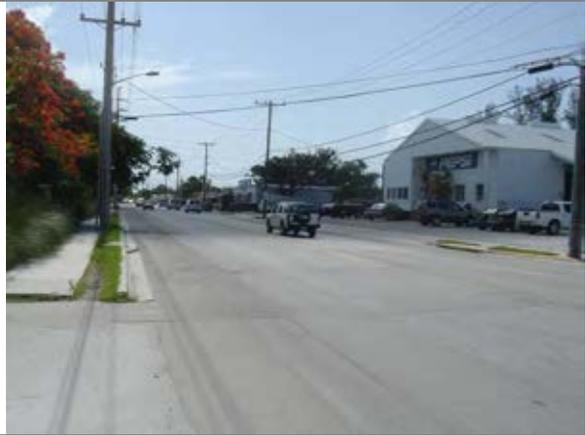
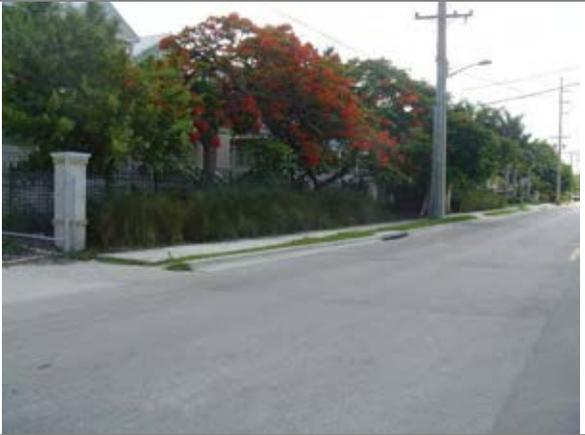
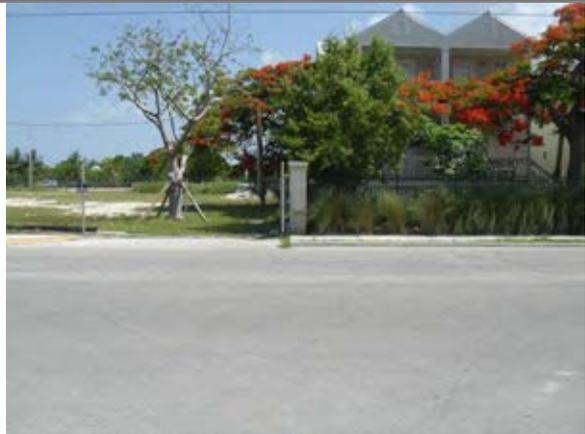
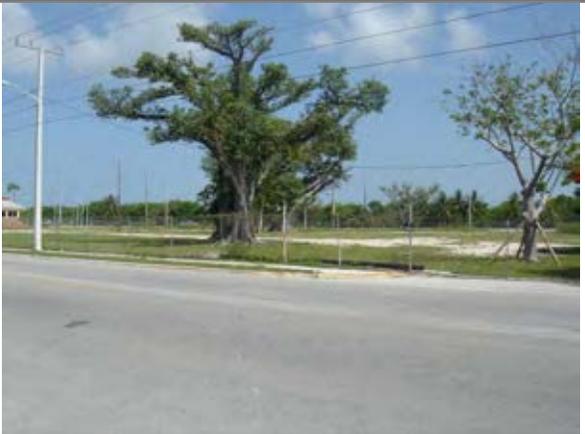
6.11 4 th STREET AND MacDONALD AVENUE	
Road Atlas Identification:	S X.XX S 4.1

Observation	Recommendations
<p>SOUTHEAST CORNER</p> <ul style="list-style-type: none"> ⊗ Non-compliant detectable warnings at corner. (Typical Photo 02) <p>SOUTHEAST SIDEWALK SOUTH ON 4th STREET</p> <ul style="list-style-type: none"> • Survey Points 0'-100' ⊗ Sidewalk does not exist in this area. <p>SOUTHEAST SIDEWALK EAST ON MacDONALD AVENUE</p> <ul style="list-style-type: none"> • Survey Points 0'-300' ⊗ Non-compliant driveway approach. (Typical Photo 04) <p>NORTH SIDEWALK EAST ON MacDONALD AVENUE</p> <ul style="list-style-type: none"> • Survey Points 0'-100' ⊗ Sidewalk stops at curb cut with no accessible connection to street. (Typical Photo 10) ⊗ Non-compliant driveway approach. (Typical Photo 04) ⊗ Cracks / gaps greater than ½" in surface. (Typical Photo 07) • Survey Points 100'-300' ⊗ Non-compliant driveway approach. (Typical Photo 04) ⊗ Cracks / gaps greater than ½" in surface. (Typical Photo 07) <p>NORTH SIDEWALK WEST ON MacDONALD AVENUE</p> <ul style="list-style-type: none"> • Survey Points 0'-100' ⊗ Sidewalk stops at curb cut with no accessible connection to street. (Typical Photo 10) • Survey Points 100'-300' ✓ ADA Compliant <p>SOUTHWEST CORNER</p> <ul style="list-style-type: none"> ⊗ Non-compliant detectable warnings at corner. (Typical Photo 02) ⊗ Running Slope exceeds 5%. ⊗ Cross slope exceeds 2%. 	<p>A\$ - F\$\$ - Depending on the specific situation at each location, install accessible sidewalks and intersections in compliance with ADAAG and PROWAAC guidance and FDOT Design Standards. This should include, but not be limited to, detectable warnings, driveway crossings, street crossing markings, signs, and pedestrian crossing signals as required.</p>

Observation	Recommendations
SOUTHWEST SIDEWALK WEST ON MacDONALD AVENUE <ul style="list-style-type: none"> • Survey Points 0'-300' ✓ ADA Compliant SOUTHWEST SIDEWALK SOUTH ON 4 th STREET <ul style="list-style-type: none"> • Survey Points 0'-100' ⊗ Sidewalk does not exist in this area.

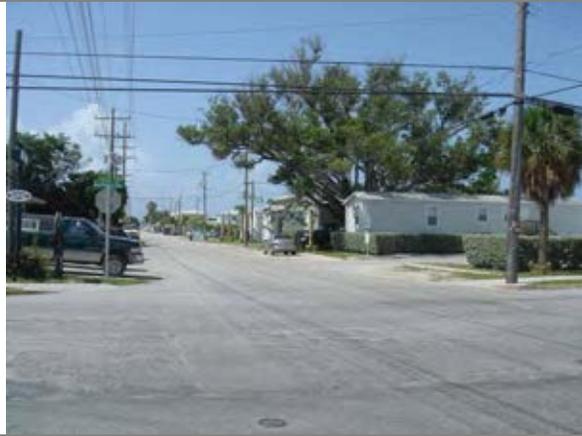
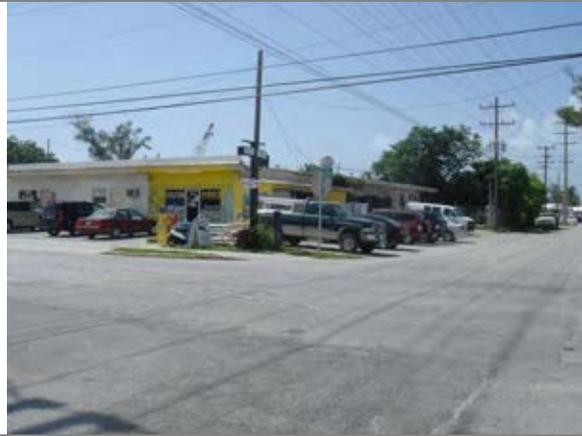
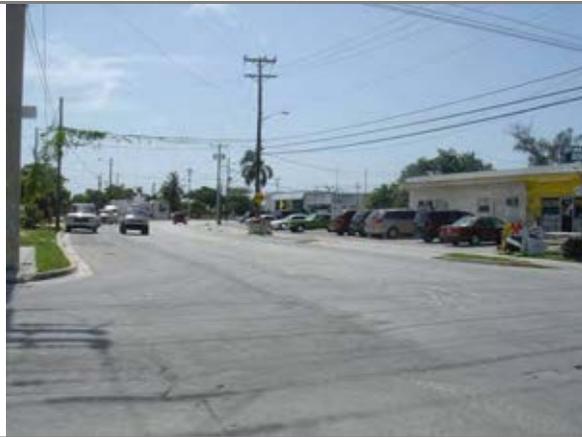
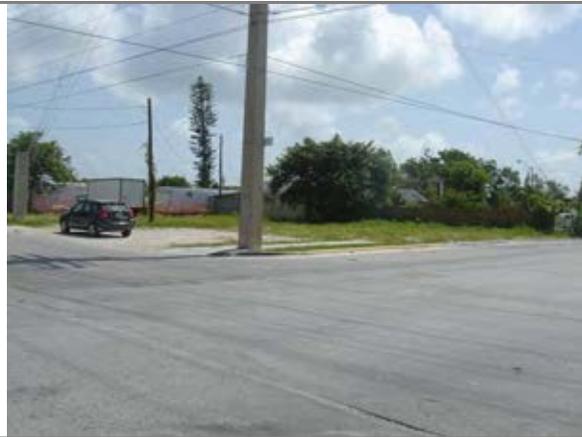
6.12 3rd STREET AND MacDONALD AVENUE

Observation	Recommendations
<p>SOUTHEAST CORNER</p> <ul style="list-style-type: none"> ⊗ Non-compliant detectable warnings at corner. (Typical Photo 02) ⊗ Running Slope exceeds 5%. <p>SOUTHEAST SIDEWALK SOUTH ON 3rd STREET</p> <ul style="list-style-type: none"> • Survey Points 0'-100' ⊗ Sidewalk does not exist in this area. <p>SOUTHEAST SIDEWALK EAST ON MacDONALD AVENUE</p> <ul style="list-style-type: none"> • Survey Points 0'-100' ⊗ Non-compliant driveway approach. (Typical Photo 04) ⊗ Cracks / gaps greater than 1/2" in surface. (Typical Photo 07) <p>NORTHEAST CORNER</p> <ul style="list-style-type: none"> ⊗ Non-compliant detectable warnings at corner. (Typical Photo 02) ⊗ Running Slope exceeds 5%. 	<p>A\$ - F\$\$ - Depending on the specific situation at each location, install accessible sidewalks and intersections in compliance with ADAAG and PROWAAC guidance and FDOT Design Standards. This should include, but not be limited to, detectable warnings, driveway crossings, street crossing markings, signs, and pedestrian crossing signals as required.</p>

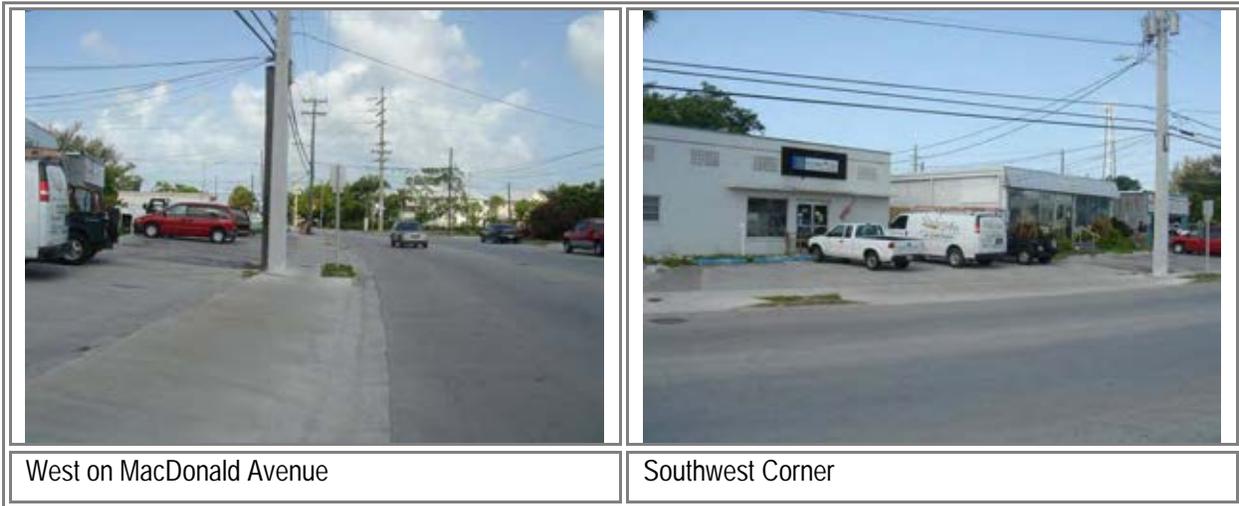
Observation	Recommendations
<p>EAST CORNER</p> <ul style="list-style-type: none"> ⊗ Non-compliant detectable warnings at corner. (Typical Photo 02) <p>EAST SIDEWALK SOUTHEAST ON MALONEY AVENUE</p> <ul style="list-style-type: none"> • Survey Points 0'-100' ✓ ADA Compliant <p>EAST SIDEWALK EAST ON MacDONALD AVENUE</p> <ul style="list-style-type: none"> • Survey Points 0'-100' ⊗ Sidewalk does not exist in this area. <p>NORTH CORNER</p> <ul style="list-style-type: none"> ⊗ Non-compliant detectable warnings at corner. (Typical Photo 02) ⊗ Running Slope exceeds 5%. ⊗ Cross slope exceeds 2%. <p>NORTH SIDEWALK EAST ON MacDONALD</p> <ul style="list-style-type: none"> • Survey Points 0'-100' ⊗ Sidewalk does not exist in this area. <p>NORTH SIDEWALK WEST ON MacDONALD AVENUE</p> <ul style="list-style-type: none"> • Survey Points 0'-100' ⊗ Non-compliant driveway approach. (Typical Photo 04) • Survey Points 100'-200' ⊗ Non-compliant driveway approach. (Typical Photo 04) ⊗ Sidewalk exists partially in this area. <p>SOUTHWEST SIDEWALK WEST ON MacDONALD AVENUE</p> <ul style="list-style-type: none"> • Survey Points 0'-100' ⊗ Non-compliant driveway approach. (Typical Photo 04) ⊗ Manhole cover protrudes above sidewalk surface. ⊗ Cracks / gaps greater than ½" in surface. (Typical Photo 07) ⊗ Cross slope exceeds 2%. • Survey Points 100'-200' 	<p>A\$ - F\$\$ - Depending on the specific situation at each location, install accessible sidewalks and intersections in compliance with ADAAG and PROWAAC guidance and FDOT Design Standards. This should include, but not be limited to, detectable warnings, driveway crossings, street crossing markings, signs, and pedestrian crossing signals as required.</p>

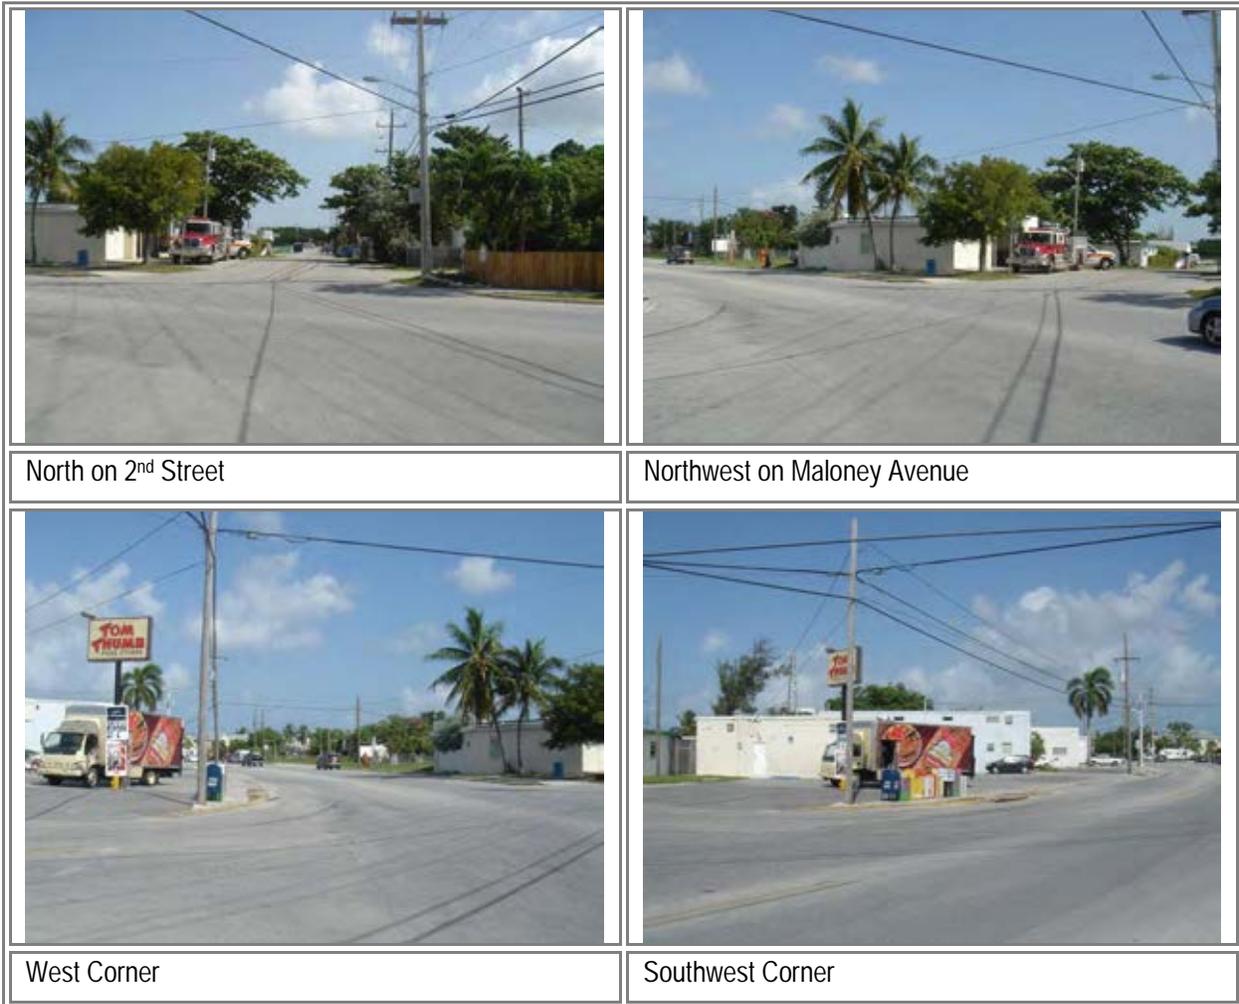
Observation	Recommendations
<p>SOUTHEAST CORNER</p> <ul style="list-style-type: none"> ⊗ Cracks / gaps greater than ½" in surface. (Typical Photo 07) ⊗ Cross slope exceeds 2%. ⊗ Existing Sidewalks do not provide accessible connection to street. (Typical Photo 10) <p>SOUTHEAST SIDEWALK SOUTH ON 2nd STREET</p> <ul style="list-style-type: none"> • Survey Points 0'-100' ⊗ Sidewalk does not exist in this area. <p>SOUTHEAST SIDEWALK SOUTHEAST ON MALONEY AVENUE</p> <ul style="list-style-type: none"> • Survey Points 0'-100' ⊗ Cross slope exceeds 2%. <p>NORTHEAST CORNER</p> <ul style="list-style-type: none"> ⊗ Cracks / gaps greater than ½" in surface. (Typical Photo 07) 	<p>A\$ - F\$\$ - Depending on the specific situation at each location, install accessible sidewalks and intersections in compliance with ADAAG and PROWAAC guidance and FDOT Design Standards. This should include, but not be limited to, detectable warnings, driveway crossings, street crossing markings, signs, and pedestrian crossing signals as required.</p>

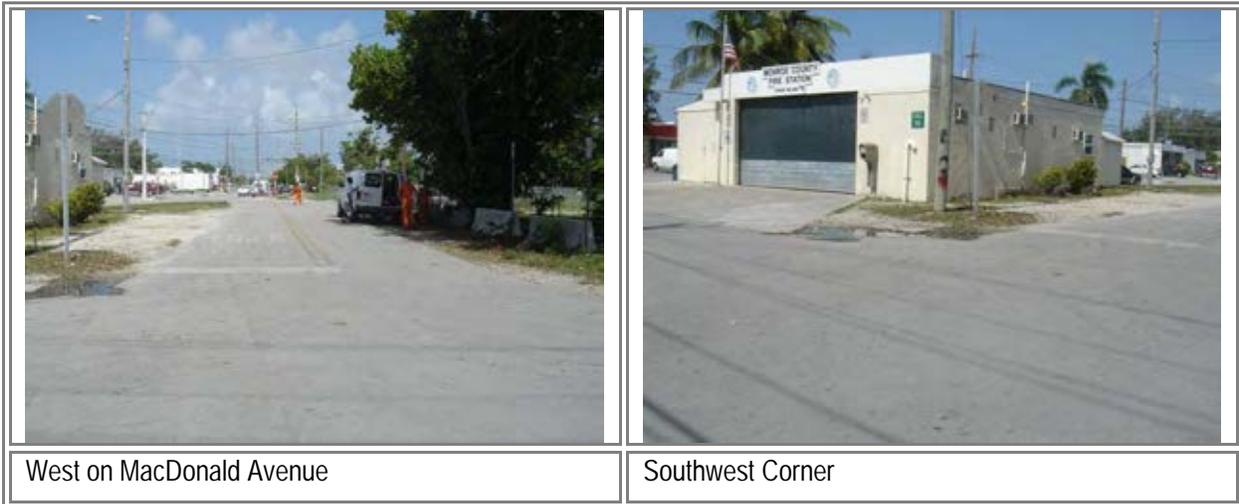
Observation	Recommendations
<p>SOUTHEAST CORNER</p> <ul style="list-style-type: none"> ⊗ Sidewalk does not exist in this area. <p>SOUTHEAST SIDEWALK SOUTH ON 2nd STREET</p> <ul style="list-style-type: none"> • Survey Points 0'-100' ⊗ Sidewalk does not exist in this area. <p>SOUTHEAST SIDEWALK EAST ON MacDONALD AVENUE</p> <ul style="list-style-type: none"> • Survey Points 0'-200' ⊗ Sidewalk does not exist in this area. <p>NORTHEAST CORNER</p> <ul style="list-style-type: none"> ⊗ Sidewalk does not exist in this area. <p>NORTHEAST SIDEWALK EAST ON MacDONALD AVENUE</p> <ul style="list-style-type: none"> • Survey Points 0'-200' ⊗ Sidewalk does not exist in this area. <p>NORTHEAST SIDEWALK NORTH ON 2nd STREET</p> <ul style="list-style-type: none"> • Survey Points 0'-200' ⊗ Sidewalk does not exist in this area. <p>NORTHWEST CORNER</p> <ul style="list-style-type: none"> ⊗ Sidewalk does not exist in this area. <p>NORTHWEST SIDEWALK NORTH ON 2nd STREET</p> <ul style="list-style-type: none"> • Survey Points 0'-200' ⊗ Sidewalk does not exist in this area. <p>NORTHWEST SIDEWALK WEST ON MacDONALD AVENUE</p> <ul style="list-style-type: none"> • Survey Points 0'-200' ⊗ Sidewalk does not exist in this area. <p>SOUTHWEST CORNER</p> <ul style="list-style-type: none"> ⊗ Sidewalk does not exist in this area. <p>SOUTHWEST SIDEWALK WEST ON MacDONALD AVENUE</p> <ul style="list-style-type: none"> • Survey Points 0'-200' ⊗ Sidewalk does not exist in this area. <p>SOUTHWEST SIDEWALK SOUTH ON 2nd STREET</p> <ul style="list-style-type: none"> • Survey Points 0'-100' 	<p>A\$ - F\$\$ - Depending on the specific situation at each location, install accessible sidewalks and intersections in compliance with ADAAG and PROWAAC guidance and FDOT Design Standards. This should include, but not be limited to, detectable warnings, driveway crossings, street crossing markings, signs, and pedestrian crossing signals as required.</p>

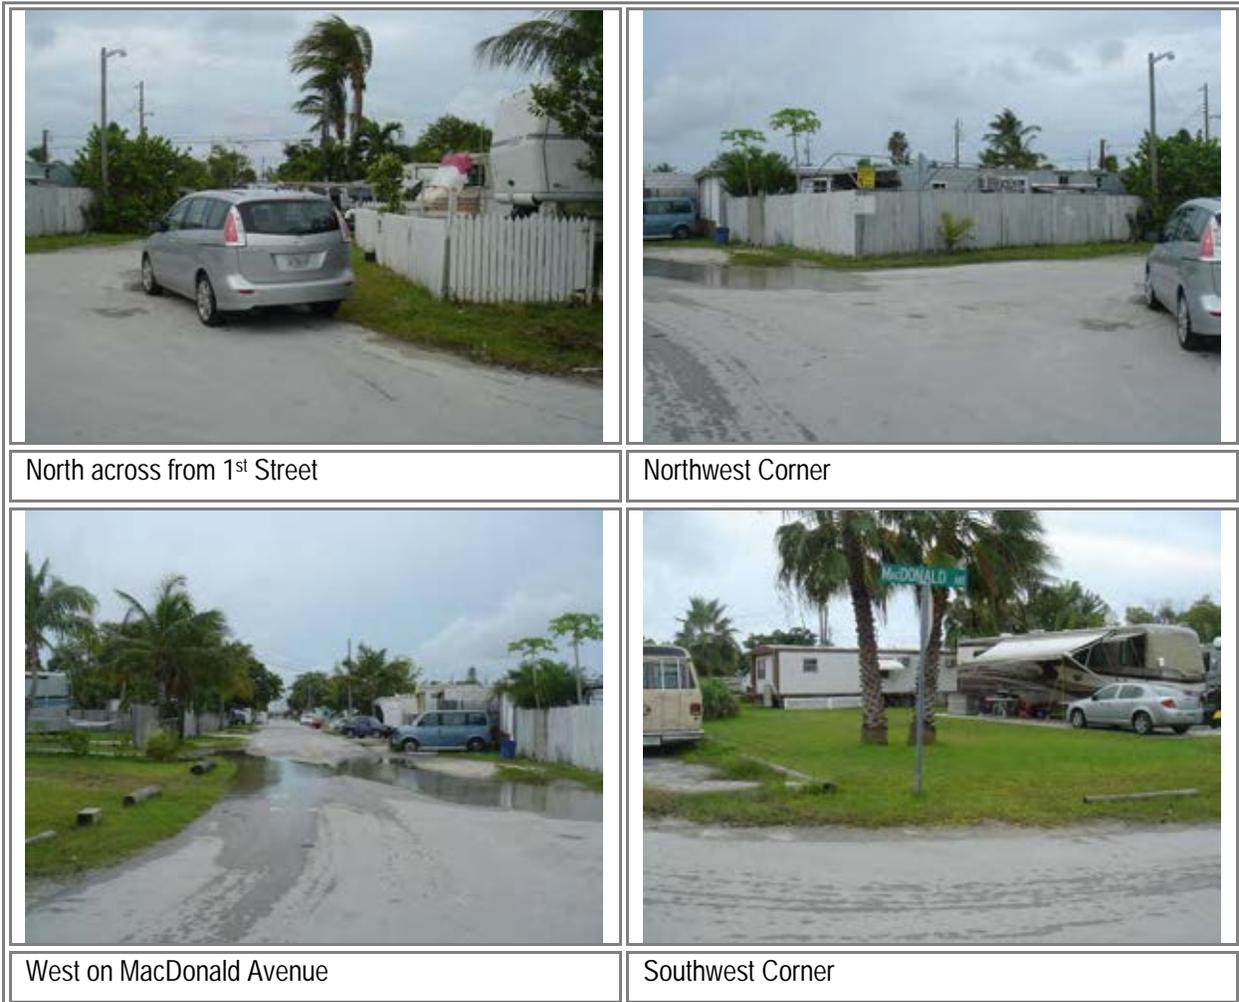
Observation	Recommendations
<p>NORTHEAST CORNER</p> <ul style="list-style-type: none"> ⊗ Sidewalk does not exist in this area. <p>NORTHEAST SIDEWALK SOUTH ON 1st STREET</p> <ul style="list-style-type: none"> • Survey Points 0'-100' ⊗ Sidewalk does not exist in this area. <p>NORTHEAST SIDEWALK WEST ON MacDONALD AVENUE</p> <ul style="list-style-type: none"> • Survey Points 0'-300' ⊗ Sidewalk does not exist in this area. <p>SOUTHWEST CORNER</p> <ul style="list-style-type: none"> ⊗ Sidewalk does not exist in this area. <p>SOUTHWEST SIDEWALK WEST ON MacDONALD AVENUE</p> <ul style="list-style-type: none"> • Survey Points 0'-300' ⊗ Sidewalk does not exist in this area. <p>SOUTHWEST SIDEWALK SOUTH ON 1st STREET</p> <ul style="list-style-type: none"> • Survey Points 0'-100' ⊗ Sidewalk does not exist in this area. 	<p>A\$ - F\$\$ - Depending on the specific situation at each location, install accessible sidewalks and intersections in compliance with ADAAG and PROWAAAC guidance and FDOT Design Standards. This should include, but not be limited to, detectable warnings, driveway crossings, street crossing markings, signs, and pedestrian crossing signals as required.</p>

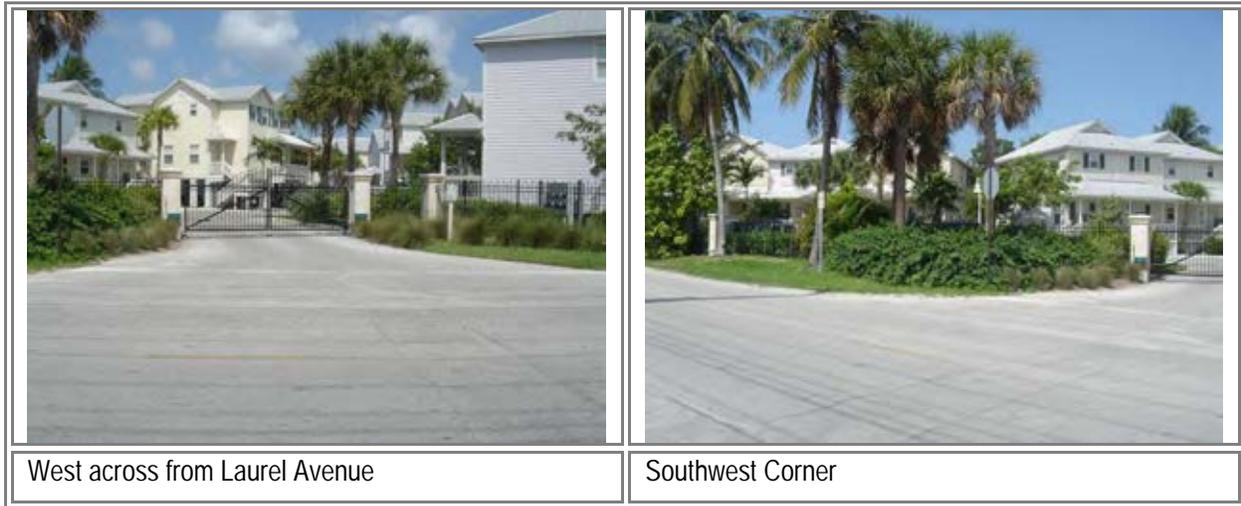
Observation	Recommendations
<p>SOUTHEAST CORNER</p> <ul style="list-style-type: none"> ⊗ Sidewalk does not exist in this area. <p>SOUTHEAST SIDEWALK SOUTH ON 3rd STREET</p> <ul style="list-style-type: none"> • Survey Points 0'-100' ⊗ Sidewalk does not exist in this area. <p>SOUTHEAST SIDEWALK EAST ON LAUREL AVENUE</p> <ul style="list-style-type: none"> • Survey Points 0'-200' ⊗ Sidewalk does not exist in this area. <p>NORTHEAST CORNER</p> <ul style="list-style-type: none"> ⊗ Sidewalk does not exist in this area. <p>NORTHEAST SIDEWALK EAST ON LAUREL AVENUE</p> <ul style="list-style-type: none"> • Survey Points 0'-200' ⊗ Sidewalk does not exist in this area. <p>NORTHEAST SIDEWALK NORTH ON 3rd STREET</p> <ul style="list-style-type: none"> • Survey Points 0'-200' ⊗ Sidewalk does not exist in this area. <p>WEST SIDEWALK NORTH ON 3rd STREET</p> <ul style="list-style-type: none"> • Survey Points 0'-200' ⊗ Sidewalk does not exist in this area. <p>WEST SIDEWALK SOUTH ON 3rd STREET</p> <ul style="list-style-type: none"> • Survey Points 0'-100' ⊗ Sidewalk does not exist in this area. 	<p>A\$ - F\$\$ - Depending on the specific situation at each location, install accessible sidewalks and intersections in compliance with ADAAG and PROWAAC guidance and FDOT Design Standards. This should include, but not be limited to, detectable warnings, driveway crossings, street crossing markings, signs, and pedestrian crossing signals as required.</p>

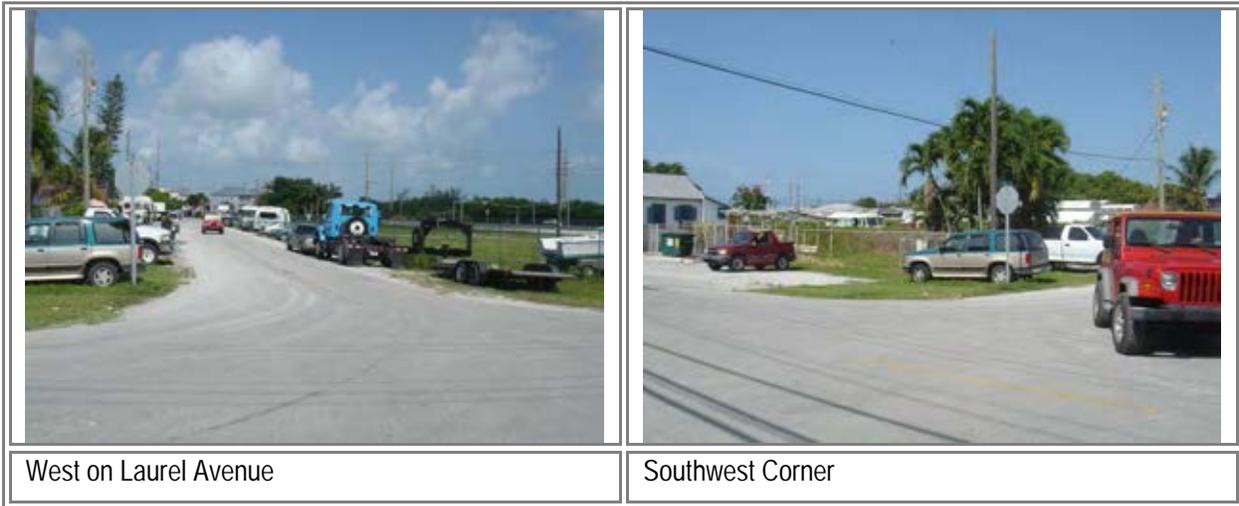
Observation	Recommendations
<p>SOUTHEAST CORNER ☒ Sidewalk does not exist in this area.</p> <p>SOUTHEAST SIDEWALK SOUTH ON 2nd STREET</p> <ul style="list-style-type: none"> • Survey Points 0'-100' ☒ Sidewalk does not exist in this area. <p>SOUTHEAST SIDEWALK EAST ON LAUREL AVENUE</p> <ul style="list-style-type: none"> • Survey Points 0'-300' ☒ Sidewalk does not exist in this area. <p>NORTHEAST CORNER ☒ Sidewalk does not exist in this area.</p> <p>NORTHEAST SIDEWALK EAST ON LAUREL AVENUE</p> <ul style="list-style-type: none"> • Survey Points 0'-300' ☒ Sidewalk does not exist in this area. <p>NORTHEAST SIDEWALK NORTH ON 2nd STREET</p> <ul style="list-style-type: none"> • Survey Points 0'-300' ☒ Sidewalk does not exist in this area. <p>NORTHWEST CORNER ☒ Sidewalk does not exist in this area.</p> <p>NORTHWEST SIDEWALK NORTH ON 2nd STREET</p> <ul style="list-style-type: none"> • Survey Points 0'-300' ☒ Sidewalk does not exist in this area. <p>NORTHWEST SIDEWALK WEST ON LAUREL AVENUE</p> <ul style="list-style-type: none"> • Survey Points 0'-300' ☒ Sidewalk does not exist in this area. <p>SOUTHWEST CORNER ☒ Sidewalk does not exist in this area.</p> <p>SOUTHWEST SIDEWALK WEST ON LAUREL AVENUE</p> <ul style="list-style-type: none"> • Survey Points 0'-300' ☒ Sidewalk does not exist in this area. <p>SOUTHWEST SIDEWALK SOUTH ON 2nd STREET</p> <ul style="list-style-type: none"> • Survey Points 0'-100' 	<p>A\$ - F\$\$ - Depending on the specific situation at each location, install accessible sidewalks and intersections in compliance with ADAAG and PROWAAC guidance and FDOT Design Standards. This should include, but not be limited to, detectable warnings, driveway crossings, street crossing markings, signs, and pedestrian crossing signals as required.</p>
