Americans with Disabilities Act Transition Plan Lower Keys - Part 2

Volume 4 of 4

Monroe County

October 29, 2010

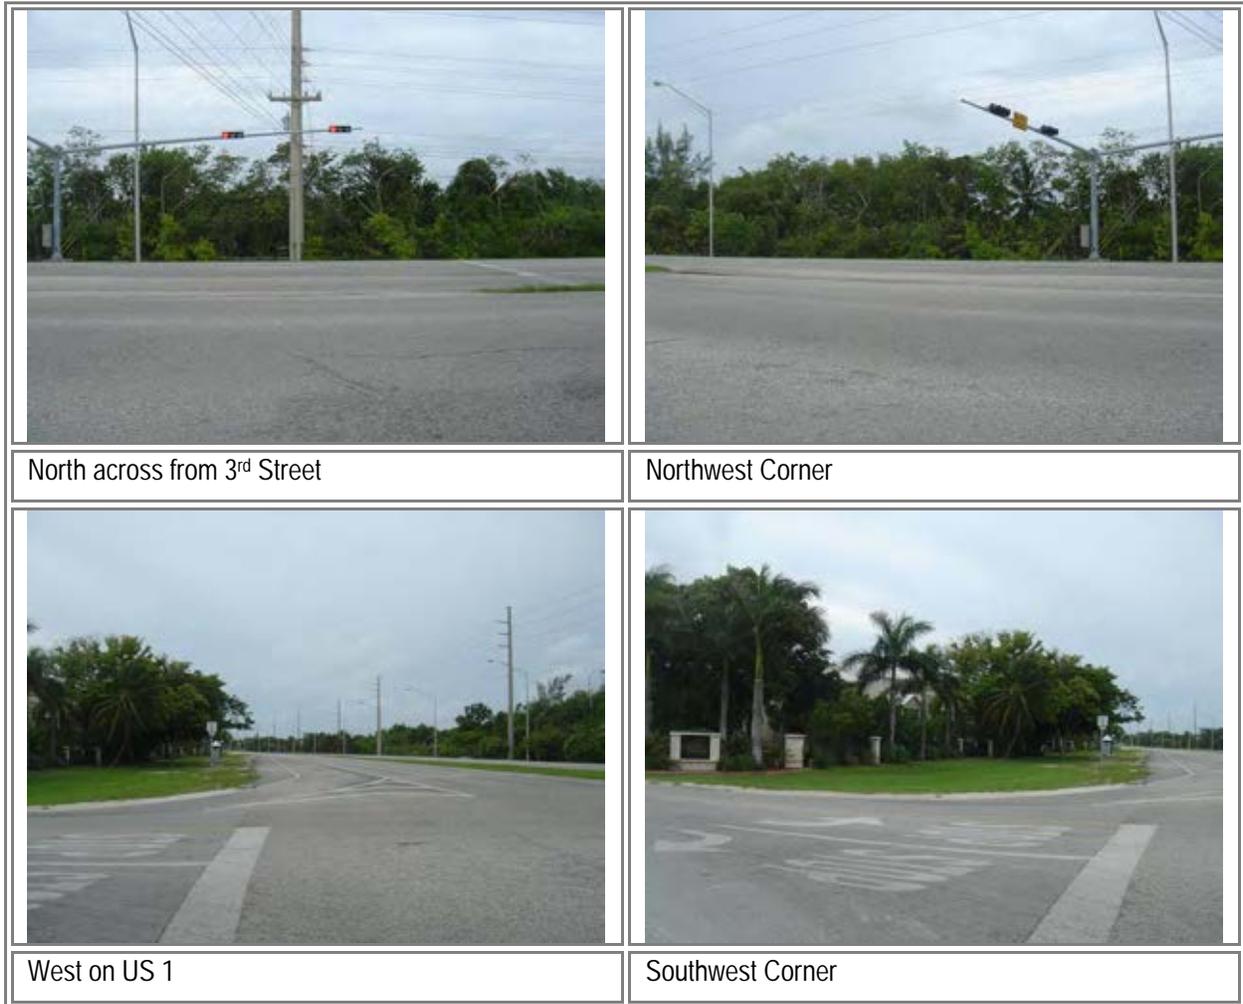
Observation	Recommendations
<p>SOUTHEAST CORNER</p> <ul style="list-style-type: none"> ⊗ Sidewalk does not exist in this area. <p>SOUTHEAST SIDEWALK SOUTH ON 3rd STREET</p> <ul style="list-style-type: none"> • Survey Points 0'-100' ⊗ Sidewalk does not exist in this area. <p>SOUTHWEST CORNER</p> <ul style="list-style-type: none"> ⊗ Sidewalk does not exist in this area. <p>SOUTHWEST SIDEWALK SOUTH ON 3rd STREET</p> <ul style="list-style-type: none"> • Survey Points 0'-100' ⊗ Sidewalk does not exist in this area. 	<p>A\$ - F\$\$ - Depending on the specific situation at each location, install accessible sidewalks and intersections in compliance with ADAAG and PROWAC guidance and FDOT Design Standards. This should include, but not be limited to, detectable warnings, driveway crossings, street crossing markings, signs, and pedestrian crossing signals as required.</p>

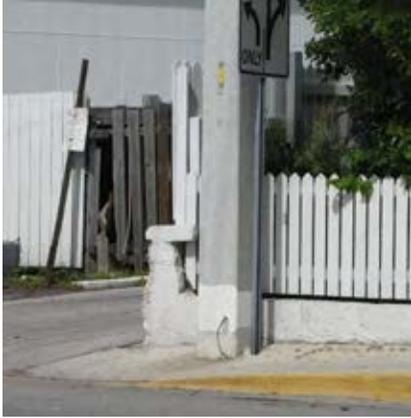
Typical Photo 01: Utility pole reduces clear width

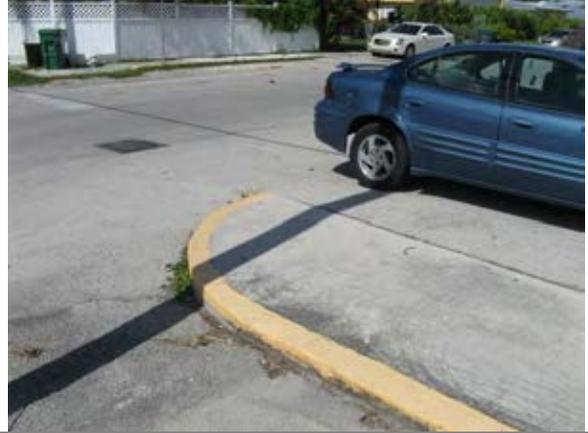
Typical Photo 02: Sidewalk ends abruptly

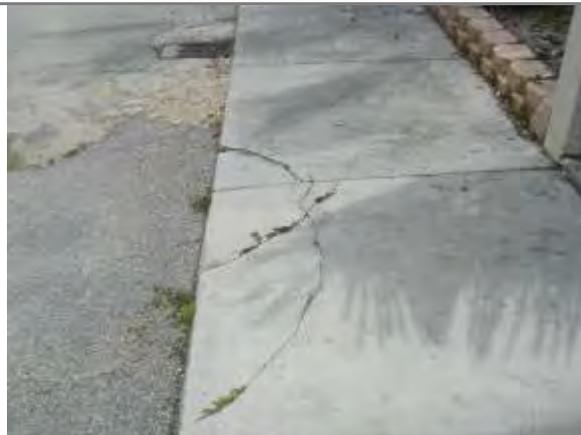
Typical Photo 03: Cracks greater than 1/2" in surface

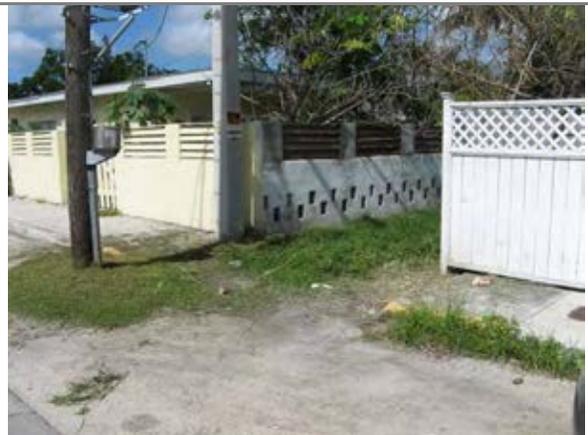
Typical Photo 04: Non-compliant crossing of right of way alley

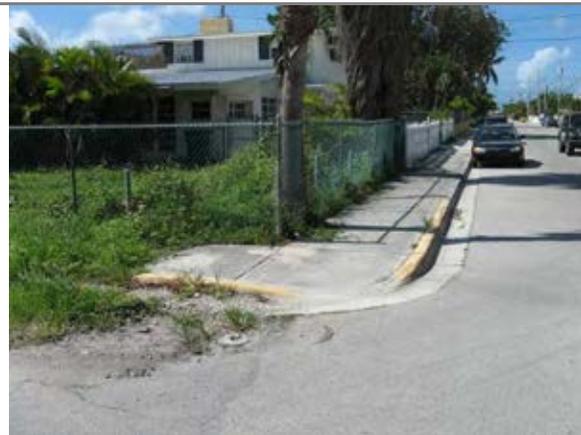
Typical Photo 05: Sidewalk exists partially in this area

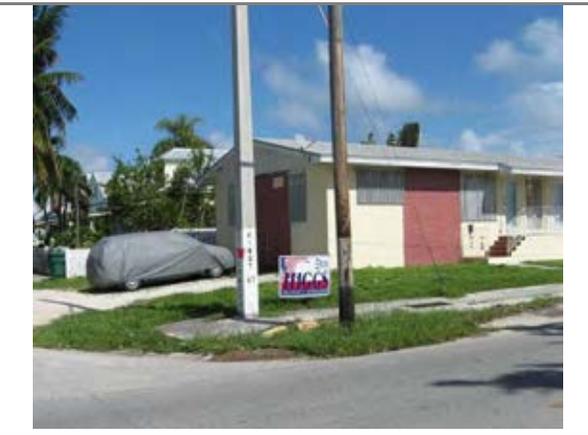
Typical Photo 06: Existing sidewalk does not provide accessible connection to street

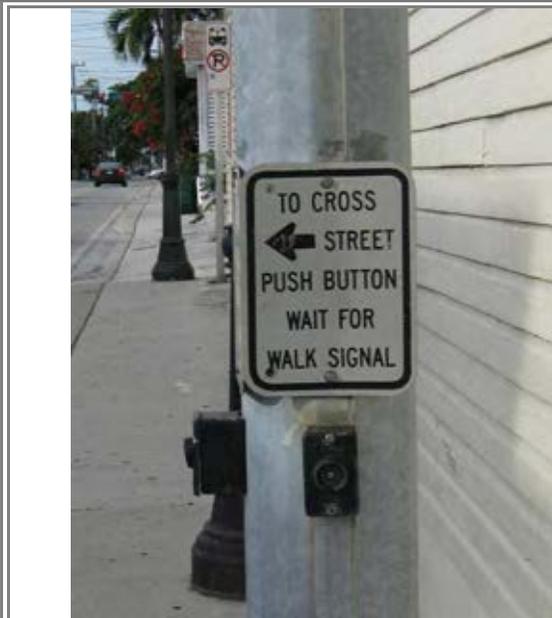
Typical Photo 07: Pedestrian Detector with incorrect push button control

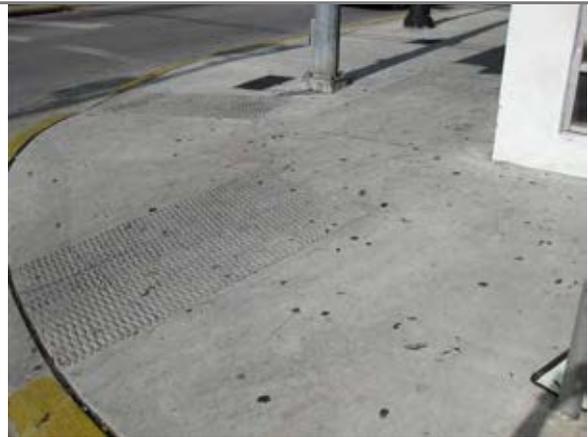
Typical Photo 08: Existing sidewalk with non-compliant pressed diamond shape detectable warning

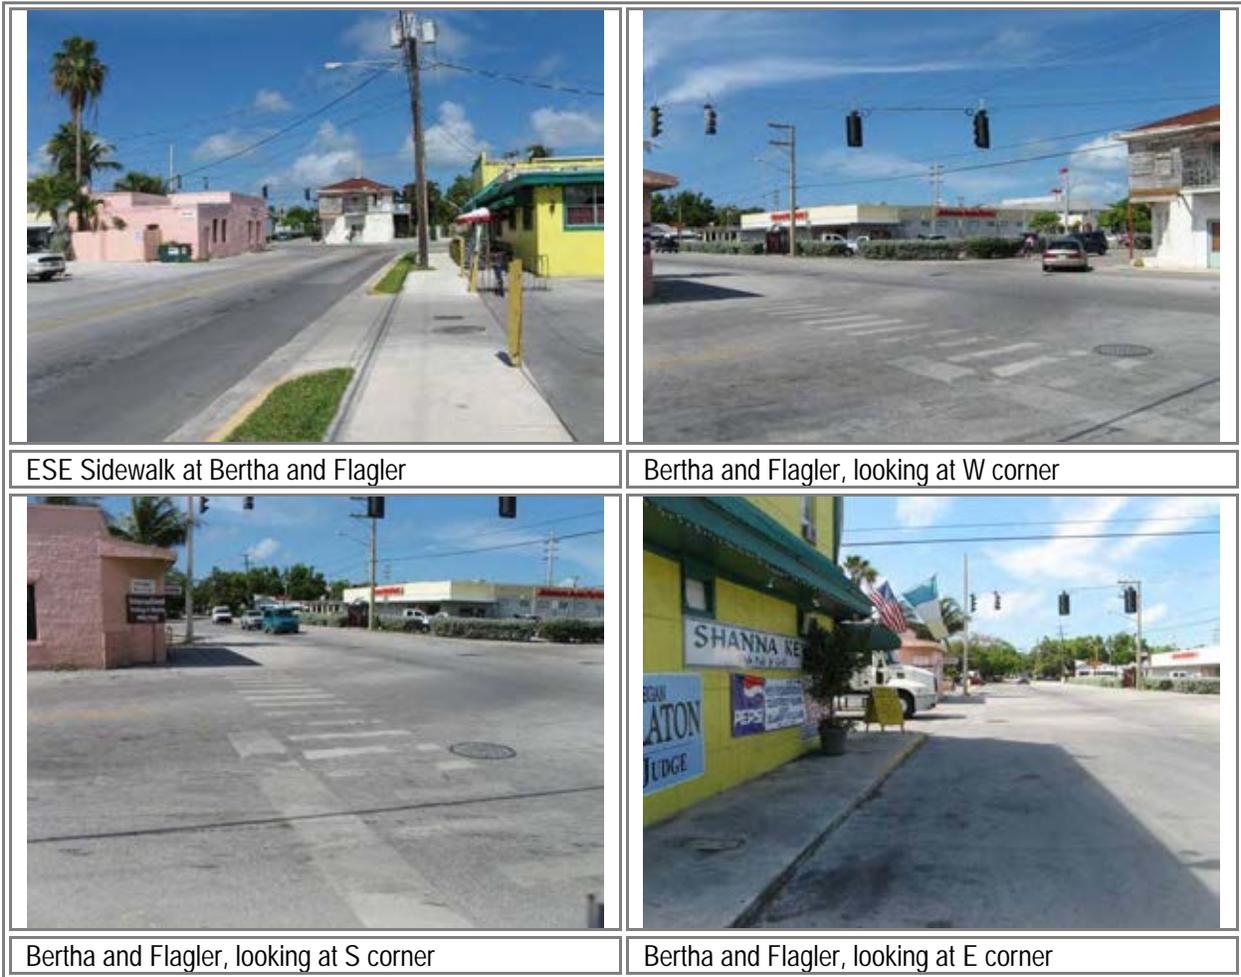
5.2 BERTHA STREET OBSERVATIONS	
Observation	Recommendations
<p>BERTHA and South Roosevelt Blvd. The sidewalk exists only on the ENE portion of S. Roosevelt and the WNW portion of Bertha. It runs to Atlantic. There is no sidewalk on the NNW side of the street.</p>	
<p>BERTHA and Atlantic There is a sidewalk on the S corner on both Bertha and Atlantic. There is a partial ESE sidewalk that runs several hundred feet toward the ocean and stops abruptly.</p> <ul style="list-style-type: none"> ✓ There are curb ramps and detectable warnings on the N and E corners. ⊗ Pedestrian crossing lines do not exit across Bertha from the E to S corners. <p>There is no sidewalk on the W corner.</p> <ul style="list-style-type: none"> ⊗ The S corner curb ramp has nowhere to go. 	<p>A\$ - Repaint pedestrian crosswalk areas in accordance with FDOT Design Standards.</p>

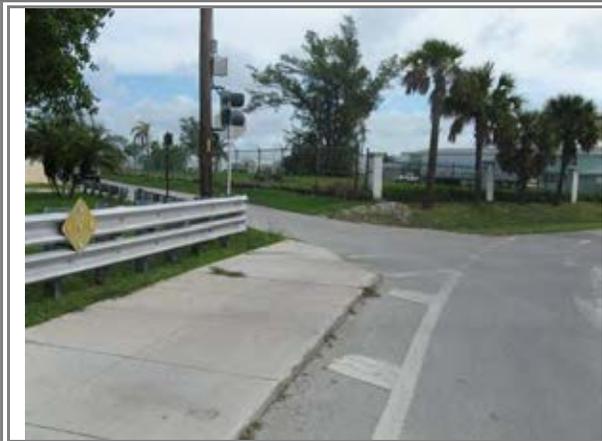
PALM Ave. and Upton Ct.

8.2 PALM AVENUE OBSERVATIONS	
Observation	Recommendations
<p>PALM and Upton Ct. The north sidewalk ends at Upton Ct. with a curb ramp to the pavement level. The bicycle route turns into an ongoing paved sidewalk/bicycle route. There is a paved sidewalk on the south side of Palm also.</p> <ul style="list-style-type: none"> ⊗ There are no detectable warnings at the end of the sidewalk. ⊗ There are no markings across Upton, leading to the bike path. 	<p>A\$ - Install detectable warnings in accordance with FDOT Design Standards. A\$ - Repaint pedestrian crosswalk areas in accordance with FDOT Design Standards. City of Key West areas of responsibility.</p>
<p>PALM and Ely Street Ely leads into Trumbo Point Annex. There are no curb ramps. The sidewalk/bike path runs across the street. The lines of the bike path run across the intersection.</p> <ul style="list-style-type: none"> ⊗ There are no detectable warnings to indicate a street crossing. <p>There is a bus stop just to the east of Ely St. The bike path follows the recessed area for the bus stop.</p> <ul style="list-style-type: none"> ✓ It is clearly marked. 	<p>A\$ - Install detectable warnings in accordance with FDOT Design Standards. City of Key West areas of responsibility.</p>

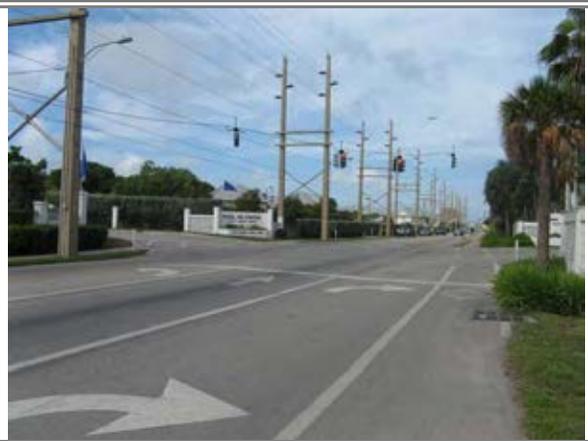
PALM Ave. and Peary Ct. intersection

<p>PALM and Peary Ct. Peary Ct. leads into Peary Court Annex. There are no curb ramps. The sidewalk/bike path runs across the street. The lines of the bike path run across the intersection.</p> <ul style="list-style-type: none"> ⊗ There are no detectable warnings to indicate a street crossing. ✓ The street turning lanes are clearly marked. 	<p>A\$ - Install detectable warnings in accordance with FDOT Design Standards. City of Key West areas of responsibility.</p>

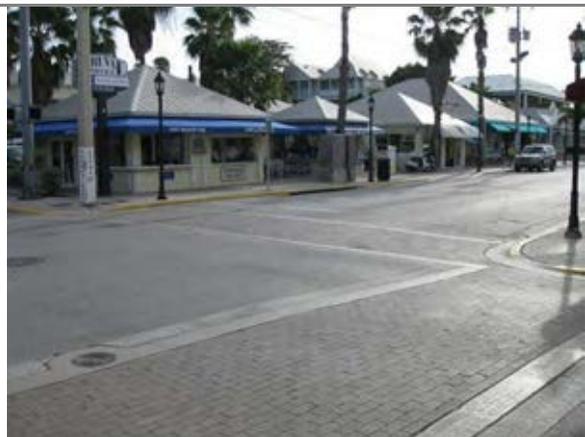
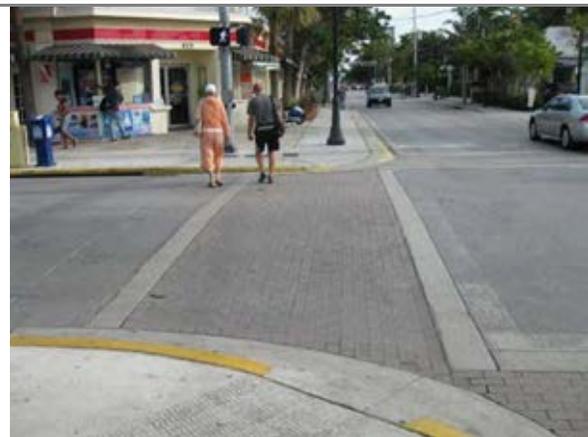
10.2 DUVAL STREET OBSERVATIONS	
Observation	Recommendations
<p>DUVAL and Truman Avenue This is a light controlled intersection.</p> <ul style="list-style-type: none"> ✓ There are corner curb ramps on all 4 corners. ⊗ All have old style detectable warnings. ✓ The pedestrian crosswalks are brick with painted outline. ✓ There are pedestrian crossing lights on all corners. ⊗ The pedestrian detection devices have old push buttons. 	<p>A\$ - Install pedestrian detector controls in accordance with FDOT Design Standards. City of Key West areas of responsibility.</p>
<p>DUVAL and Olivia Street There is a flashing light at this intersection.</p> <ul style="list-style-type: none"> ✓ There are 2 way curb ramps on all 4 corners. 	<p>A\$ - Repaint pedestrian crosswalk areas in accordance with FDOT Design Standards.</p>

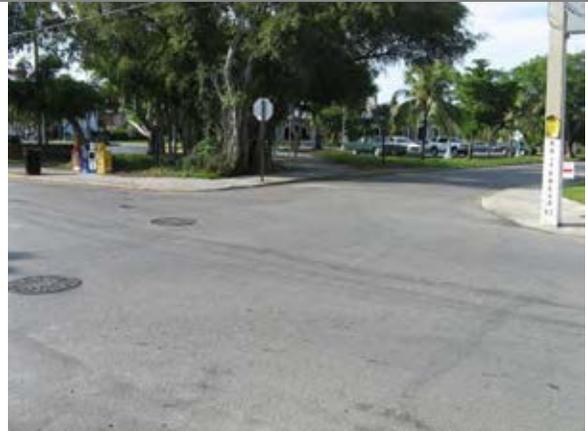
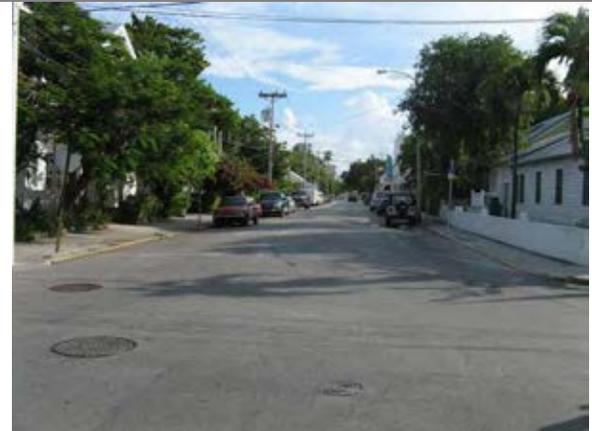
Whitehead and Eaton	Whitehead and Eaton

7.2 EATON STREET OBSERVATIONS	
Observation	Recommendations
EATON and Whitehead Street ☒ Curb ramps on North and West corners do not have detectable warnings. ☒ There are no curb ramps on South and East corners. The pavement is ramped up. ☒ There are no crosswalk markings.	A\$ - Repaint pedestrian crosswalk areas in accordance with FDOT Design Standards. A\$ - Install curb ramps with detectable warnings in accordance with FDOT Design Standards. City of Key West areas of responsibility.
EATON and Duval Street ☒ There is no pedestrian crossing signal at this light controlled intersection. ✓ There is a cross walk in four directions. ☒ The curb ramps have old style diamond pattern detectable warnings. ☒ The N and W corners have 2-way curb ramps; the S and E only have one each. ☒ There are no curb ramps for the pedestrian crossing from E corner to S corner. Markings lead into a drain.	A\$ - Repaint pedestrian crosswalk areas in accordance with FDOT Design Standards. A\$ - Install curb ramps with detectable warnings in accordance with FDOT Design Standards. A\$ - Install pedestrian signals at this lighted intersection in accordance with FDOT Design Standards. City of Key West areas of responsibility.
